**From:** "Davis, James T." <JTDAVIS@southernco.com>  
**To:** "Christian Araguas" <CJA2@nrc.gov>  
**Date:** 4/16/2007 6:18:10 PM  
**Subject:** RAI Letter #6 Hydrology Response 2 of 4

FINAL REPORT ON DEWATERING AND REPAIR OF EROSION  
IN CATEGORY I BACKFILL IN POWER BLOCK AREA

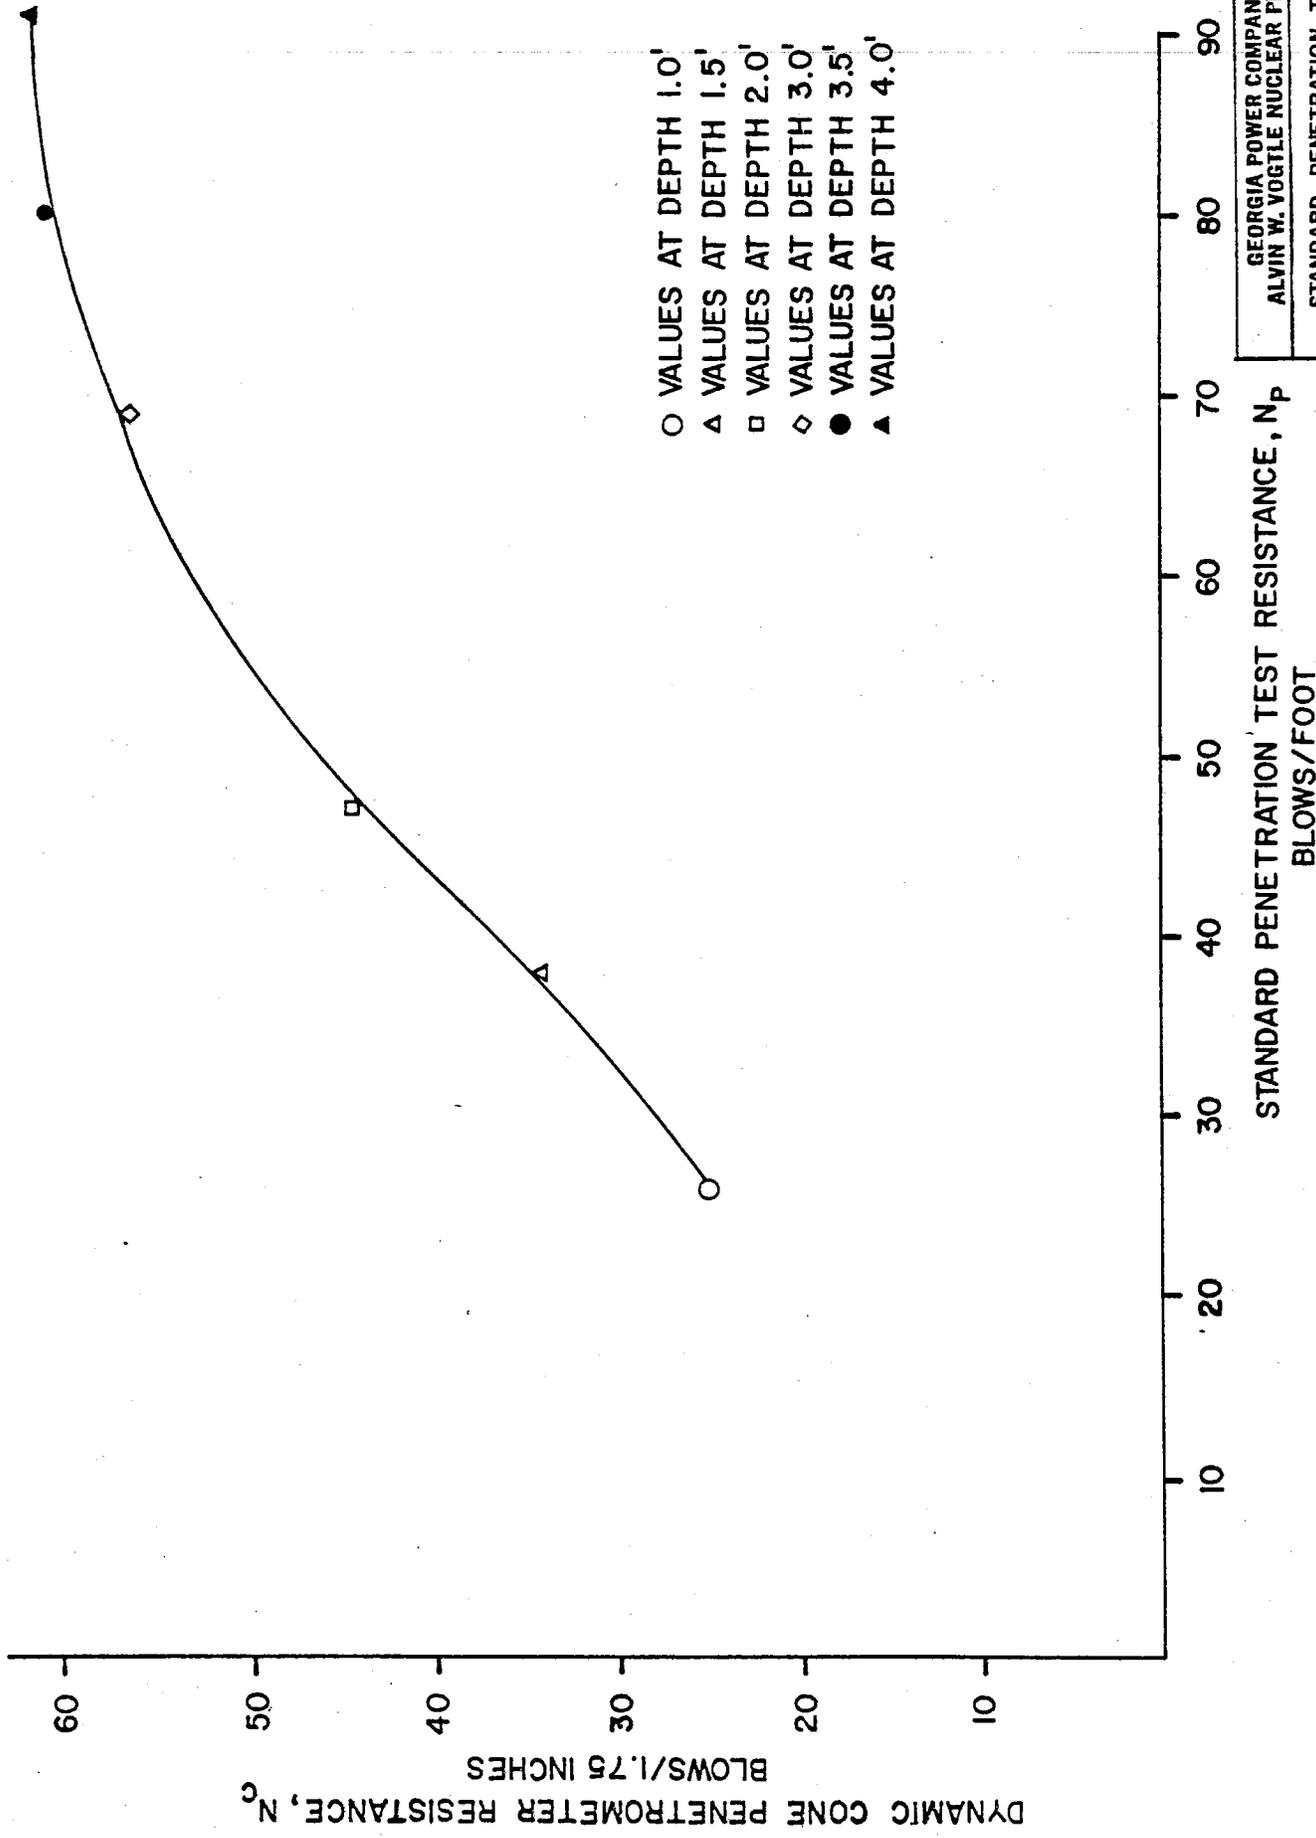
GEORGIA POWER COMPANY ALVIN W. VOGTLE NUCLEAR PLANT	
STANDARD PENETRATION TEST AND DYNAMIC CONE PENETROMETER TEST CALIBRATION CURVE	
SCALE:	DRAWING NO. REV.
JOB NO. 9510	FIGURE 3

Depth (ft.)	Average SPT Values, Blows/Ft., Np	Average DCP Values, Blows/1.75 Inches Nc	Remarks
1.0	26	25	Values Plotted in Figure 3
1.5	38*	34	
2.0	47*	44	
3.0	69*	56	
3.5	80*	60	
4.0	92	62

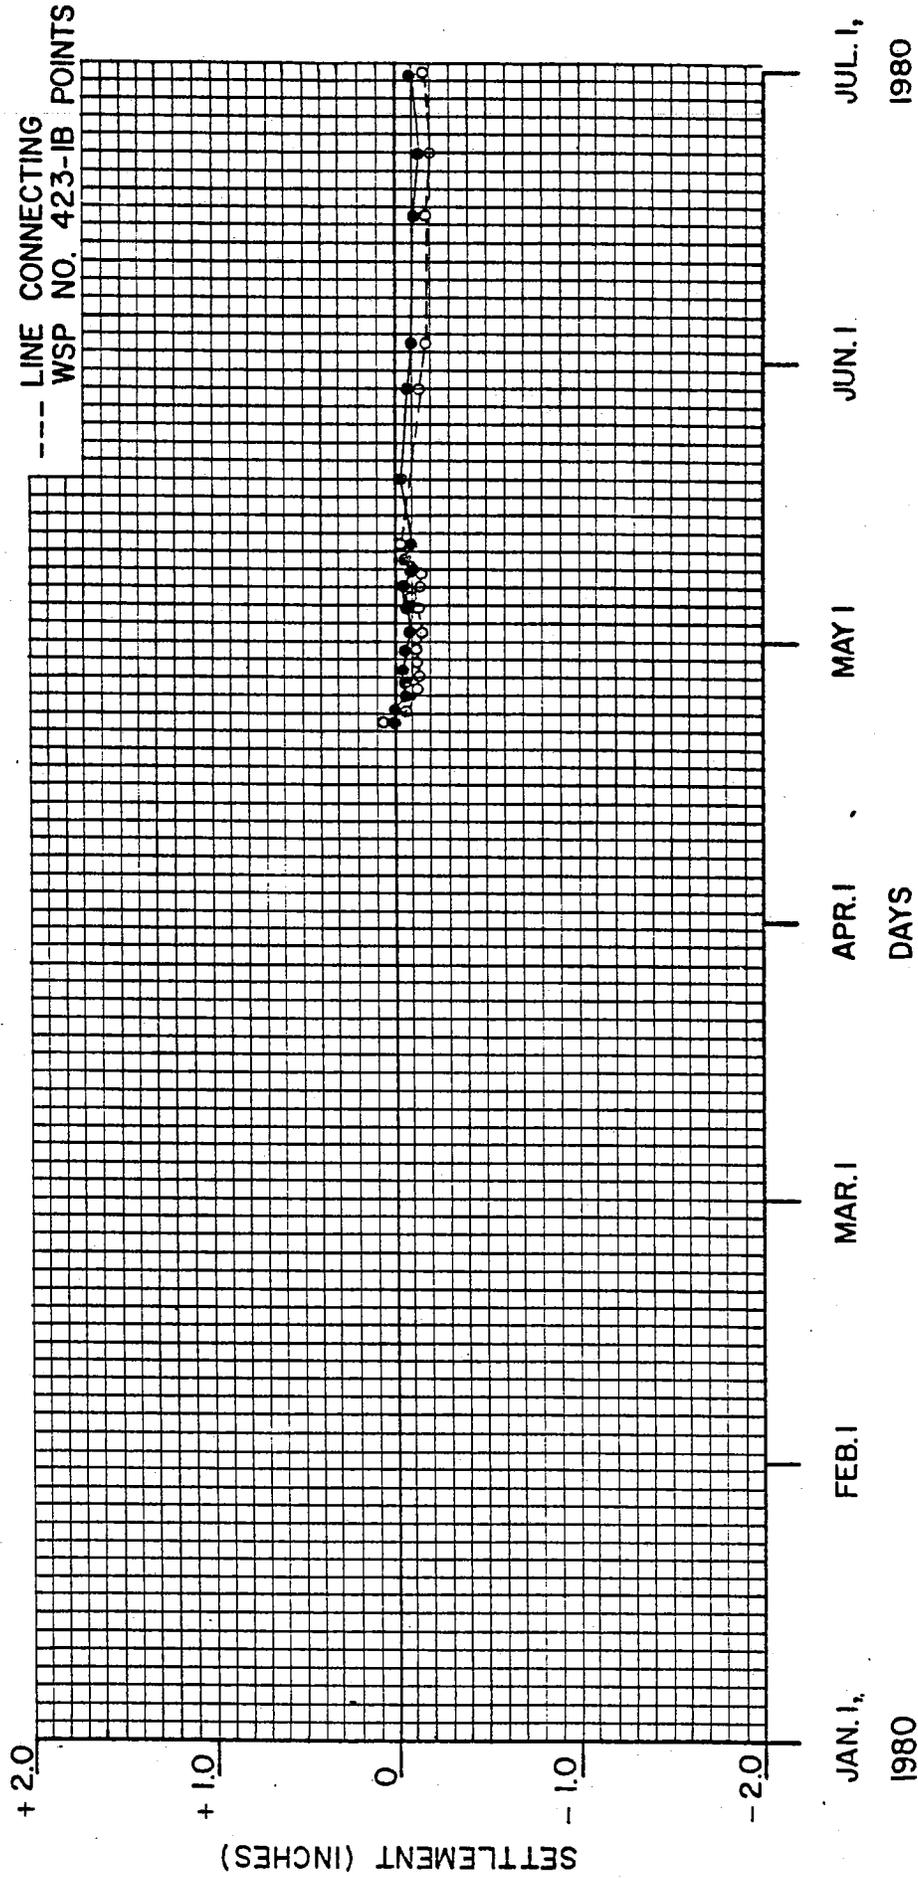
GEORGIA POWER COMPANY	
ALVIN W. VOGTLE NUCLEAR PLANT	
SETTLEMENT VERSUS TIME	
FOR ELECTRICAL TUNNEL UNIT 1	
SCALE:	DRAWING NO.
JOB NO. 9510	REV.
	FIGURE 16-4B

January, 1980, onward. Plots of settlement versus time for the markers are shown on Figures 16-4A and 16-4B. The maximum recorded settlement was on the order of 0.2 inch, which is reasonable considering the current loading and the limits of the survey accuracy.

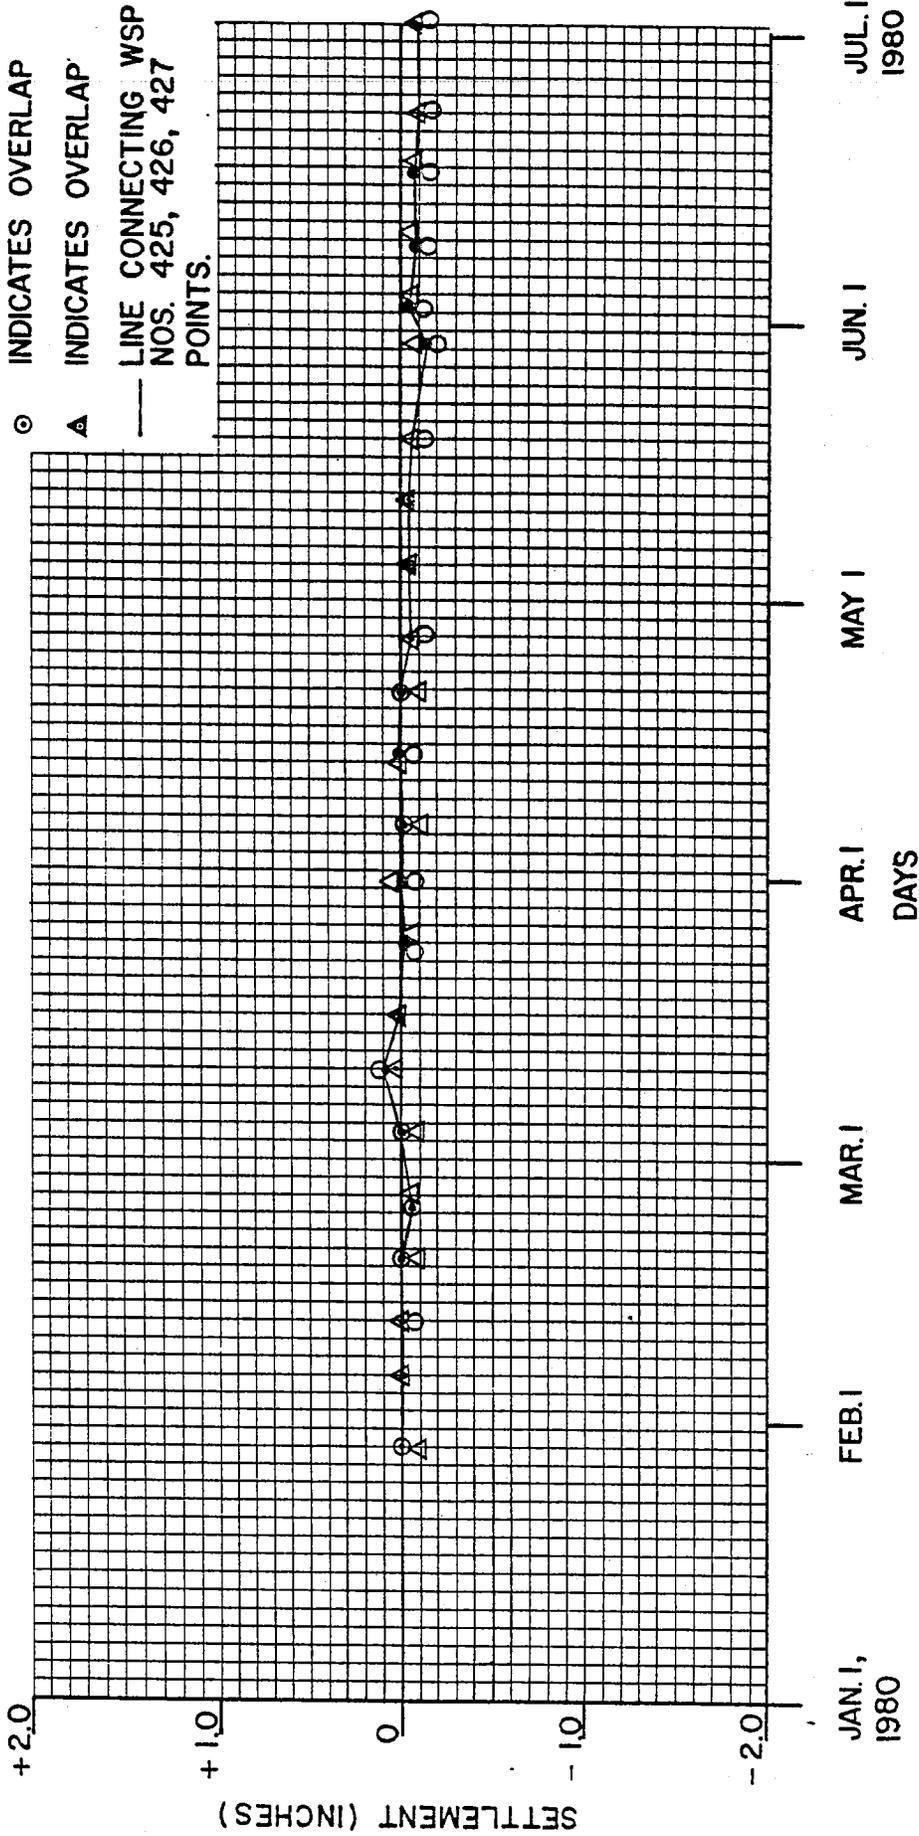
GEORGIA POWER COMPANY ALVIN W. YOGTLE NUCLEAR PLANT		
SETTLEMENT VERSUS TIME FOR CONTAINMENT UNIT 2		
SCALE:	DRAWING NO.	REV.
JOB NO. 9510	FIGURE 16-5

Three settlement markers had been installed to monitor settlement of the Tendon Gallery foundation. These markers, designated as Nos. 425, 426 and 427, were located as shown on Figure 16. A plot of settlement versus time for the period January 1, 1980, through July 1, 1980, is shown on Figure 16-5. The data indicate that a maximum settlement of 0.17 inch was recorded, which is considered reasonable for the current loading condition and the limits of the survey accuracy. It was concluded from field test data and visual observations that the Unit 2 Containment Tendon Gallery was not affected by erosion adjacent to the foundation.

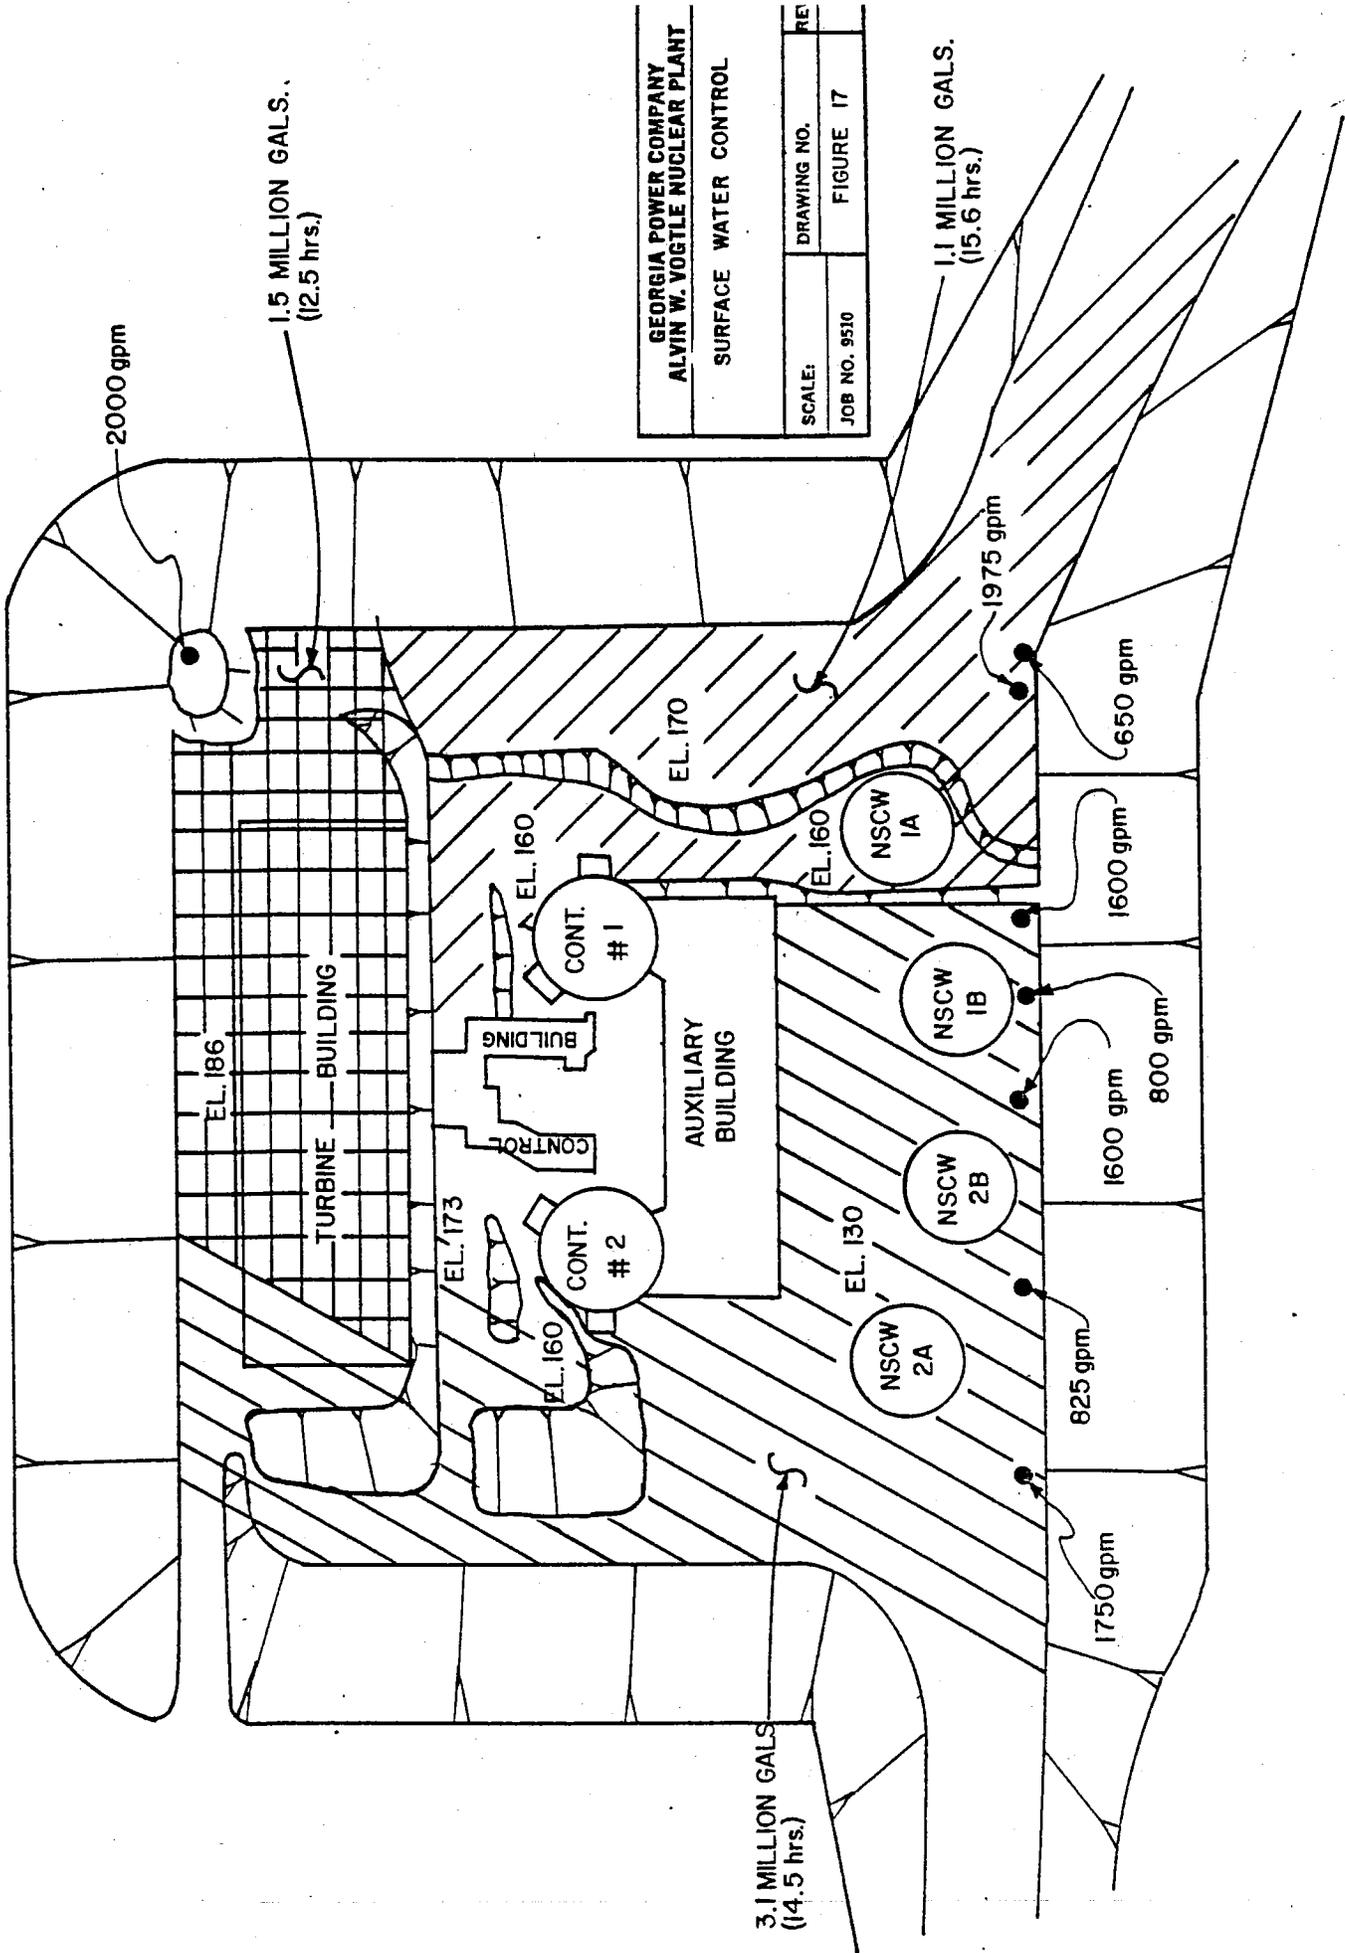
GEORGIA POWER COMPANY ALVIN W. VOGTLE NUCLEAR PLANT	
SURFACE WATER CONTROL	
SCALE:	DRAWING NO. RE
JOB NO. 9510	FIGURE 17

Figure 17, Surface Water Control, shows the location of the sumps along with pumping capacity. The pumping system in the northeast corner is capable of pumping 2000 gpm. Five pumping systems located in the southwest area of the power block have a total capacity of 6575 gpm. Two systems located in the southeast area have a total capacity of 2625 gpm. The total capacity of all systems is 11,200 gpm. The pump capacities shown on Figure 17 are as-built conditions and may be increased.

Calculations were made based on 5-inches of rainfall to determine the amount of water that would collect in the power block and the length of time necessary to remove this run-off from the power block. A 10-year storm with a duration of 12-hours would produce 4.5-inches of rainfall; a 50-year storm with a duration of 24-hours would provide 10-inches of rainfall. Figure 17 shows the amount of rainfall and the length of time needed to remove the run-off from each area. These figures are based on having approximately 4500 gpm of groundwater entering the power block and show that the existing system can adequately handle both the 10-year, 12-hour storm and the 50-year, 24-hour storm. Several areas of the power block may also be utilized to store rainfall for later removal. The northeast sump has a capacity of approximately 450,000 gallons, the southwest area has a storage capacity of approximately 1.7-million gallons, and the Auxiliary Building and its sumps may store 200,000 gallons without causing any harm to equipment.

Figure 17 Surface Water Control shows the locations of the sumps, pumps and the northeast impoundment. The pump located in the northeast impoundment is rated at 2600 gpm at 45' of head. The remaining seven pumps located in the main power block have a total rating of 13,000 gpm at 90' of head. Five of the pumps are each rated at 2200 gpm at 90' of head, the other two pumps are rated at 1000 gpm at 90' of head. The total pumping capacity from the power block during a rainfall is 15,600 gpm.

9. Remove kinks from suction line hoses on diesel pumps.  
Replace 8" hose section on pump E with 8" hard piping.
