NUREG/CR-6095
SAND93-1803

Aging, Loss-of-Coolant Accident (LOCA), and High Potential Testing of Damaged Cables

Prepared by
R. A. Vigil/SEA
M. J. Jacobus/SNL

Sandia National Laboratories
Operated by
Sandia Corporation

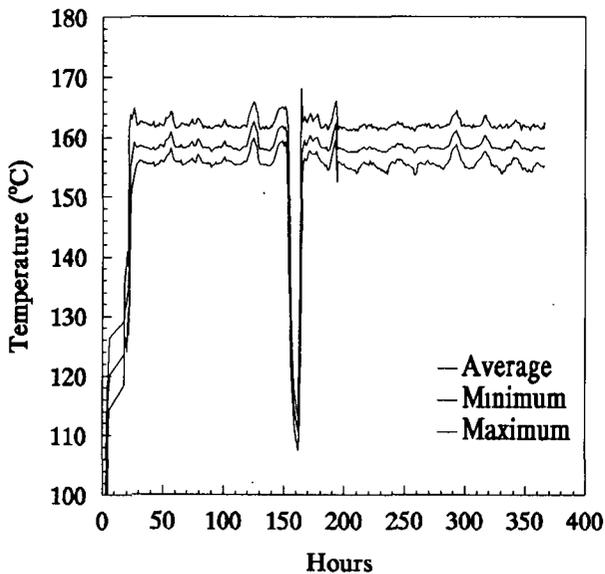
Figure 2 Thermal Aging Profile

thermal aging. Note the drop in temperature at approximately 6 days. This anomaly in temperature was caused by a failed electric circulation heater. The defective electric circulation heater was removed while the remaining electric circulation heater maintained the chamber temperature above 100°C until a new electric circulation heater was added to restore the chamber to the desired temperature. The drop in temperature existed for approximately 24 hours. The thermal aging was extended by 24 hours to compensate for this anomaly. The effect of this anomaly is an insignificant increase in the total thermal aging.

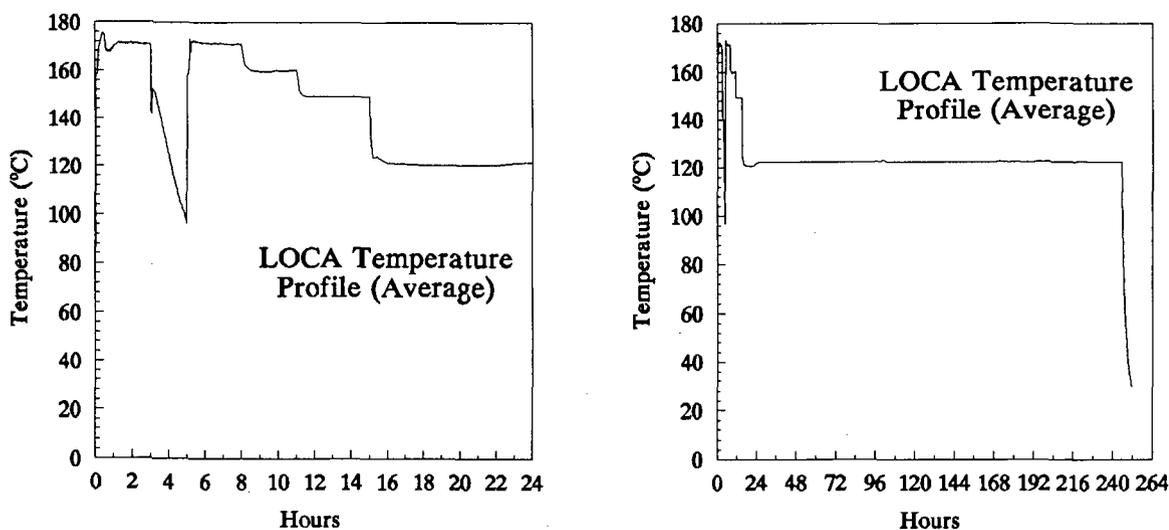
Figure 4 LOCA Simulation Temperature Profiles

Following aging, the cables were subjected to the LOCA simulation. The temperature and pressure profiles during the LOCA simulation are shown in Figures 4 and 5, respectively. Plots for the first 24 hours of the accident simulation are shown along with overall test profiles. The IR of each cable during the accident simulation is shown in Appendix A. The power supply energizing the test cables failed unexpectedly at approximately 30 hours into the LOCA simulation. A new power supply was installed at approximately 46 hours into the LOCA simulation—this accounts for the brief transient noted in many of the insulation resistance graphs. The only effect of the failed power supply was a loss of continuous IR data during the outage.

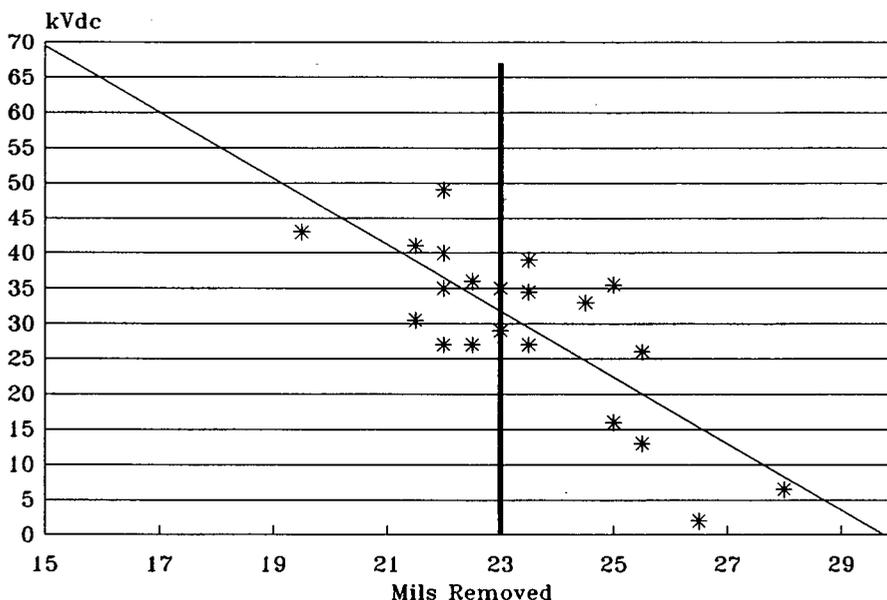
Figure 9 Breakdown Voltages for Damaged Brand Rex Cables Tested in Water

The results from the Phase III testing show the differences in breakdown voltages between Brand Rex cables cycled at 35 kVdc and the uncycled Brand Rex cables from Phase I. The 35 kVdc cycling voltage criterion was determined by examining the results of numerous breakdown tests of damaged (milled) Brand Rex cables as shown in Figure 9 and from previous Sandia tests [2]. The 35 kVdc test voltage will detect when Brand Rex cables have insulation damage greater than 23 mils provided that the cables are tested in water. Twenty-five cables were cycled as in Phase I for a total of 60 minutes at 35 kVdc (30 minutes
