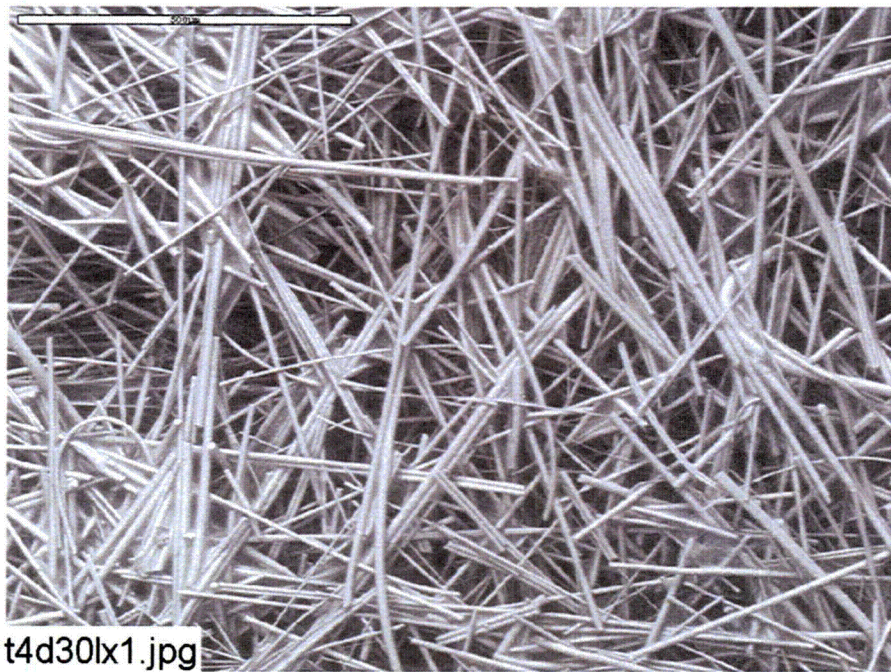
A similar amount and composition of the film deposits were found with Day-30 low-flow fiberglass samples compared to Day-5 and Day-15 low-flow fiberglass samples. No significant difference was found regarding the amount of the film deposits between the exterior and the interior Day-30 low-flow fiberglass samples. As with the Day-5 and 15 samples, the film was composed of O, Na, Ca, Mg, Al, C, K, and possibly Si. Besides the film, a coating was found on the glass fibers (see Figure 3-39). The coating was likely formed by chemical precipitation. EDS analysis shows the coating had the same composition as the film, suggesting both are likely of chemical origin. Figures 3-37 through 3-43 show the Day-30 low-flow fiberglass results.

Figure 3-37. ESEM image magnified 100 times for a Test #4, Day-30 exterior low-flow fiberglass sample. (t4d30lx1.jpg)

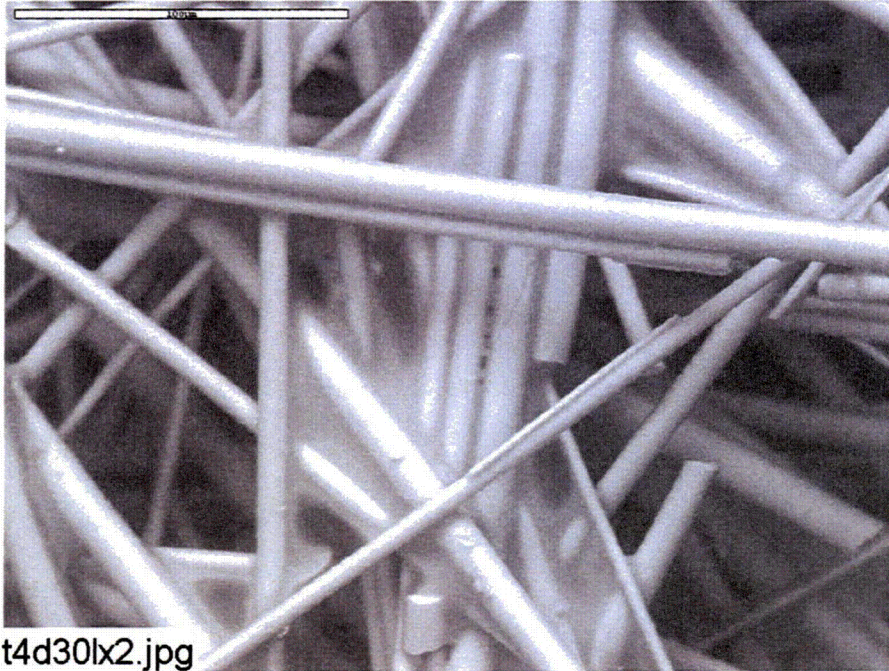
Figure 3-38. ESEM image magnified 500 times for a Test #4, Day-30 exterior low-flow fiberglass sample. (t4d30lx2.jpg)

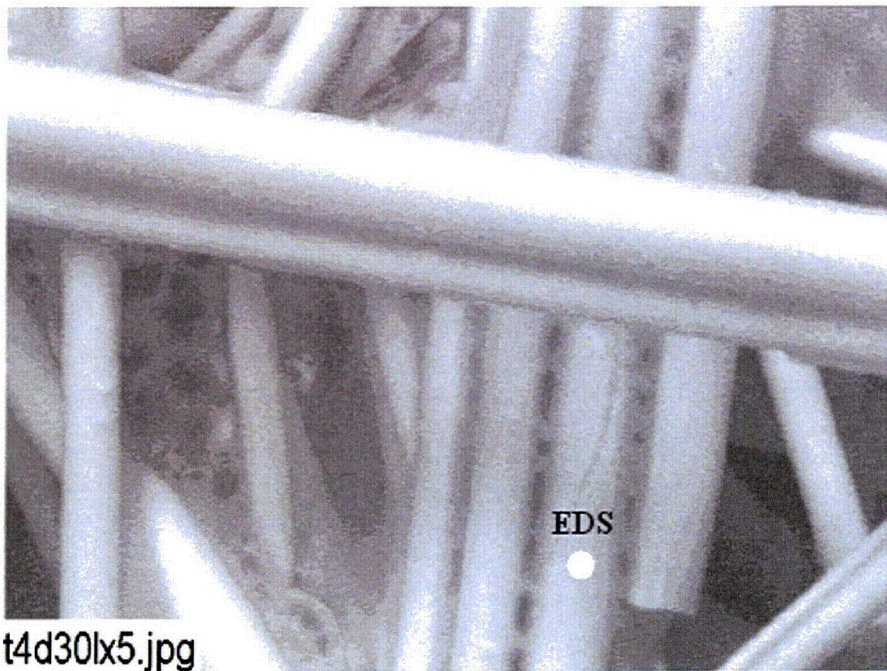
Figure 3-39. ESEM image magnified 1000 times for a Test #4, Day-30 low-flow fiberglass sample. (t4d30lx5.jpg)

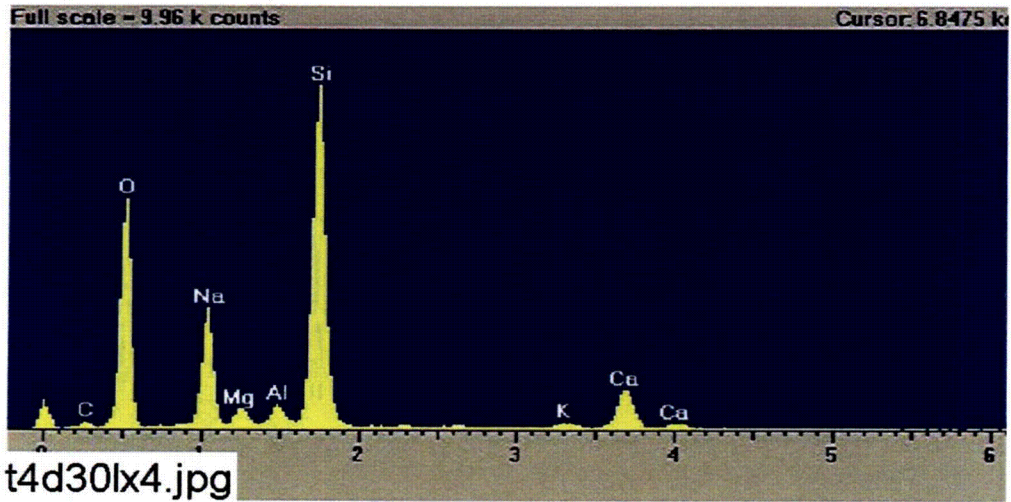
Figure 3-40. EDS counting spectrum for the spot of coating substance on the fiberglass shown in Figure 3-39. (t4d30lx4.jpg)

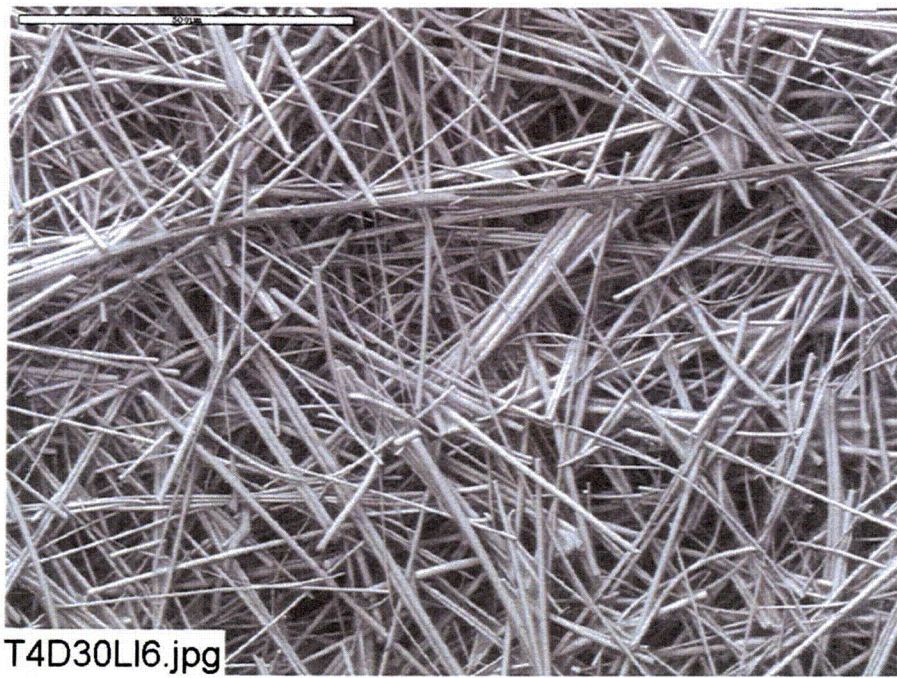
Figure 3-41. ESEM image magnified 100 times for a Test #4, Day-30 interior low-flow fiberglass sample. (T4D30LI6.jpg)

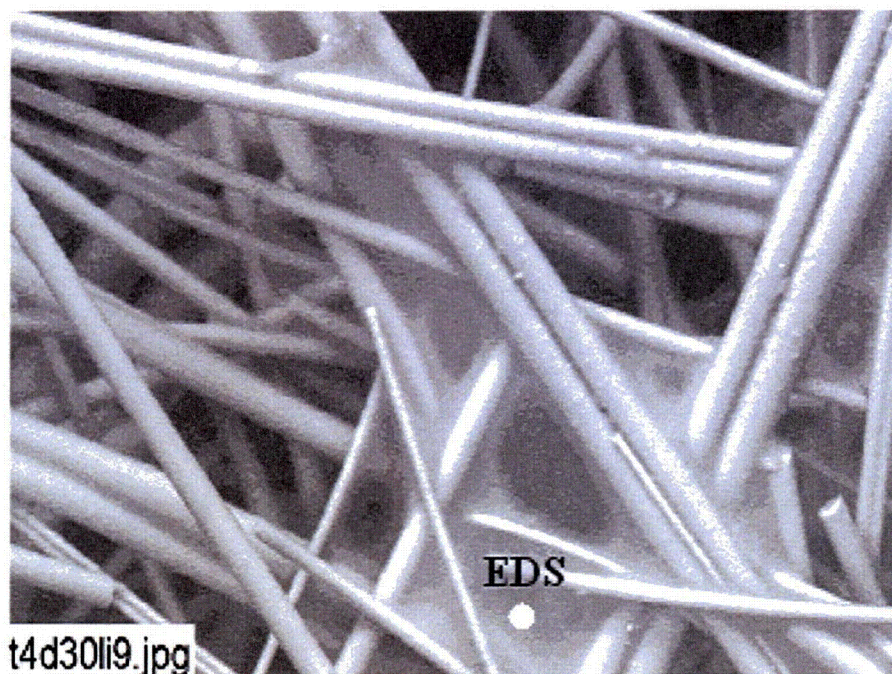
Figure 3-42. ESEM image magnified 500 times for a Test #4, Day-30 interior low-flow fiberglass sample. (t4d30li9.jpg)

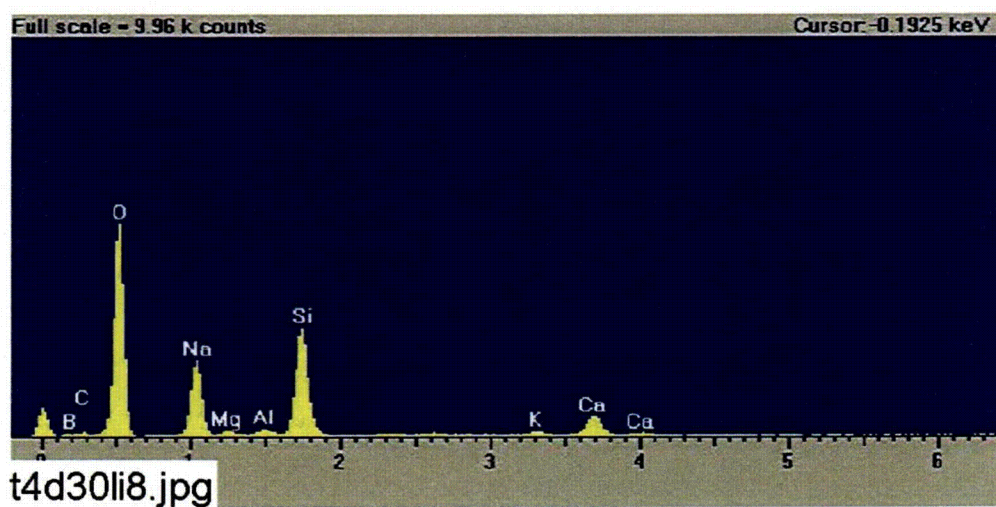
Figure 3-43. EDS counting spectrum for the film on the fiberglass shown in Figure 3-42. (t4d30li8.jpg)

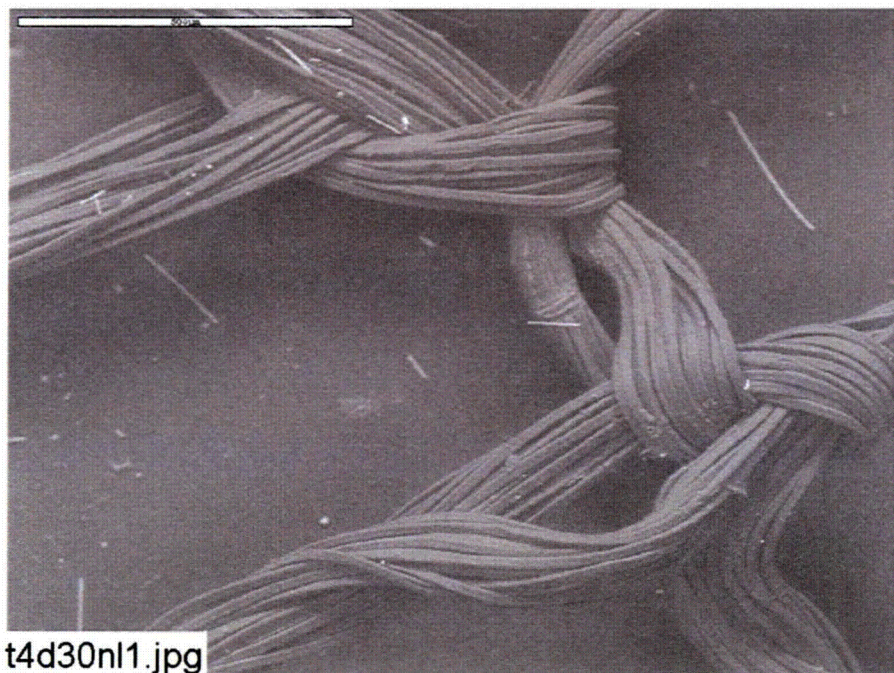
A 5 g fiberglass sample was enclosed in a nylon mesh and submerged in a low-flow zone of the tank on Day 3, to provide a comparison to all other fiberglass samples, which were enclosed in stainless steel mesh and placed in the tank on Day 0. The purpose of using a nylon mesh was to see if the mesh material (i.e., stainless steel or nylon) affects the deposits on the fiberglass samples. Comparing these results to Day-30 low-flow fiberglass samples, no significant difference was observed. The film was still the dominant deposit on both of the exterior and the interior samples. There were no particulate deposits found on the fiberglass. This result suggests that the mesh material did not significantly affect the deposits on fiberglass. In addition, ESEM images show that the nylon fiber was relatively clean and without significant deposits on it. The nylon mesh sample was put in the tank on Day 3, and no significant difference was found compared to the low-flow fiberglass samples put in the tank at the start of the test. Figures 3-44 through 3-49 show the Day-30 nylon-enclosed fiberglass results.

Figure 3-44. ESEM image magnified 100 times for a Test #4, Day-30 nylon mesh submerged in low-flow area (inserted on Day 4). (t4d30n11.jpg)

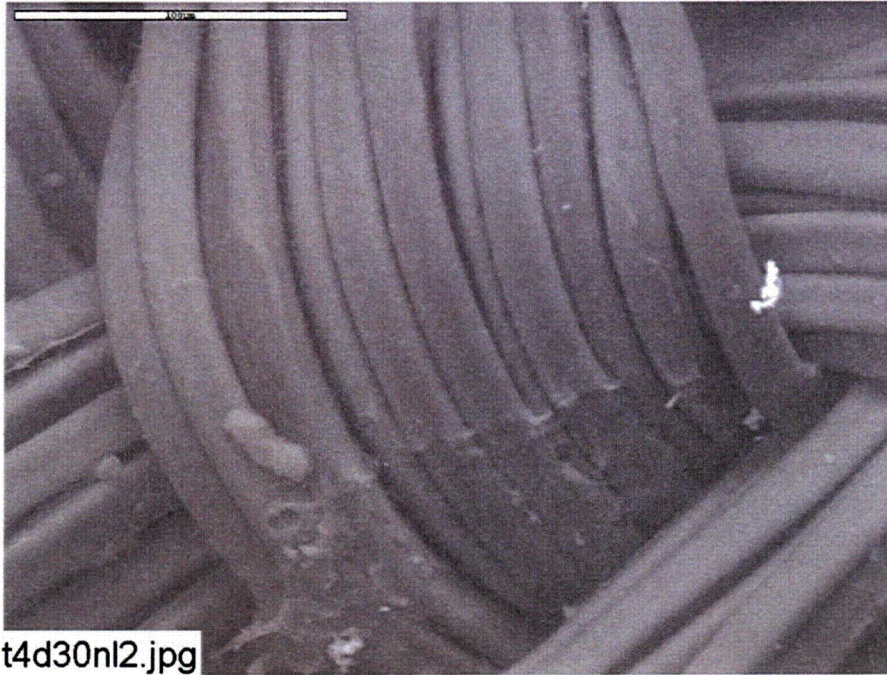
Figure 3-45. ESEM image magnified 500 times for a Test #4, Day-30 nylon mesh submerged in low-flow area (inserted on Day 4). (t4d30nl2.jpg)

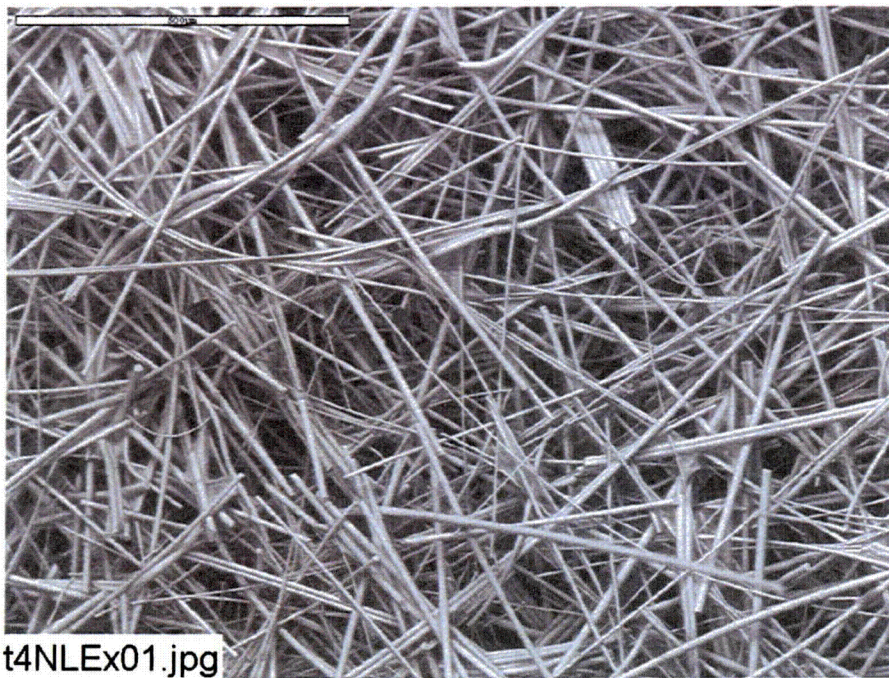
Figure 3-46. ESEM image magnified 100 times for a Test #4, Day-30 exterior low-flow fiberglass sample contained in a nylon mesh (inserted on Day 4). (t4NLEx01.jpg)

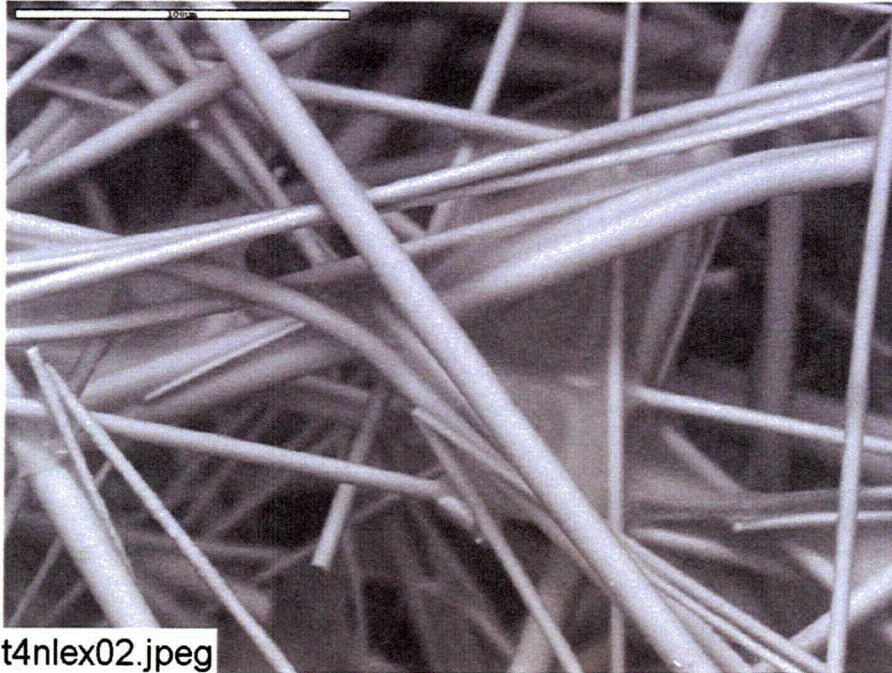
Figure 3-47. ESEM image magnified 500 times for a Test #4, Day-30 exterior low-flow fiberglass sample contained in a nylon mesh (inserted on Day 4). (t4nlex02.jpg)

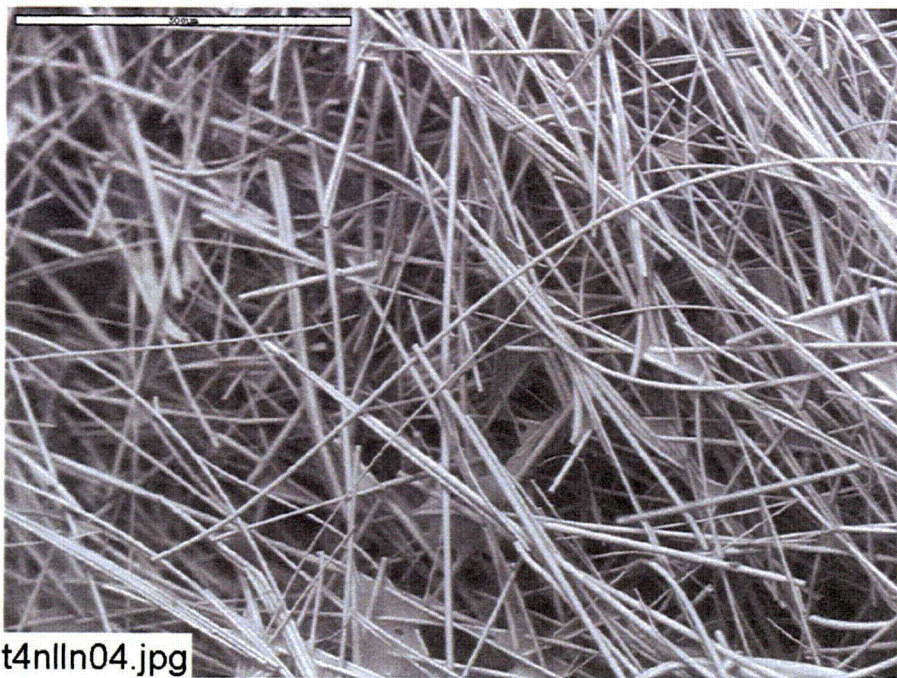
Figure 3-48. ESEM image magnified 100 times for a Test #4, Day-30 interior low-flow fiberglass sample contained in a nylon mesh (inserted on Day 4). (t4nlln04.jpg)

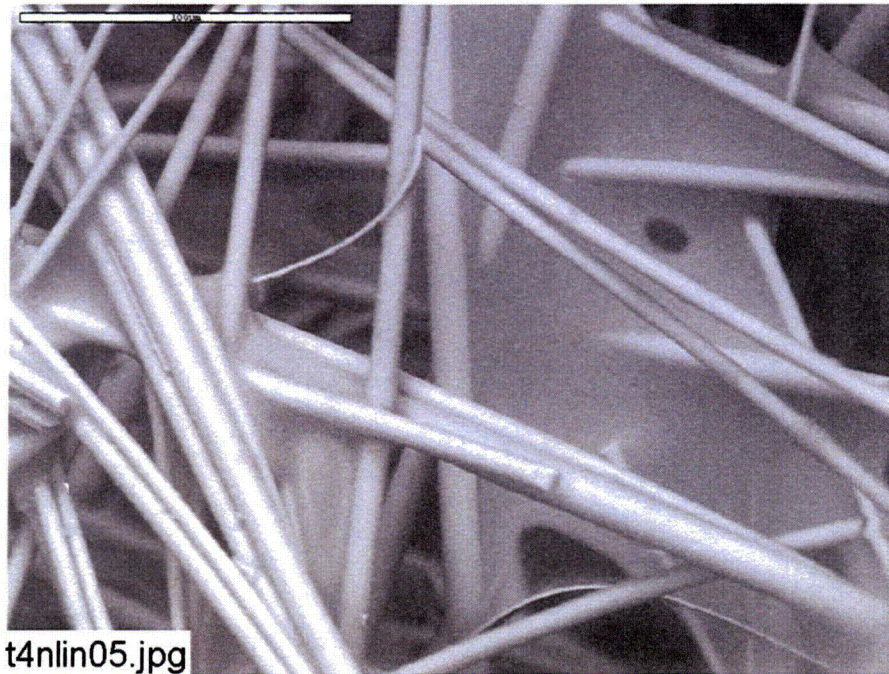
Figure 3-49. ESEM image magnified 500 times for a Test #4, Day-30 interior low-flow fiberglass sample contained in a nylon mesh (inserted on Day 4). (t4nlin05.jpg)

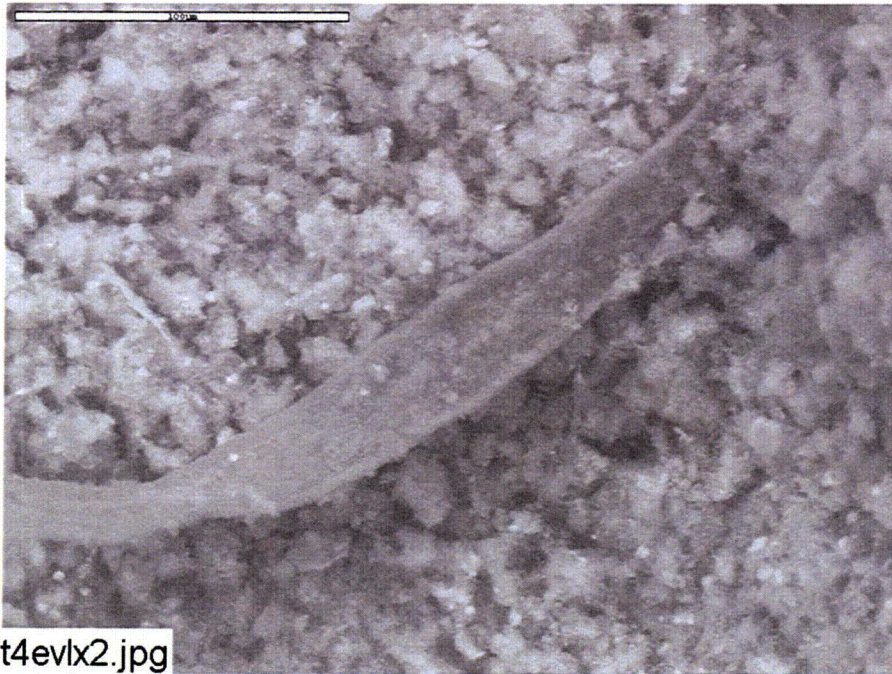
t4evlx2.jpg

Compared to other Day-30 low-flow fiberglass samples, a significant amount of particulate deposits was observed on the exterior of the Day-30 low-flow samples in the big envelope. The big envelope sat on the tank bottom and was in contact with the test sediment on the bottom of the envelope. Figure 3-120 shows the sediment after the samples were lifted out of the tank. However, no particulate deposits were observed on the fiberglass interior. In addition, some large flat fibers were found on the exterior fiberglass samples (see Figure 3-51). These large flat fibers were likely from cal-sil (see Appendix D). It is possible that the particulate deposits and cal-sil fibers were physically attached/retained on the exterior of the fiberglass samples. Figures 3-50 through 3-53 show the results from the Day-30 low-flow fiberglass enclosed in the big envelope. In contrast to other samples, these samples were gently rinsed with RO water and no film was found on either the exterior or the interior of the fiberglass. The disappearance of the film is likely caused by the rinse of RO water to keep the sample moist before ESEM analysis. Based on the control experiment noted earlier (see Appendix C4), the film is soluble.

Figure 3-51. ESEM image magnified 500 times for a Test #4, Day-30 exterior low-flow fiberglass sample in a big envelope. (t4evlx2.jpg)

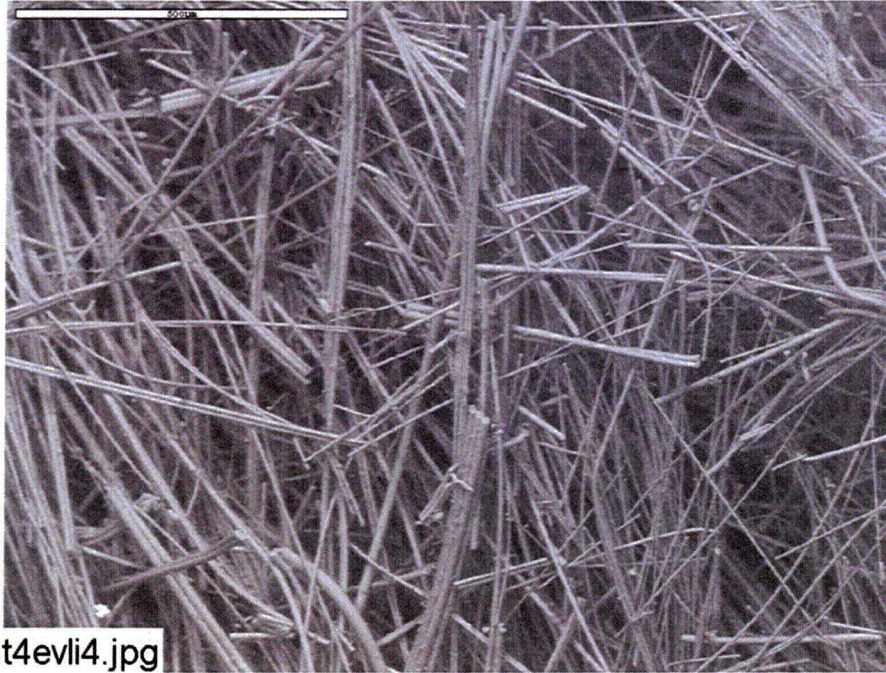
Figure 3-52. ESEM image magnified 100 times for a Test #4, Day-30 interior low-flow fiberglass sample in a big envelope. (t4evli4.jpg)

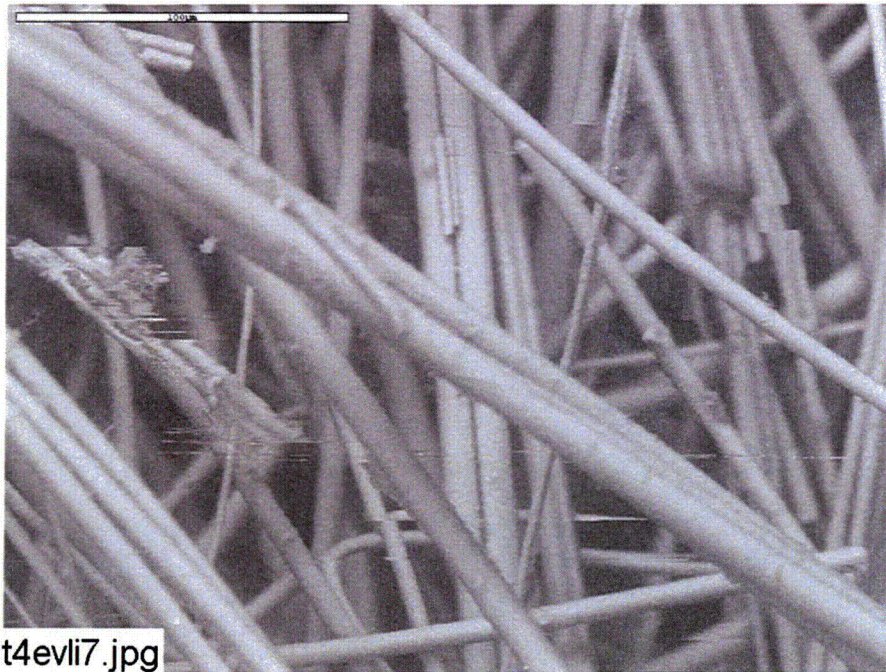
Figure 3-53. ESEM image magnified 500 times for a Test #4, Day-30 interior low-flow fiberglass sample in a big envelope. (t4evli7.jpg)

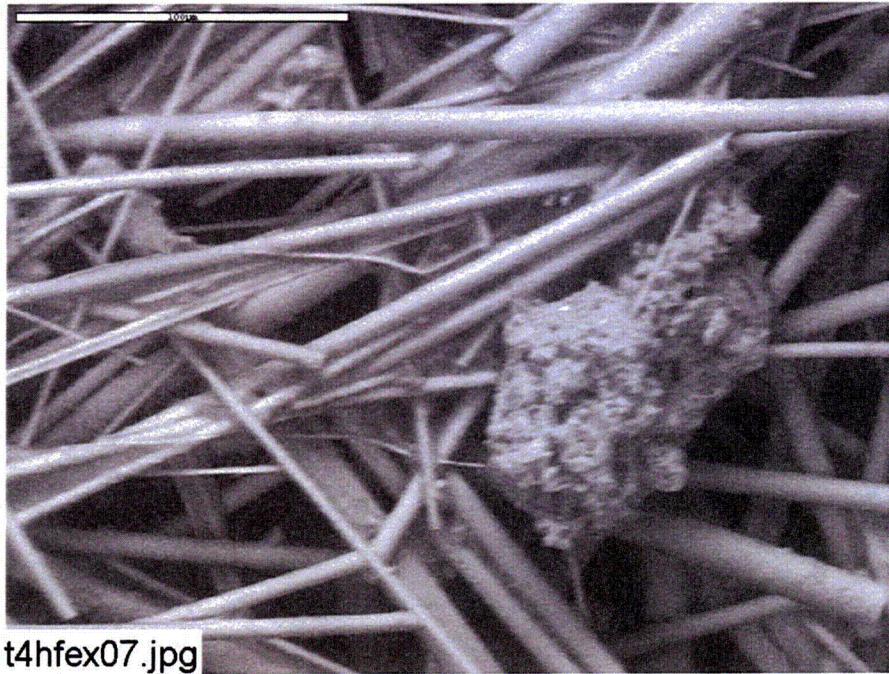
t4hfex07.jpg

Compared to Day-30 low-flow fiberglass samples, a significant amount of particulate deposits and fiberglass debris were found on high-flow exterior samples. However, no particulate deposits were found on the interior. This result suggests that these particulate deposits were physically attached/retained on the fiberglass exterior. However, similar film deposits were found on both of the fiberglass exterior and the interior. The EDS result shows the film was composed of O, Na, Ca, C, Mg, Al, K, and possibly Si, which is similar to other EDS results. Figures 3-54 through 3-61 show the Day-30 high-flow fiberglass results. Figures 3-60 and 3-61 show fiberglass after it was rinsed with RO water.

Figure 3-55. ESEM image magnified 500 times for a Test #4, Day-30 exterior high-flow fiberglass sample. (t4hfex07.jpg)

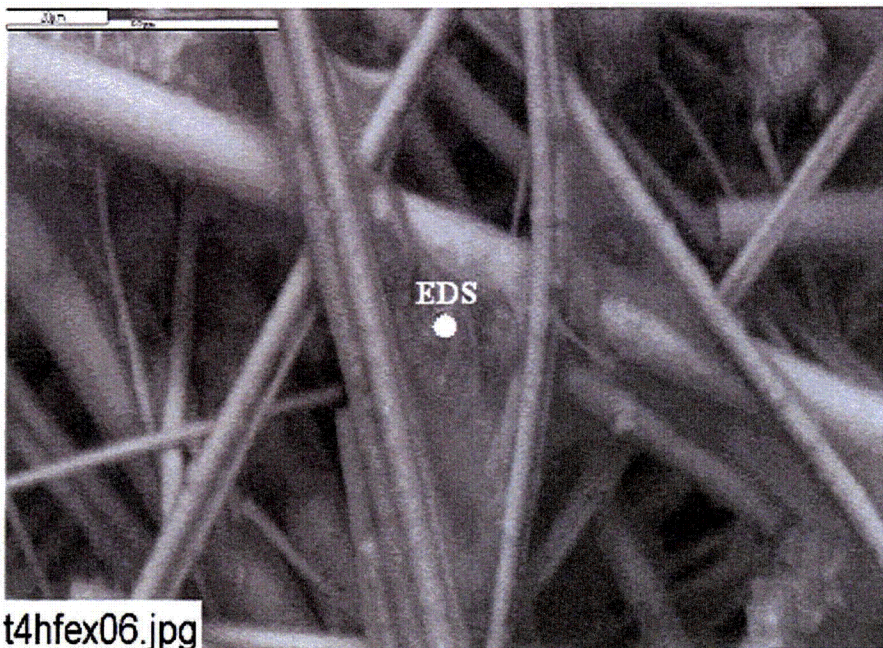
t4hfex06.jpg

Figure 3-56. ESEM image magnified 800 times for a Test #4, Day-30 exterior high-flow fiberglass sample. (t4hfex06.jpg)

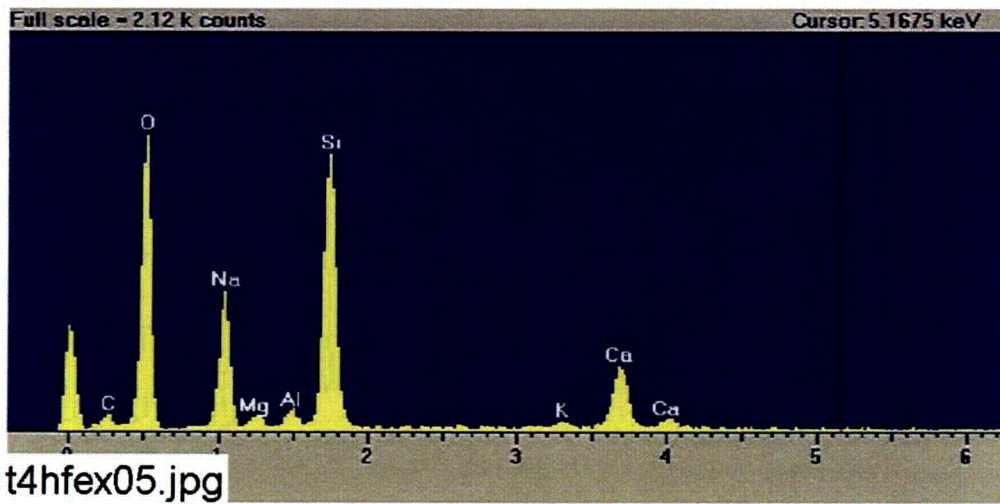
Figure 3-57. EDS counting spectrum for the spot of film on the fiberglass shown in Figure 3-56. (t4hfex05.jpg)

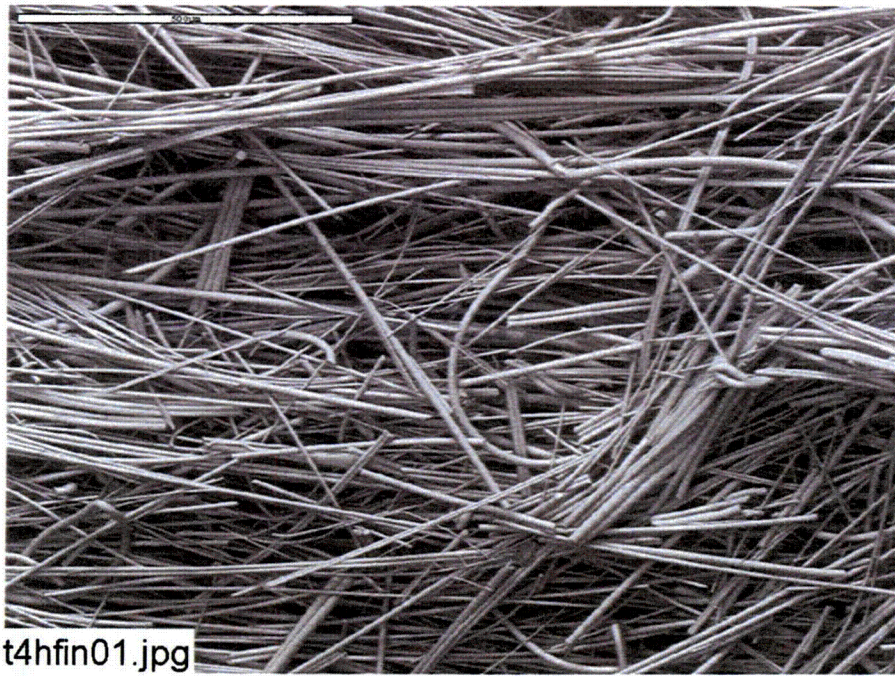
Figure 3-58. ESEM image magnified 100 times for a Test #4, Day-30 interior high-flow fiberglass sample. (t4hfin01.jpg)

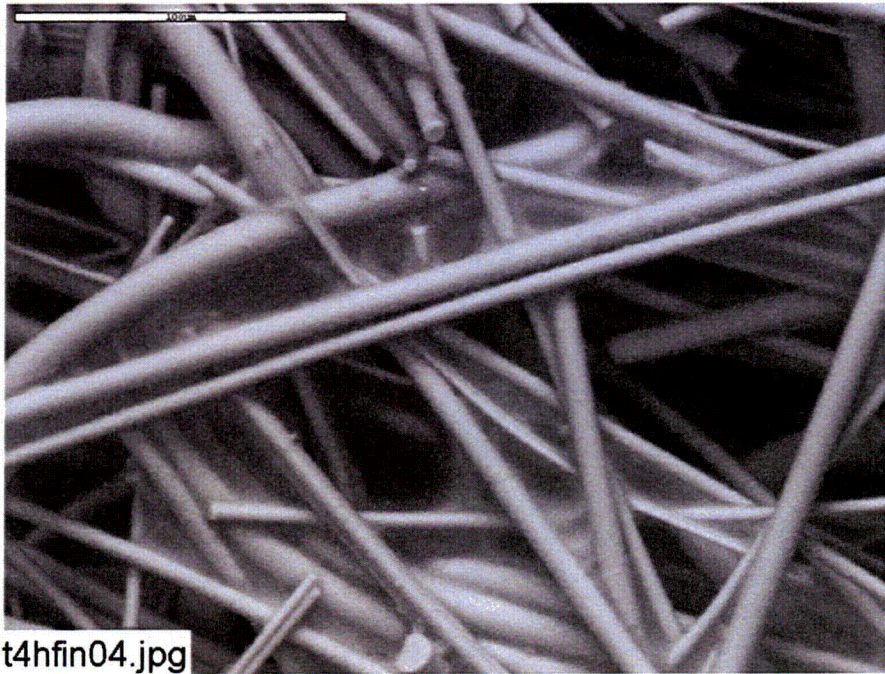
Figure 3-59. ESEM image magnified 500 times for a Test #4, Day-30 interior high-flow fiberglass sample. (t4hfin04.jpg)

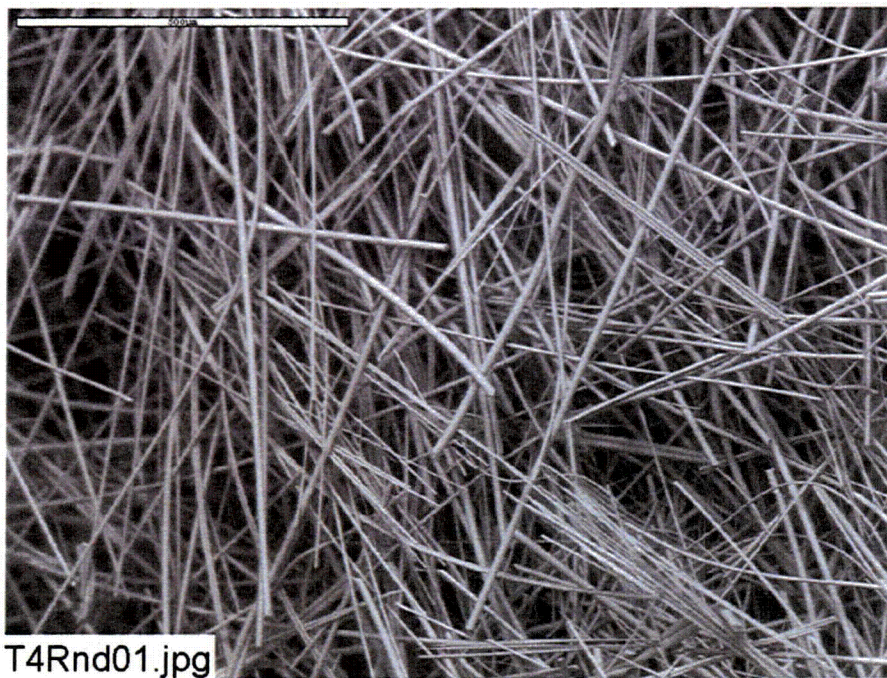
Figure 3-60. ESEM image magnified 100 times for a Test #4, Day-30 interior high-flow fiberglass sample. The sample was gently prerinsed with RO water. (T4Rnd01.jpg)

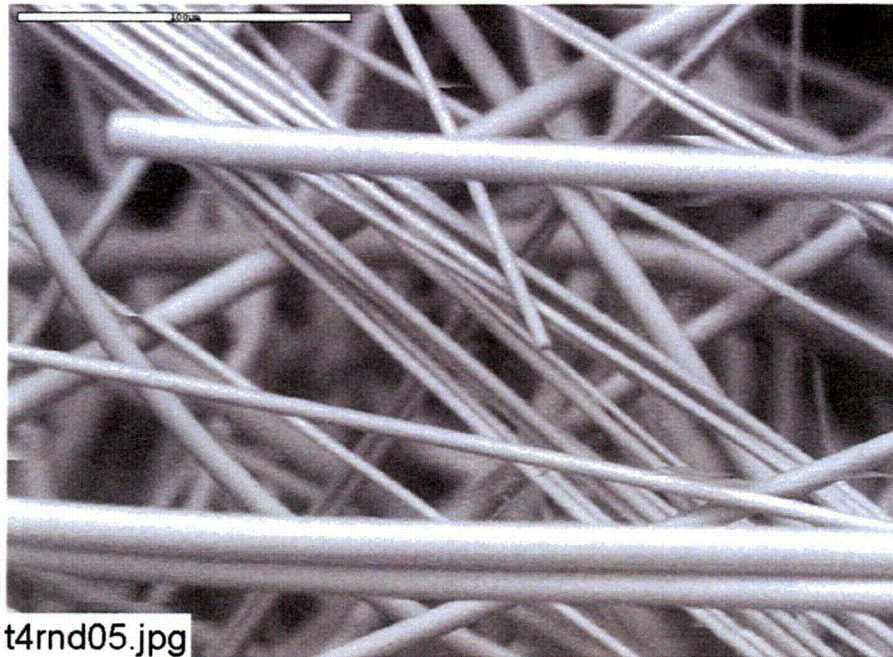
Figure 3-61. ESEM image magnified 500 times for a Test #4, Day-30 interior high-flow fiberglass sample. The sample was gently prerinse with RO water. (t4rnd05.jpg)

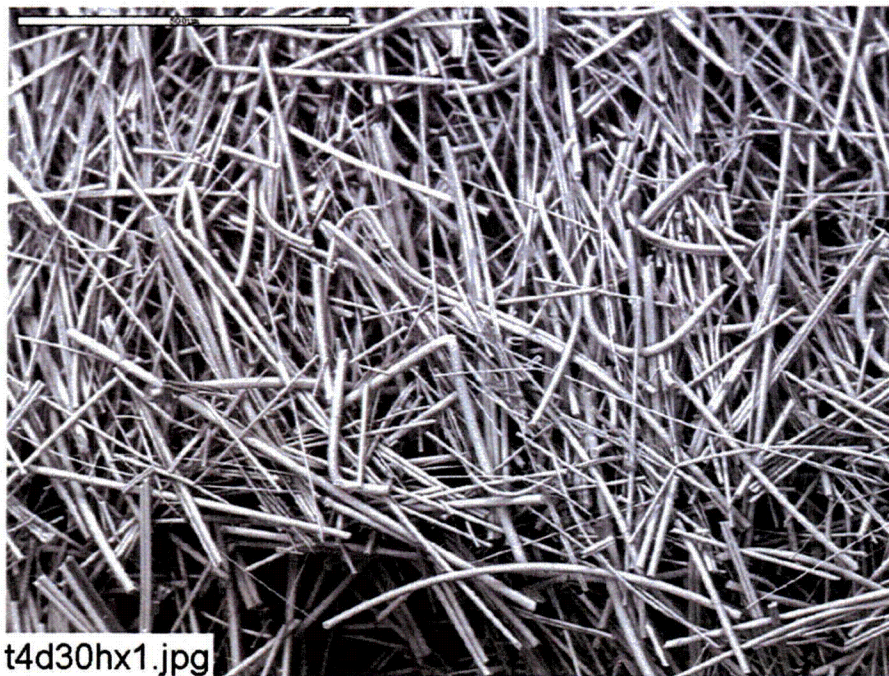
The images of the fiberglass in front of a header are different from the conventional high-flow fiberglass samples in Section 3.3.1.7. The header sample was put in the tank on Day 2 to compare with samples placed in the tank on Day 0. Due to settling of suspended particles and decrease in turbidity during the first two days of the test, no significant particulate deposits were found on the header fiberglass exterior, as shown by ESEM images. This suggests that the deposits observed on the exterior of the high-flow samples put in the tank on Day 0 are due to the higher suspended solids and turbidity present in the system during the first several days. However, the coating and film deposits were found on both the exterior and the interior of the header samples. Consistent with earlier observations, the coating and the film were composed of O, Na, Ca, Mg, Al, C, K, and possibly Si. As mentioned before, coating and film deposits are likely caused by chemical precipitation when the samples were partially dehydrated. Figures 3-62 through 3-68 show the results from the Day-30 high-flow fiberglass in front of a header.

Figure 3-62. ESEM image magnified 100 times for a Test #4, Day-30 exterior high-flow fiberglass sample in front of a header (inserted on Day 4). (t4d30hx1.jpg)

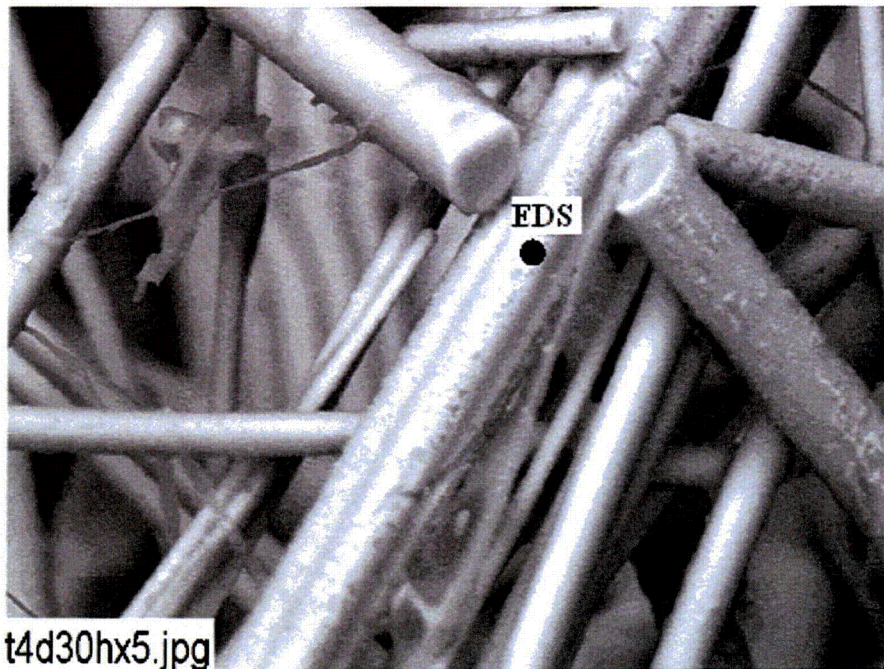
Figure 3-63. ESEM image magnified 1000 times for a Test #4, Day-30 exterior high-flow fiberglass sample in front of a header (inserted on Day 4). (t4d30hx5.jpg)

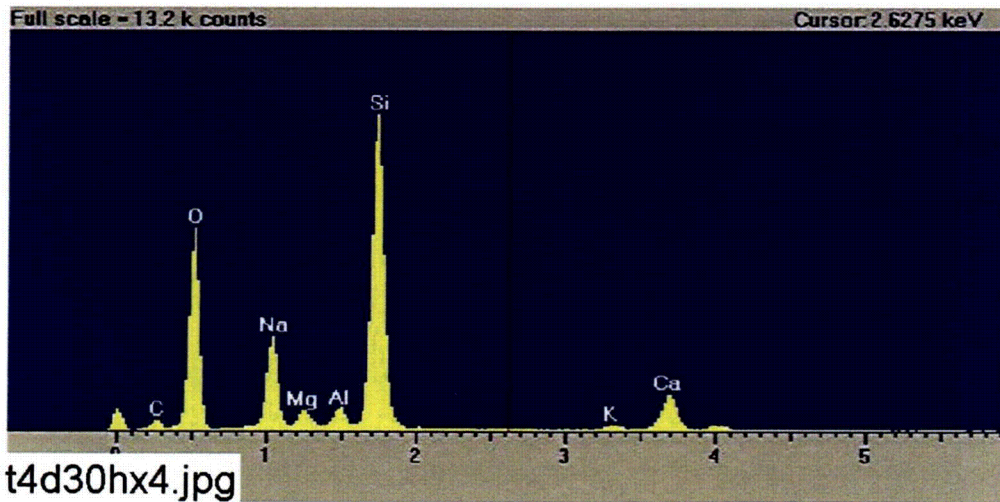
Figure 3-64. EDS counting spectrum for the spot of coating substance on fiberglass shown in Figure 3-63. (t4d30hx4.jpg)

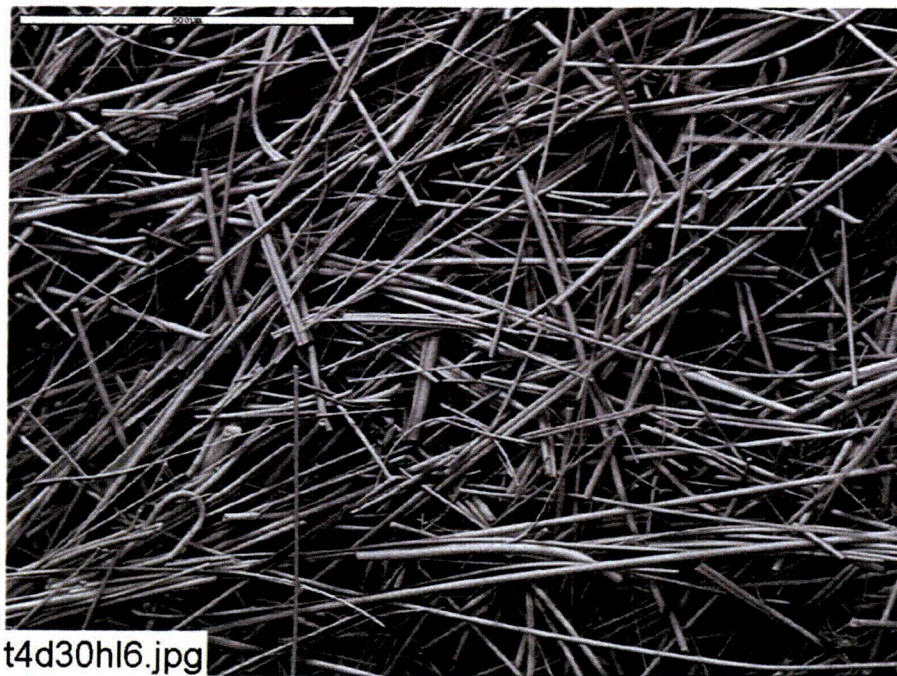
Figure 3-65. ESEM image magnified 100 times for a Test #4, Day-30 interior high-flow fiberglass sample in front of a header (inserted on Day 4). (t4d30hl6.jpg)

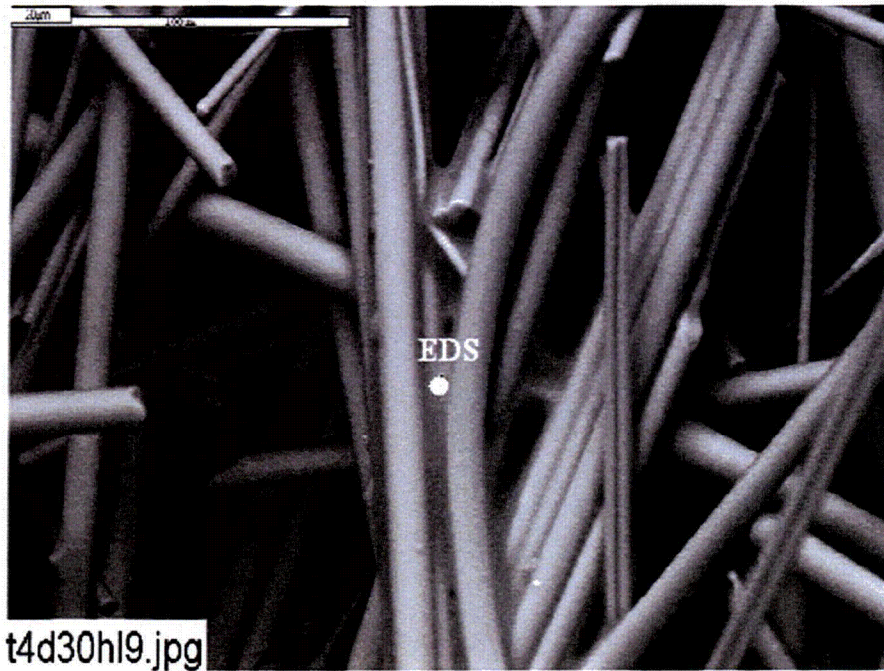
Figure 3-66. ESEM image magnified 500 times for a Test #4, Day-30 interior high-flow fiberglass sample in front of a header (inserted on Day 4). (t4d30h19.jpg)

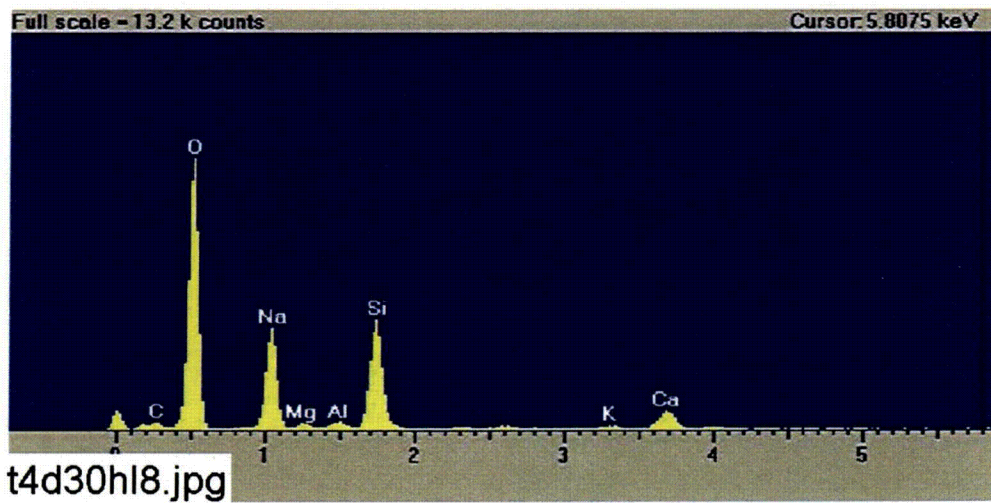
Figure 3-67. EDS counting spectrum for the spot of substance attached on fiberglass shown in Figure 3-66. (t4d30h18.jpg)

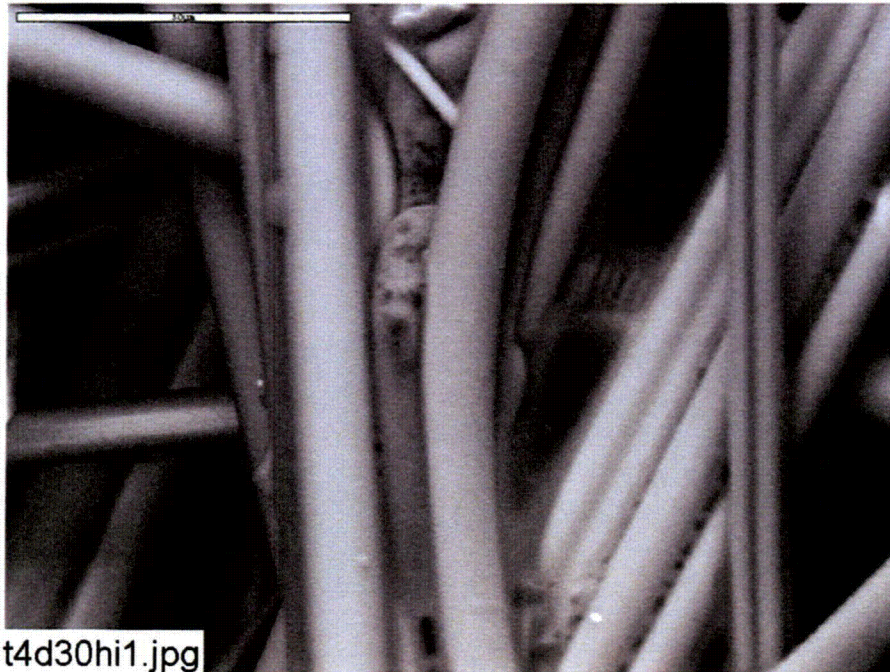
Figure 3-68. ESEM image magnified 1000 times for a Test #4, Day-30 interior high-flow fiberglass sample in front of a header (inserted on Day 4). (t4d30hi1.jpg)

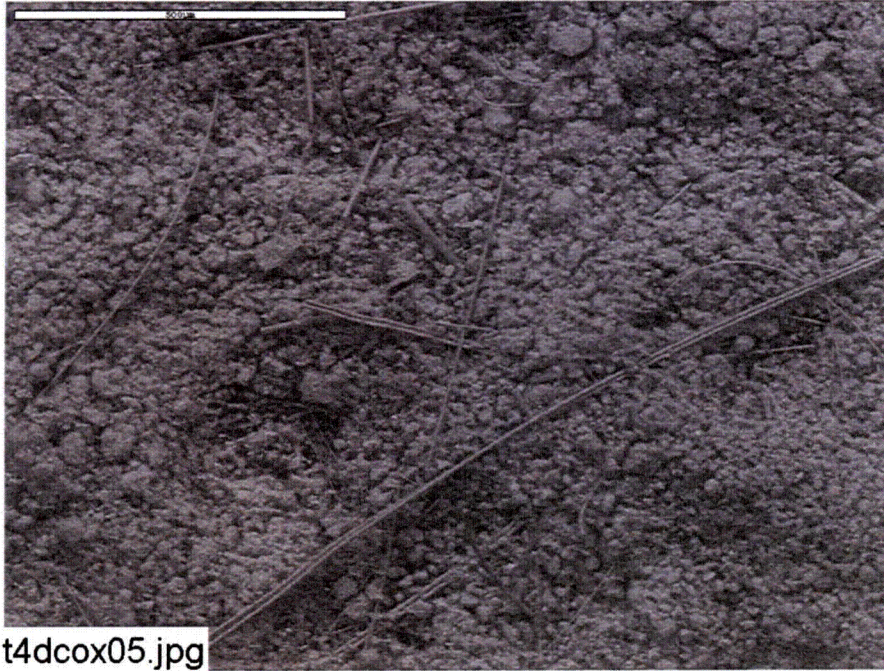
When the tank was drained, the drain collar was totally surrounded by sediment. Figure 3-121 shows the drain collar after the tank was drained. Both the exterior fiberglass sample that was farthest from the drain screen and the exterior sample that was next to the drain screen have significant amounts of particulate deposits. Inspection revealed the development of a continuous coating on the drain collar exterior, including particulate deposits that were likely physically retained or attached. The amount of deposits on the drain collar exterior was greater than on high- and low-flow fiberglass samples. EDS results indicate that the particulate deposits were mainly composed of O, Si, Ca, Na, Al, and C, regardless of whether the drain collar exterior was farthest from the drain screen or next to the drain screen. The high content of Si and Ca in the particulate deposits suggests that they were probably from cal-sil debris. In contrast to the exterior, no significant particulate deposits were found in the drain collar interior sample, and only film-like deposits were found (see Figure 3-75). The drain collar interior appears similar to the other high- and low- flow fiberglass interior samples. This result suggests that almost all of the particulate deposits were physically retained at the fiberglass exterior, which is consistent with Day-30 high-flow fiberglass samples. Figures 3-69 through 3-79 show the drain collar fiberglass results.

Figure 3-69. ESEM image magnified 100 times for a Test #4, Day-30 exterior fiberglass sample on the drain collar (away from the drain screen). (t4dcox05.jpg)

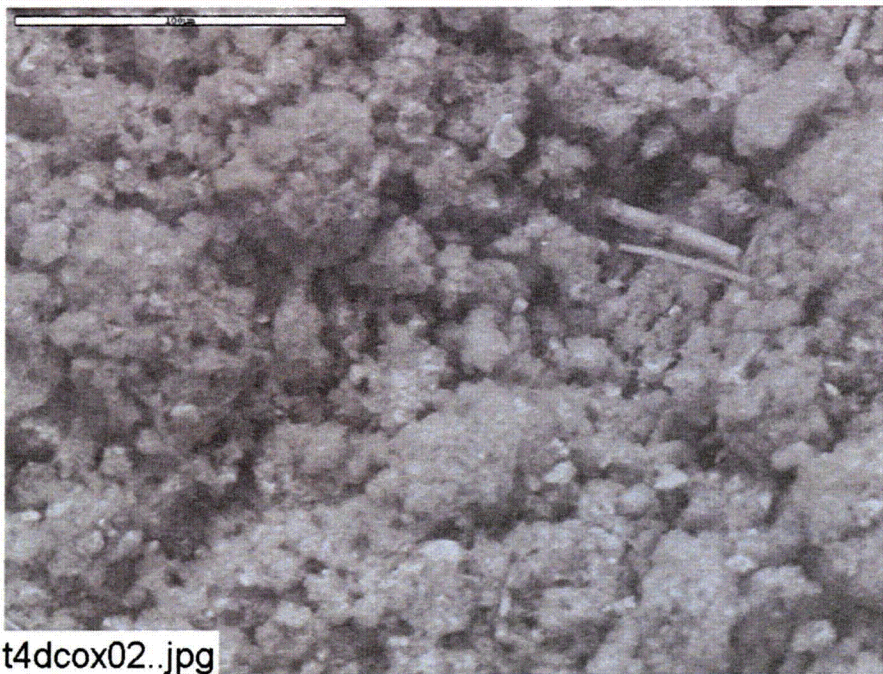
Figure 3-70. ESEM image magnified 500 times for a Test #4, Day-30 exterior fiberglass sample on the drain collar (away from the drain screen). (t4dcox02.jpg)

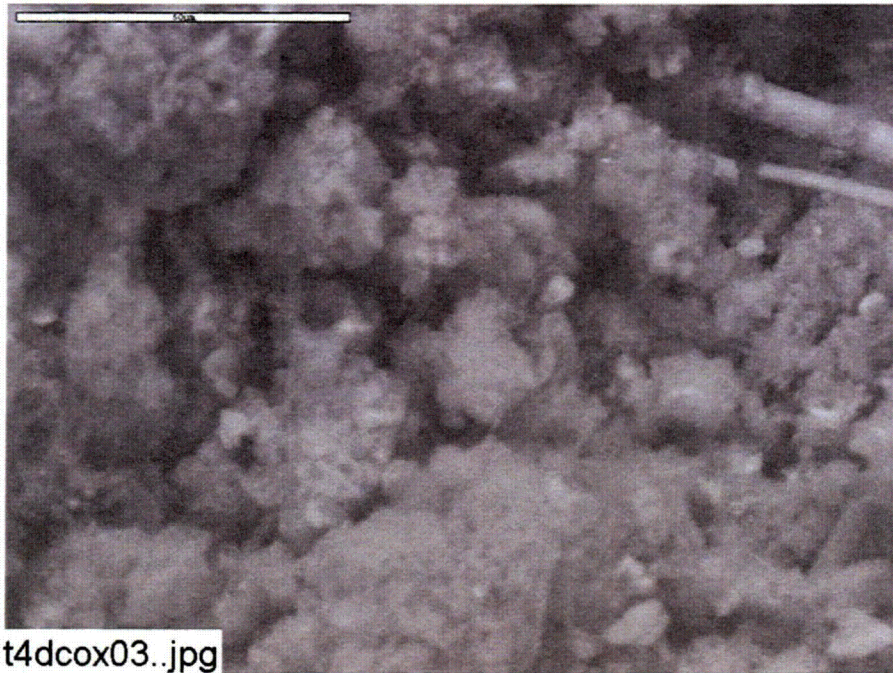
Figure 3-71. ESEM image magnified 1000 times for a Test #4, Day-30 exterior fiberglass sample on the drain collar (away from the drain screen). (t4dcox03.jpg)

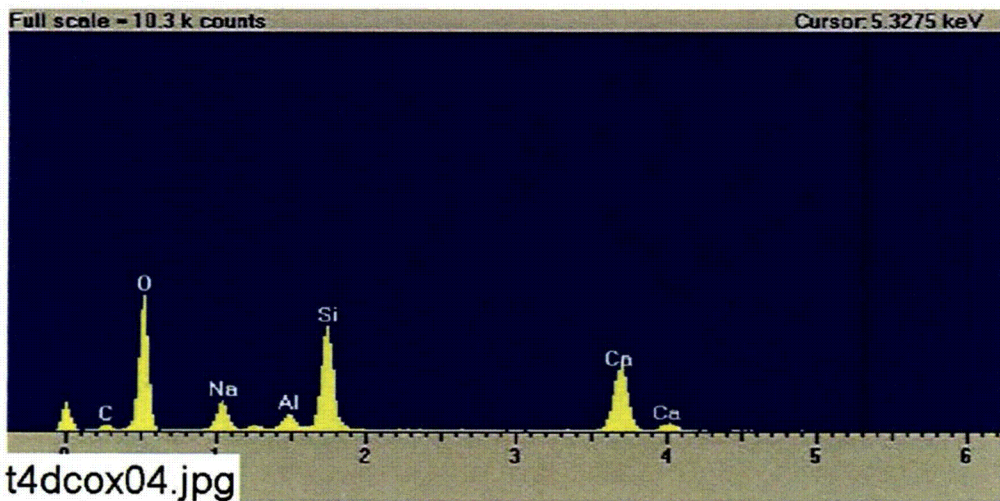
Figure 3-72. EDS counting spectrum for the large mass of particulate deposits on fiberglass shown in Figure 3-71. (t4dcox04.jpg)
