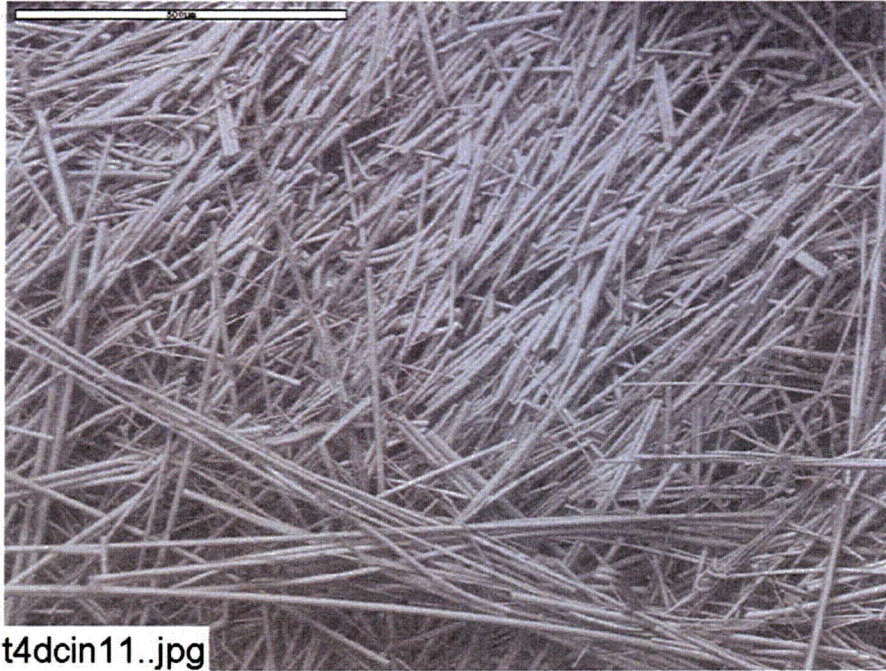
t4dcin11..jpg

Figure 3-73. ESEM image magnified 100 times for a Test #4, Day-30 interior fiberglass sample on the drain collar. (t4dcin11.jpg)

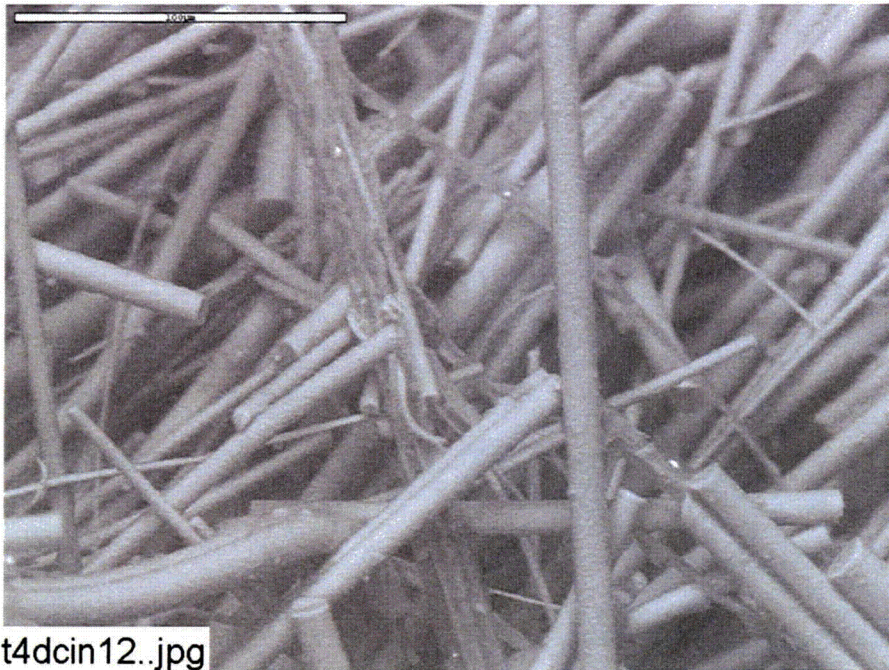
t4dcin12..jpg

Figure 3-74. ESEM image magnified 500 times for a Test #4, Day-30 interior fiberglass sample on the drain collar. (t4dcin12.jpg)

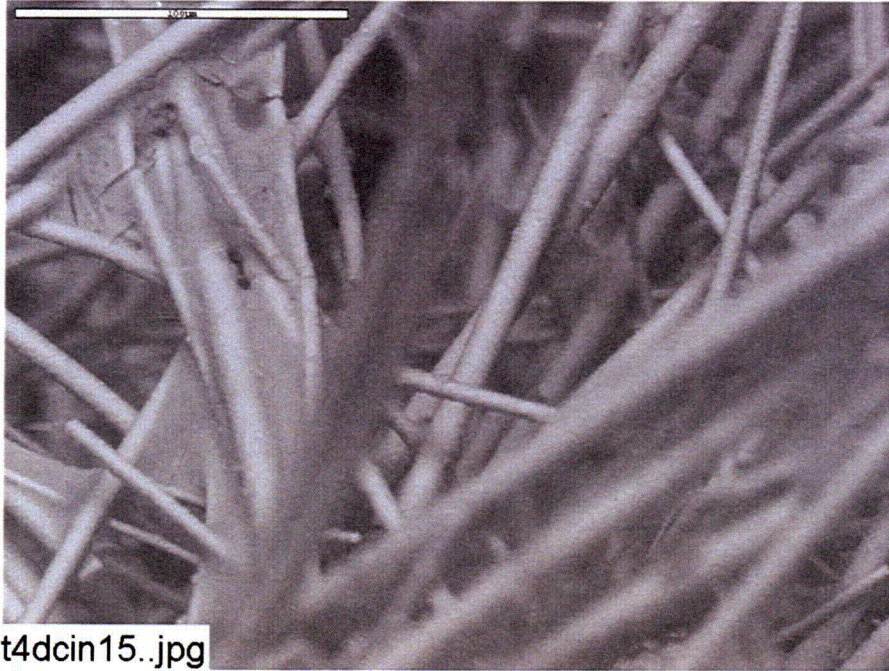
t4dcin15.jpg

Figure 3-75. ESEM image magnified 500 times for a Test #4, Day-30 interior fiberglass sample on the drain collar. (t4dcin15.jpg)

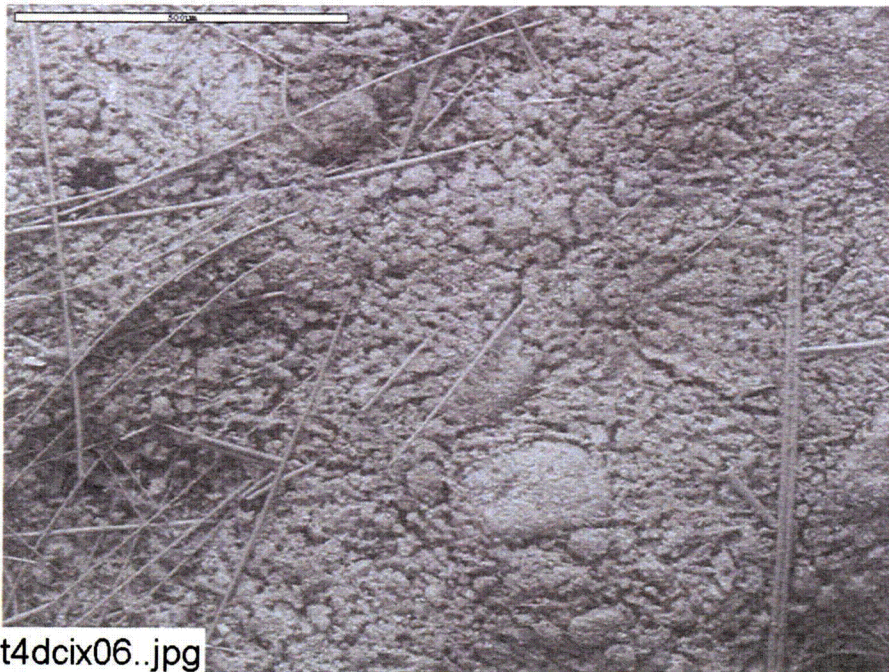
t4dcix06.jpg

Figure 3-76. ESEM image magnified 100 times for a Test #4, Day-30 exterior fiberglass sample on the drain collar (next to the drain screen). (t4dcix06.jpg)

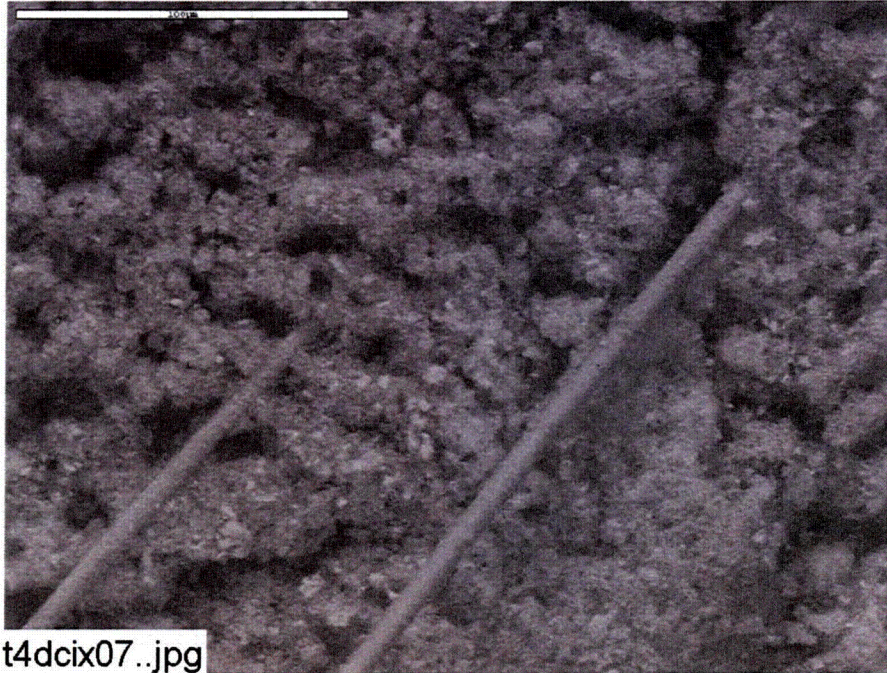
t4dcix07..jpg

Figure 3-77. ESEM image magnified 500 times for a Test #4, Day-30 exterior fiberglass sample on the drain collar (next to the drain screen). (t4dcix07.jpg)

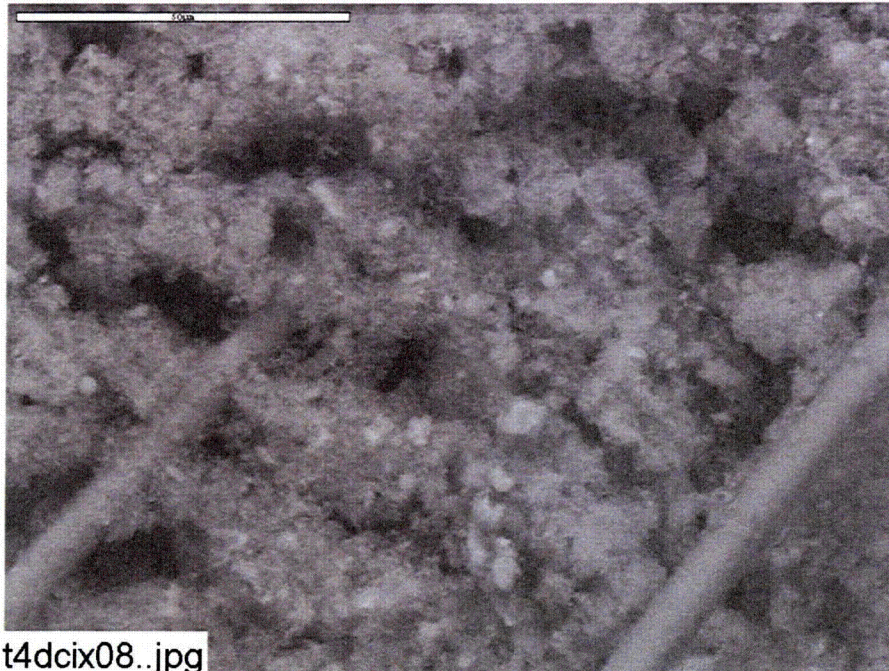
t4dcix08..jpg

Figure 3-78. ESEM image magnified 1000 times for a Test #4, Day-30 exterior fiberglass sample on the drain collar (next to the drain screen). (t4dcix08.jpg)

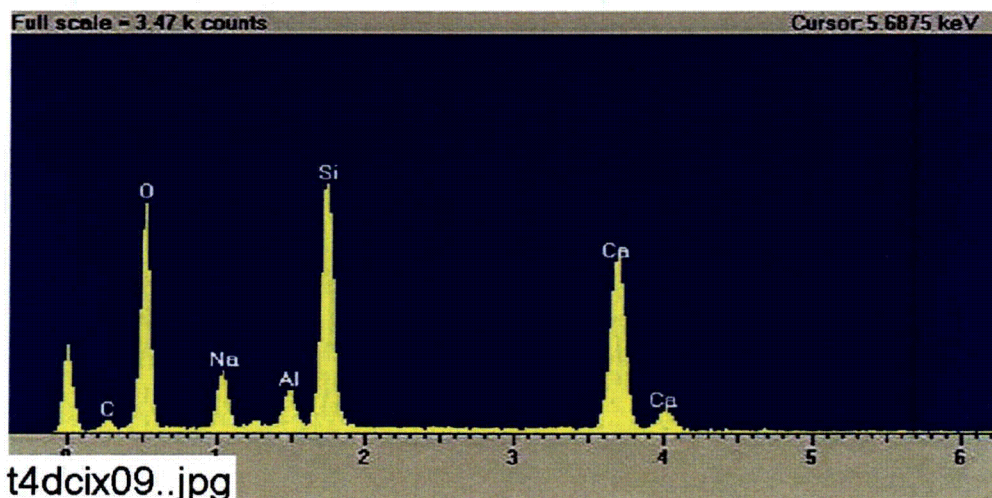
When the tank was drained, the drain collar was totally surrounded by sediment. Figure 3-121 shows the drain collar after the tank was drained. Both the exterior fiberglass sample that was farthest from the drain screen and the exterior sample that was next to the drain screen have significant amounts of particulate deposits. Inspection revealed the development of a continuous coating on the drain collar exterior, including particulate deposits that were likely physically retained or attached. The amount of deposits on the drain collar exterior was greater than on high- and low-flow fiberglass samples. EDS results indicate that the particulate deposits were mainly composed of O, Si, Ca, Na, Al, and C, regardless of whether the drain collar exterior was farthest from the drain screen or next to the drain screen. The high content of Si and Ca in the particulate deposits suggests that they were probably from cal-sil debris. In contrast to the exterior, no significant particulate deposits were found in the drain collar interior sample, and only film-like deposits were found (see Figure 3-75). The drain collar interior appears similar to the other high- and low- flow fiberglass interior samples. This result suggests that almost all of the particulate deposits were physically retained at the fiberglass exterior, which is consistent with Day-30 high-flow fiberglass samples. Figures 3-69 through 3-79 show the drain collar fiberglass results.

Figure 3-79. EDS counting spectrum for the large mass of particulate deposits on fiberglass shown in Figure 3-78. (t4dcix09.jpg)

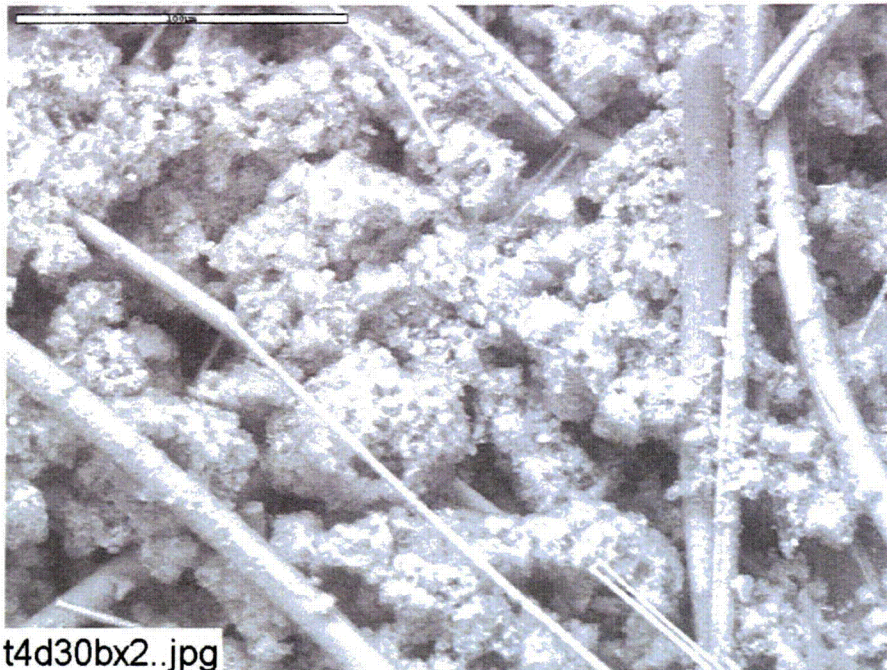
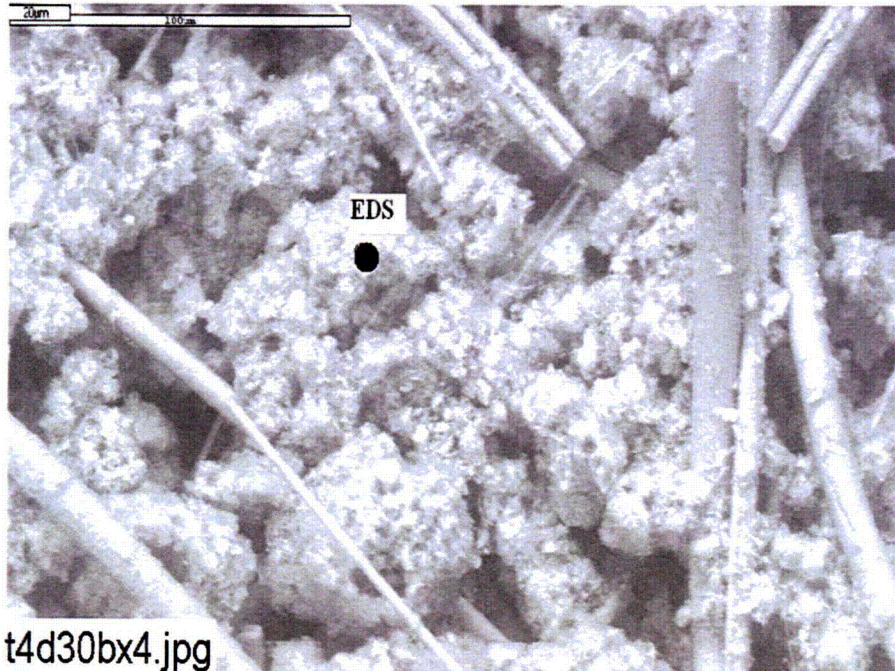
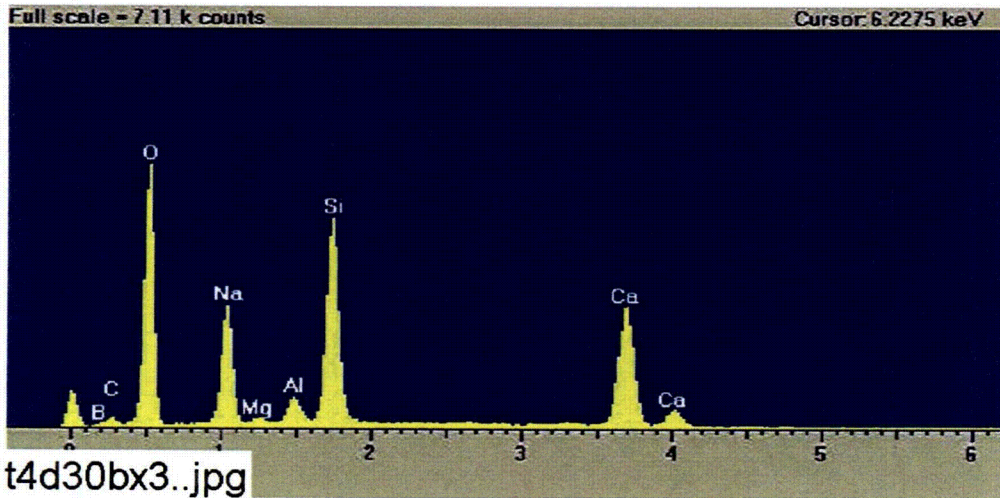
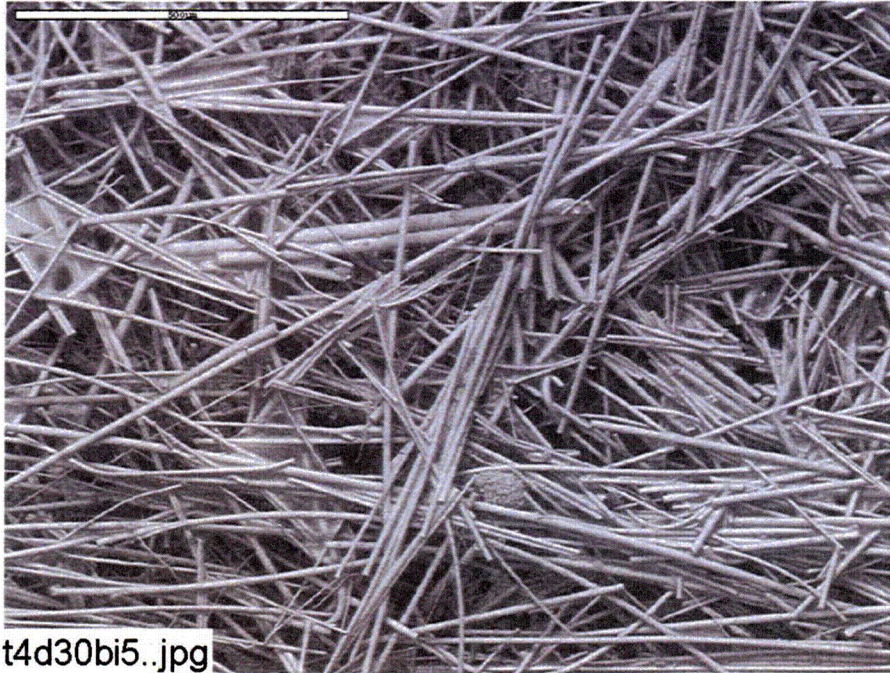
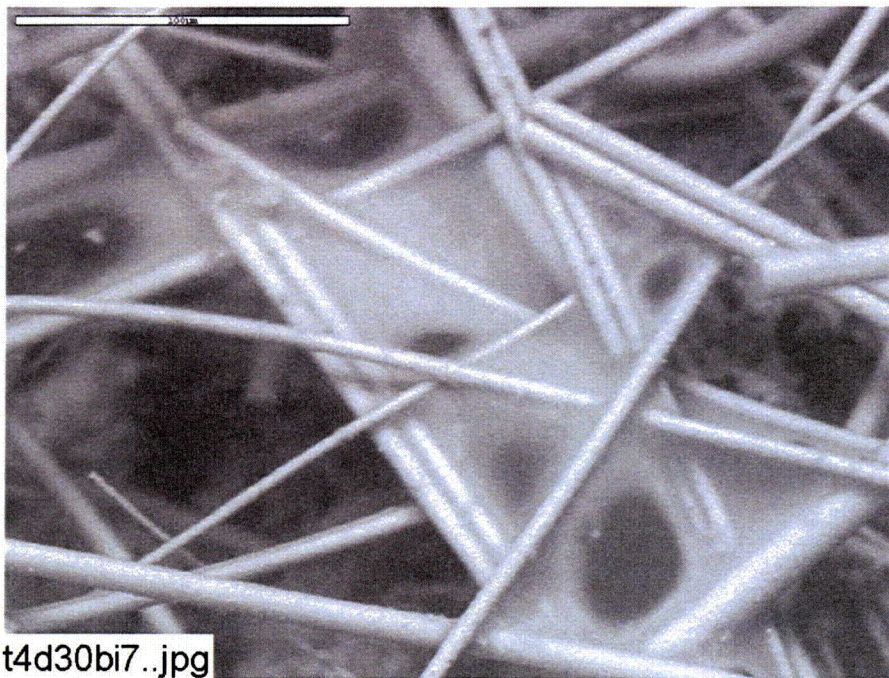
For the Day-30 fiberglass sample within the birdcage, the SEM images indicate a significant amount of particulate deposits (see Figure 3-80) on the exterior of the fiberglass. The location of the birdcage was on top of a large cal-sil sample that sat on the bottom of the tank and was in direct contact with the sediment. The birdcage, however, was not in direct contact with the sediment. The amount of particulate deposits was greater than the amounts on the high- and low-flow fiberglass samples, but less than the drain collar exterior. The EDS result shows that the particulate deposits were composed of O, Si, Ca, Na, Al, and C, which is consistent with the drain collar exterior. Again, the high content of Si and Ca suggests these particulate deposits were from cal-sil debris. Compared to the exterior, the interior sample was relatively clean. Only film deposits were found. These film deposits were similar to the observed high- and low-flow fiberglass samples, which were likely caused by chemical precipitation during the drying process. Again, this result suggests that almost all of the particulate deposits were physically retained at the fiberglass exterior, consistent with Day-30 high-flow and drain collar fiberglass samples. Figures 3-80 through 3-85 show the birdcage fiberglass results.

Figure 3-81. ESEM image magnified 500 times for a Test #4, Day-30 exterior fiberglass sample within the birdcage. (T4D30bx2.jpg)

Figure 3-82. Annotated ESEM image magnified 500 times for a Test #4, Day-30 exterior fiberglass sample within the birdcage. (t4d30bx4.jpg)

Figure 3-83. EDS counting spectrum for the particulate deposits on fiberglass shown in Figure 3-82. (T4D30bx3.jpg)

Figure 3-84. ESEM image magnified 100 times for a Test #4, Day-30 interior fiberglass sample within the birdcage. (t4d30bi5.jpg)

Figure 3-85. ESEM image magnified 500 times for a Test #4, Day-30 interior fiberglass sample within the birdcage. (t4d30bi7.jpg)

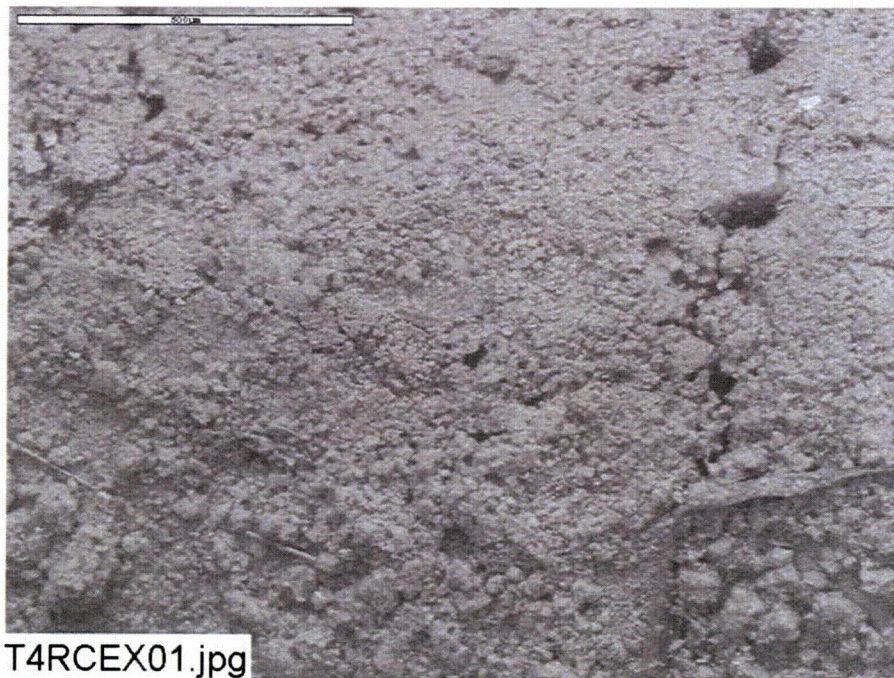
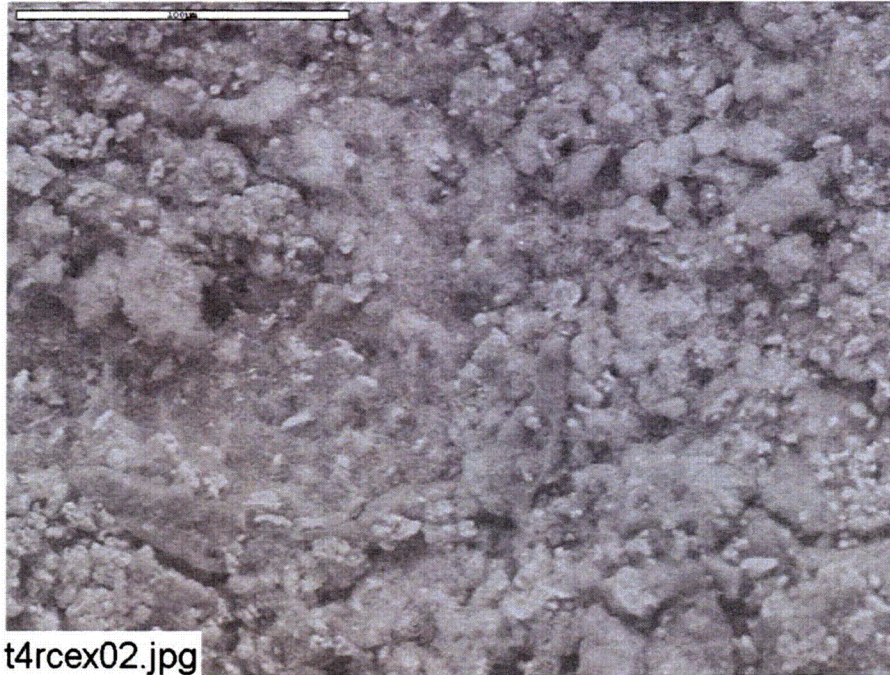
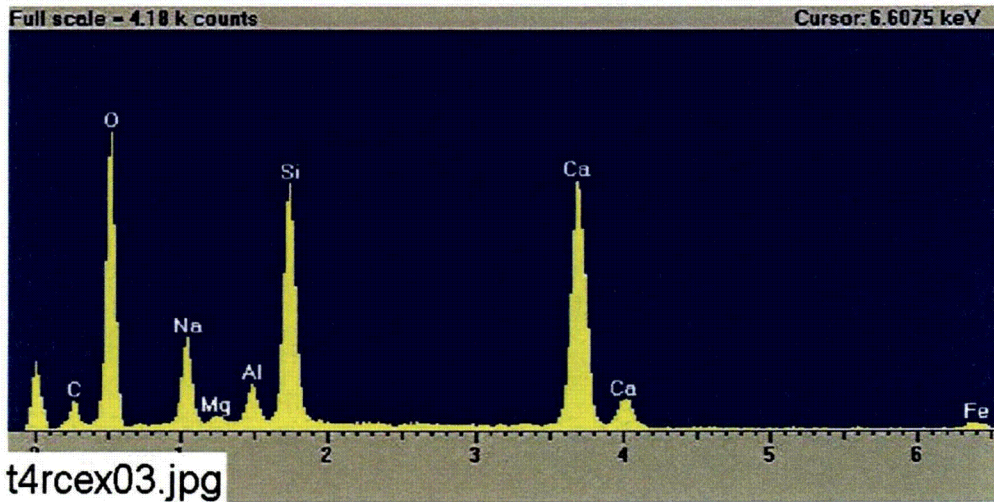
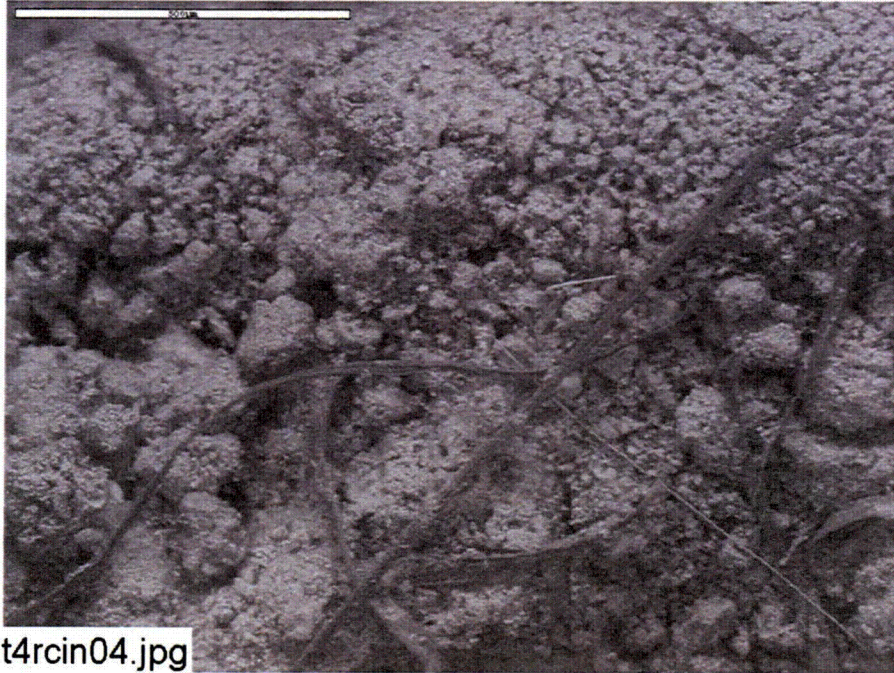
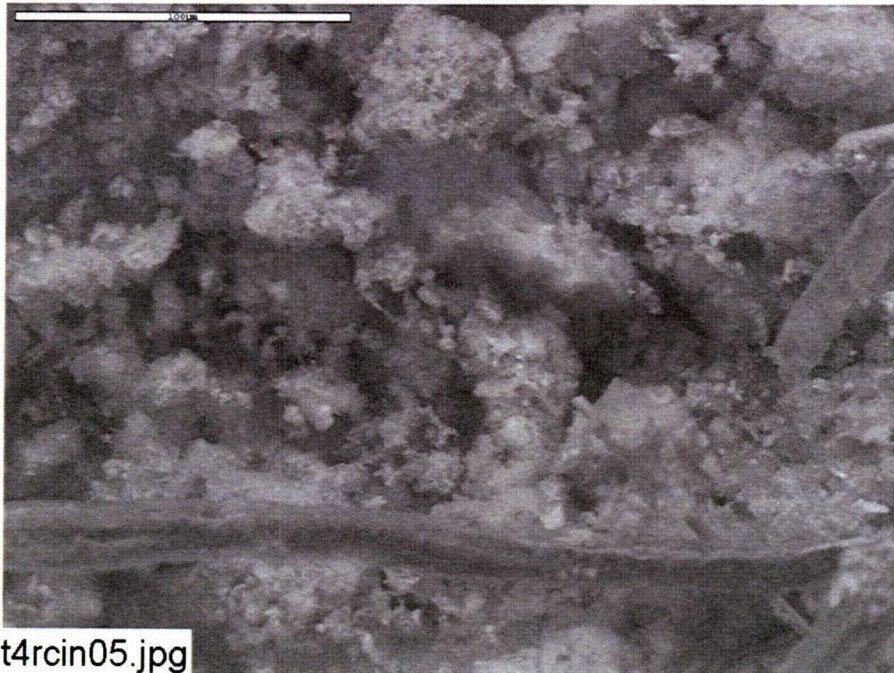
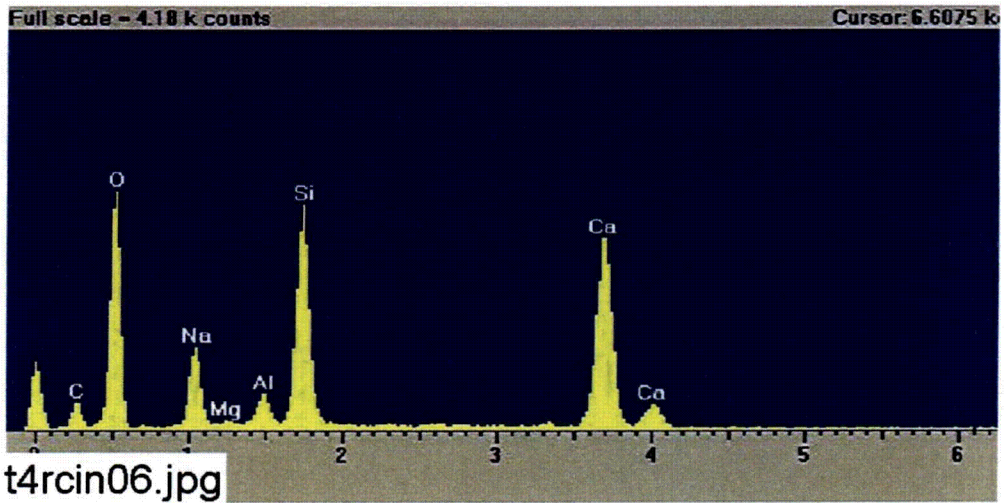
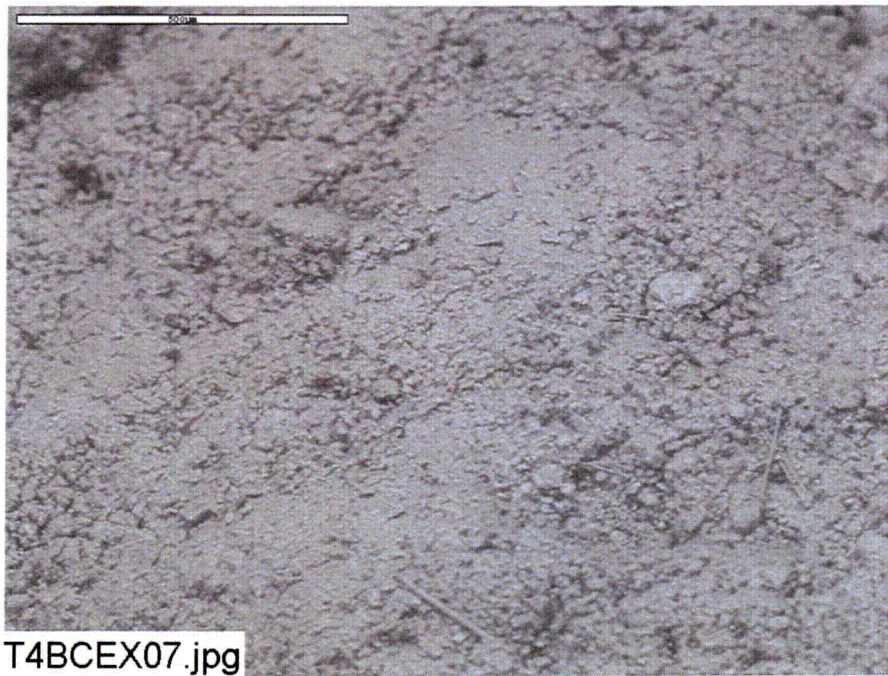
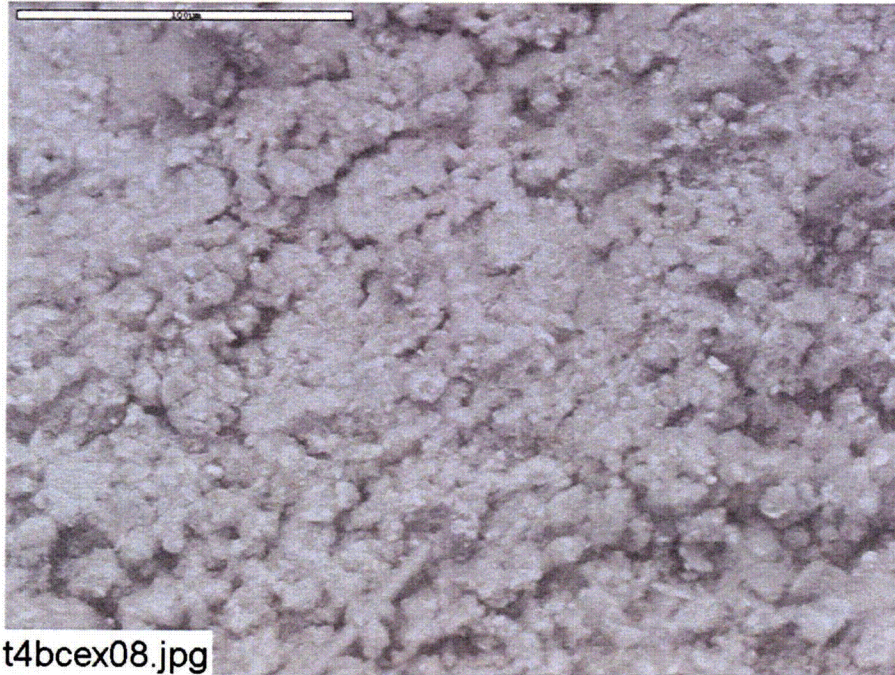
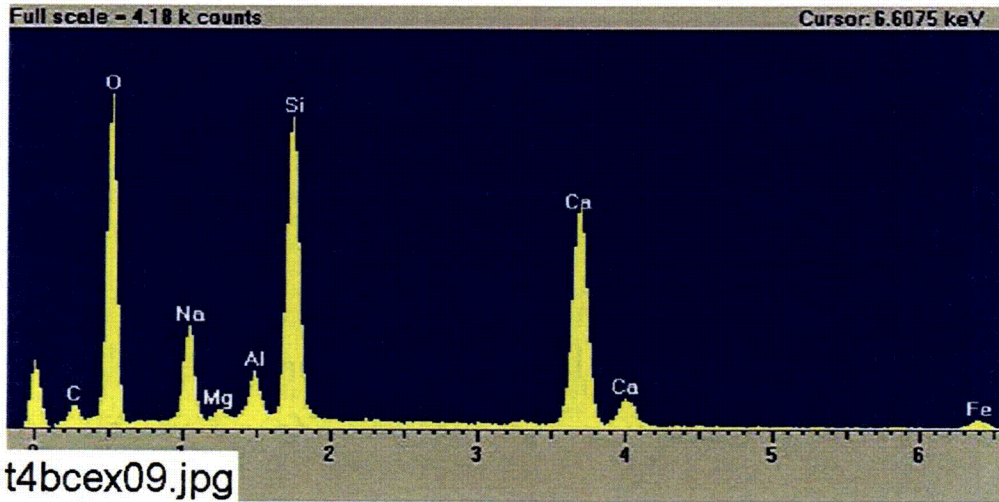
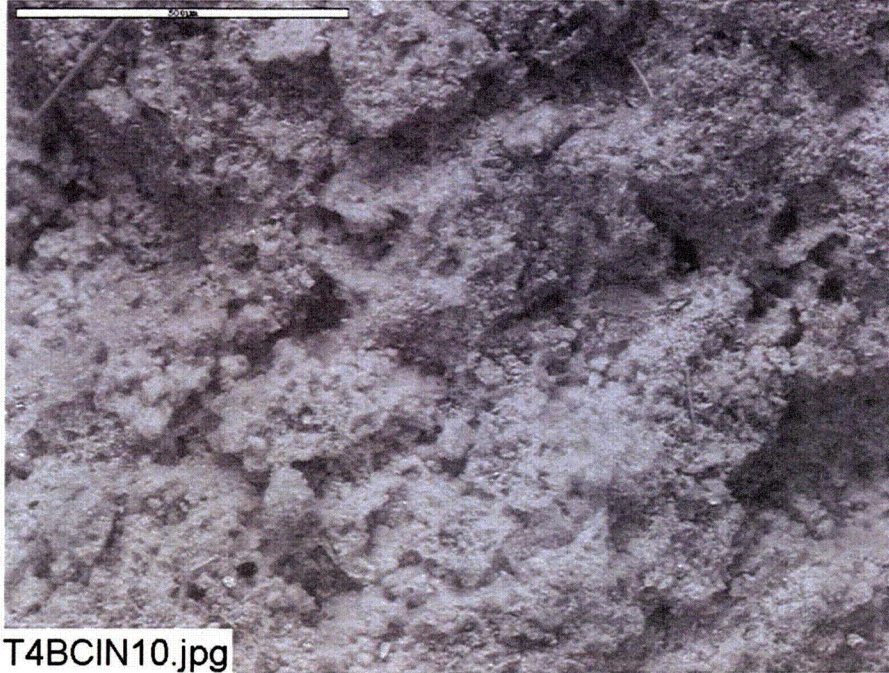
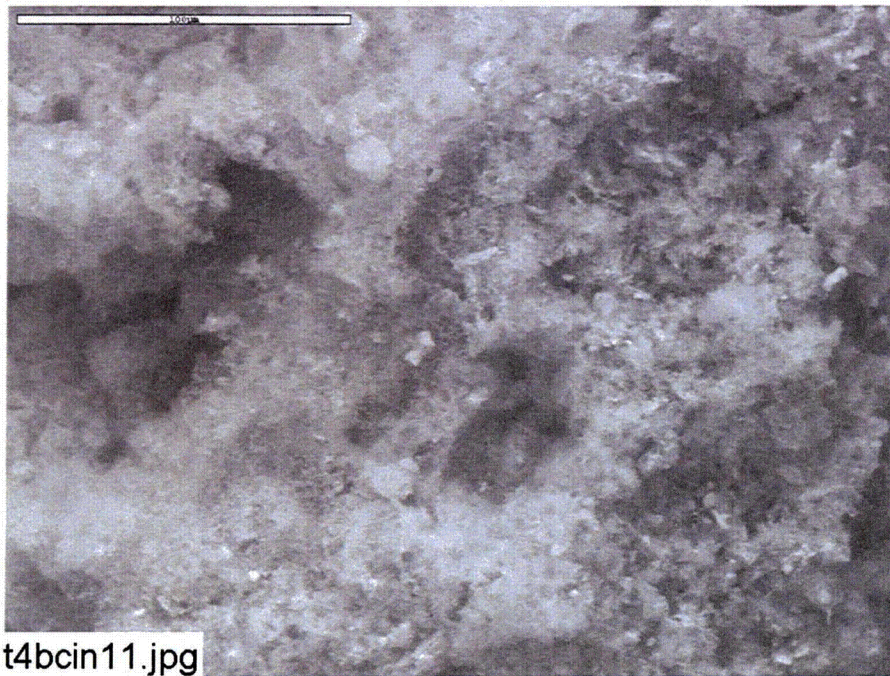
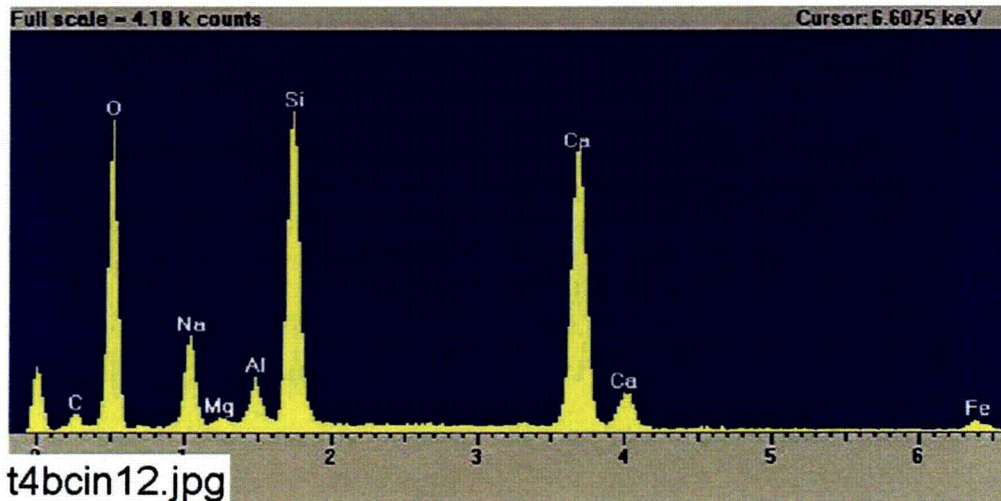
Both raw and baked cal-sil samples were submerged in the tank throughout the test. No significant differences were found between the raw and baked cal-sil, or between the exterior and the interior. EDS results show that both raw and baked cal-sil were composed primarily of O, Si, Ca, Na, Al, C, Mg, and Fe. Due to the granular shape of cal-sil particles, it is difficult to distinguish whether the particles are foreign deposits or they are the cal-sil particles themselves. Figures 3-86 through 3-97 show cal-sil results.

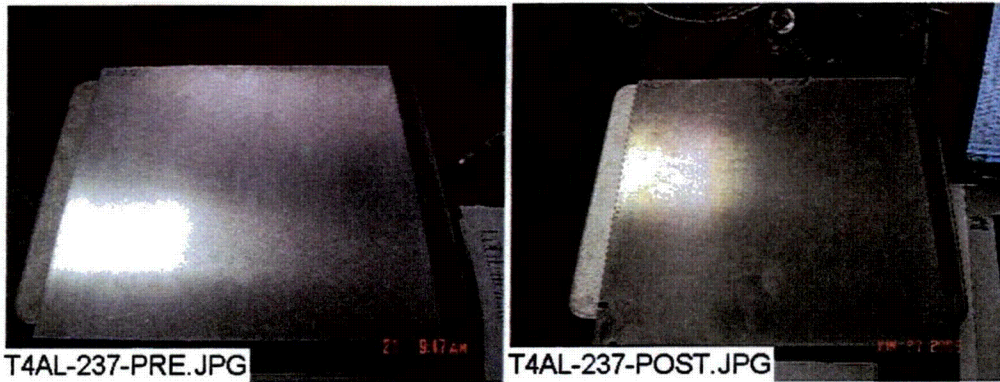
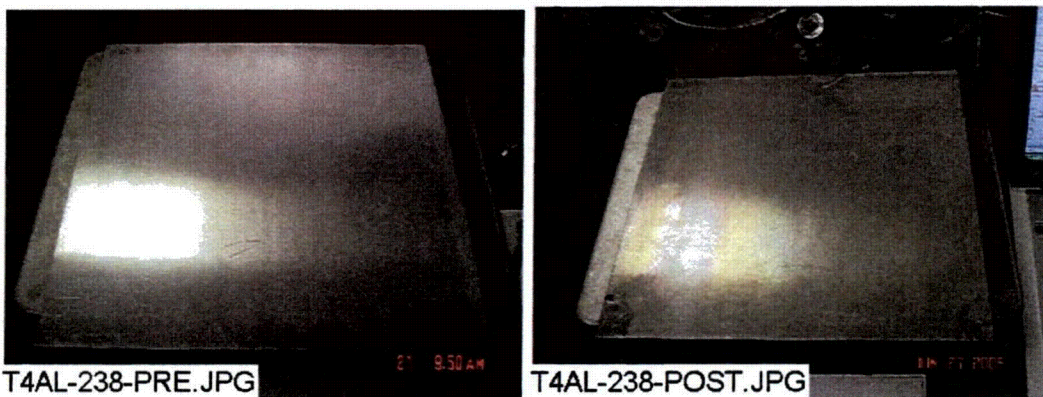
There are three submerged aluminum coupons in each test. Figures 3-98 through 3-100 display the pre- and post-test pictures of those coupons that were in Test #4. The relative locations of the aluminum coupons from east to west of the tank are: Al-239, Al-238, and Al-237. Al-239 and Al-238 were the two aluminum coupons that were isolated next to the concrete coupon. There were no visual differences between the three coupons after they were removed from the tank. The overall appearance of the aluminum coupons did not significantly change from their pre-test appearance. The post-test coupons appeared to have a light film on them and had lost their pre-test shiny appearance.

According to SEM/EDS results, the dominant corrosion products on the submerged Al coupons are likely aluminum hydroxide with other substances containing Si, Ca, O, and C. For submerged Cu coupons, the possible corrosion products include CuO, $\text{Cu}_2(\text{CO}_3)(\text{OH})_2$, and substances containing Ca, Si, Al, and O. For the submerged galvanized steel coupons, the possible corrosion products are oxides, hydroxides, silicate, and carbonate compounds of Zn, Ca, and Al. For the submerged steel coupon, the possible corrosion products include oxide, hydroxide, silicate, and carbonate compounds of Fe and Ca and compounds composed of Fe, Si, Ca, O, and Al.

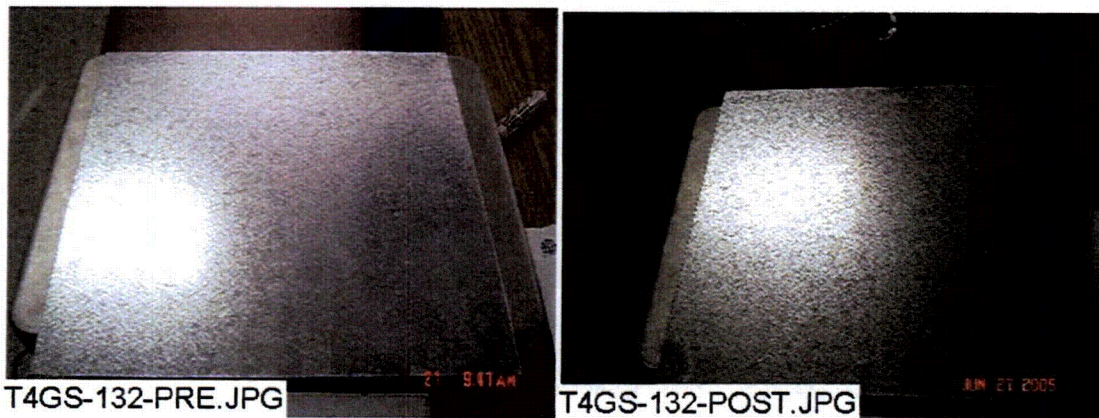
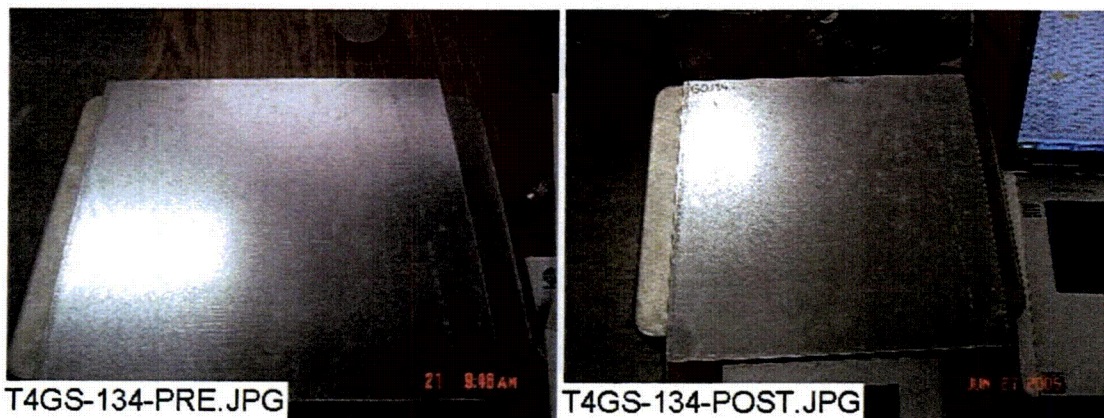
Figures 3-101 through 3-103 present the pre- and post-test pictures of three submerged galvanized steel coupons. The galvanized steel coupons did not experience any significant observable change. The coupons appeared to be relatively clean and the only noticeable marks of any sort are the circular marks caused by the racks that they are mounted in. GS-130 does appear to have some particle deposition that is concentrated mainly on the bottom corners and on the top where the coupon resides in the rack.

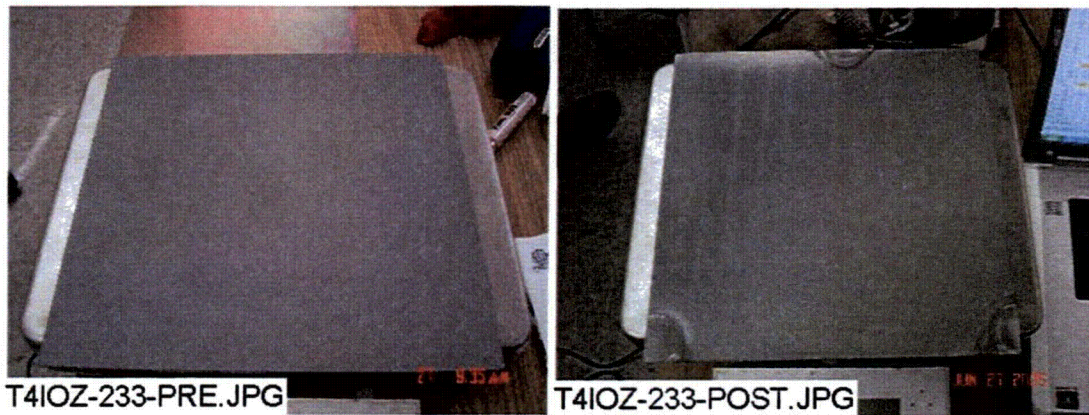
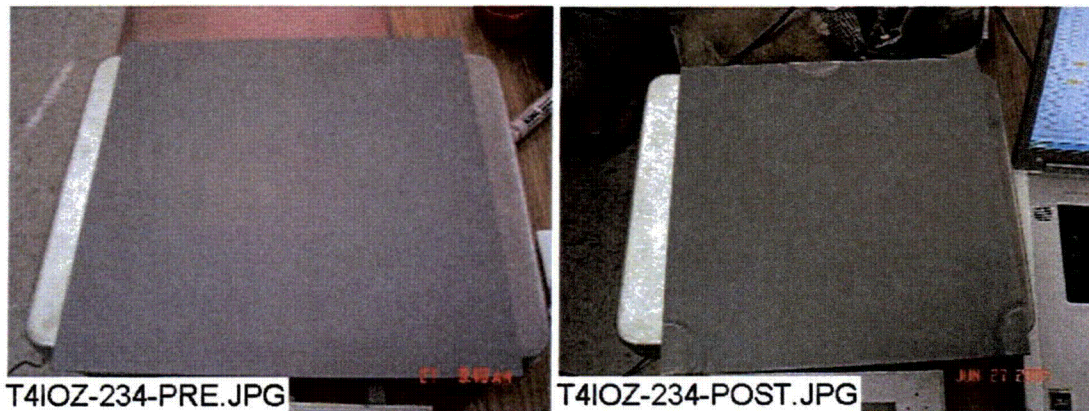
Figures 3-104 and 3-105 present the pre- and post-test pictures of two submerged inorganic zinc (IOZ) coated steel coupons. Both submerged IOZ coated steel coupons have similar, light particle depositions. There is a small accumulation of a white precipitate that originates mostly from the points of contact with the racks. However on IOZ-233, the particles seem to be distributed over the majority of the surface of the

coupon. This coupon was the westernmost IOZ coupon in the rack in relation to the others.

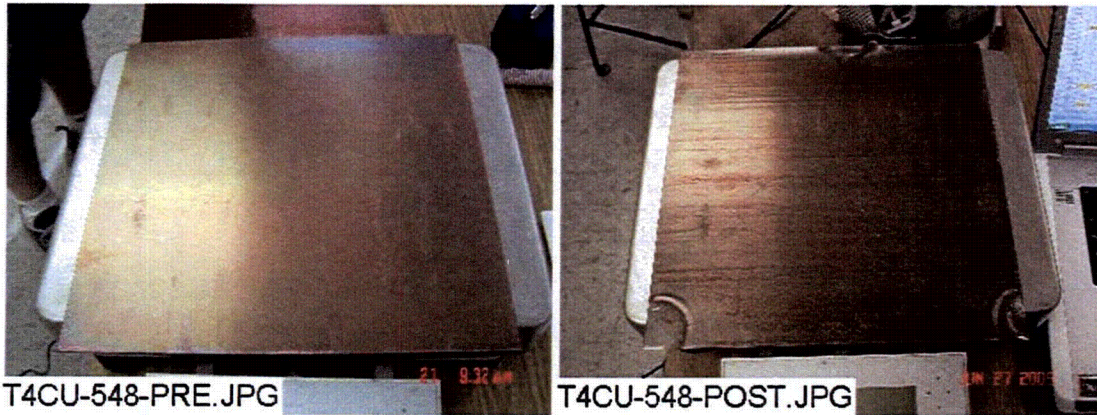
Figures 3-106 and 3-107 present the pre- and post-test pictures of two submerged copper coupons. The copper coupons were mainly unchanged. Like the other coupons, there is a very light concentration of particulate deposits in the areas where the coupons contact the rack.

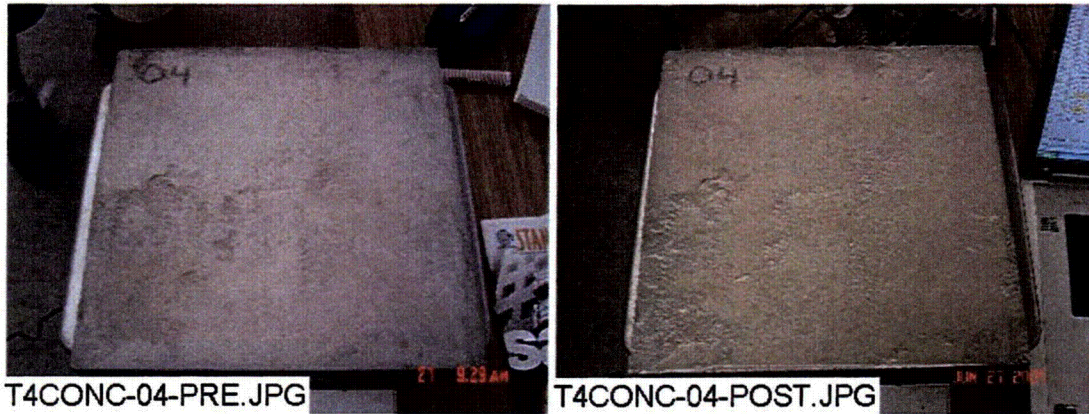
Figure 3-109 presents the pre- and post-test pictures of the submerged concrete coupon. The post-test concrete coupon exhibits a brownish color.

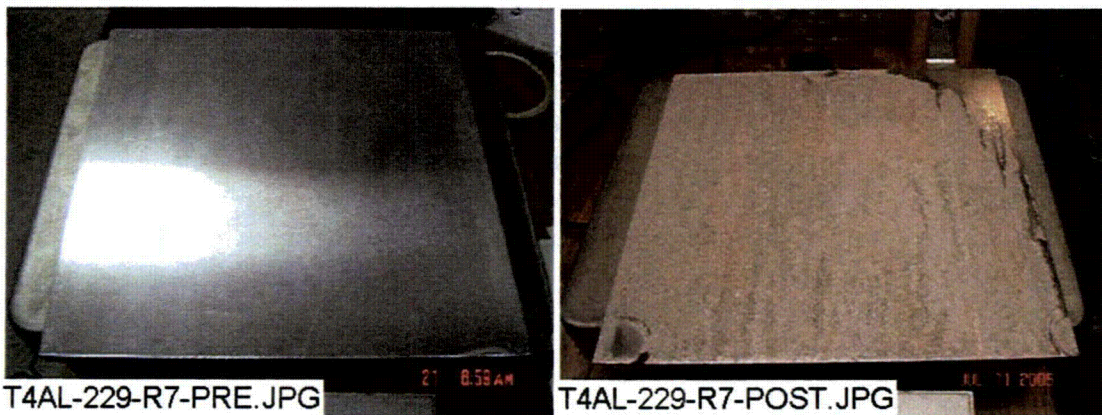
Figures 3-110 and 3-111 show the pre- and post-test pictures of two unsubmerged aluminum coupons. Each unsubmerged aluminum coupon accumulated a white particle deposition along with some areas of a brownish color. This coating caused the surface of the aluminum coupons to become coarse and rough. The photo of Al-229 shows that most of the surface is coated with the particle deposition, however, in the upper right hand corner the surface is relatively smooth with a color change observable. This is likely caused by uneven spray on the coupons. Even though the four spray nozzles were set to spray uniformly across their spray radius, the spray was not a perfect mist. There were some non-uniform areas, and the positions of the six coupon racks also interfered with the sprays. Al-003 was loaded in Rack 2 (bottom tier, southernmost), and Al-229 was loaded in Rack 7 (upper tier, northernmost).

According to SEM/EDS results, the dominant corrosion products on the unsubmerged Al coupons are likely aluminum hydroxide and/or aluminum oxide, and other corrosion products containing Si, Ca, O, and C. For unsubmerged Cu, the corrosion products on the coupon surface are likely CuO. The corrosion products were composed of C, O, Ca, Si, and Cl on the unsubmerged galvanized steel coupon surface. For the unsubmerged steel coupon, the likely corrosion products are Fe_2O_3 , $\text{Fe}(\text{OH})_3$, and $\text{Fe}_2(\text{CO}_3)_3$.

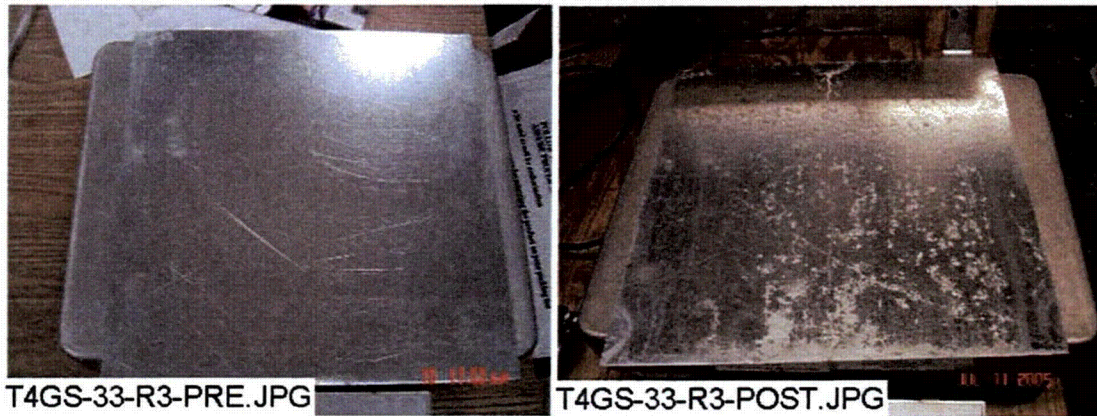
Figures 3-112 and 3-113 show the pre- and post-test pictures of two unsubmerged galvanized steel coupons. There was some white deposition on the surface of these coupons although it was in small amounts. The post-test coupons were relatively clean,

with little change. GS-33 was mounted in Rack 3 (bottom tier, middle rack), and GS-91 was mounted in Rack 6 (upper tier, middle rack).

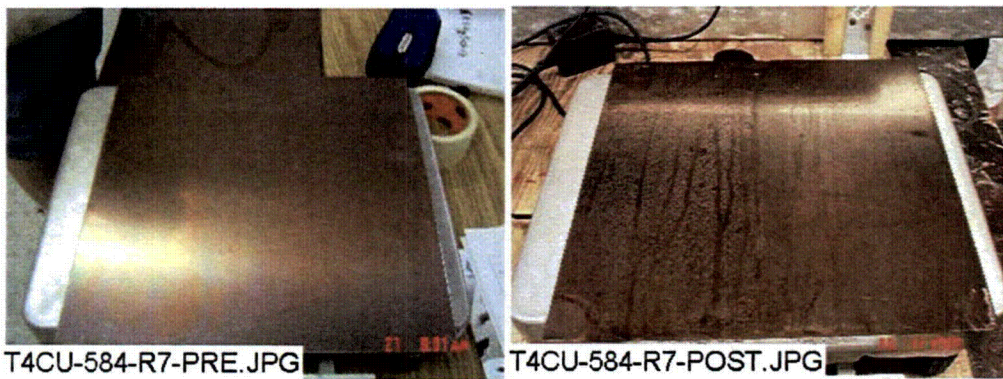
Figures 3-114 and 3-115 present the pre- and post-test pictures of two unsubmerged copper coupons. All of the copper coupons had vertical water marks that were caused by water flowing downward on the coupon surface during the spray portion of the test. The copper coupons did not appear to accumulate any particle deposition. Cu-536 was mounted in Rack 2 (bottom tier, southernmost), and Cu-584 was mounted in Rack 7 (upper tier, northernmost).

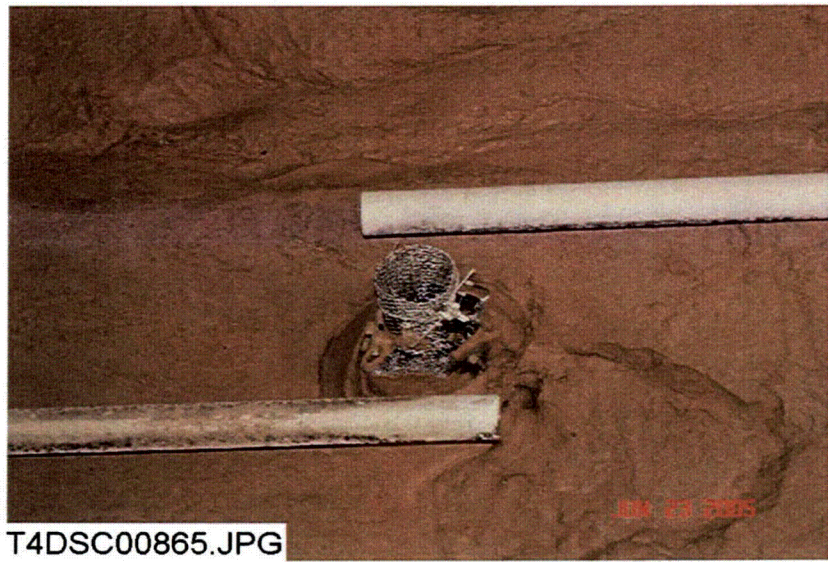
Figure 3-121. Drain collar surrounded by sediment on the tank bottom.
