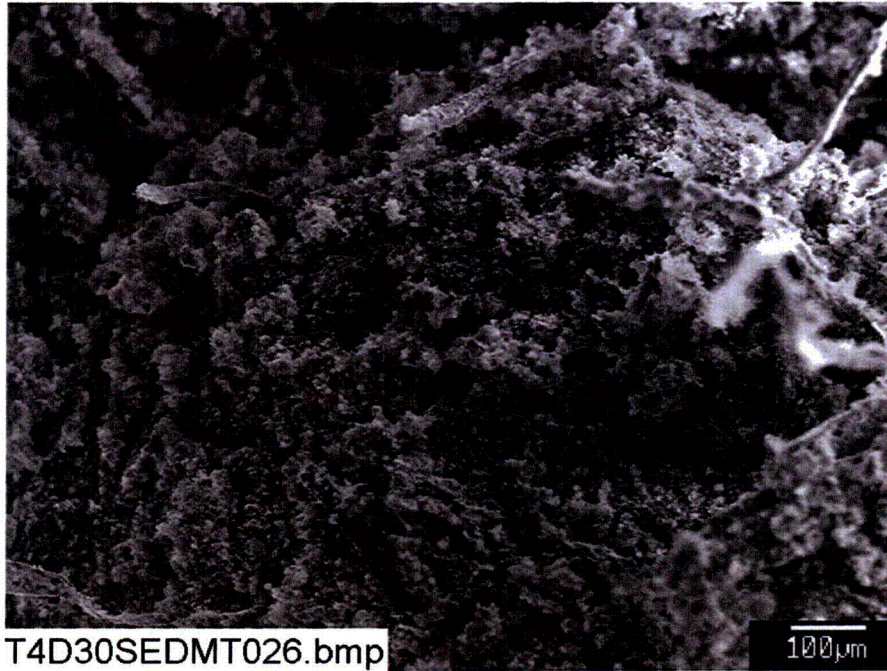
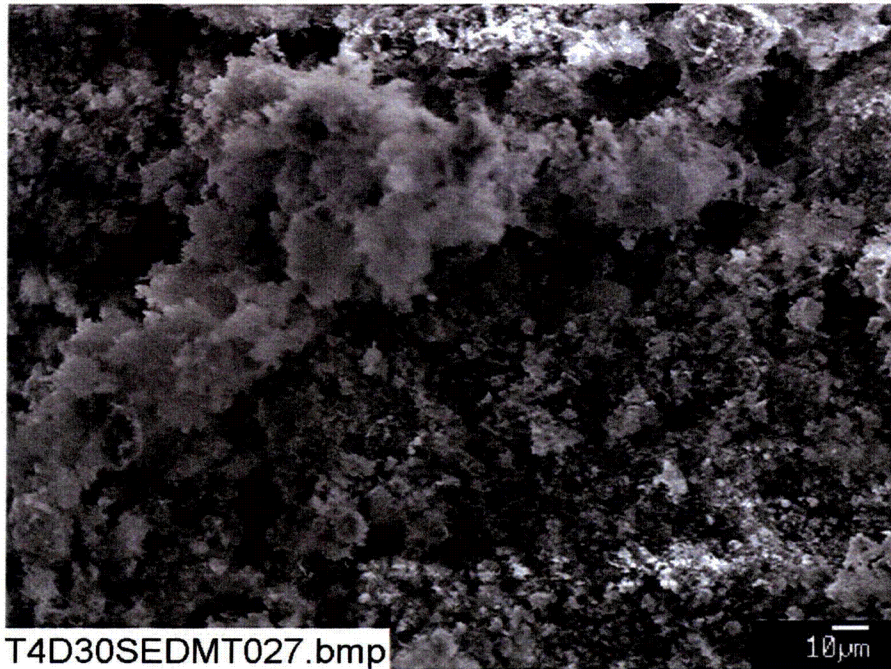
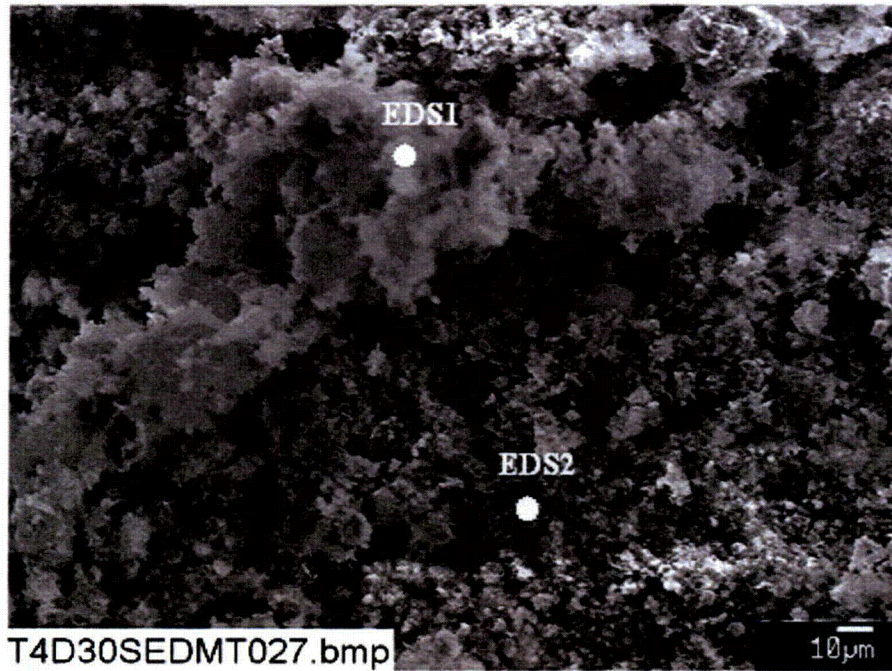
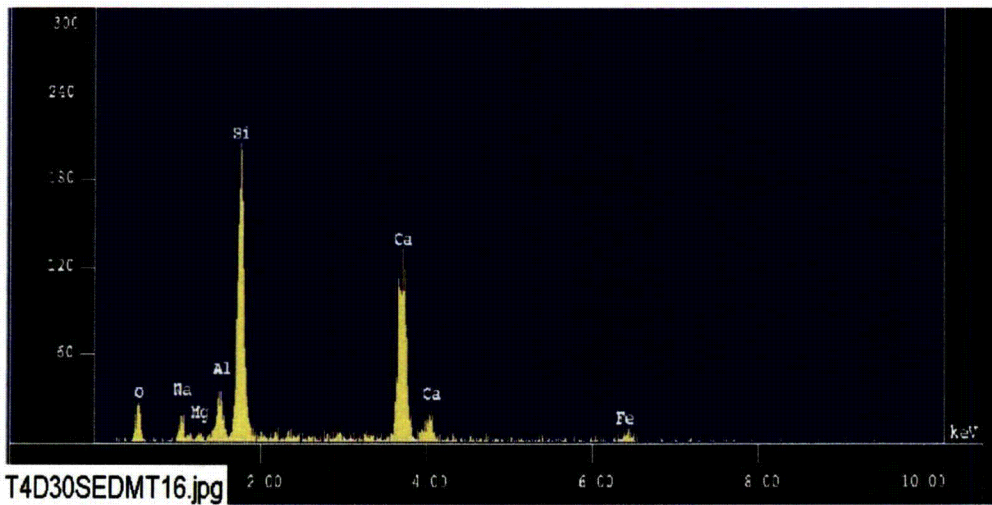
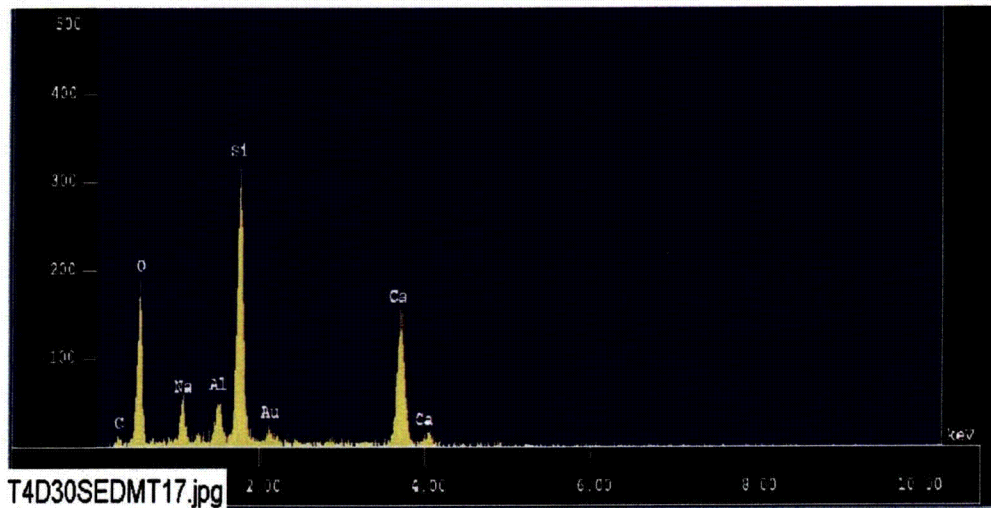
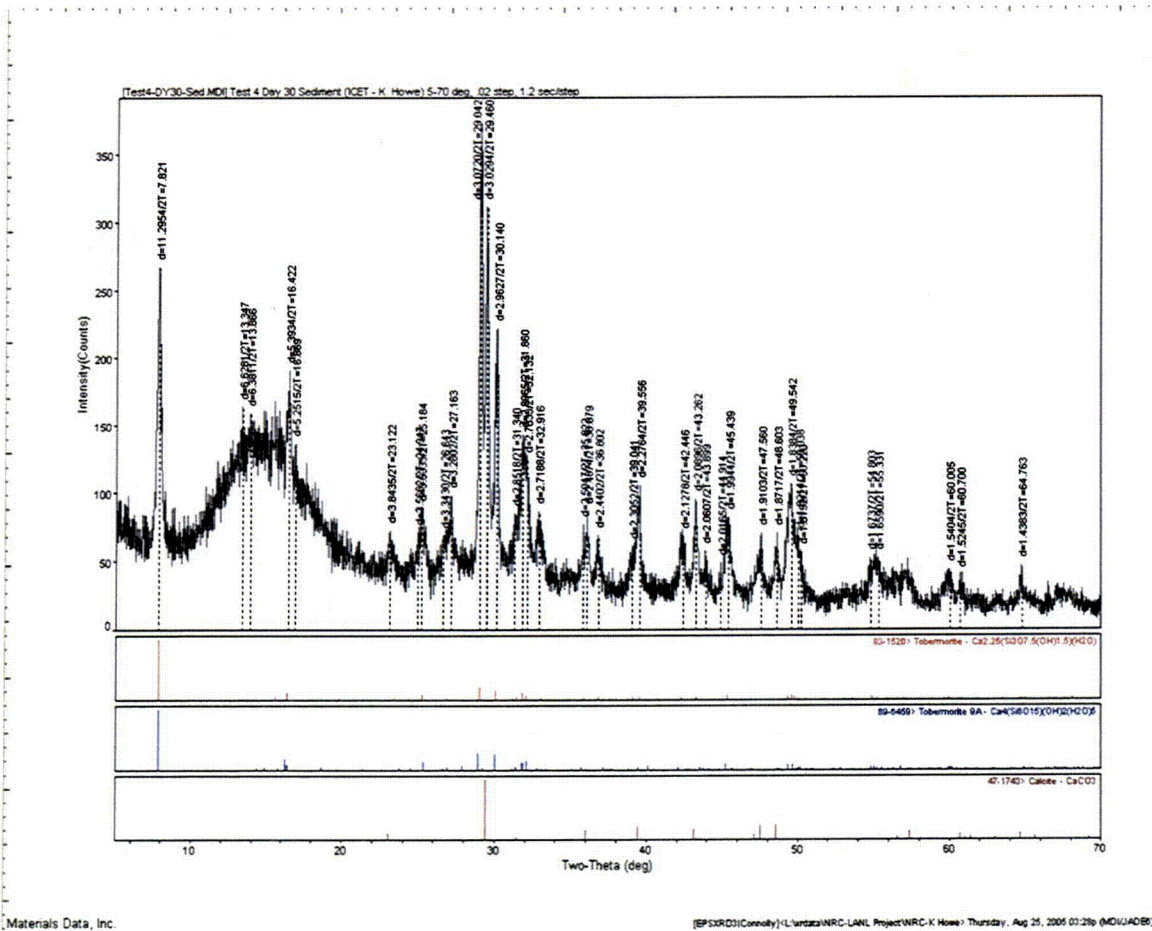
Based on XRD results, the sediment sample contained crystalline substances of tobermorite ($\text{Ca}_{2.25}(\text{Si}_3\text{O}_{7.5}(\text{OH})_{1.5})(\text{H}_2\text{O})$) and $\text{Ca}_4(\text{Si}_6\text{O}_{15}(\text{OH})_2)(\text{H}_2\text{O})_5$ as well as calcite (CaCO_3), which are the same as unused raw or unused baked cal-sil samples. Considering the collective evidence from the EDS, XRF, and XRD analyses, it is likely that the sediment was composed of a significant amount of cal-sil debris, including both raw and baked cal-sil. It should be noted that other deposits such as fiberglass debris and corrosion products may also contribute to the sediments and can not be ruled out.

Figure 3-126. Annotated SEM image magnified 500 times for a Test #4, Day-30 sediment sample at the bottom of the tank. (T4D30SEDMT027.bmp)

Figure 3-127. EDS counting spectrum for the white snow like deposits (EDS1) shown in Figure 3-126. (T4D30SEDMT16.jpg)

Figure 3-128. EDS counting spectrum for the dark deposits (EDS2) shown in Figure 3-126. (T4D30SEDMT17.jpg)

Figure 3-129. XRD result of the possible matching crystalline substances in Test #4, Day-30 sediment.

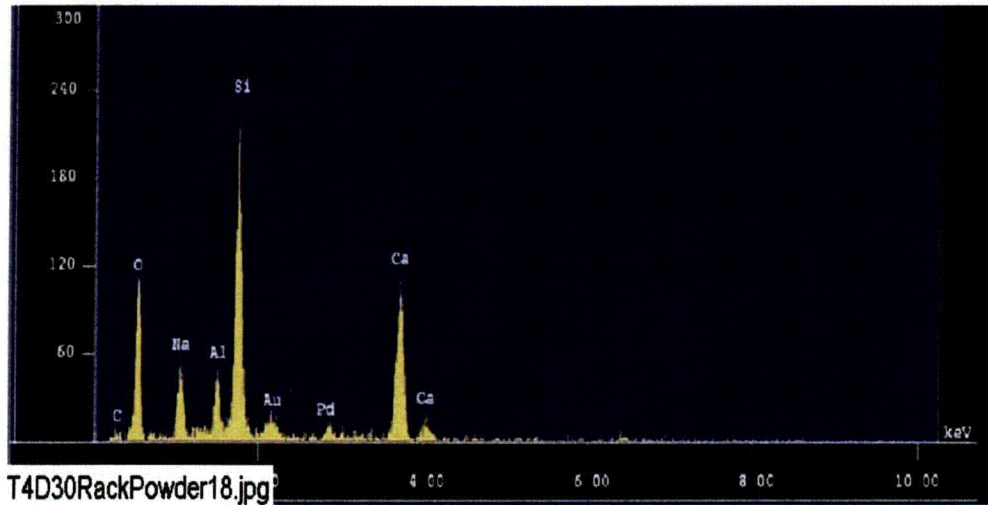
The deposition of debris/corrosion products in the tank after it was drained was observed on the submerged objects in the tank. These corrosion/deposition products, which looked like a fine powder, were collected for analysis. Those collected were from the submerged CPVC coupon rack. SEM/ EDS results indicated that these fine powders were mainly composed of O, Ca, Si, Na, Al, and C. The high content of Ca and Si suggests that the powders were likely from cal-sil and fiberglass debris.

Figure 3-131. EDS counting spectrum for the particles (whole image) shown in Figure 3-130. (T4D30Rackpowder18.jpg)
