U.S. Department of Energy Office of Legacy Management

2004 Annual Site Inspection and **Monitoring Report for Uranium Mill Tailings Radiation Control Act Title I Disposal Sites**

December 2004

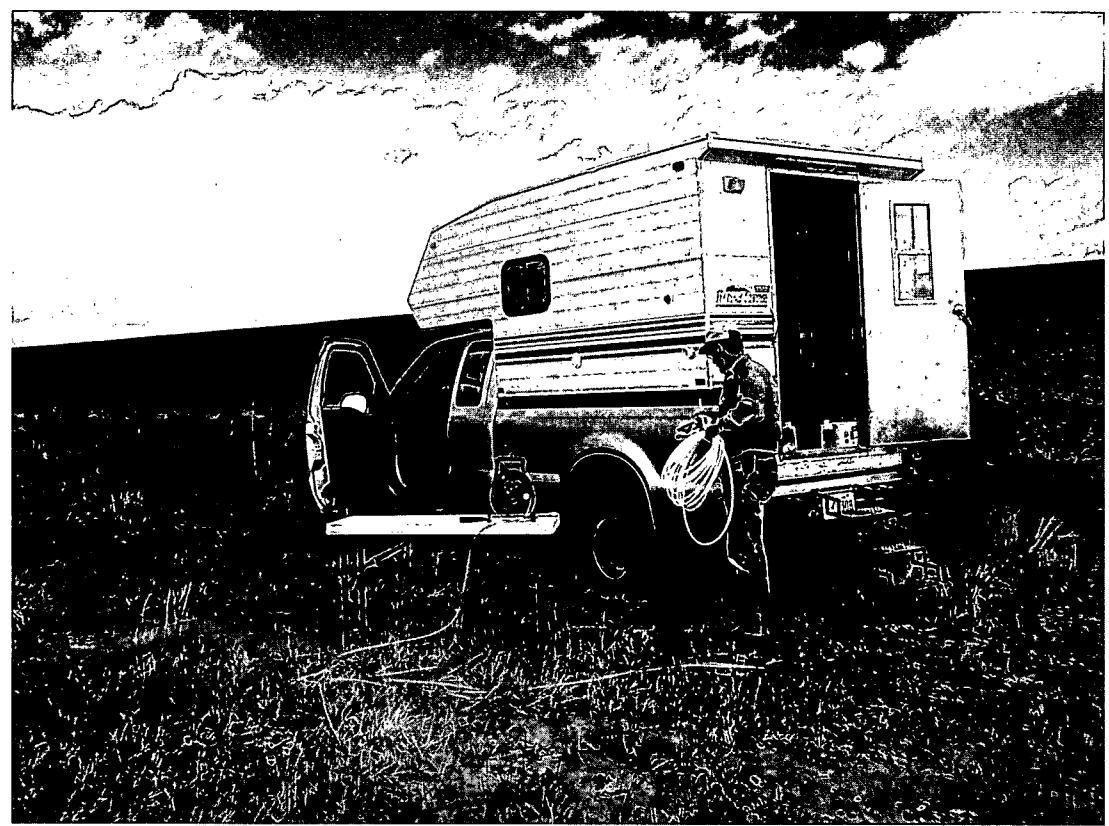
AMB 9/2004. PL-2. Ground water sampling at monitor well MW-0675.

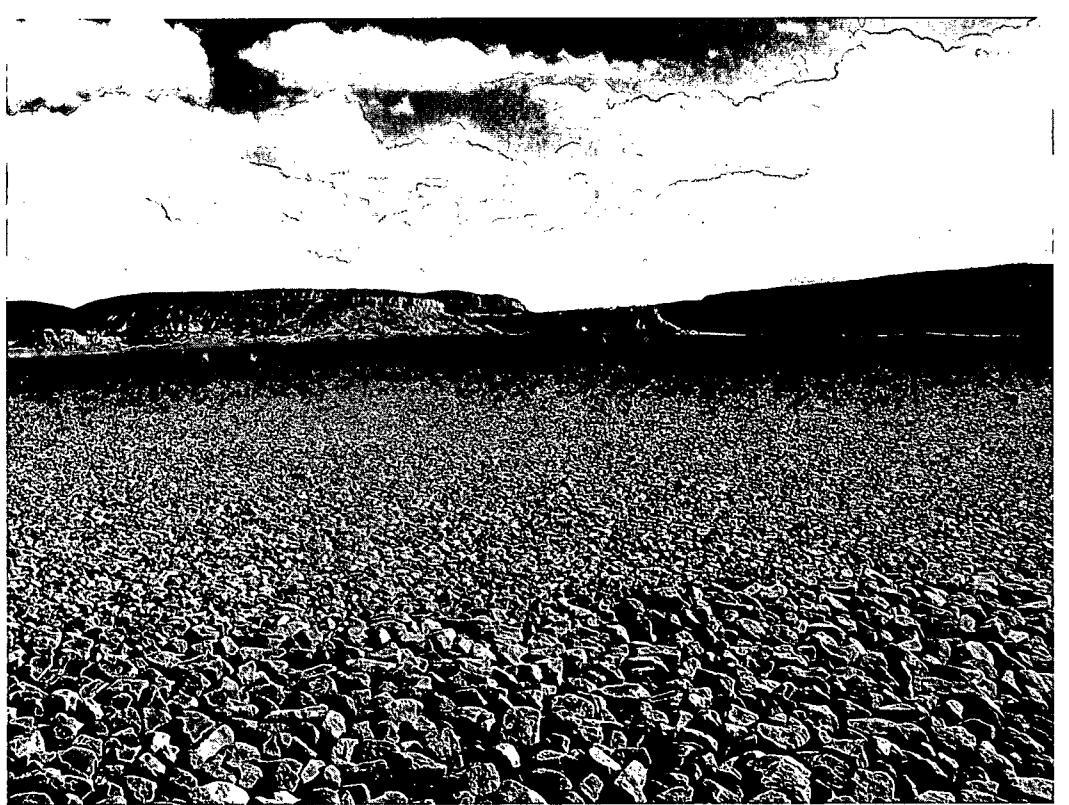
AMB 9/2004. PL–3. View across the disposal cell top. The foreground shows the transition between the smaller top slope riprap and the larger side slope riprap.

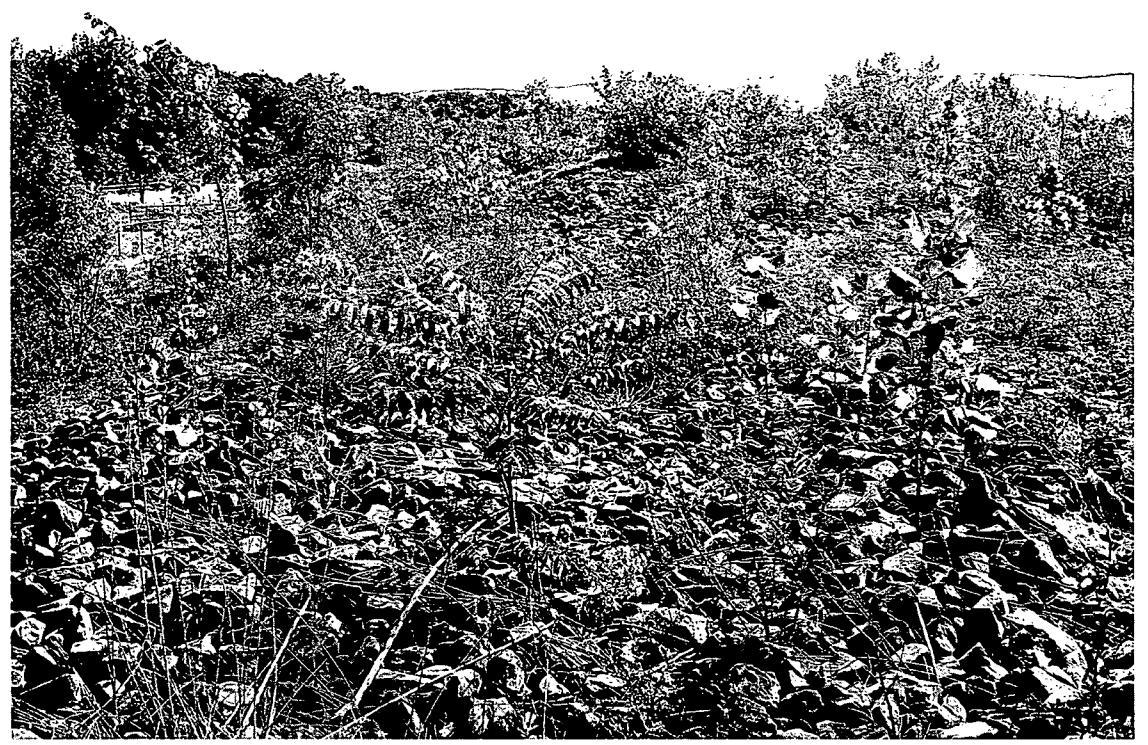
BUR 9/2004. PL-1. Vegetation establishing on top of the disposal cell.

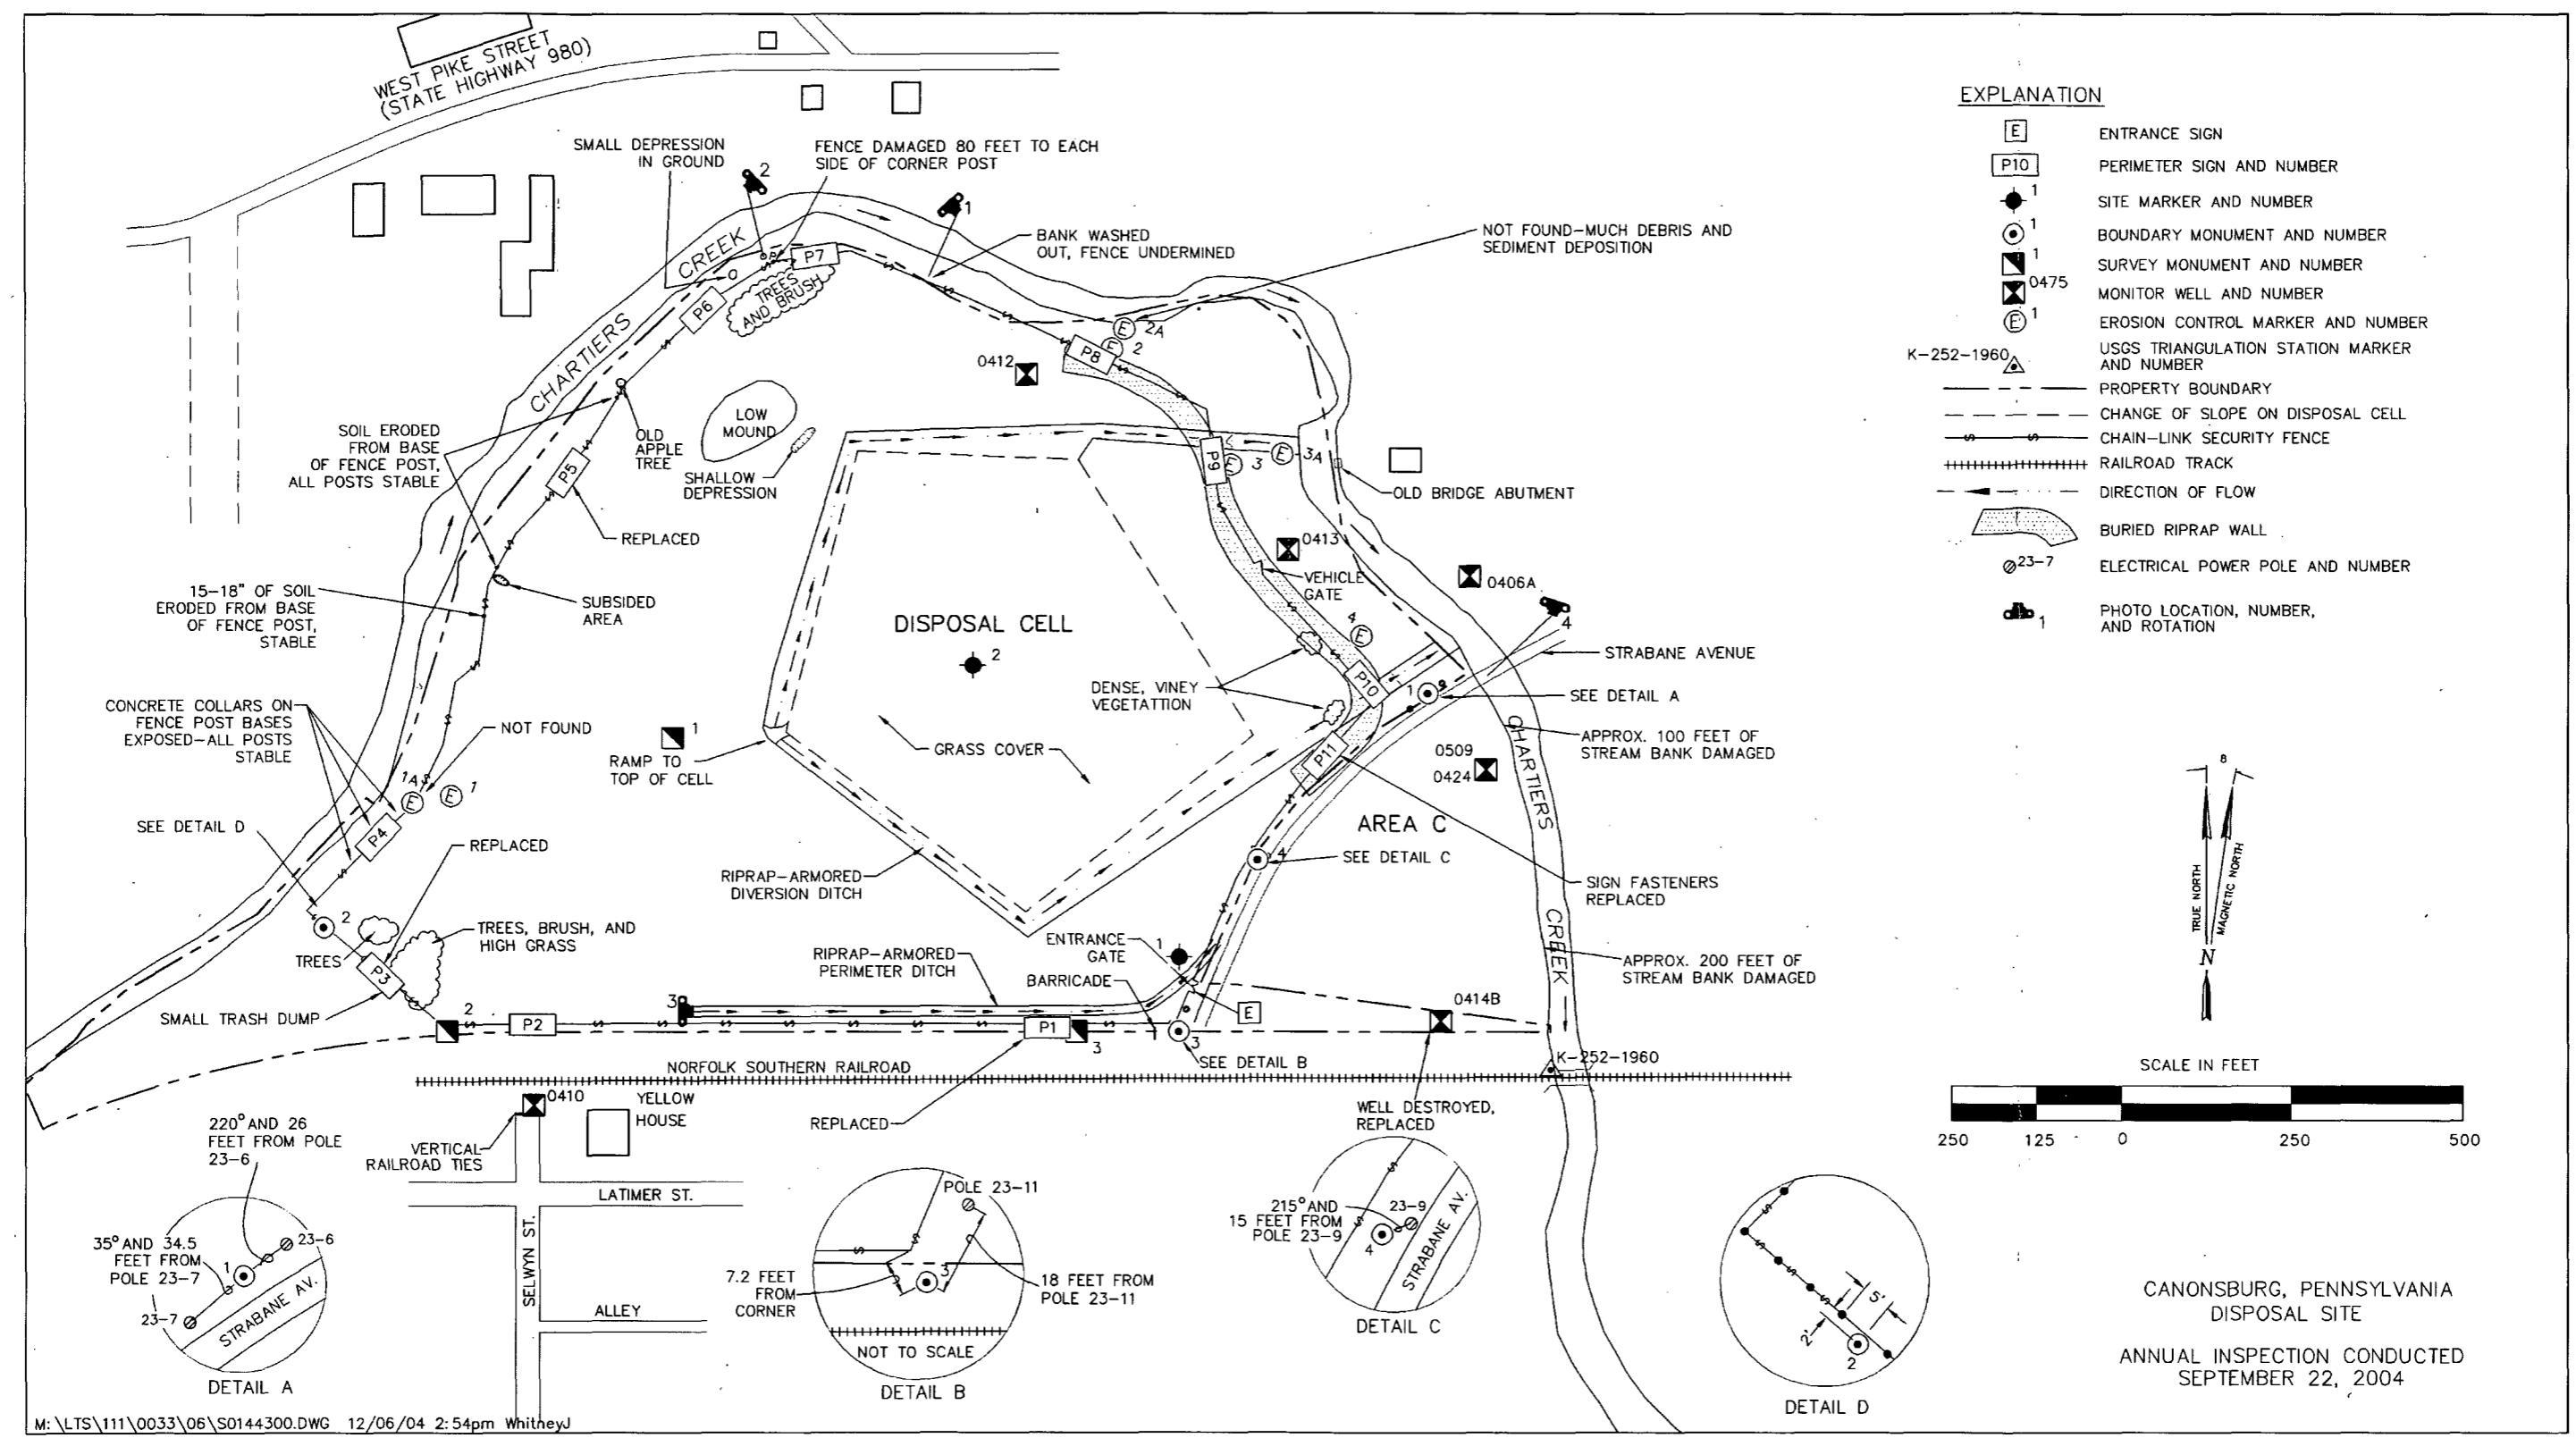
Figure 3–1. 2004 Annual Compliance Drawing for the Canonsburg, Pennsylvania, Disposal Site

Disposal Cell—The hurricane-related storms did not damage the disposal cell. Storm water was conveyed away from the cell as designed without causing erosion.

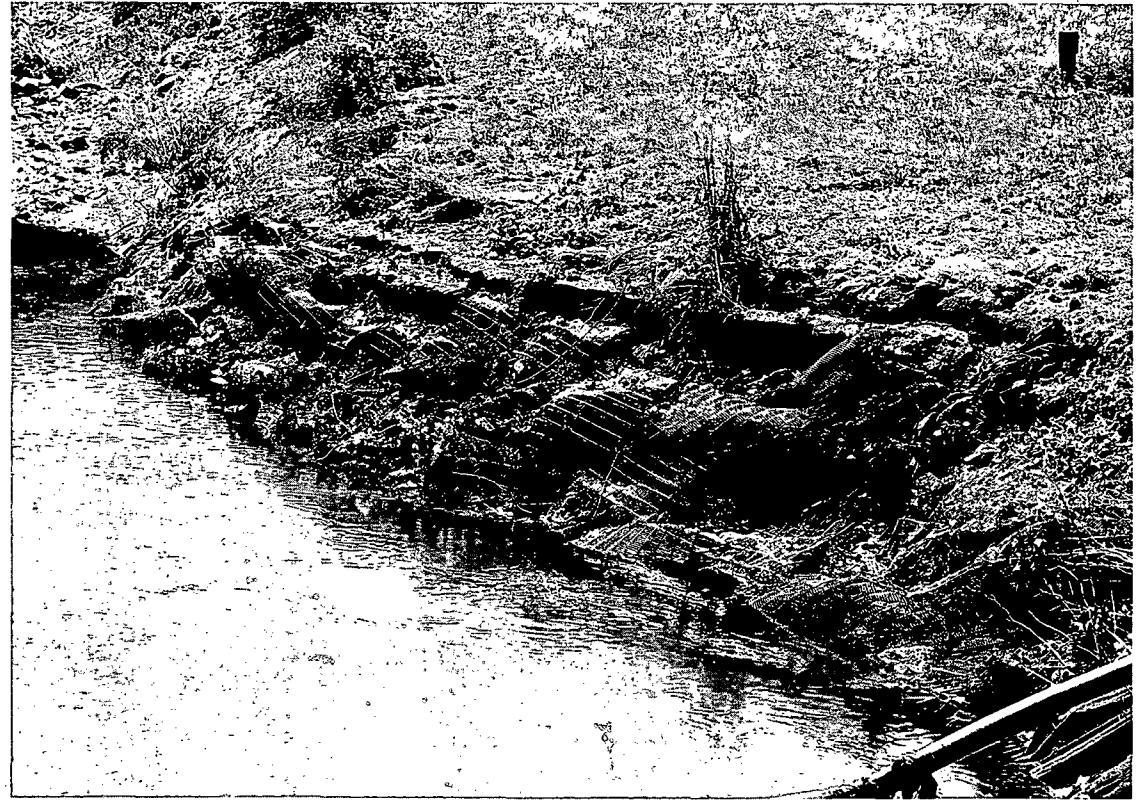
CAN 9/2004. PL-4. Stream bank erosion along Area C.

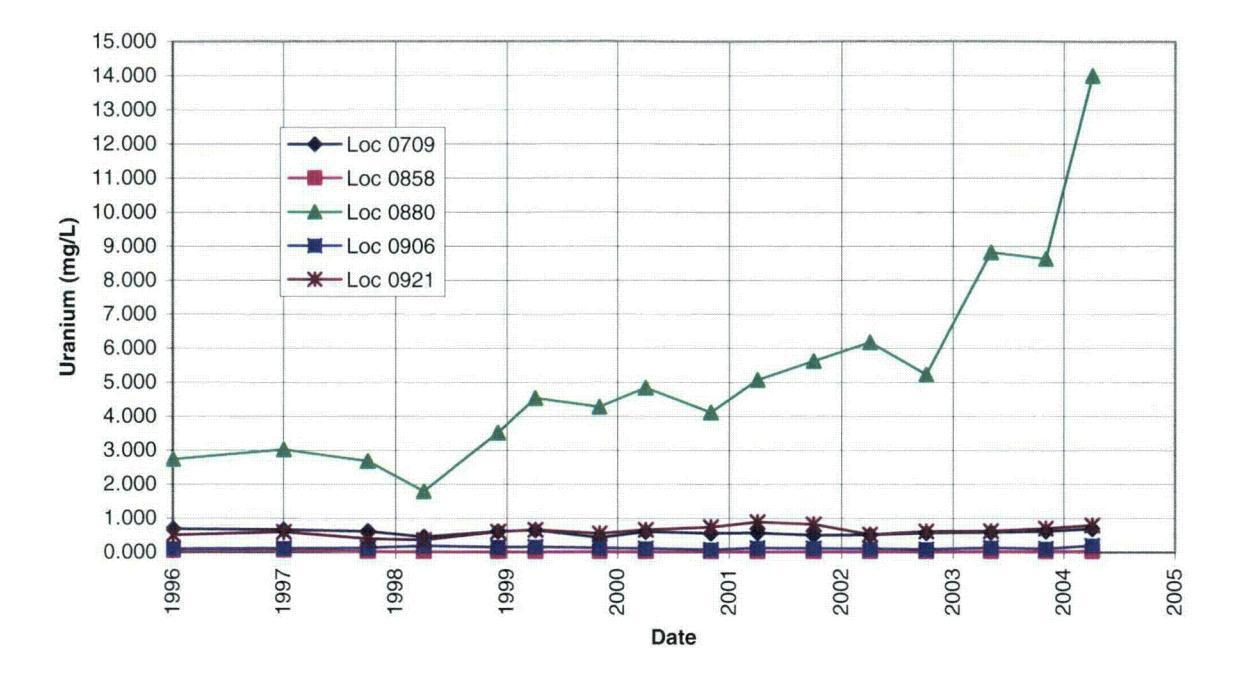
Figure 5–5. Uranium in Ground Water at Cell Performance Monitoring Locations at the Falls City, Texas, Disposal Site

Uranium concentrations in ground water in the vicinity of the disposal cell are consistent with the previous sampling event. The concentration in monitor well MW–0880 continues to be substantially greater than the other wells and continues to increase (Figure 5–5). The increase may be an indication of seepage from the disposal cell, as expected; there is no risk, however, because ground water is not used in the area. As shown on Figure 5–6, uranium in ground water in the compliance monitoring network has varied substantially in two wells (MW–0891 and MW–0924) since 1997 and exceeded the maximum concentration limit of 0.044 mg/L in four wells (MW–0886, MW–0891, MW–0924, and MW–0963). The increasing trend in uranium concentration in MW–0924 cannot be attributed to degradation of the cell because the wells between it and the cell continue to have low concentrations.

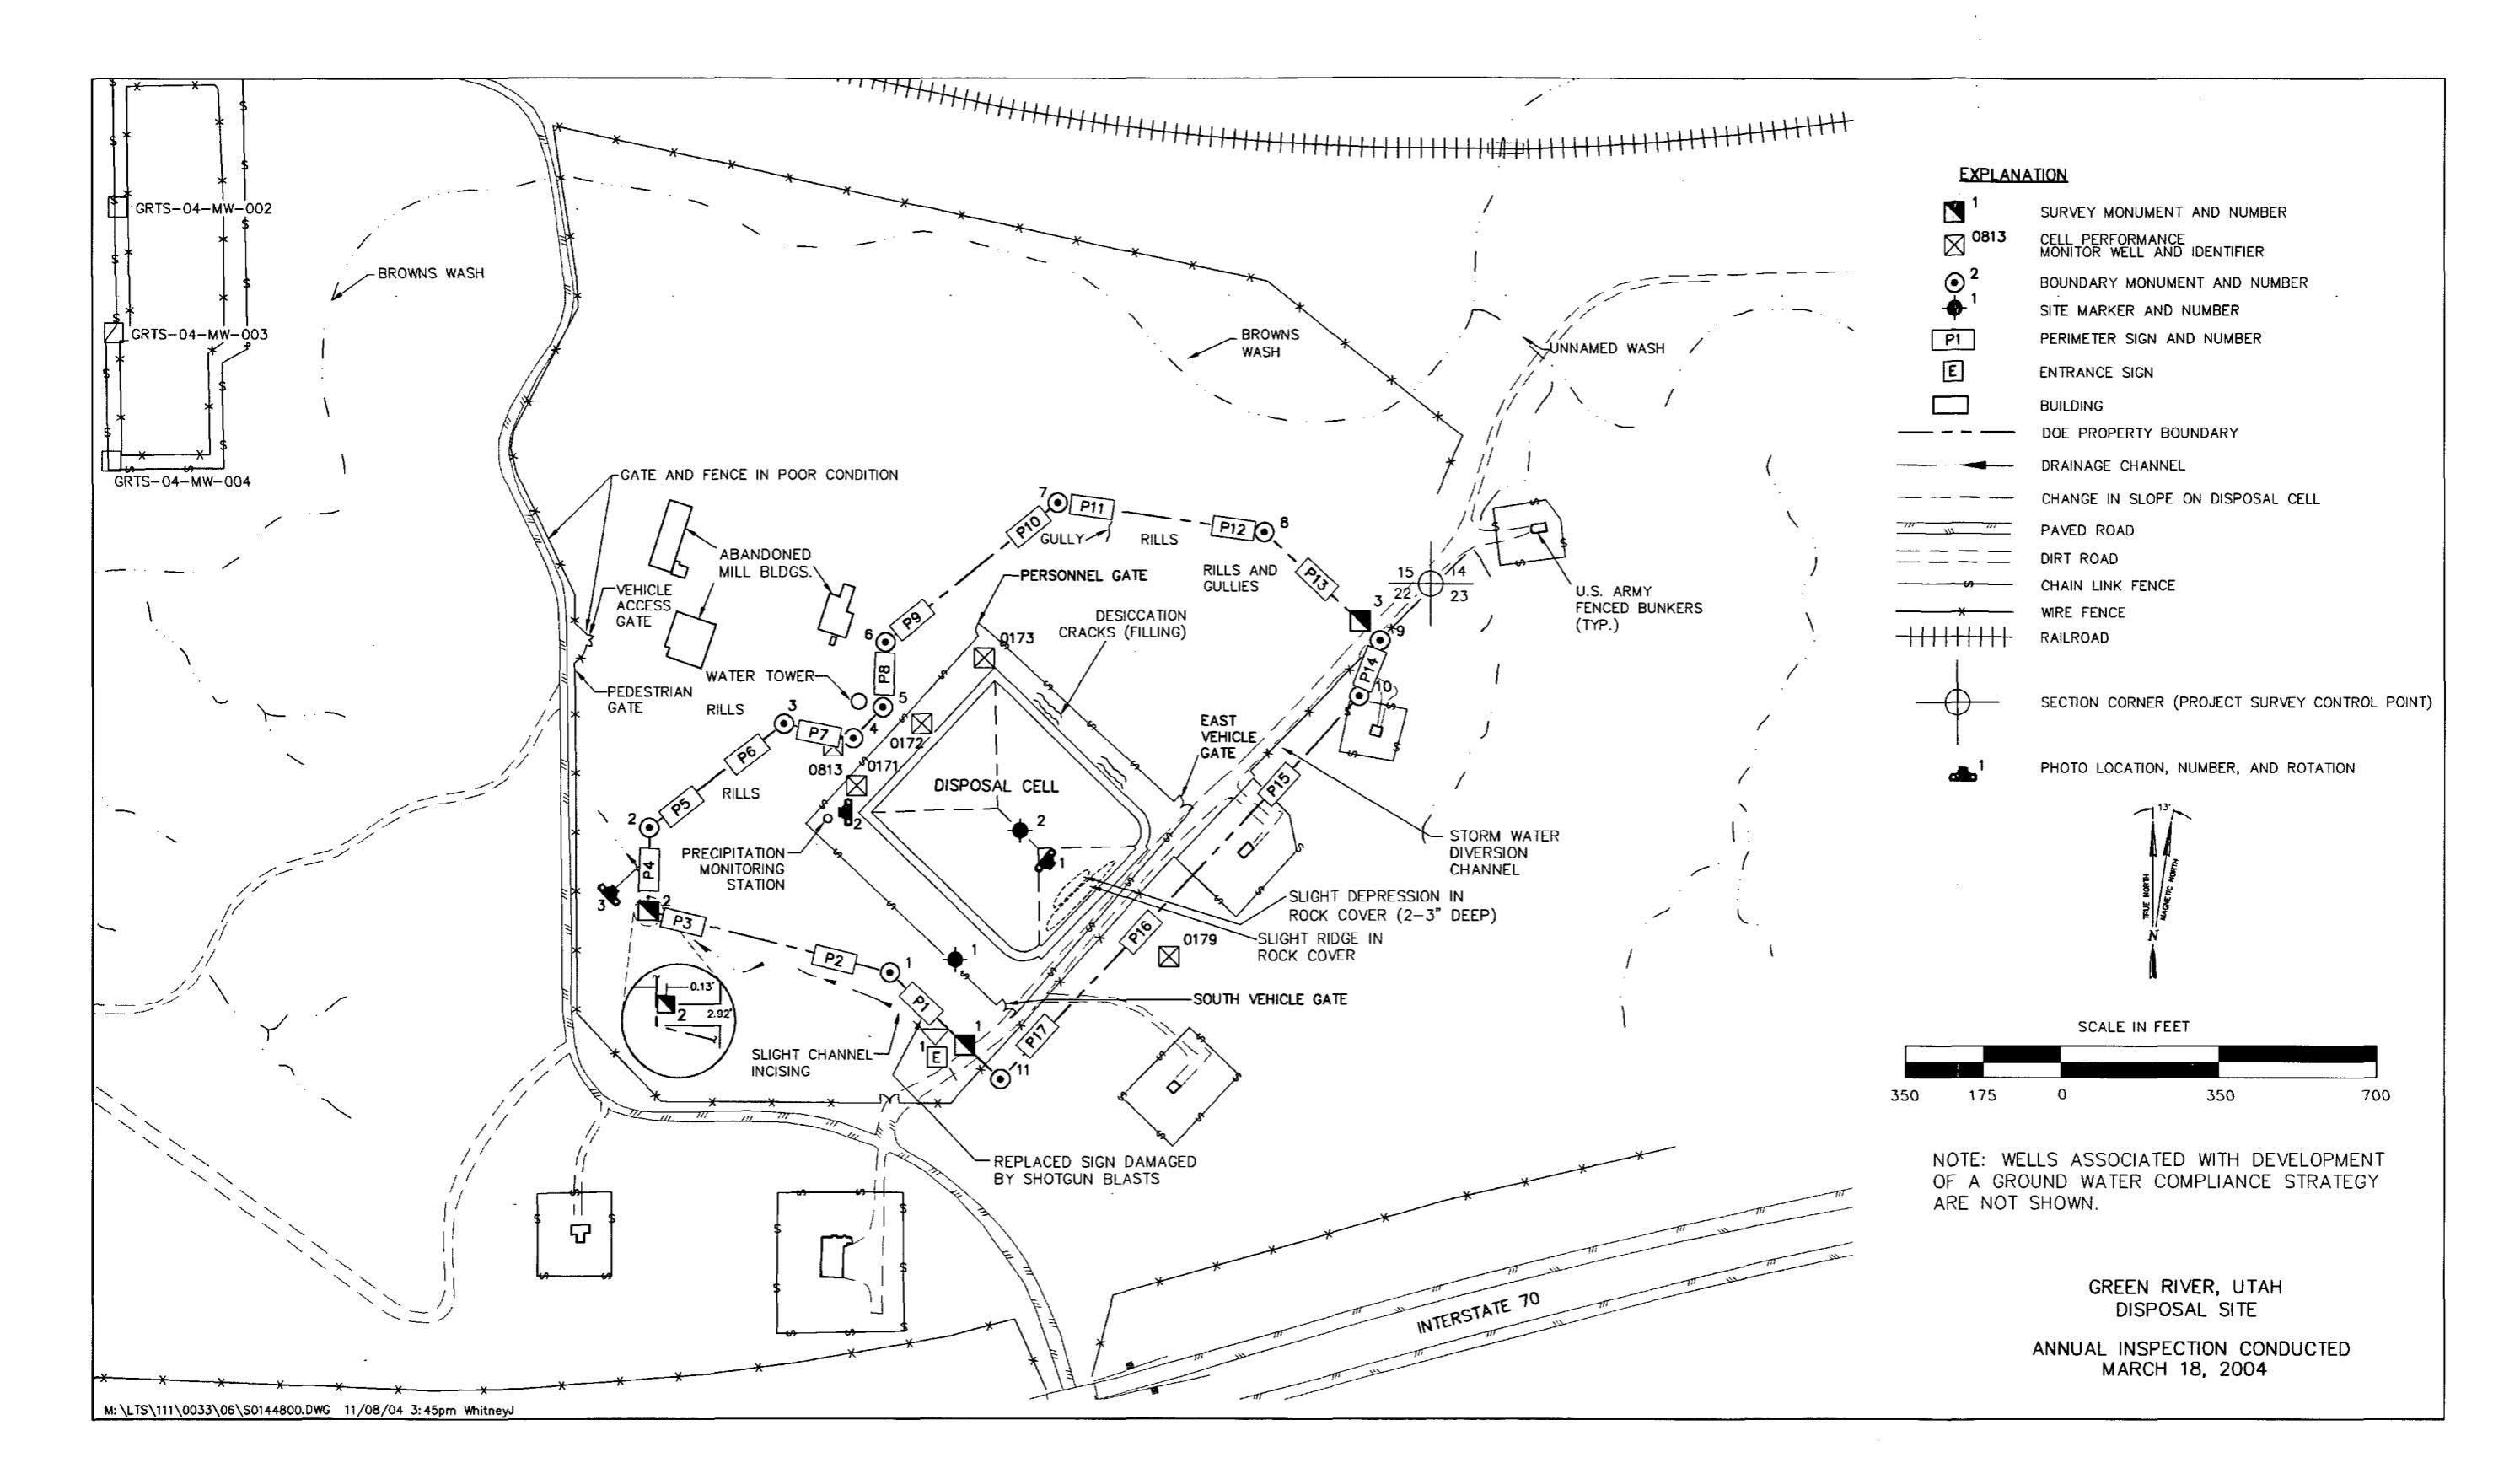
Figure 7-1. 2004 Annual Compliance Drawing for the Green River, Utah, Disposal Site
Rill erosion has occurred on the west side of the property but no new erosion was noted during the inspection. Site grading was performed in December 2003 to repair erosion damage and to divert runoff away from perimeter sign P4 (PL-3) and boundary monument BM-3.

Rill and gully erosion noted during previous inspections on the hillside northeast of the disposal cell in the area between boundary monument BM–7 and survey monument SM–3 was unchanged from 2003. Maximum gully depth in this area is approximately 3 feet. The rill and gully erosion poses no threat to the integrity of the disposal cell but eventually could damage perimeter signs and boundary monuments; therefore, monitoring of erosion in this area will continue.

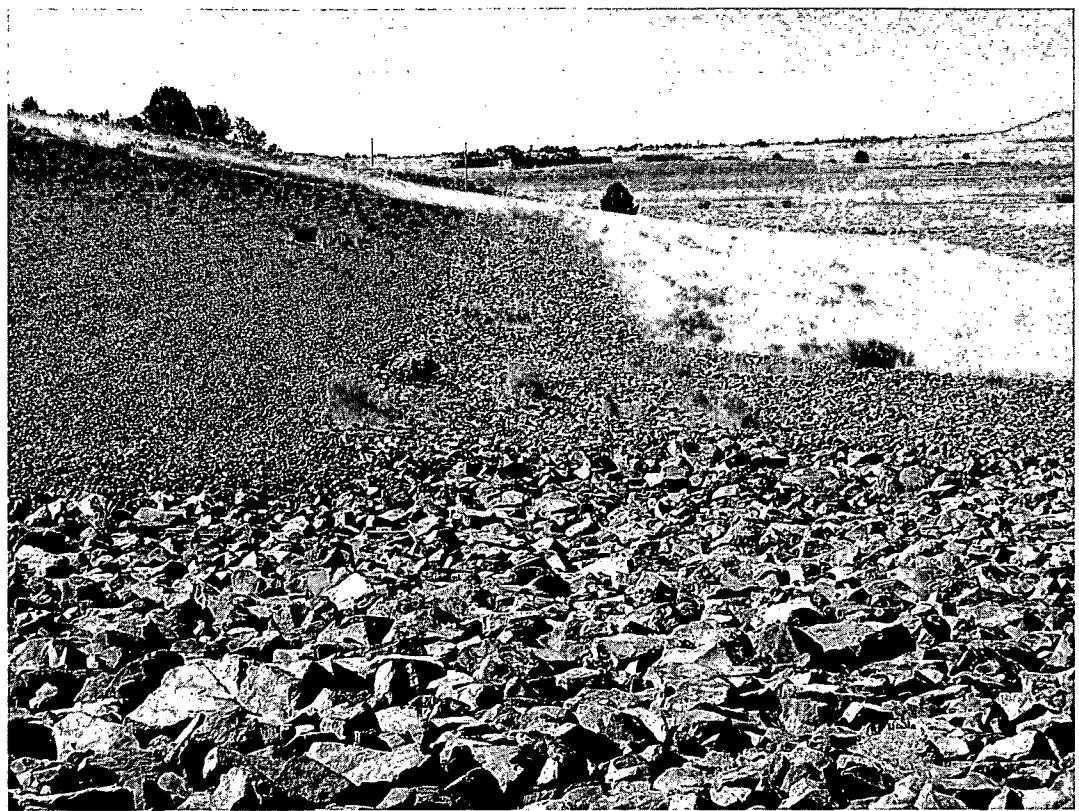
LKV 7/2004. PL-1. View of the west side slope and apron. The energy dissipation area of the drainage channel is in the foreground.

Top and Side Slope of the Disposal Cell—Basalt riprap armors the top and west-facing side slope of the disposal cell, which conforms to the east-to-west sloping topography of the site. An apron of larger riprap surrounds the disposal cell on all sides. The riprap was in excellent condition, and no evidence of subsidence, cracking, or differential settlement on the disposal cell was observed (PL-1).

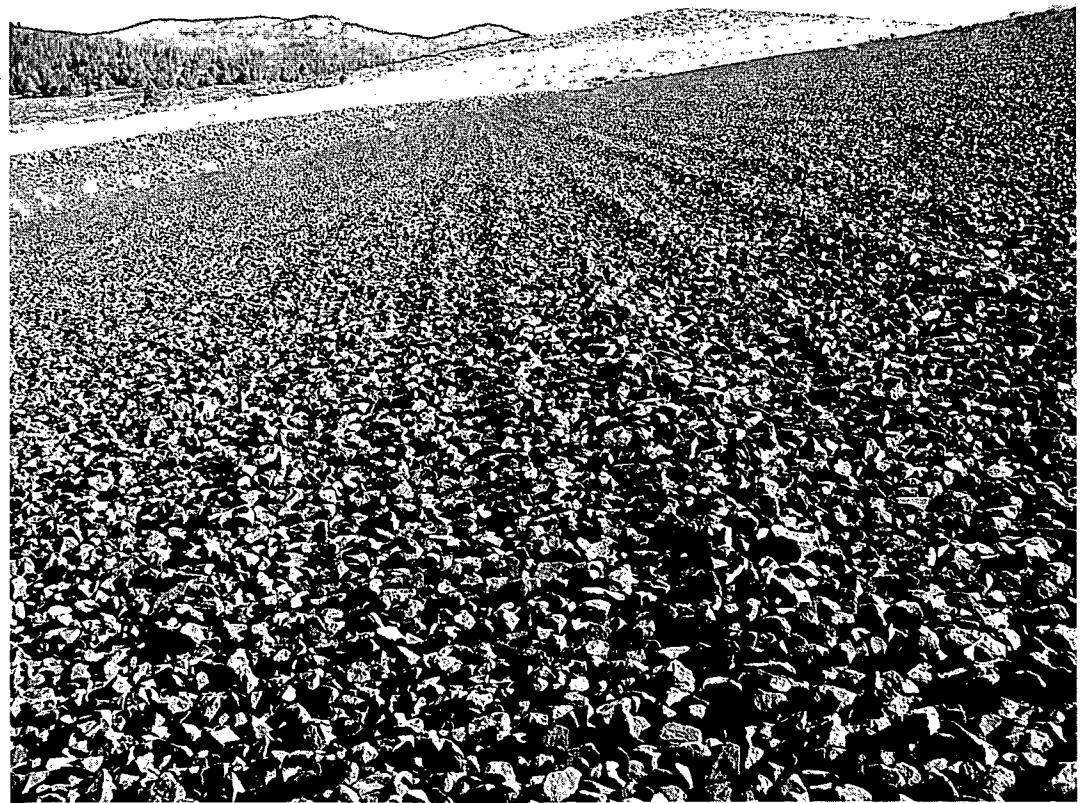
LKV 7/2004. PL-2. Original construction textures on the west side slope are still parallel, indicating no slumping along the slope.

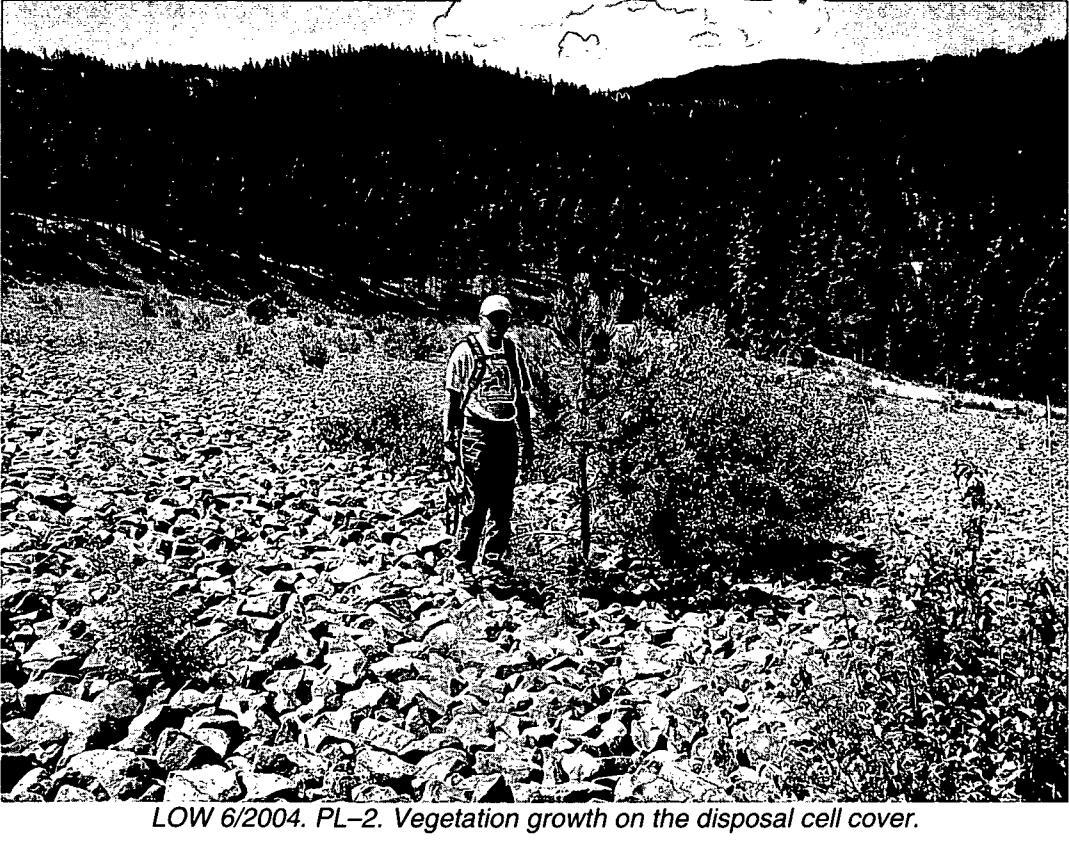
Encroachment of vegetation continues on the top and side slope of the disposal cell (PL-2). Based on the results of column leach studies conducted by DOE, the natural plant community succession can be allowed to proceed without increased risk to human health, safety, or the environment. A representative of the State of Idaho attended the inspection and recommended that the surrounding ponderosa pine forest be allowed to encroach and establish on the disposal cell with no requirement or plan for future logging because logging activities would damage the cell cover. As subsequently confirmed by a plant specialist, ponderosa pine trees have deep root systems and do not tend to be blown down, so there is minimal risk of exposing the encapsulated materials due to uprooting of the trees. The recommendation to allow continued encroachment of the native plant community will be included in the revised LTSP that DOE will submit to NRC for concurrence.

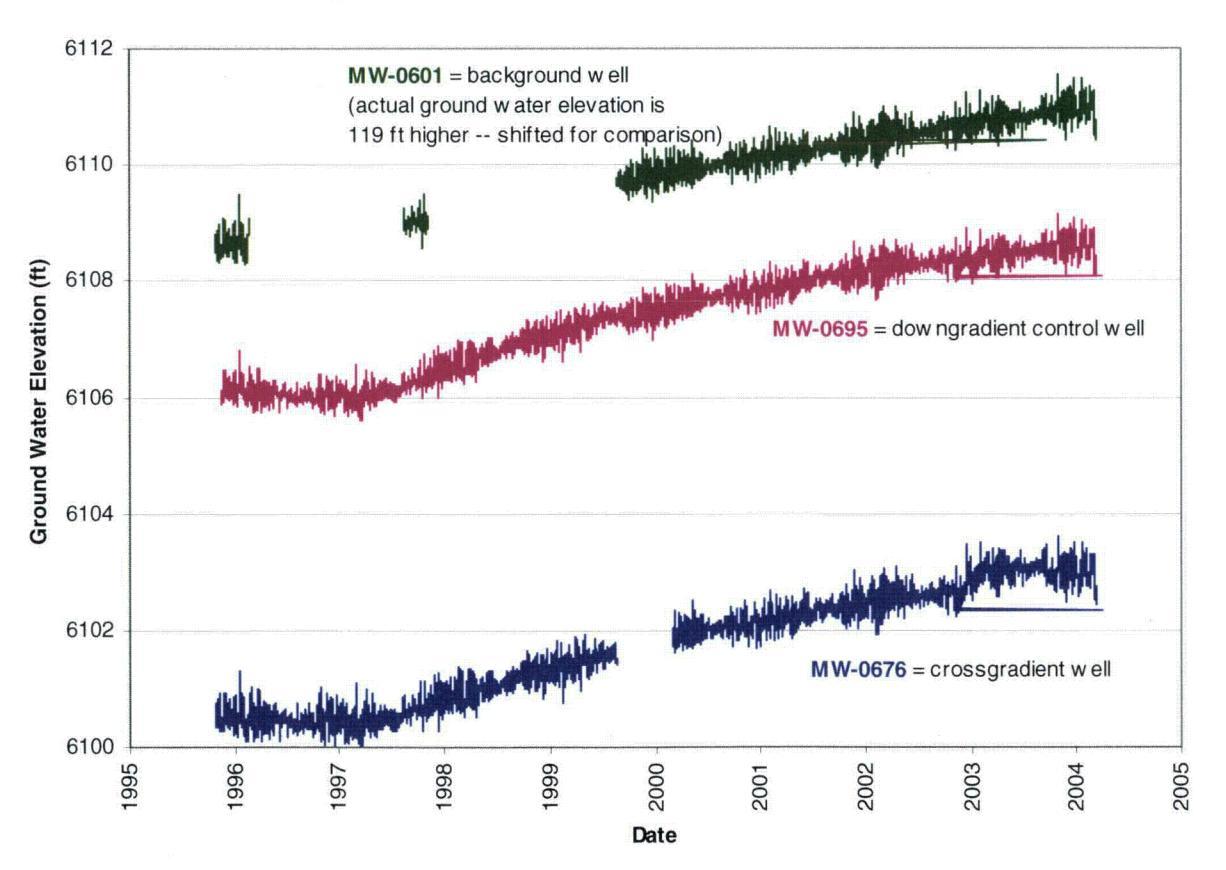
Figure 11–2. Water Level Measurements at the Maybell, Colorado, Disposal Site

As a best management practice, DOE performed continuous ground water level monitoring downgradient from the disposal cell for the purpose of measuring changes in ground water levels that may be related to transient drainage from the disposal cell. Evaluation of datalogger information from monitor wells MW–0695 (downgradient control well), MW–0676 (crossgradient well), and MW–0601 (upgradient/background well) from November 1995 through March 2004 (in excess of the required 5-year period) shows a slight increasing trend of ground water levels since mid-1997 (Figure 11–2). Because the ground water level in the upgradient well increased at approximately the same rate as that in the downgradient wells, the change in water level is attributed to regional causes rather than being directly related to disposal cell performance. Based on these water level monitoring results, there is no evidence of any transient drainage interaction with the ground water system near the disposal cell. This observation confirms earlier qualitative assumptions that the potential water level increase from dissipation of the ground water mound under the cell which, in turn, would be affected by the natural fluctuation of ground water levels in the area.

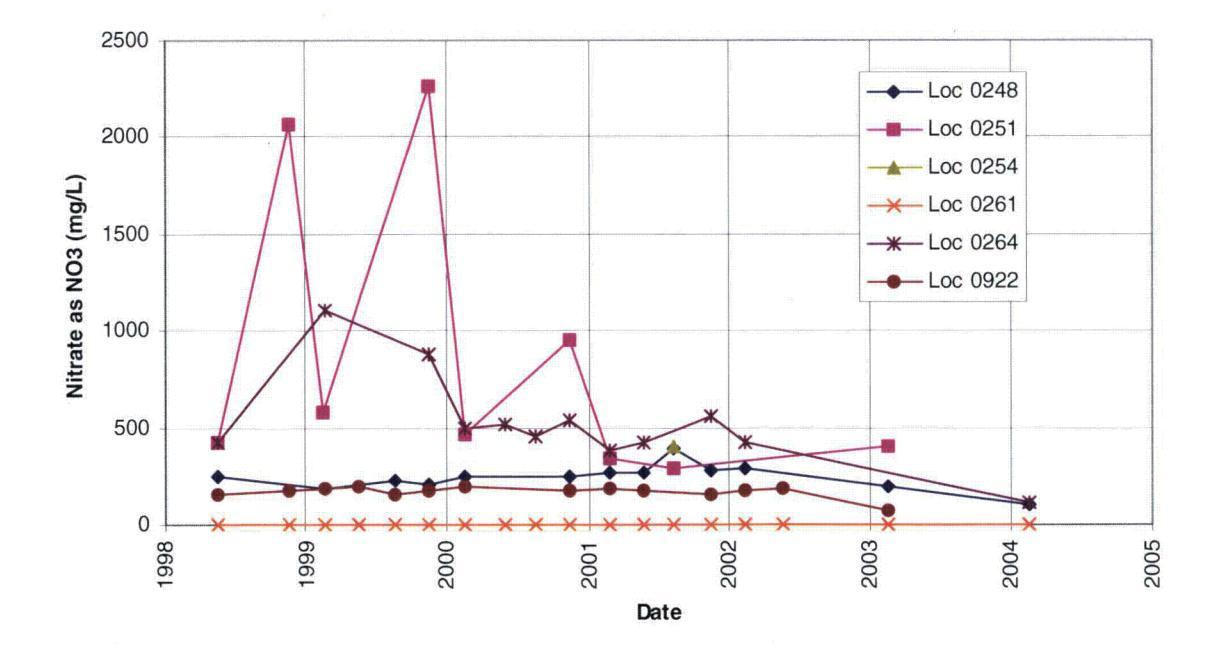
Figure 12–2. Time-Concentration Plots of Nitrate (as NO₃) in Seep Water at the Mexican Hat, Utah, Disposal Site

Concentrations of nitrate continue to decrease, with 110 mg/L in the North Arroyo seep and 100 mg/L in the Gypsum Creek seep (Figure 12–2). Concentrations in the background seep remain below 1 mg/L.

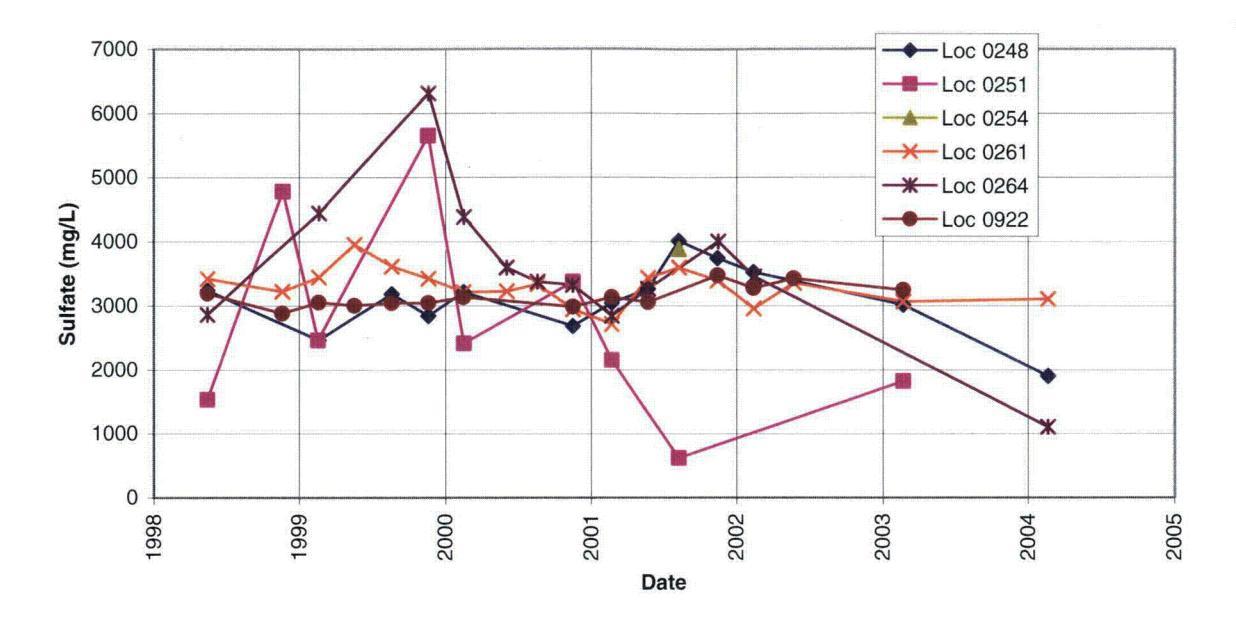
Figure 12–3. Time-Concentration Plots of Sulfate in Seep Water at the Mexican Hat, Utah, Disposal Site

Sulfate concentrations similarly have decreased in the North Arroyo seep and in the Gypsum Creek seep to less than 2,000 mg/L (Figure 12–3). Concentrations in the background seep remained relatively steady at 3,000 mg/L.

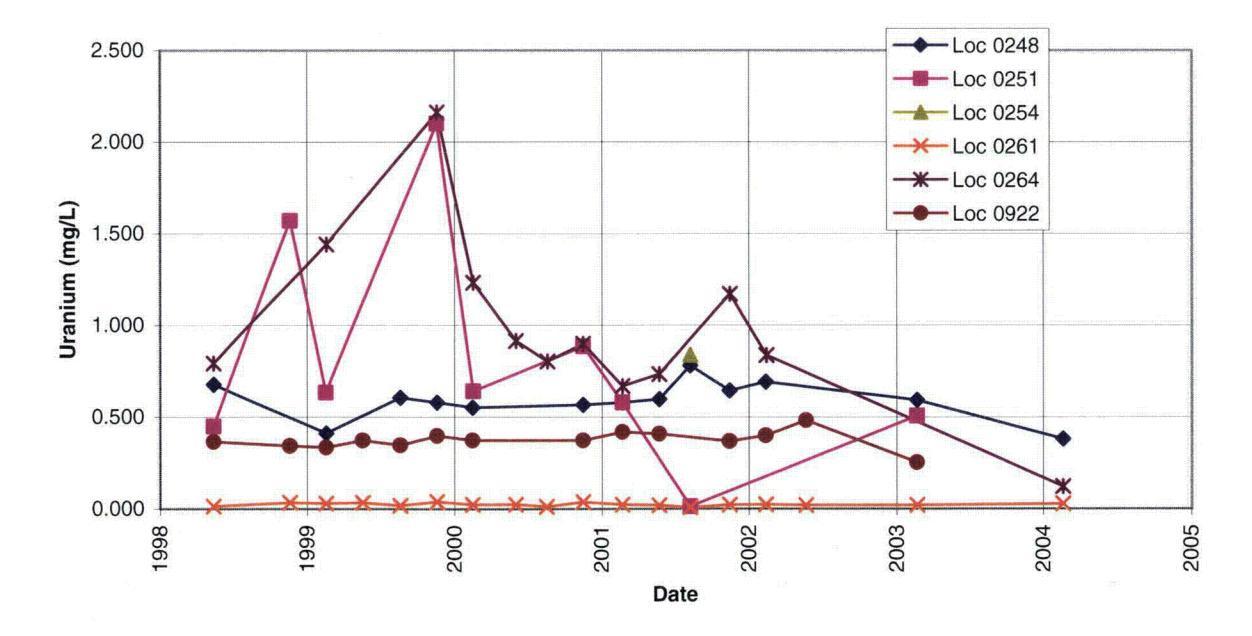
Figure 12–4. Time-Concentration Plots of Uranium in Seep Water at the Mexican Hat, Utah, Disposal Site

Concentrations of uranium in the North Arroyo seep decreased to 0.120 mg/L, and in the Gypsum Creek seep to 0.380 mg/L (Figure 12–4). Background levels at seep 0261 have remained relatively constant at approximately 0.025 mg/L for the past several years.

Results of monitoring in 2004 show that concentrations of all target constituents are generally decreasing in the North Arroyo and Gypsum Creek seeps. No trends of increase in concentrations are evident that would suggest degradation of the disposal cell cover.

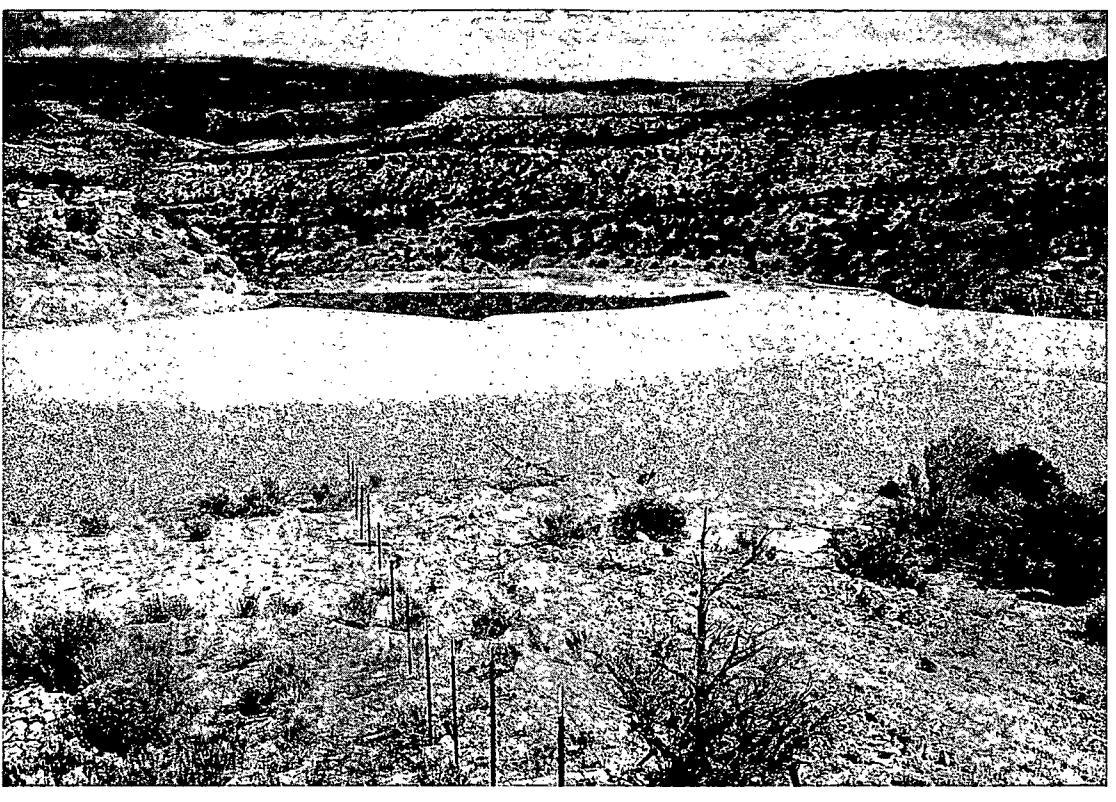
Top of Disposal Cell and Side Slopes—Rock covers the 2-acre top of the disposal cell and the approximate 8 acres of side slopes (PL-1). The rock is rounded, with larger rock on the side slopes than on the top. The cell top and side slopes of the disposal cell were in excellent condition. No evidence of subsidence, differential settlement, slumping, or other modifying process was noted, and no vegetation was present.

NAT 4/2004. PL-1. East view of the disposal cell.

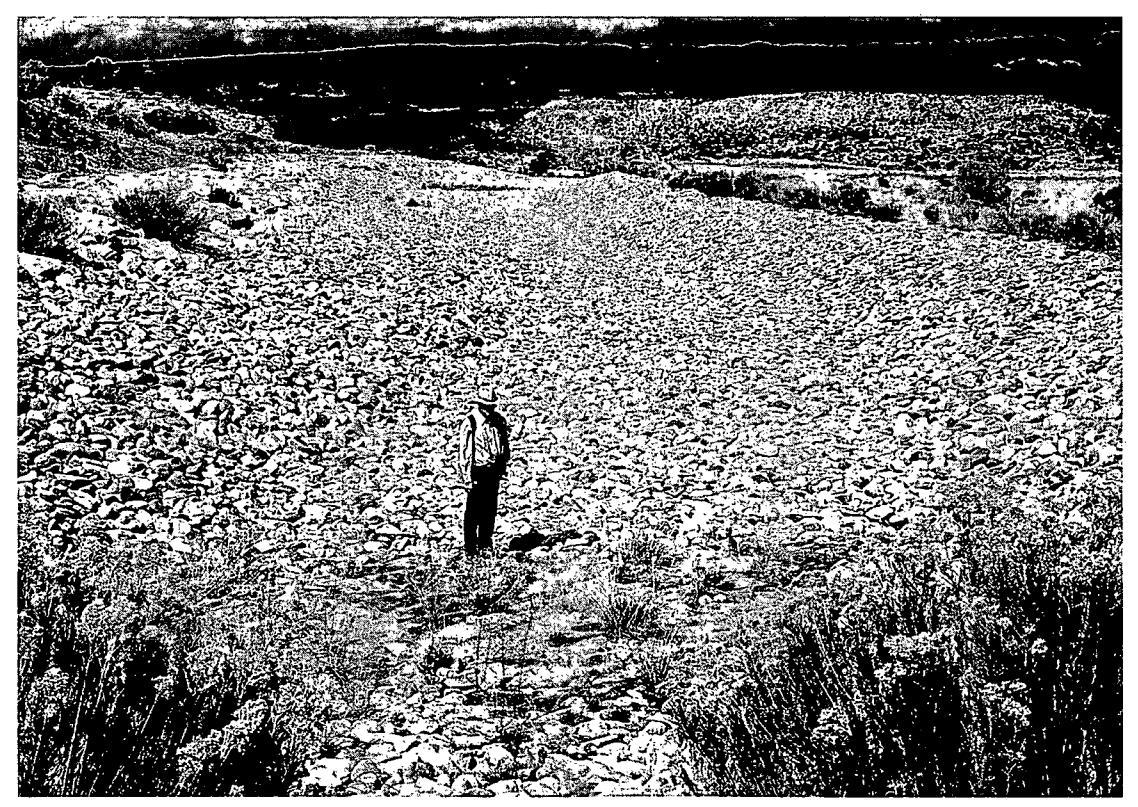
Interceptor Channel—A riprap-armored interceptor channel, upslope and northwest of the disposal cell, diverts storm water and snowmelt run-on to the east across County Road EE22. Some erosion has occurred outside the property uphill from the channel resulting in minor deposition of sediment in the channel (PL–2). A small amount of a noxious weed (halogeton) and some tamarisk was observed at the southwest, upstream end of the channel (PL–2). Treatment with herbicide was not performed in 2004, but is scheduled to occur in 2005. Otherwise, the channel is in excellent condition. The accumulated sediment and plant growth does not impair the function of the channel.

NAT 4/2004. PL-2. Minor sedimentation and plant growth in the upstream end of the interceptor channel.
