U.S. Department of Energy Office of Legacy Management

2004 Annual Site Inspection and **Monitoring Report for Uranium Mill Tailings Radiation Control Act Title I Disposal Sites**

December 2004

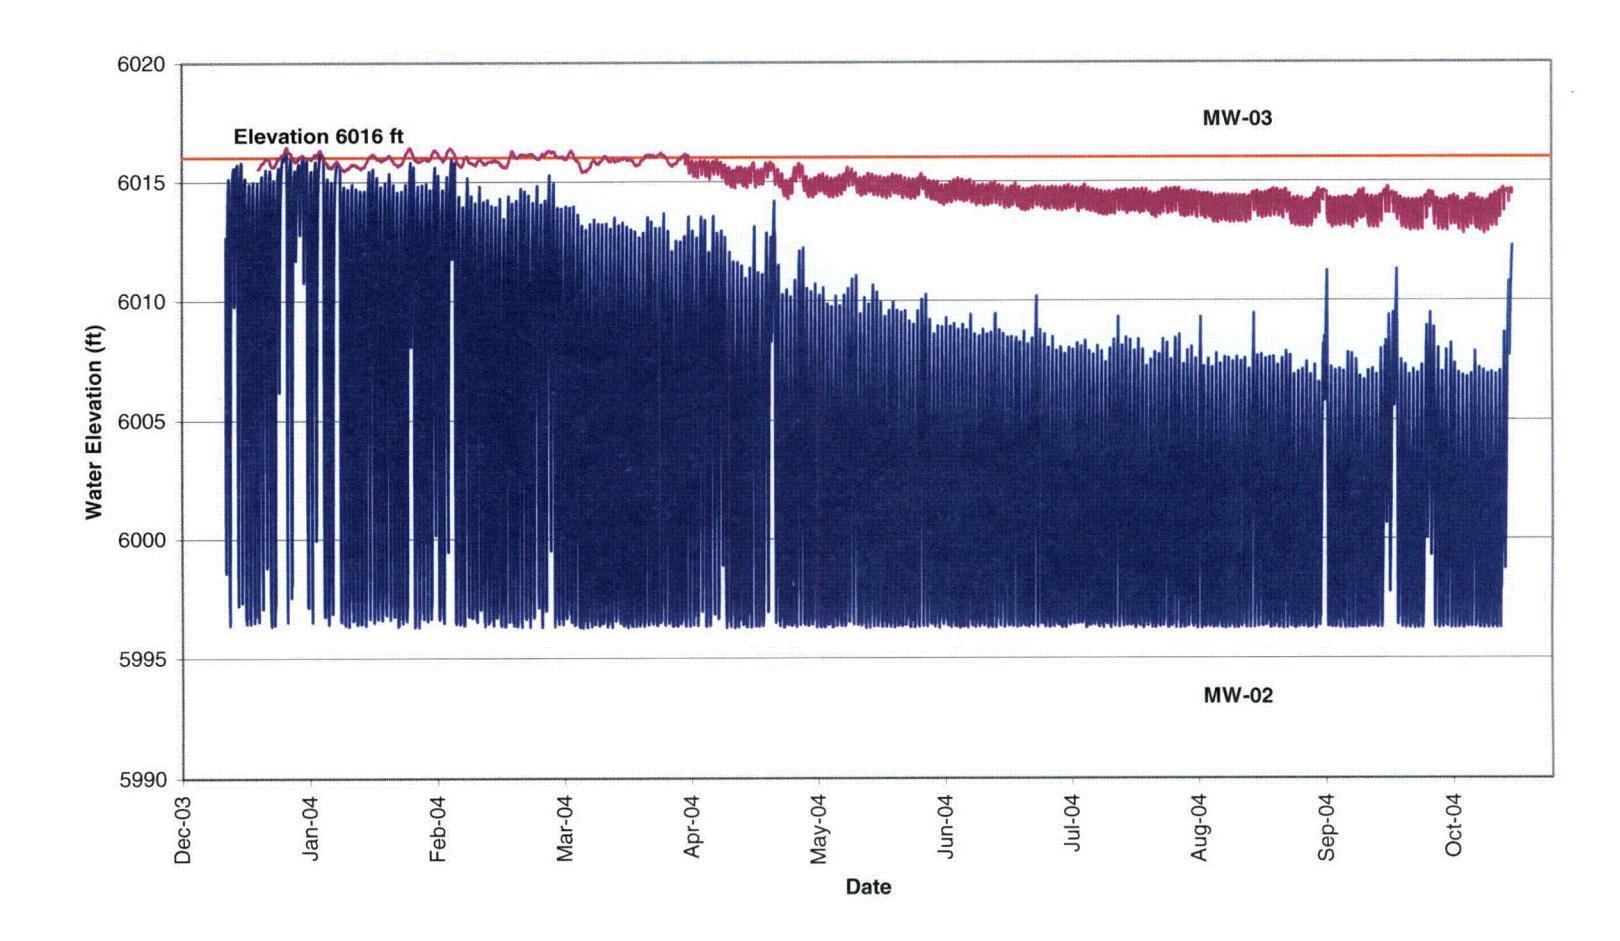
Figure 14–2. Water Levels in Standpipes MW–02 and MW–03 at the Rifle, Colorado, Disposal Site

U.S. Department of Energy December 2004 At the time of the inspection, the pump in MW–02 was operating at about 1 gallon per minute (gpm) and the pump in MW–03 was operating at about 4 gpm. As shown by datalogger measurements (Figure 14–2), water levels steadily decreased in the past year, and the water level elevation has remained below 6,015 feet in both standpipes since June 2004. Fluctuations in the water levels represent drawdown and recovery during pumping cycles. The pumps are shut off for the winter because of reduced evaporation rates during that time.

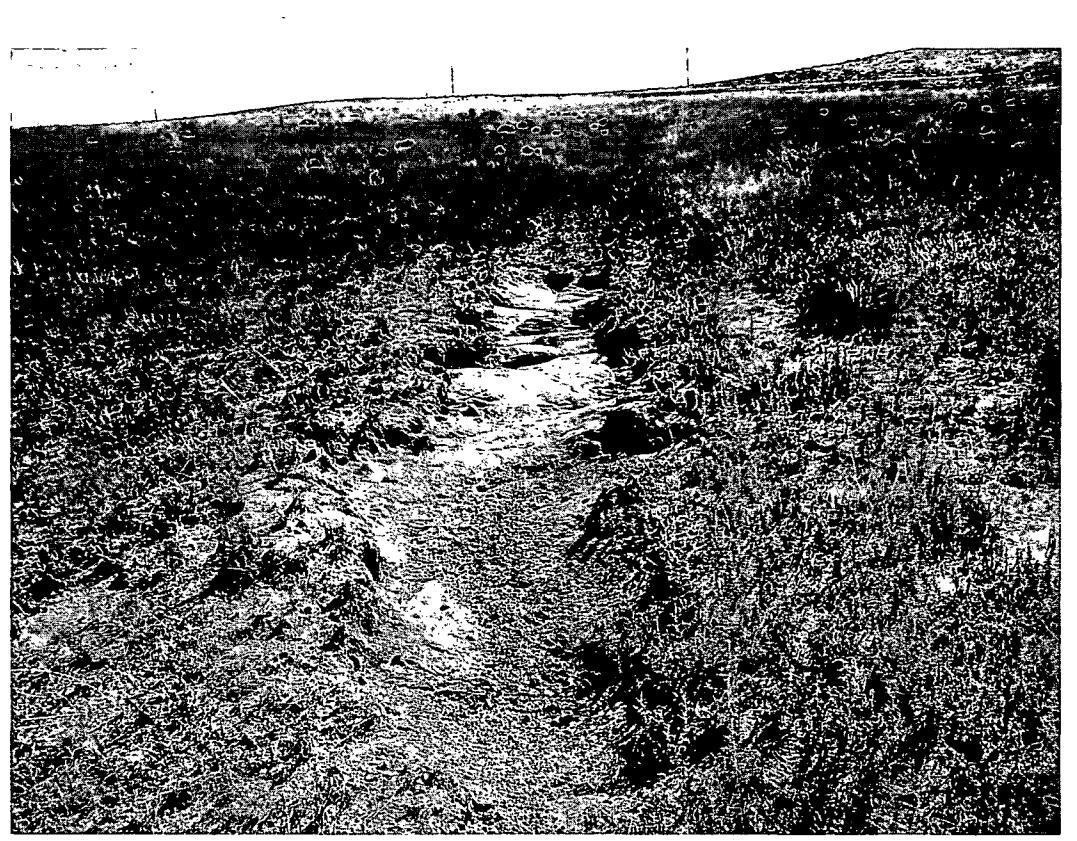
SPK 8/2004. PL-3. Erosion feature scoured to bedrock adjacent to the cell cover.

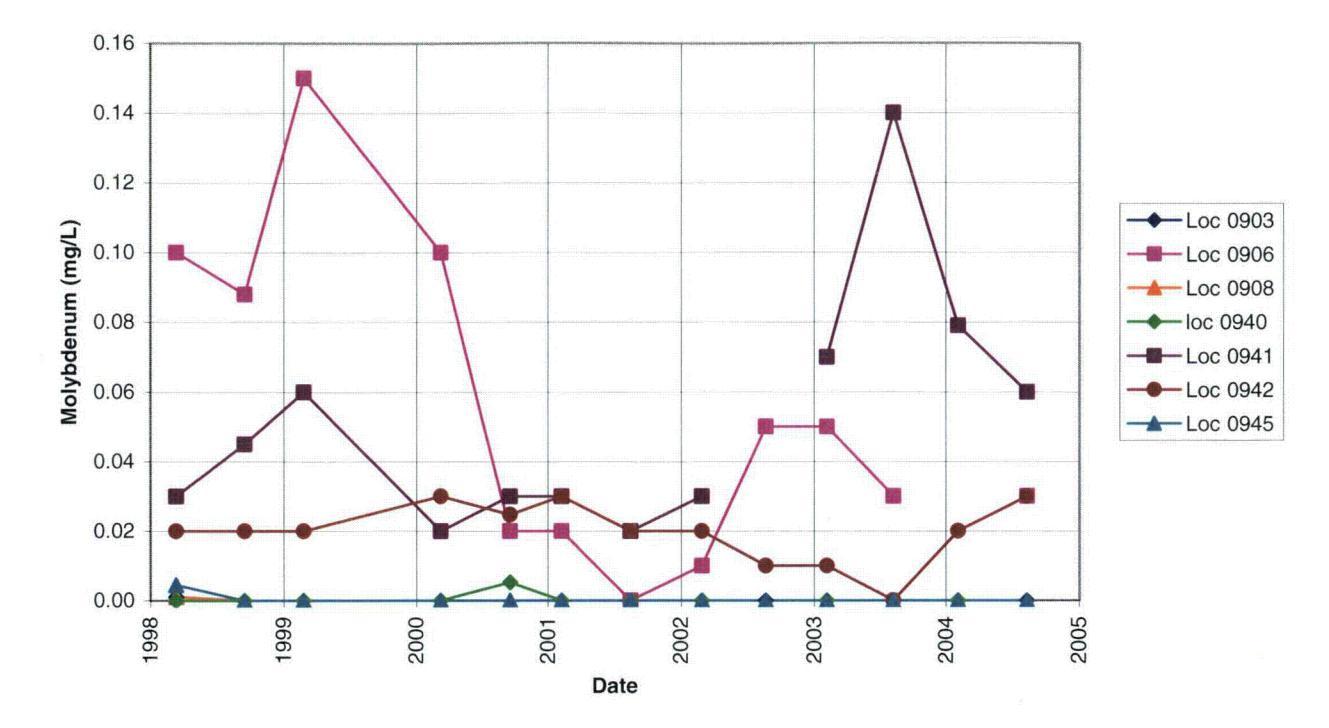
Molybdenum concentrations were below the MCL in 2004. The concentrations have not varied significantly in the last 7 years (Figure 19–2).

Figure 19–2. Time-Concentration Plots of Molybdenum in Ground Water at the Tuba City, Arizona, Disposal Site

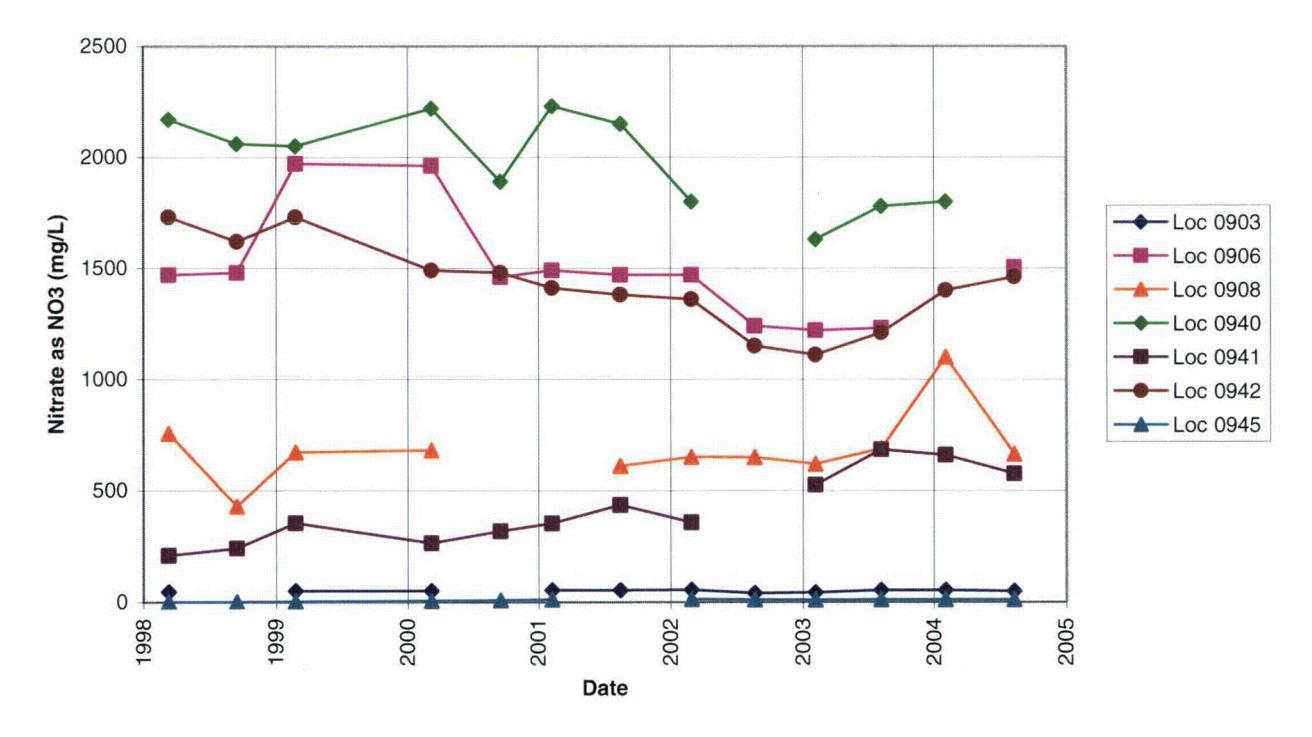
In 2004, concentrations of nitrate (as NO₃) exceeded the MCL in samples from all monitor wells except background well MW–0945. Between 2003 and 2004, no significant increases or decreases in concentrations were observed in samples from any well, although concentrations varied considerably from well to well (Figure 19–3).

Figure 19–3. Time-Concentration Plots of Nitrate (as NO₃) in Ground Water at the Tuba City, Arizona, Disposal Site

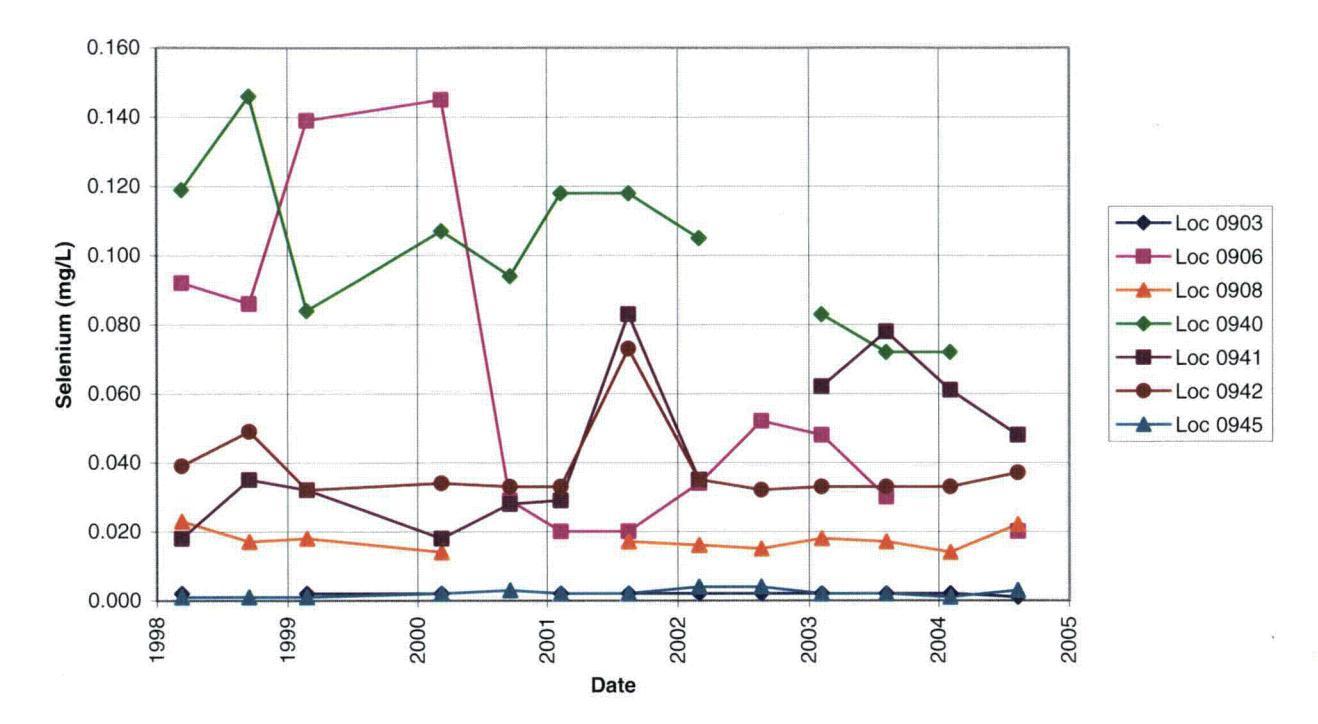
Consistent with historical data, selenium concentrations exceeded the MCL in 2004 in samples from all wells except background well MW–0945 and off-site, downgradient well MW–0903 (Figure 19–4).

Figure 19–4. Time-Concentration Plots of Selenium in Ground Water at the Tuba City, Arizona, Disposal Site

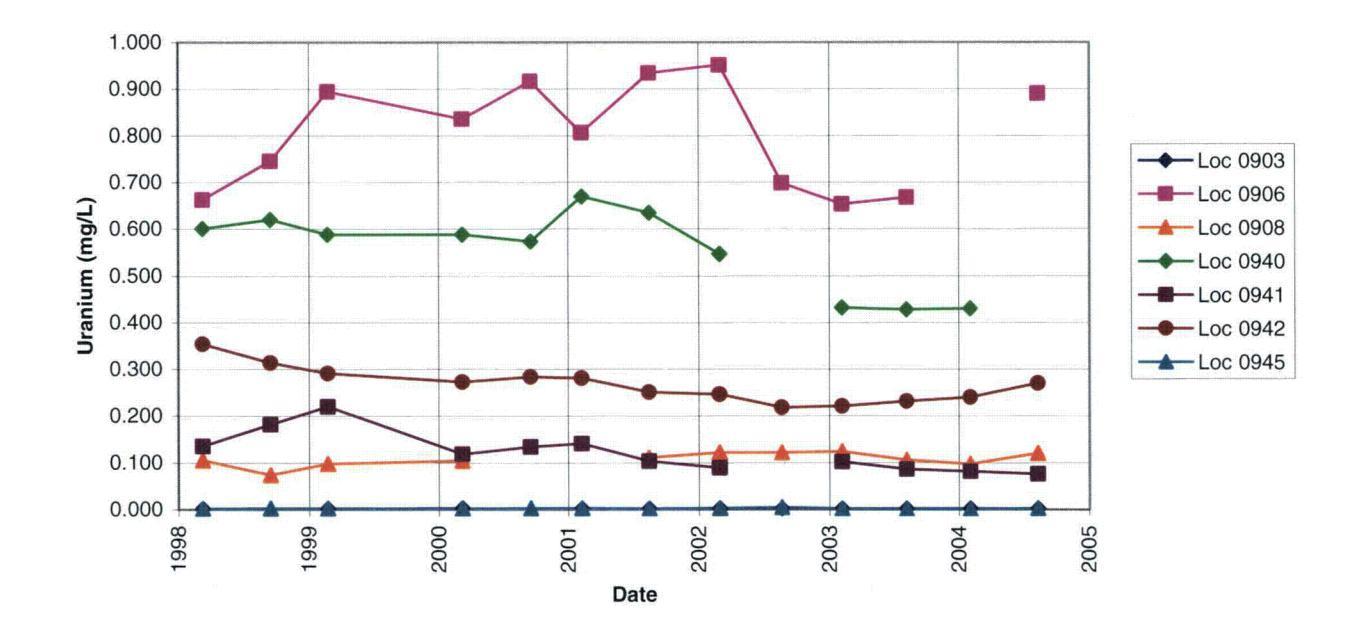
Uranium concentrations exceeded the MCL in 2004 samples from all wells except background well MW–0945 and off-site, downgradient well MW–0903. Concentrations have remained fairly constant over time in samples from all wells except MW–0906 and MW–0940 (Figure 19–5).

Figure 19–5. Time-Concentration Plots of Uranium in Ground Water at the Tuba City, Arizona, Disposal Site

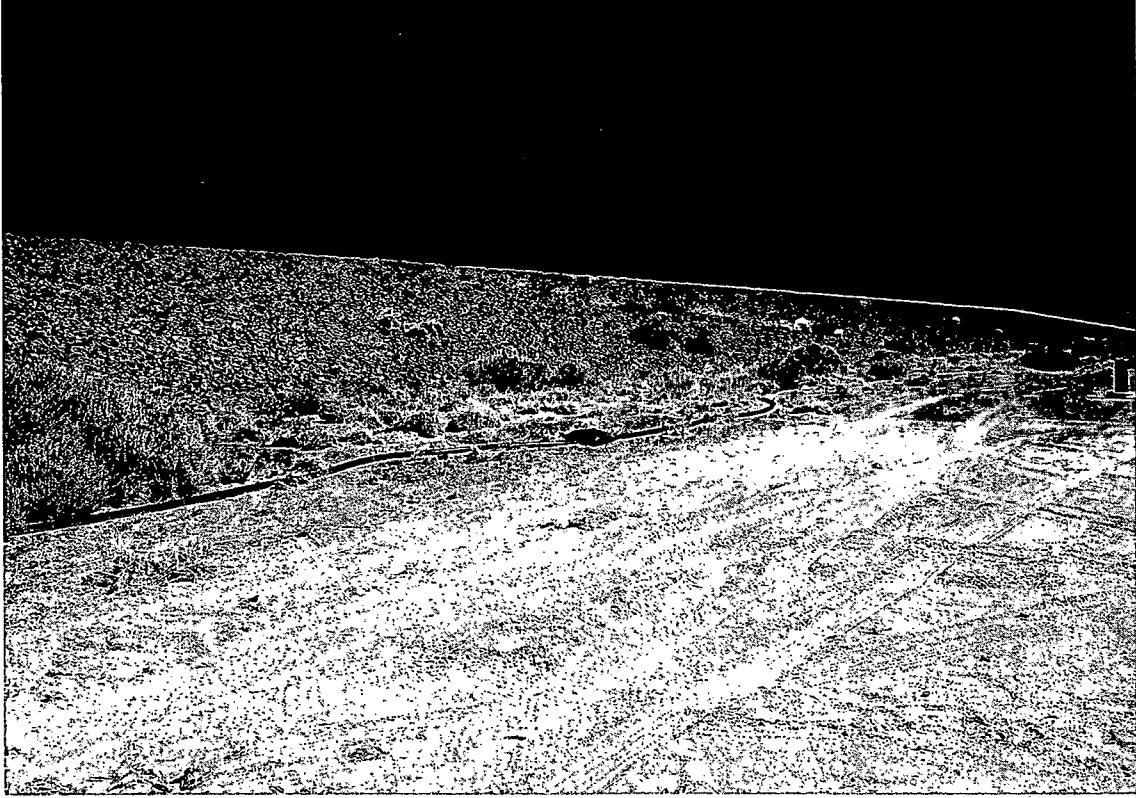
Patches of dead annual weeds were seen on the top and side slopes of the cell (PL-2). Only one deep-rooted woody plant (four-wing saltbush) was observed on top of the disposal cell.

TUB 9/2004. PL-2. Vegetation encroachment on the south side slope of the disposal cell.

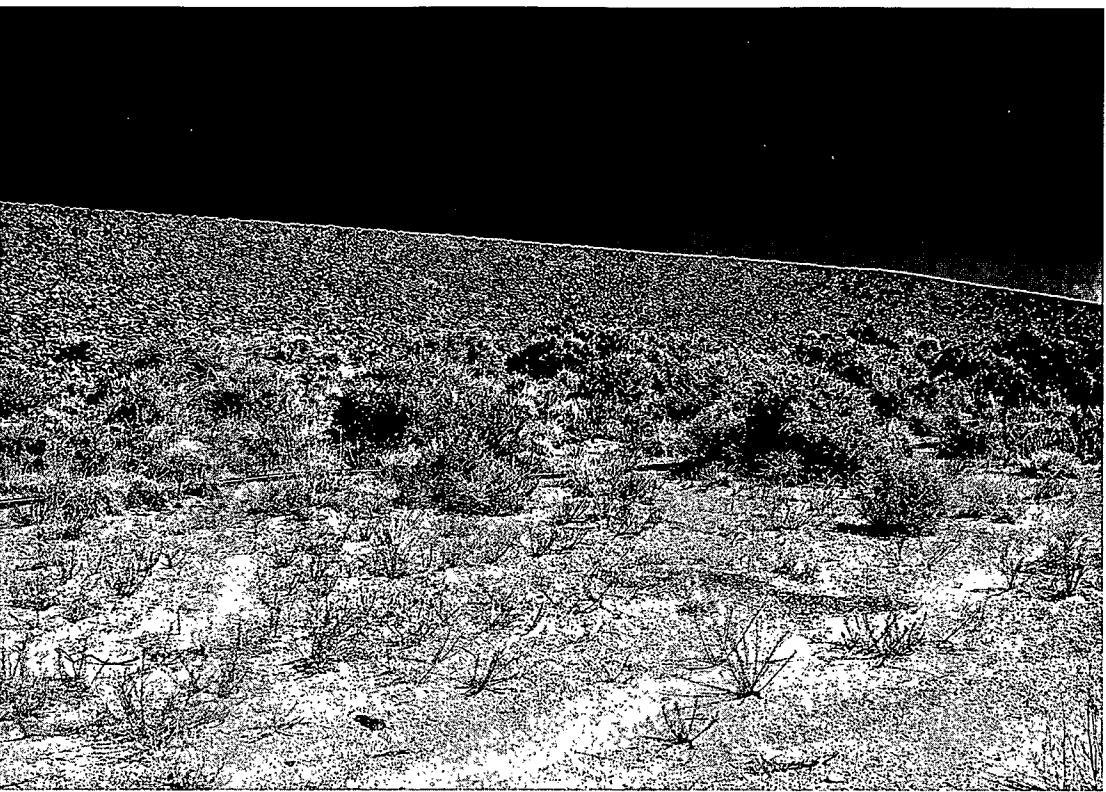
TUB 9/2004. PL–3. Vegetation encroachment and sand accretion along the base of the south side slope of the disposal cell.

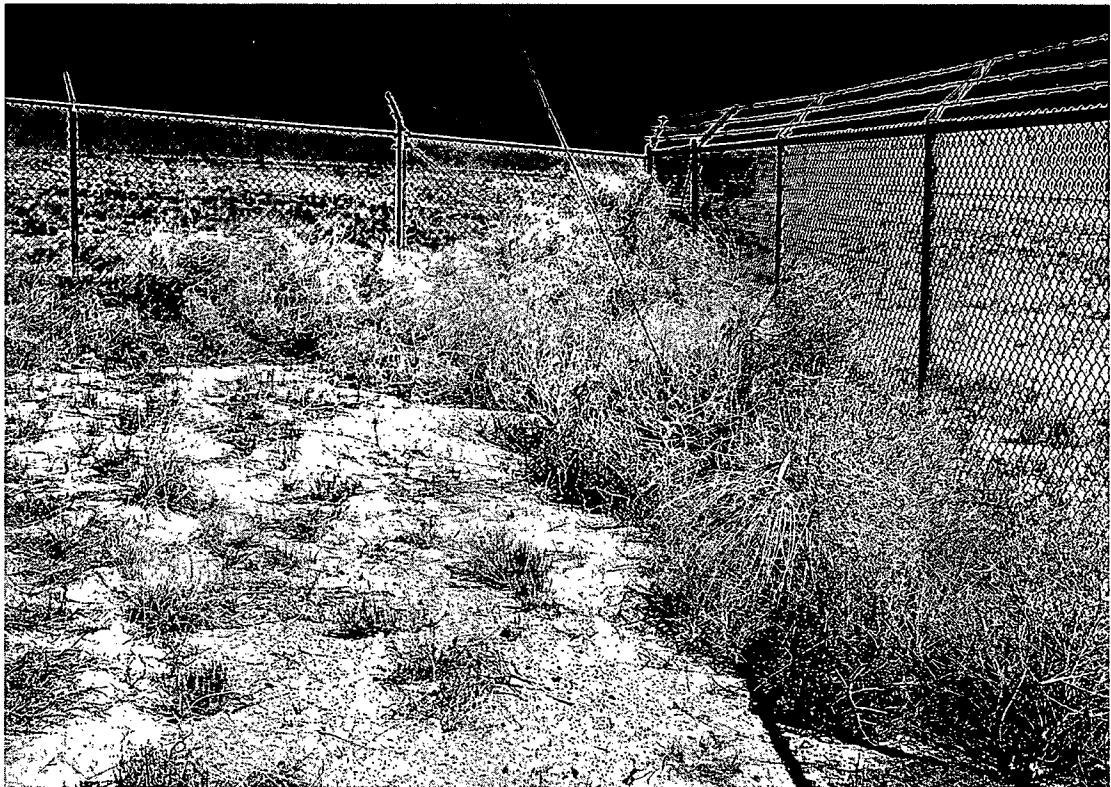
Tumbleweeds (dead Russian thistle) tend to accumulate along the fence lines and can cause windblown sand deposition to occur. At the time of the 2004 inspection, tumbleweeds had
19C accumulated along the east fence line and in the northeast corner of the property (PL-4); the tumbleweeds subsequently were removed. The northeast corner boundary monument was buried in sand and was uncovered for verification.

TUB 9/2004. PL-4. Tumbleweeds and windblown sand deposits in the northeast corner of the site.
