RE: Blazosky Associates, Inc. - Troxler Nuclear Gauge #29883 Damage Incident on June 25, 2007.

Incident Response Report

Incident: Moisture/density gauge with radioactive sources damaged.

Gauge: Troxler model 3440 moisture/density gauge, S/N 29883 containing a 40 mCi ²⁴¹Am-Be neutron source S/N 47-26893 and an 8 mCi ¹³⁷Cs source S/N 750-4210.

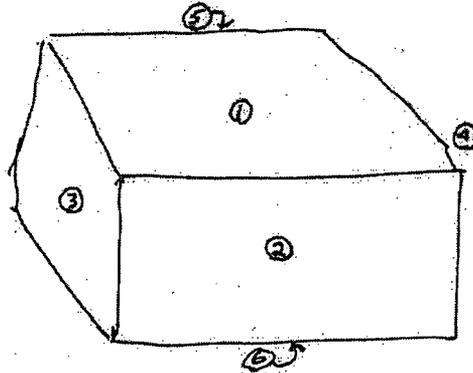
RADIOACTIVE CONTAMINATION SURVEY

LOCATION ERPA site Rt 322 Port Mahila DATE 25 Jun 07
 SURVEYOR R. Carlson
 CONDITIONS Trolley 3440 damaged packaged for shipment
 INSTRUMENT(S) Thermo J1220 S/N 11267 - B by 20 uB/hr

Contact			1m.		
NO.	mR/hr - DPM	LOCATION	NO.	mR/hr - DPM	LOCATION
1	5.0	Top	1	0.12	Top
2	2.5	front	2	0.12	front
3	1.5	right	3	0.07	right
4	0.2	left	4	0.05	left
5	3.0	rear	5	0.15	rear
6	3.0	bottom	6	0.15	bottom

COMMENTS Yellow II - No neutron measurement
use Trolley T.T. 0.6
