**2000 Annual Site Inspection and Monitoring
Compliance Report for Uranium Mill Tailings
Radiation Control Act Title II Disposal Sites**

September 2000

Prepared by
U.S. Department of Energy
Grand Junction Office
Grand Junction, Colorado

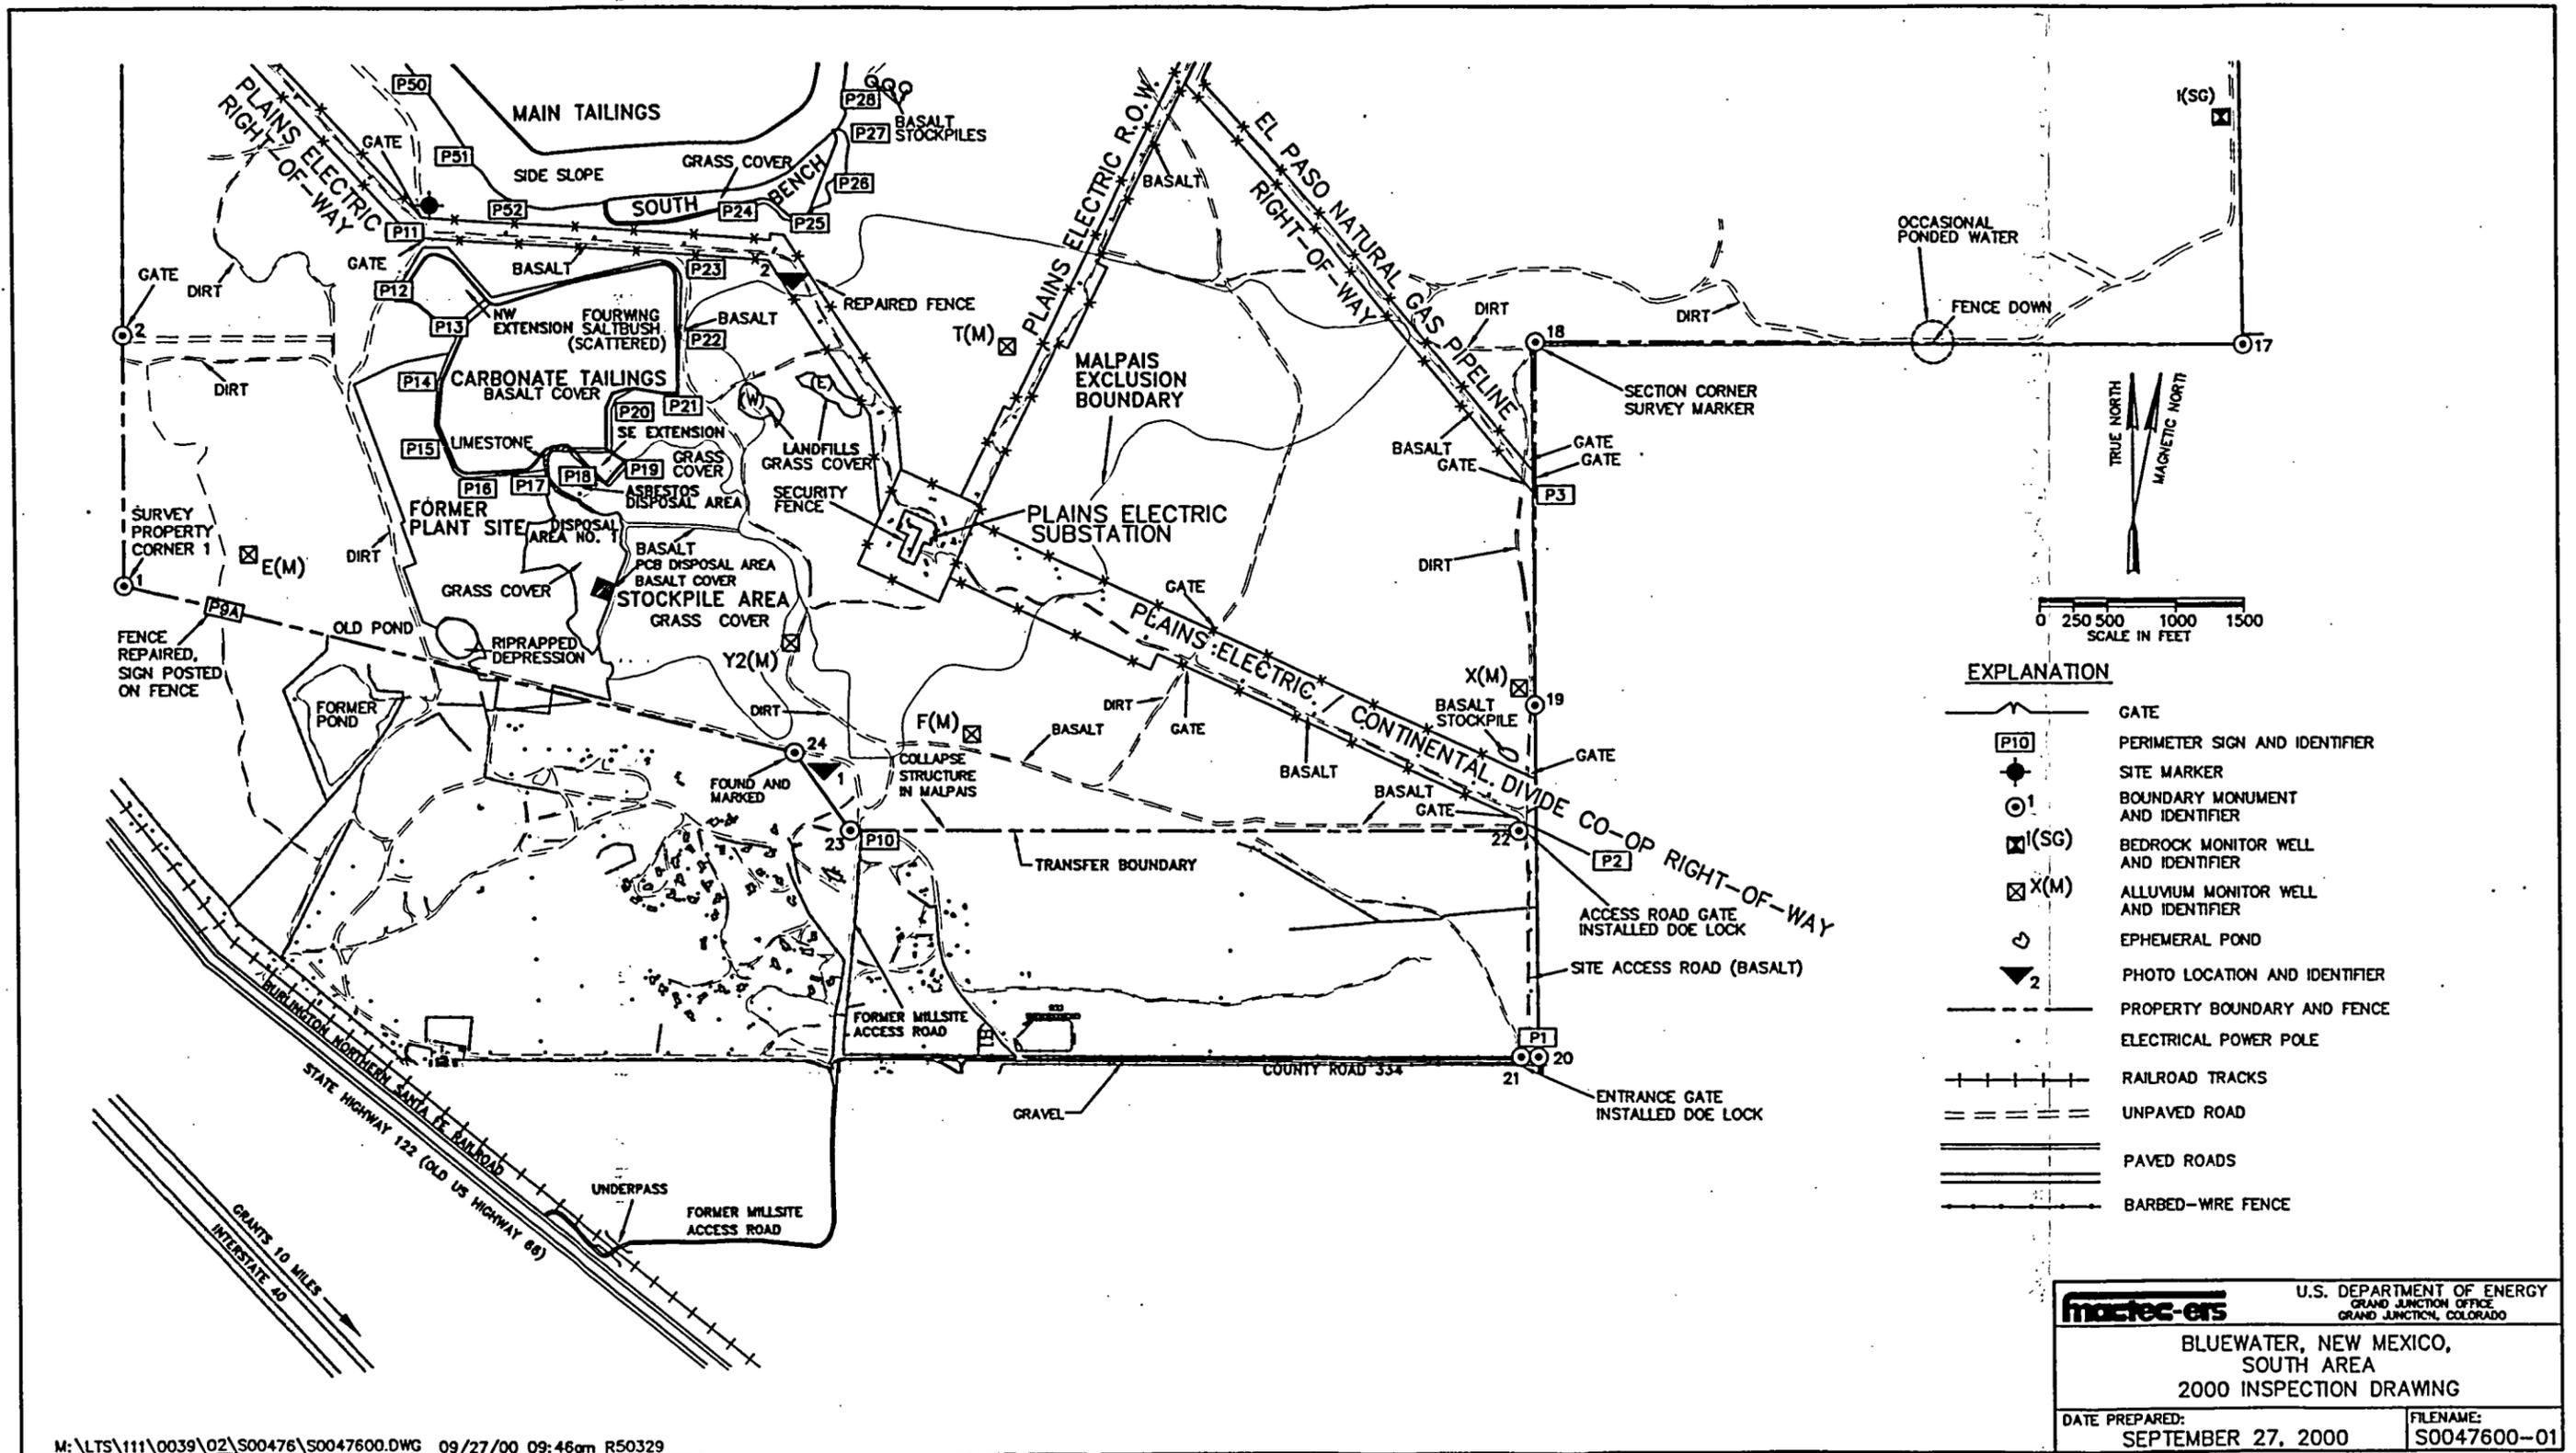
Figure 1-1. Bluewater, New Mexico, South Area, 2000 Inspection Drawing

Fifty-two perimeter or warning signs, designated P1 through P52 on Figures 1-1 and 1-2, are in two locations: (1) at various places along the site boundary, and (2) around the main and carbonate tailings disposal cells. The signs are mounted about 5 feet above the ground on steel posts set in concrete.

Twenty-four boundary monuments define the site boundary. These monuments are typically inside the perimeter fence, several feet inside the true corner or boundary line. Boundary monument BM-24 that was not located during the 1999 inspection was located during the 2000 inspection with the aid of the global positioning system unit (PL-1). The boundary monuments and the general area around the monuments were inspected for signs of disturbance. None was found.

There are nine monitor wells at this site. All are inside the site boundary. Five of the wells are screened in the alluvial aquifer (Figure 1-1). They include the letter "M" in their designation. The five alluvial wells, E(M), F(M), T(M), X(M), and Y2(M), are all in excellent condition.

The top and side slopes of the carbonate tailings disposal cell are covered by basalt riprap (Figure 1-1). The top, for the most part, slopes gently eastward. The small northwest and

An electric power substation is enclosed by a security fence near the center of the site along the Plains Electric Company right-of-way (Figure 1-1). Fencing around this station is in good condition. Inspectors repaired the fence along the right-of-way northwest of the substation (PL-2).

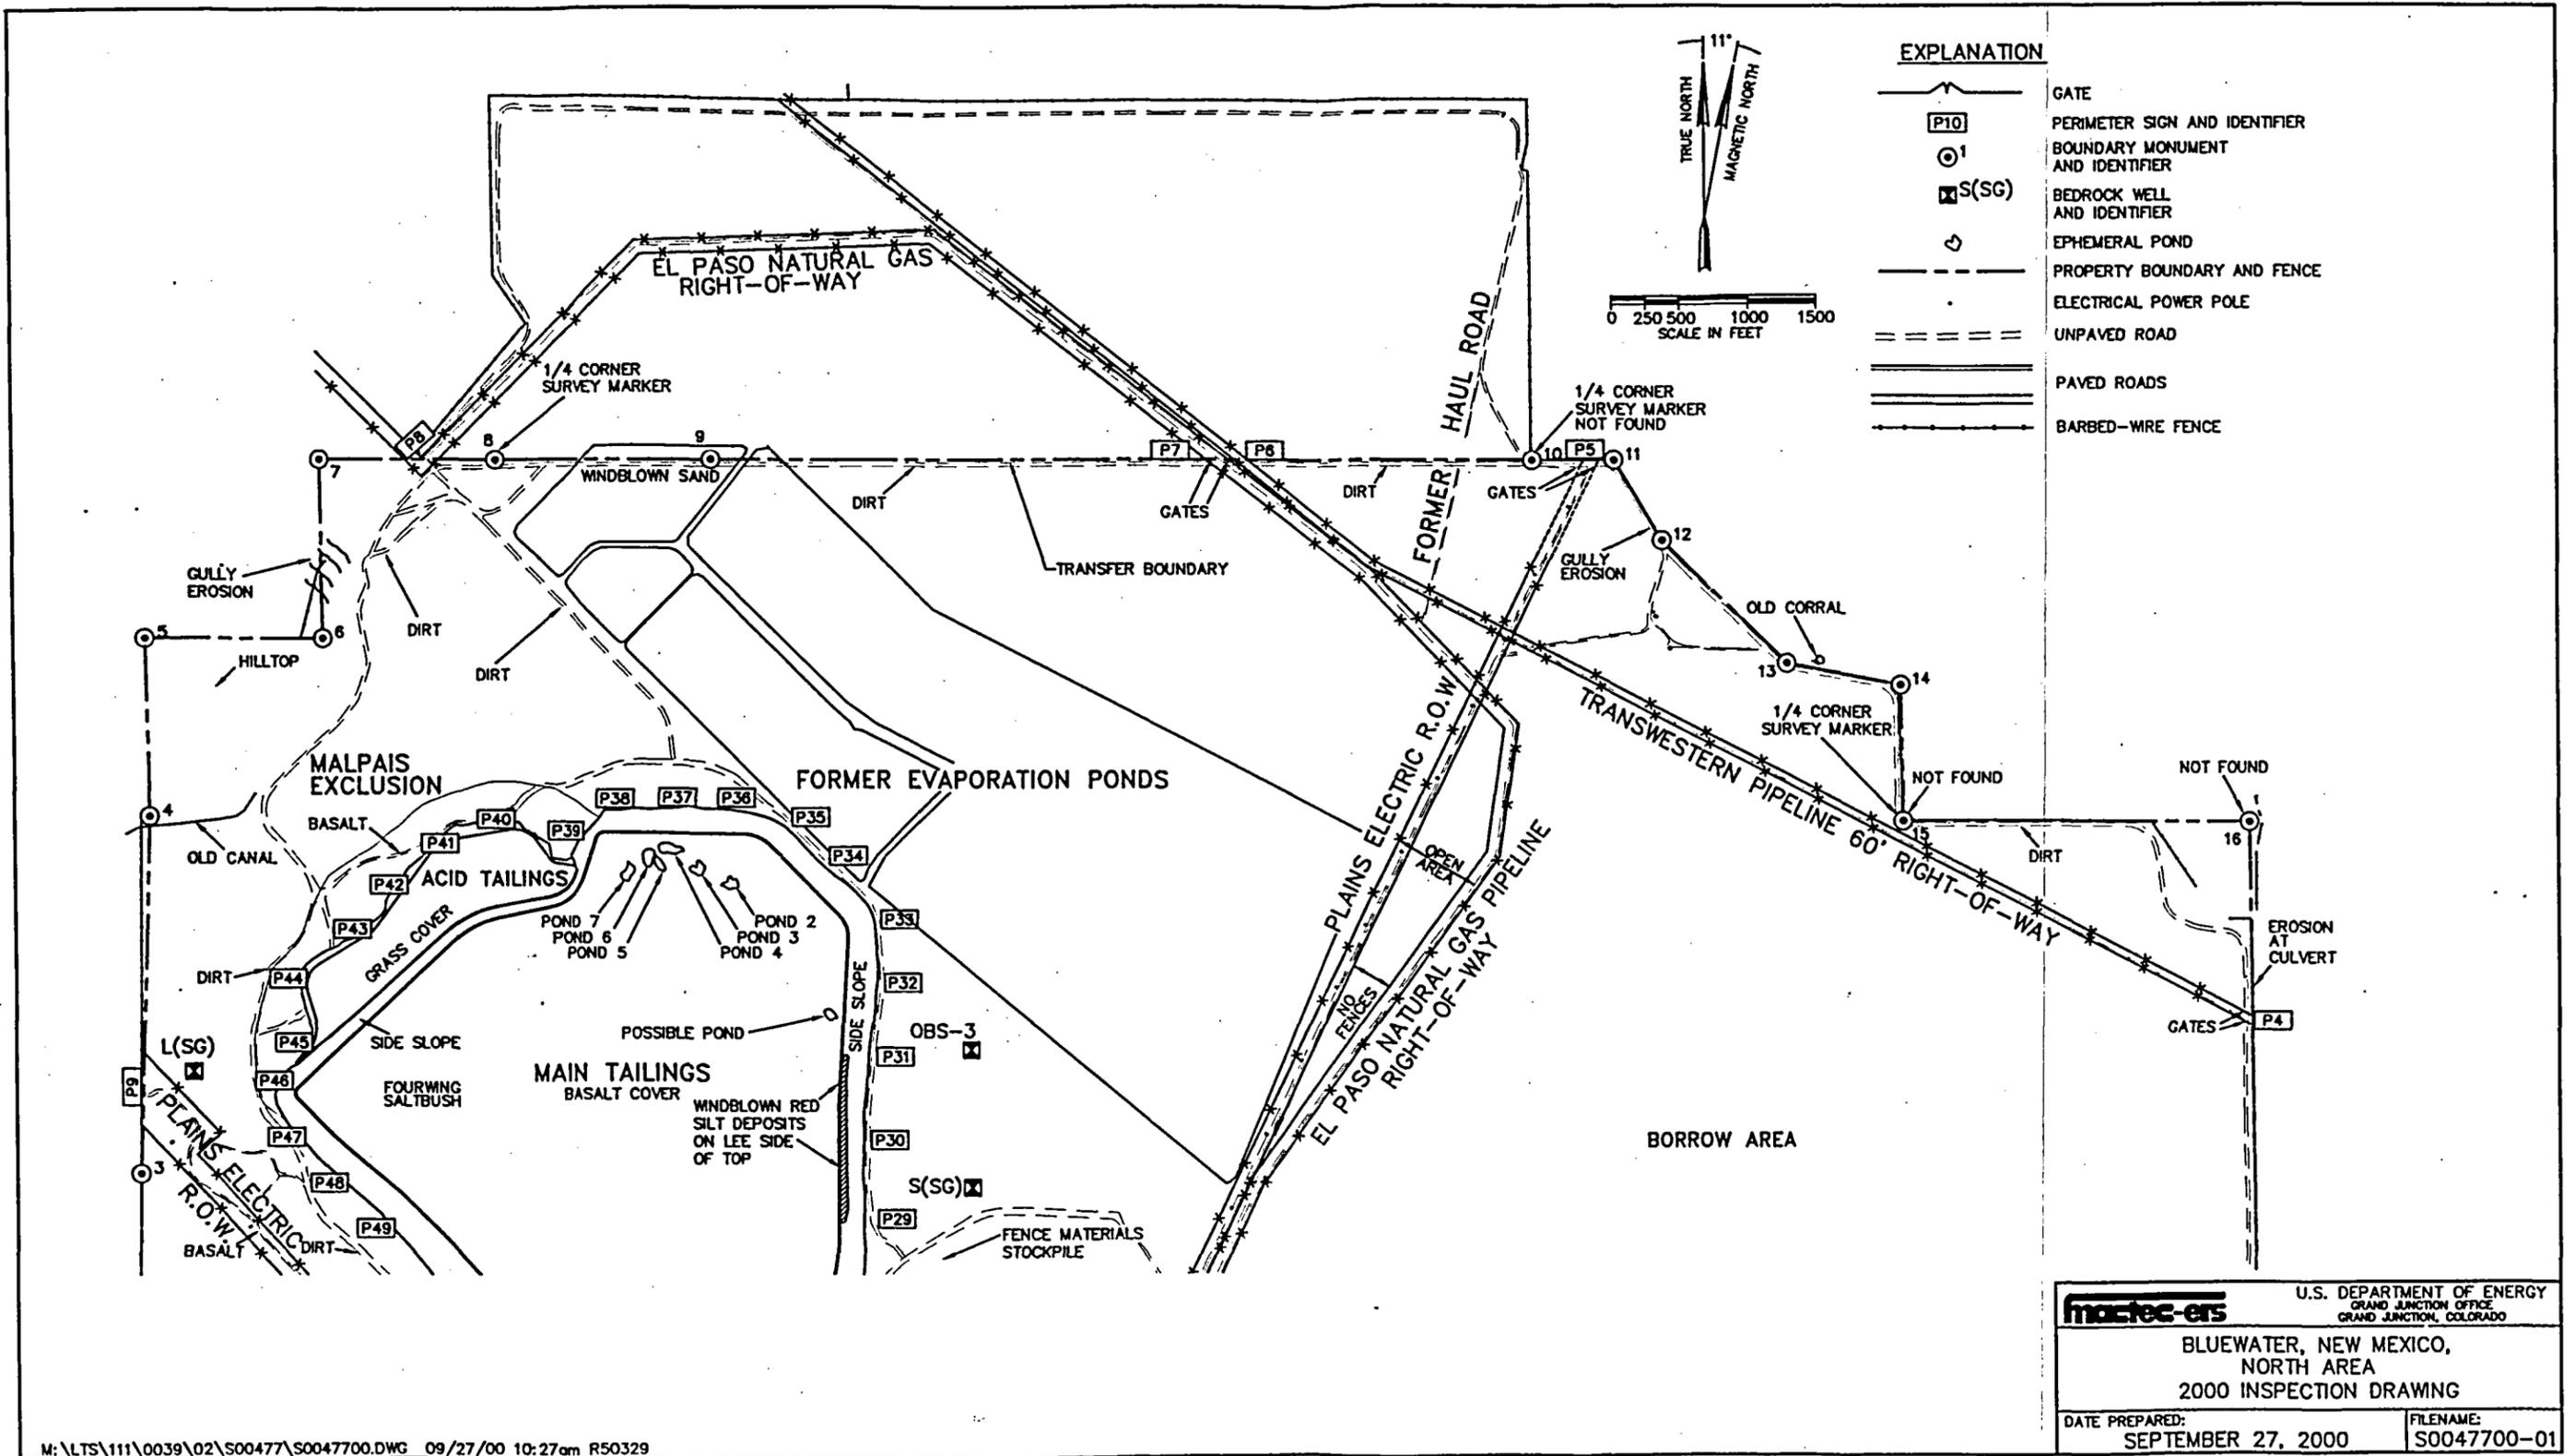
Figure 1-2. Bluewater, New Mexico, North Area, 2000 Inspection Drawing

The other four wells are screened in the San Andres Limestone-Glorieta Sandstone. The San Andres Limestone-Glorieta Sandstone is the bed rock aquifer at the site. Three of the four bedrock aquifer wells include the letters "SG" in their designation (Figures 1-1 and 1-2). A fourth well, OBS-3, is also screened in the bedrock aquifer. The four bedrock wells, L(SG), OBS-3, S(SG), and I(SG), are also in excellent condition.

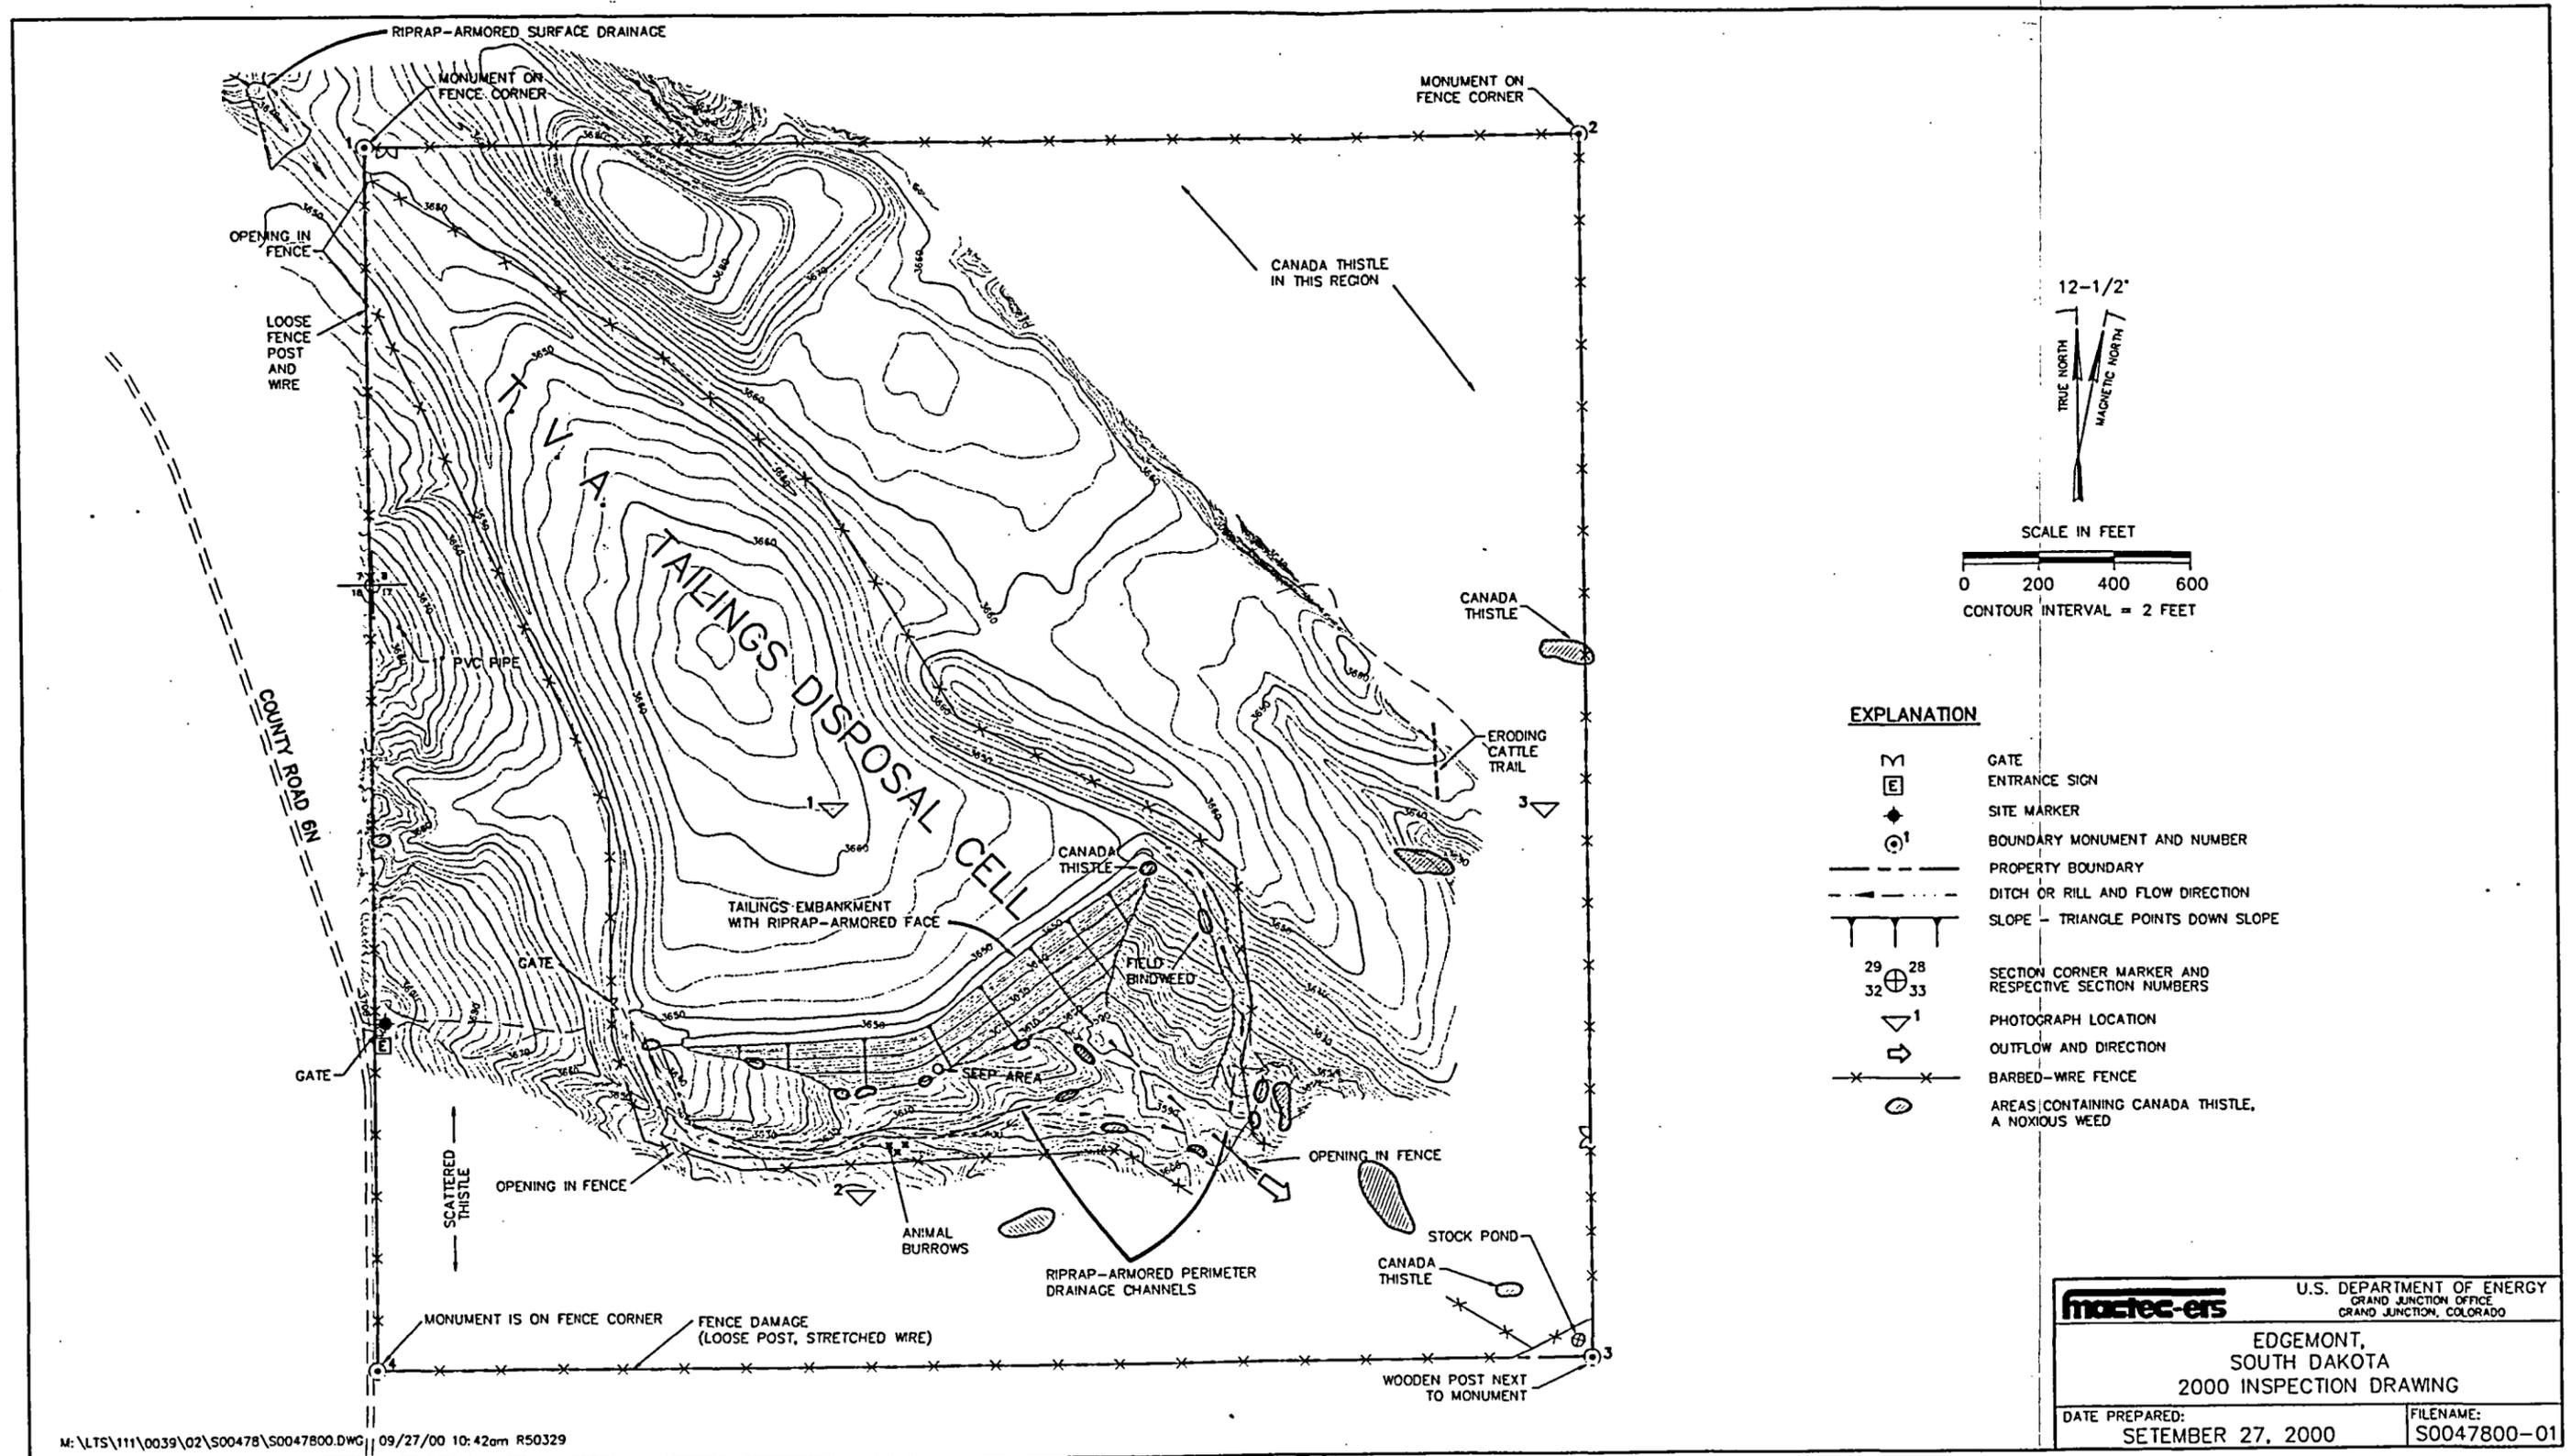
Figure 2-1. Edgemont, South Dakota, 2000 Inspection Drawing

A four-strand barbed wire fence was installed in spring 1999 on the boundaries of the site to demarcate DOE's property and to control grazing on the property. The entire fence line was walked to inspect the fence and the boundary monuments. Fence repairs are recommended at two locations. The fence has become loose from the wood posts on the south boundary line (Figure 2-1) and the wire is stretched and loose along the west boundary, north of the entrance gate. Otherwise the fence is in excellent condition.
