Appendix D2

ESEM and SEM/EDS Data for Test #2, Day-30 Fiberglass in High- and Low-Flow Zones

Appendix D3

ESEM and SEM/EDS Data for Test #2, Day-30 Drain Collar Fiberglass

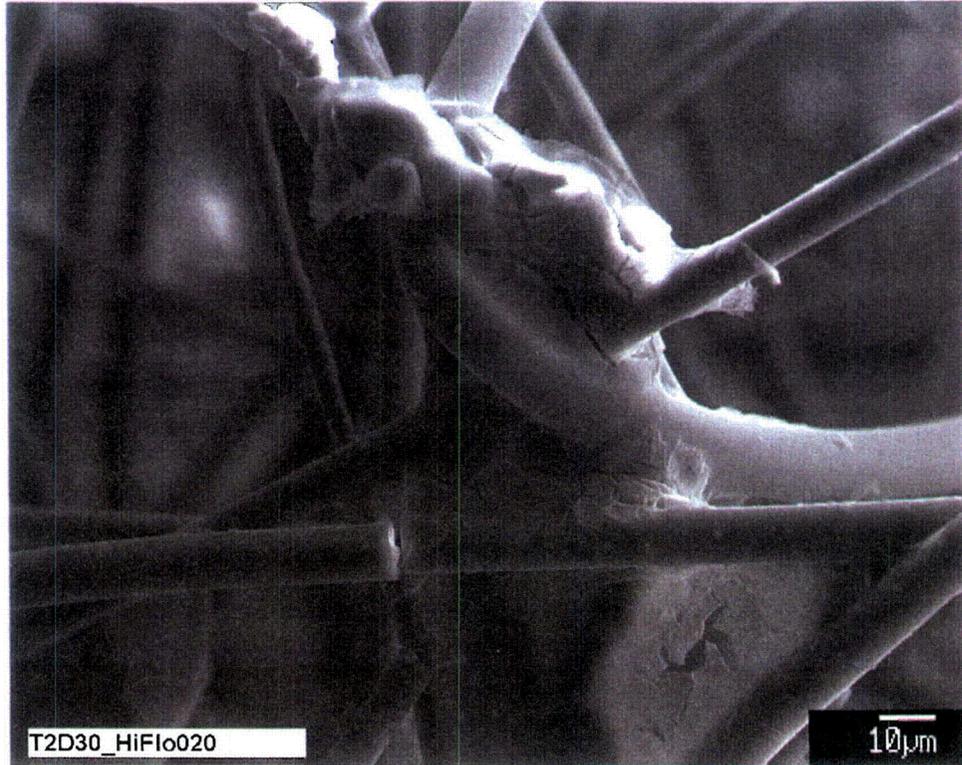
Figure D2-7. SEM image of a higher magnification for a Test #2, Day-30 high-flow exterior fiberglass sample. (T2D30_HiFlo020)

Figure D2-8. EDS counting spectrum for the film deposits or growth on fiberglass, as shown in Figure D2-7. (T2D30EDS13~Film at High Flow Exterior)

Element	Mass%	Atomic%	ZAF	Z	A	F
C	0.000	0.0000	6.0057	1.0404	5.7730	0.9999
O	68.212	77.9670	0.7076	0.9928	0.7128	1.0000
Na	15.750	12.5283	1.5604	1.0448	1.4934	1.0001
Si	7.284	4.7427	1.3779	0.9953	1.3873	0.9980
P	4.750	2.8046	0.8298	1.1782	0.7048	0.9993
Cl	2.197	1.1335	1.1025	1.0478	1.0529	0.9993
Ca	1.806	0.8239	1.0120	1.0156	0.9965	1.0000

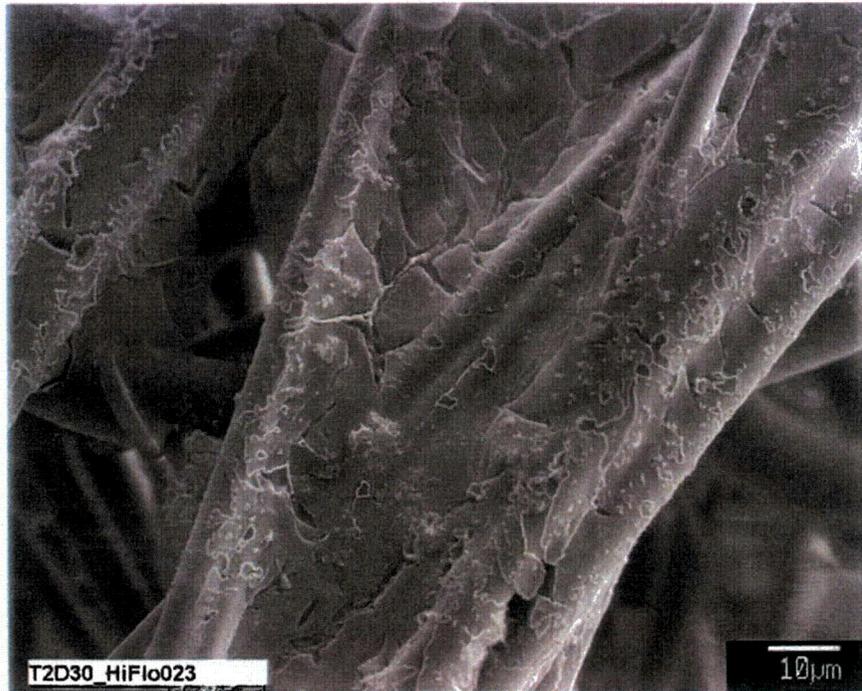
Figure D2-11. SEM image at 1000× magnification for a Test #2, Day-30 high-flow interior fiberglass sample. (T2D30_HiFlo023)

Figure D2-12. EDS counting spectrum for the film deposits or growth on fiberglass, as shown in Figure D2-11. (T2D30EDS14~Film on HiFlow Interior)

Element	Mass%	Atomic%	ZAF	Z	A	F
C	0.000	0.0000	3.8510	1.0451	3.6851	0.9999
O	85.150	90.8939	0.5770	0.9974	0.5785	1.0000
Na	4.620	3.4320	1.8017	1.0498	1.7160	1.0002
Si	6.368	3.8722	1.3235	1.0003	1.3239	0.9994
P	1.246	0.6870	0.7999	1.1842	0.6756	0.9999
Ca	2.616	1.1148	0.9886	1.0213	0.9680	1.0000

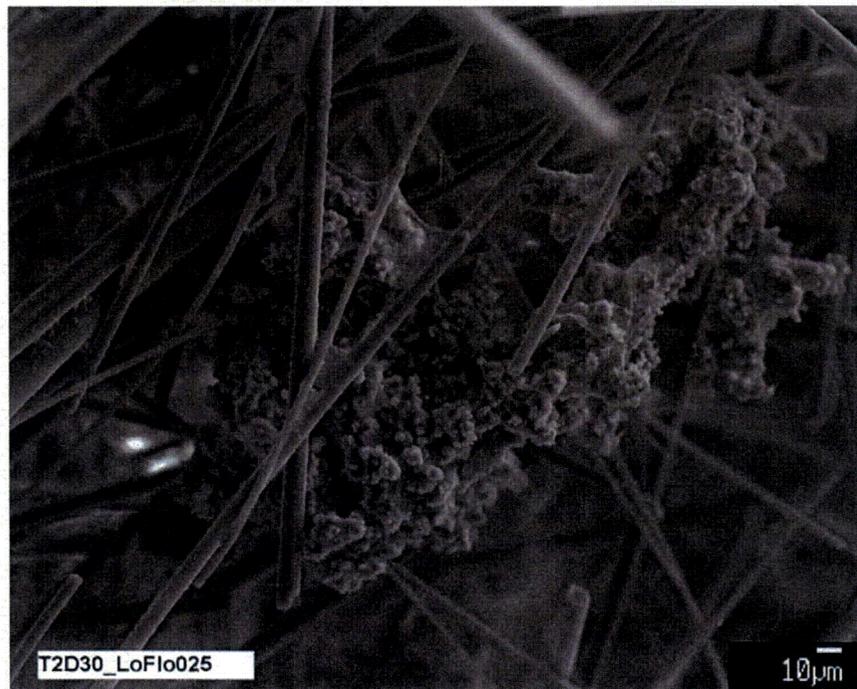
Image: T2D30_LoFlo025 350 ×	On possible bacteria or Ca Phosphate	Figure D2-14
EDS: T2D30EDS15	Globular cluster from image 025	Figure D2-15
Image: T2D30_LoFlo026 800 ×	Different area	Figure D2-16

Figure D2-14. SEM image for a Test #2, Day-30 low-flow interior fiberglass sample. (T2D30_LoFlo025)

Figure D2-15. EDS counting spectrum for the particulate deposits or growth on fiberglass, as shown in Figure D2-14. (T2D30EDS15-Particle on Lowflow Interior)

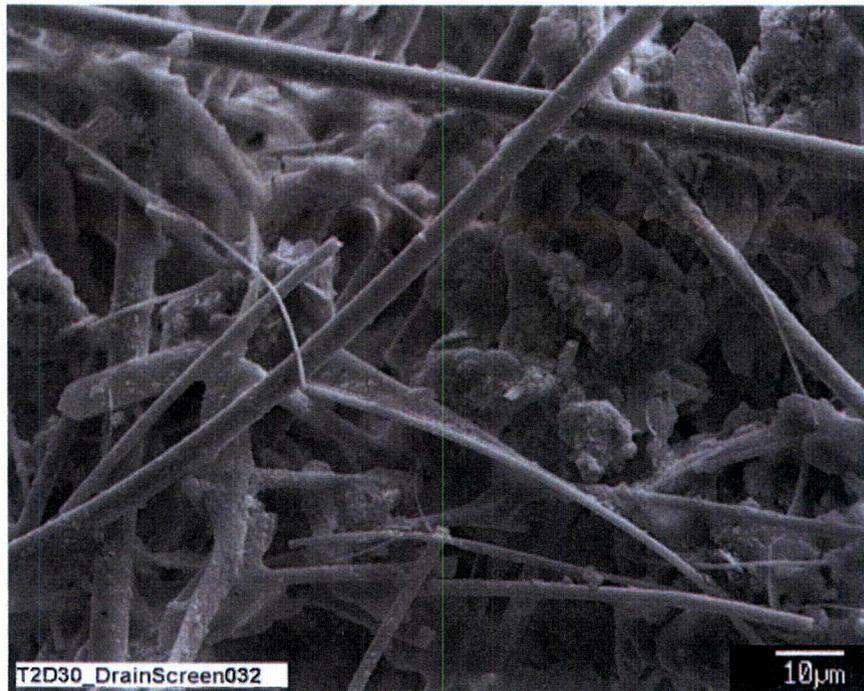
Figure D3-4. SEM image at 1000 \times magnification for a Test #2, Day-30 fiberglass sample on the drain collar next to the drain screen. (T2D30_DrainScreen032)

Figure D3-5. EDS counting spectrum for the center of the image shown in Figure D3-4. (T2D30EDS16~Drain Screen Side Center of Image 032)

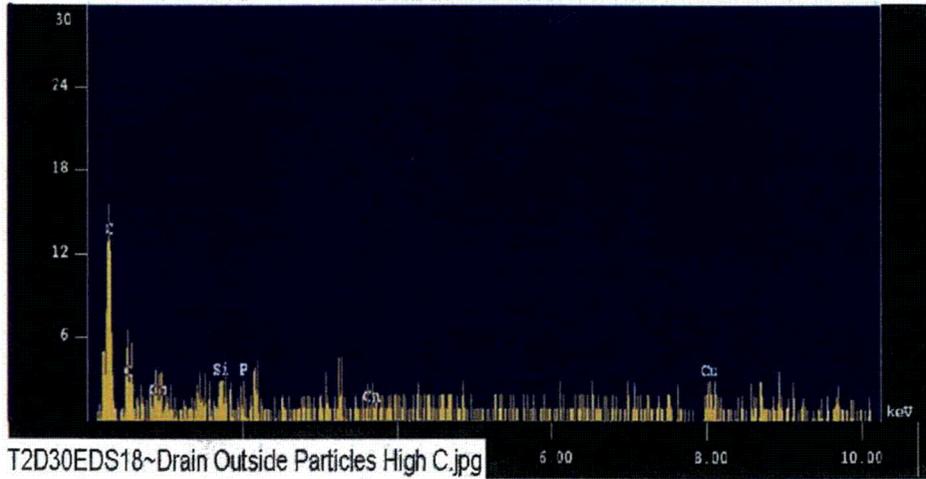
Figure D3-11. EDS counting spectrum for deposits or growth on fiberglass. The deposits contain a significant amount of carbon. (T2D30EDS18~Drain Outside Particles High C)

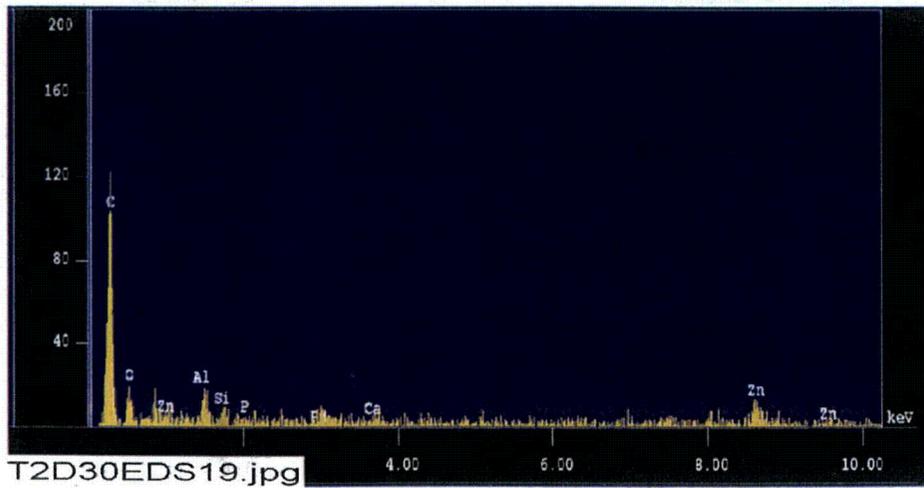
Figure D3-12. EDS counting spectrum for a deposit or growth on fiberglass. The deposit contains a significant amount of carbon. (T2D30EDS19)

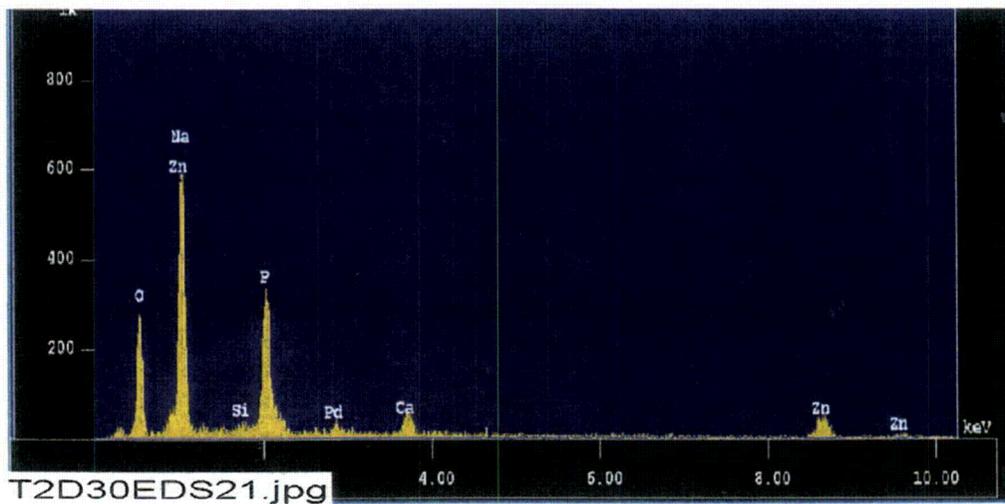
Figure D4-2. EDS counting spectrum for the bright particle on the lower-left side of Figure D4-1. (T2D30EDS21)

Element	Mass%	Atomic%	ZAF	Z	A	F
O	35.828	61.5751	1.0317	0.9179	1.1240	1.0000
Na	2.043	2.4438	1.5945	0.9209	1.7289	1.0014
P	19.372	17.1970	0.9581	1.1032	0.8685	0.9999
Ca	3.013	2.0671	0.9537	0.9240	1.0329	0.9993
Zn	39.743	16.7170	1.1826	1.1840	0.9988	1.0000
