Entergy – Waterford 3 Meeting
with NRC on Steam Generator
Batwing Issue

September 6, 2007

SG 32 - Status

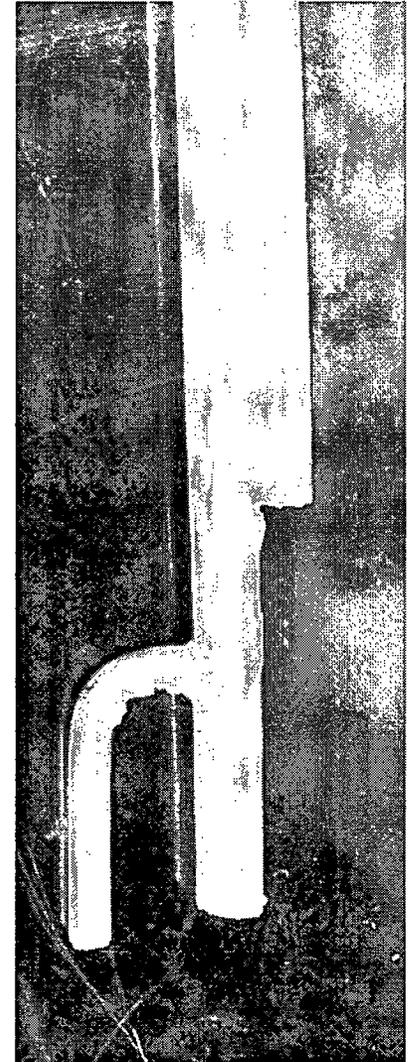
Wrap Around Bar Inspection Tooling

- Access wrap around bar from steam drum
- Guide hooks on the wrap around bar
- Video probe inserts into guide tube for inspection

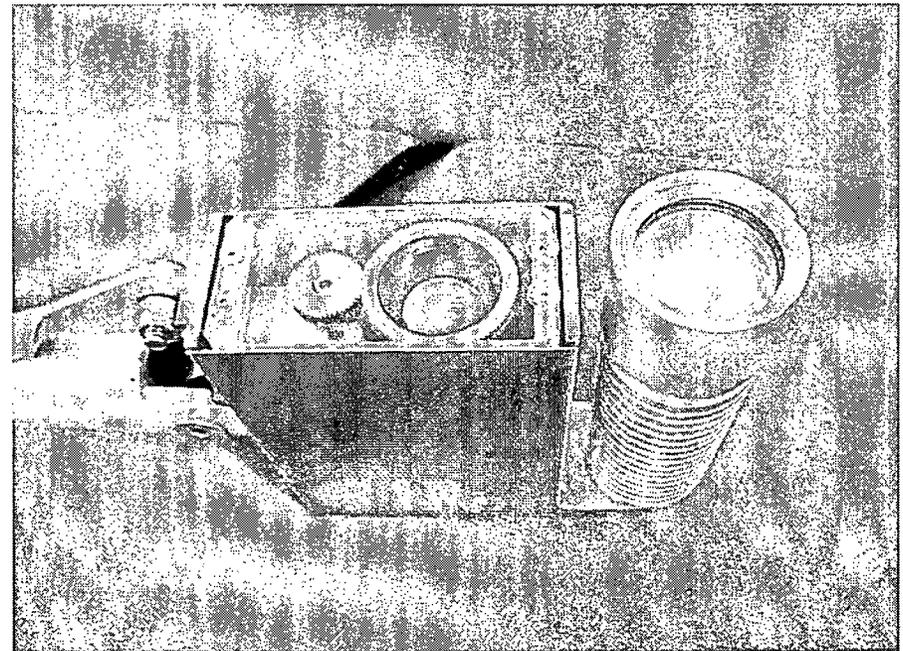
Lower Batwing Visual Inspection Tooling

- Installs through secondary handhole at tubesheet
- 18x fixed magnification

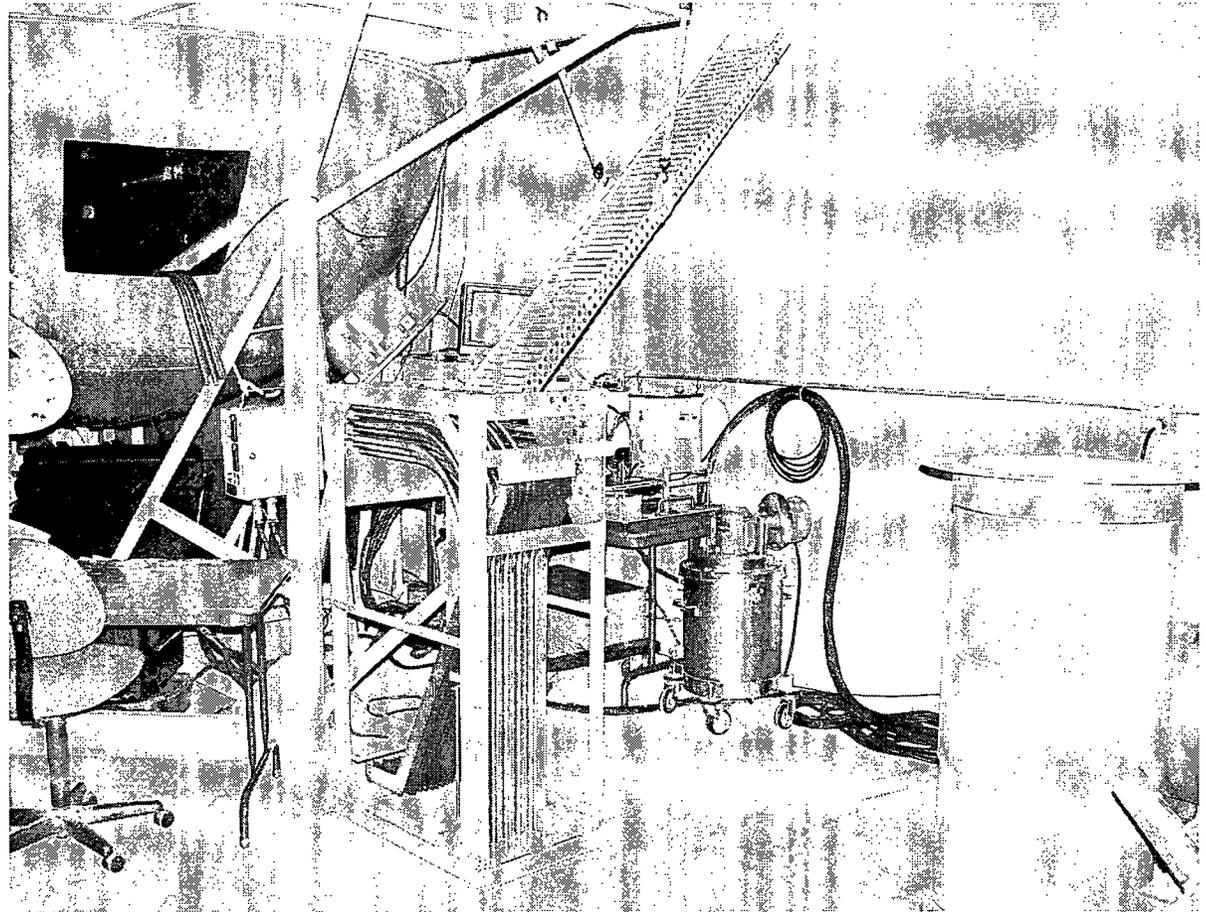
Mock-up of Upper Stay Cavity

- Simulates the upper stay cavity region
- Limited draw back space (21")

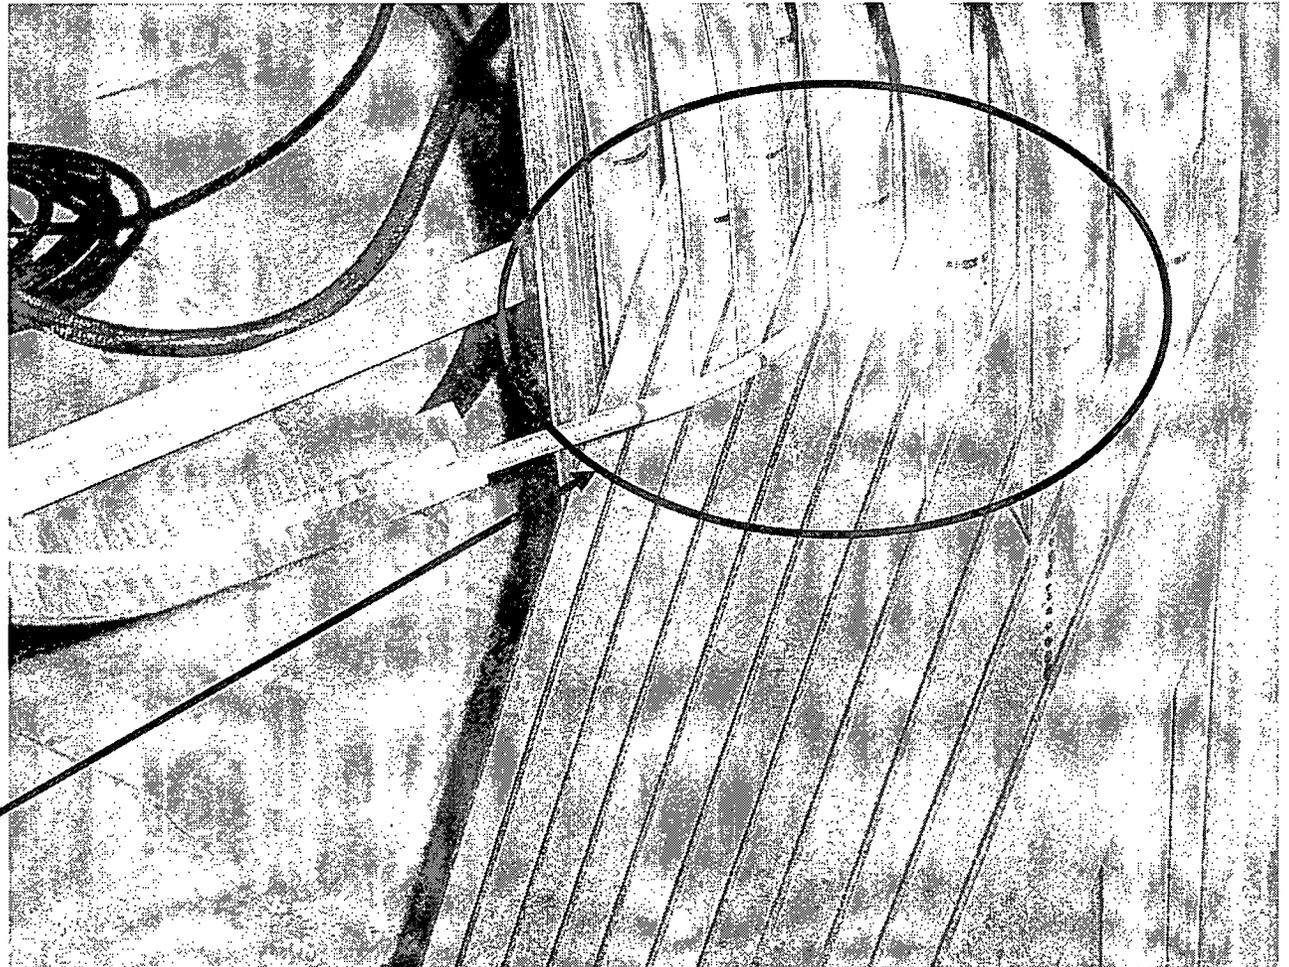
Mock-up of Upper Stay Cavity 45° Inspection

- This is a view of the mockup showing the tube to batwing interface
- Mockup test is underwater in dark environment
- Guide tube is .40" thick in a .48" gap

Area of interest for diagonal inspection

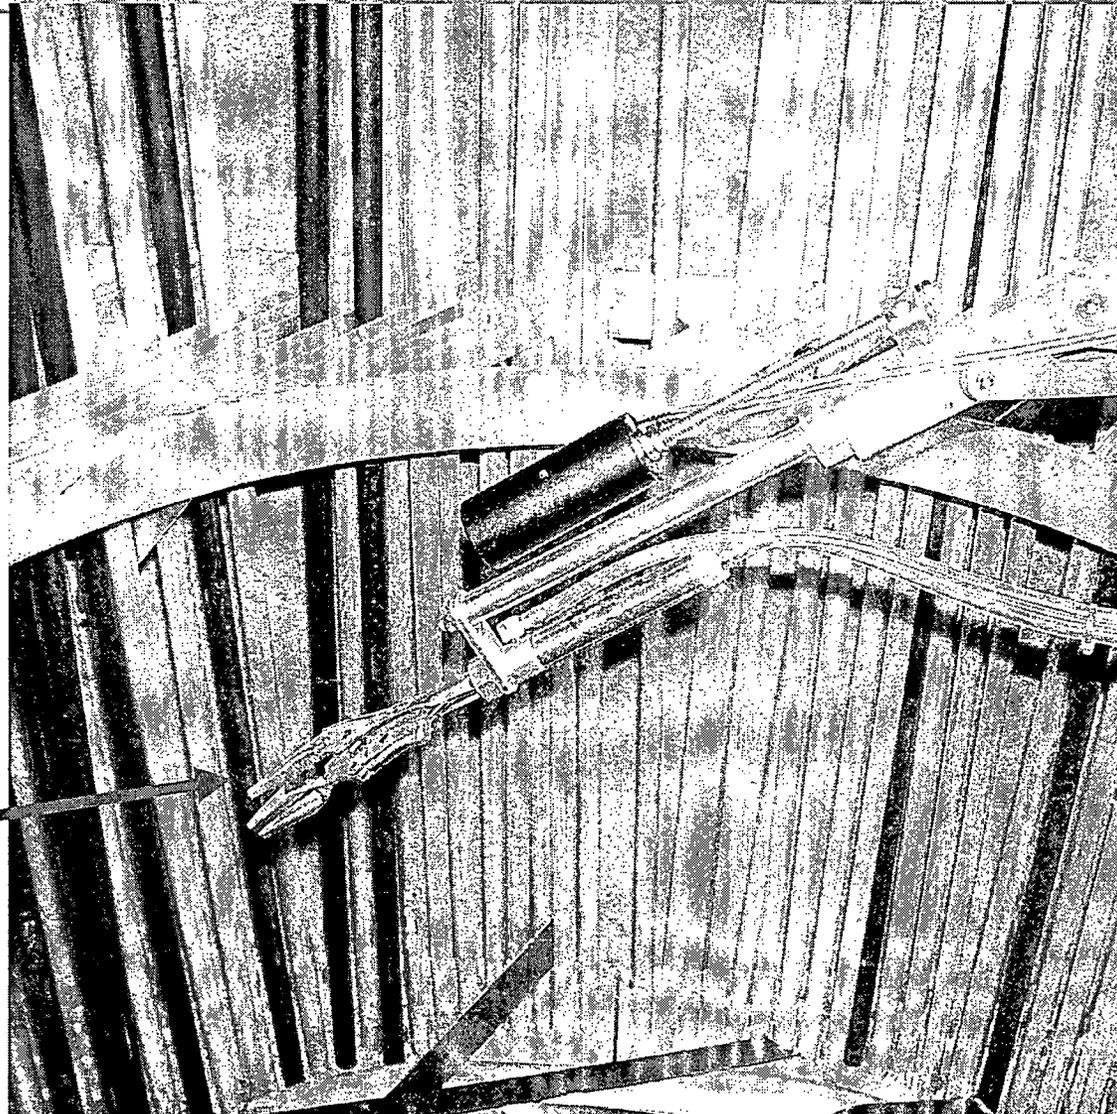
Air Gripper

- Delivery tool will have $\sim 150^\circ$ range of motion
- Multiple end effectors can be used with this delivery tool

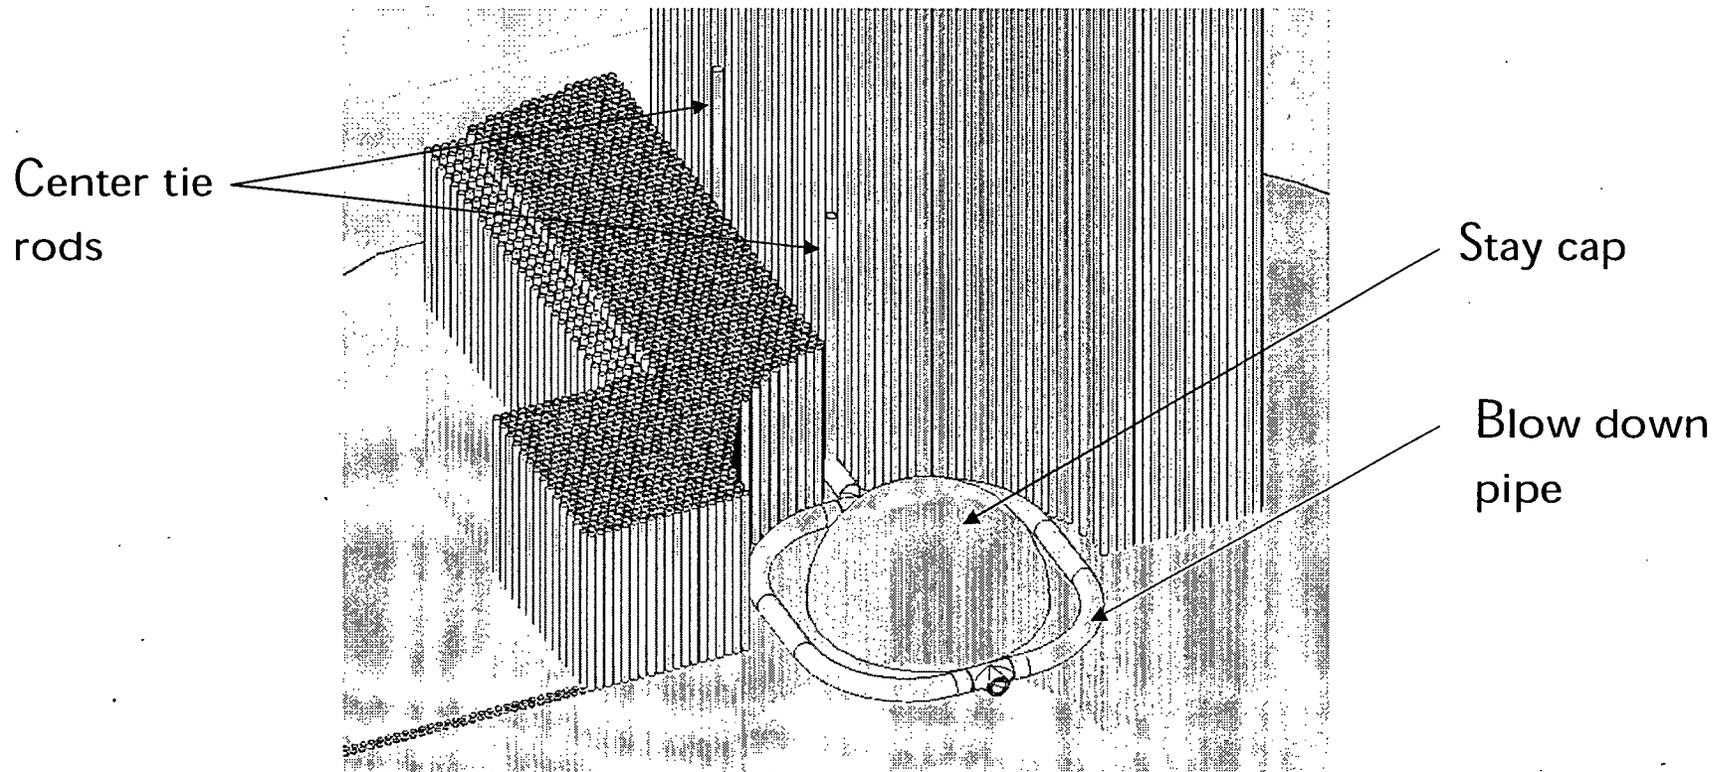
Mock-up Lower Stay Cavity Region

- Model showing the center stay area with stay cap and blow down
