# James A. FitzPatrick Nuclear Power Plant

**ACRS License Renewal Subcommittee Presentation  
September 5, 2007**

# ***Torus Repair***

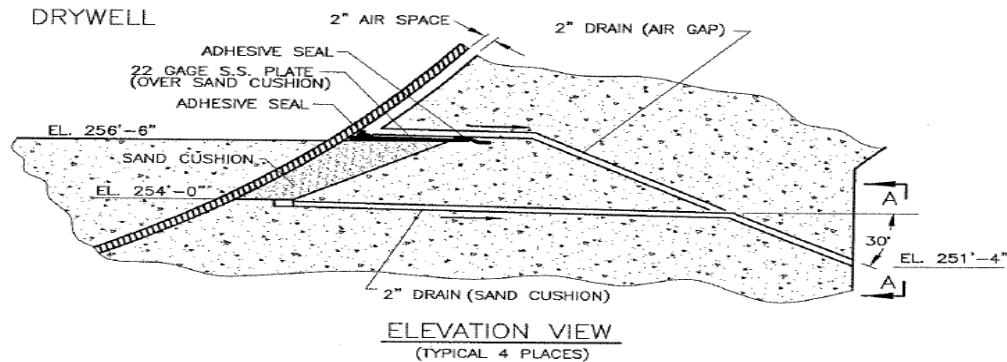
**SAND CUSHION & AIR GAP DRAIN LINE DETAILS**

- Sand Cushion Inspections. No Evidence of Moisture (Boroscopic Inspection).
- Visual Inspection of Interior Drywell Caulk Seal.
- Drywell Interior Coating System (Carbozinc 11 and Dupont Corlar Epoxy) Inspection IAW IWE Program during RFO.
