Oyster Creek Generating Station  
Facility Operating License No. DPR-16  
NRC Docket No. 50-219

Subject: Submittal of Information to ACRS Plant License Renewal Subcommittee Related to AmerGen's Application for Renewed Operating License for Oyster Creek Generating Station (TAC No. MC7624)

**Oyster Creek  
License Renewal Project  
Drywell Monitoring Program**

**Information for ACRS Subcommittee**

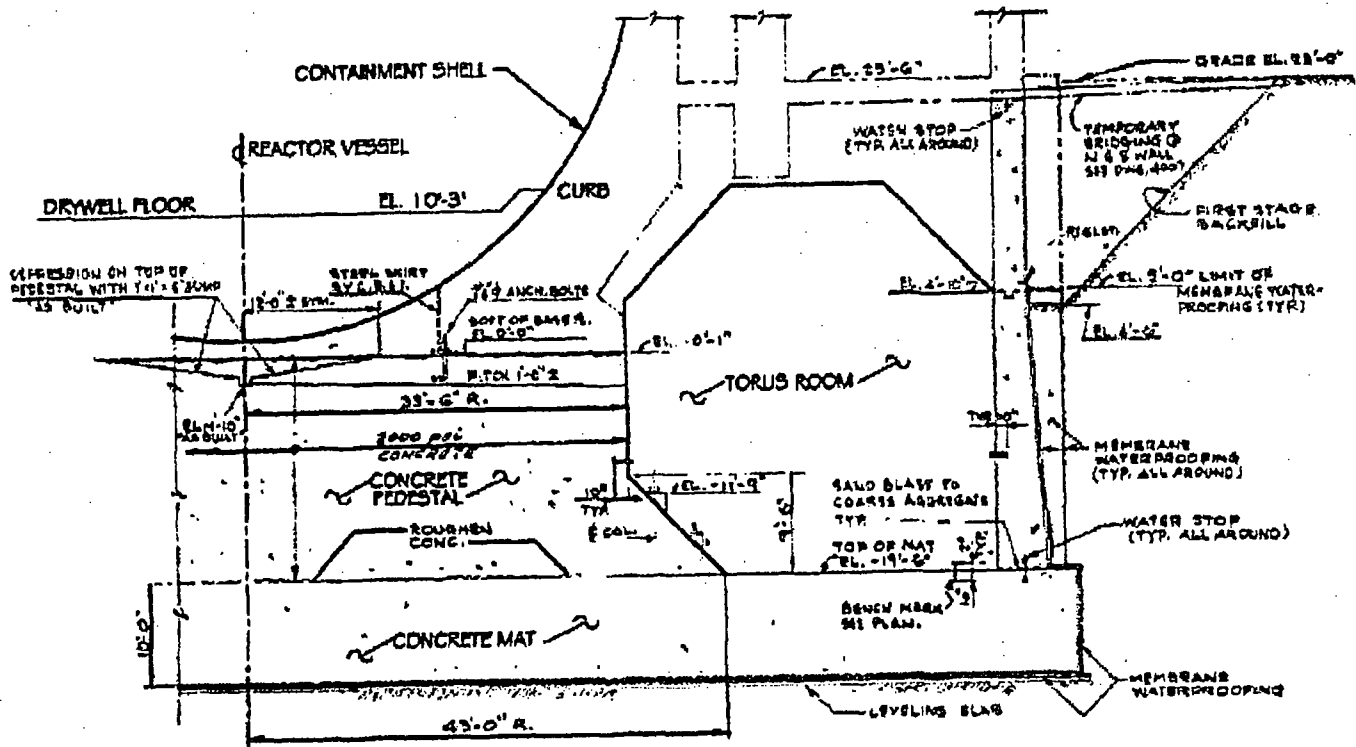
ELEVATION  
FIGURE 4

The spherical section of the drywell was supported on a 39-foot diameter continuous steel skirt during construction (See Figures 4 & 7). The area within the skirt was filled with concrete and the floor inside the bottom of the sphere (drywell floor) was poured up to elevation 10' 3". The reactor support structure (pedestal) sits on top of the drywell floor (See Figure 5). The area within the reactor pedestal provides access for Control Rod Drive exchanges and is typically referred to as the Sub-Pile Room. The room also contains the drywell sump and a drainage trough that collects any leakage within the drywell. The Sub-Pile Room floor is raised at the center and slopes toward the drainage trough. Leakage outside the Sub-Pile Room, in the drywell, is directed to the drainage trough through 4 holes in the reactor pedestal equally spaced around the circumference. A concrete curb is installed around the perimeter of the drywell floor (See Figure 4 & 5) to prevent any water that collects on the floor from coming in contact with the drywell shell. The curb is removed in two locations where two trenches (Figure 3) were excavated in the floor in 1986 to allow UT thickness measurements to be taken below the floor. A moisture barrier was added at the junction of the curb and the drywell shell and inside the trenches during the 2006 refueling outage to prevent water and moisture intrusion into the embedded drywell shell.

This discussion addresses the potential for corrosion of the interior surface of the drywell shell that is embedded in the concrete floor inside the drywell (i.e., below the concrete floor at Elevation 10' 3"). See Figure 4 in Section 3 of this Enclosure. This area includes the shell behind the concrete curb at the edge of the concrete floor. All elevations of the interior drywell shell were presumed to be coated with primer (except those areas to be embedded in concrete) that was applied following fabrication of the material to protect the steel prior to and during installation.

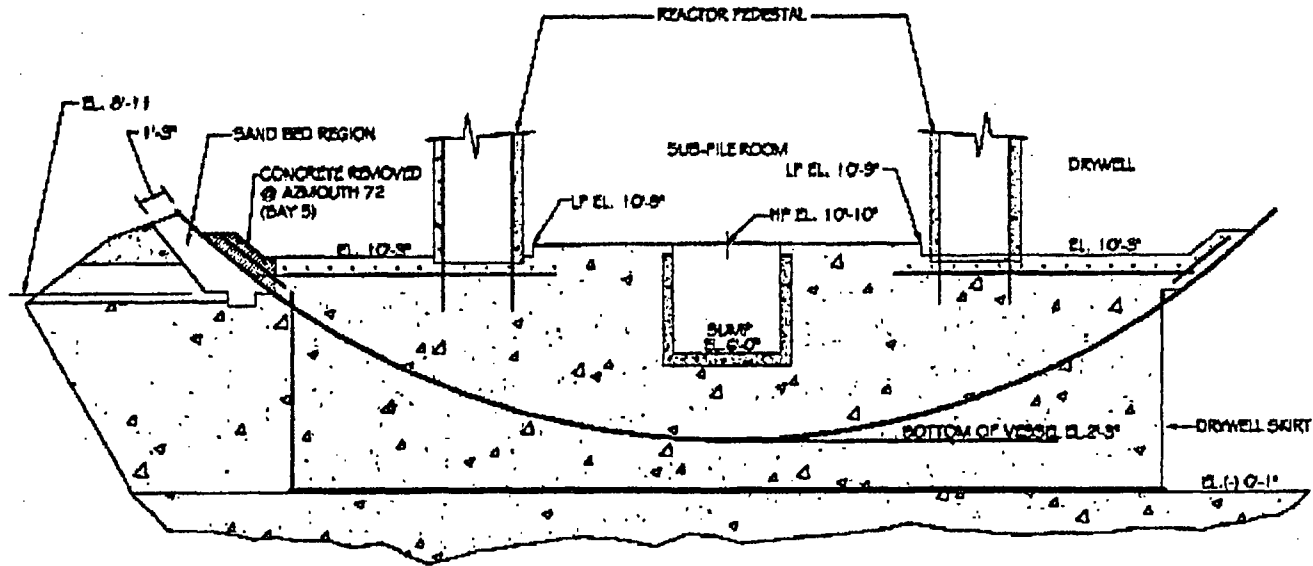
FIGURE 5

Outside the drywell support skirt and the spherical section, concrete was poured in contact with the sphere up to elevation 8' 11". At this point, the concrete was stepped back 15" radially up to elevation 12' 3" and later filled with sand (sandbed region), refer to Figures 5 & 7 for details. The purpose of the sandbed was to provide a cushion to smooth the transition of the shell plate from a condition of fully embedded between two concrete masses to a free standing condition. The sandbed region was provided with five drains designed to allow drainage of any water that may enter the region.

The drywell is described in Section 3 of this Enclosure. Figure 1 (Section 3) shows a cross-section of the drywell. Figure 4 (Section 3) shows an elevation view of the construction of the drywell foundation including the configuration of the Torus Room. Figure 5 (Section 3) provides the details of the drywell floor including the drainage trough located in the area under the reactor vessel (referred to as the Sub-Pile Room). The two areas addressed in this discussion are the embedded portions of the 1.154" thick section internal to the drywell and the 0.676" thick section at the bottom of the drywell all of which is embedded internally (See Figure 4 in Section 3). Section 6 of this Enclosure identifies the minimum required average general thickness of the 1.154" thick section as 0.736". Since the 0.676" thick section is completely encased in concrete, it is only required to contain the maximum drywell pressure (44 psig) and is not required to withstand buckling or membrane stresses. The minimum required thickness for this section required due to the maximum drywell pressure is 0.479" per Reference [42].

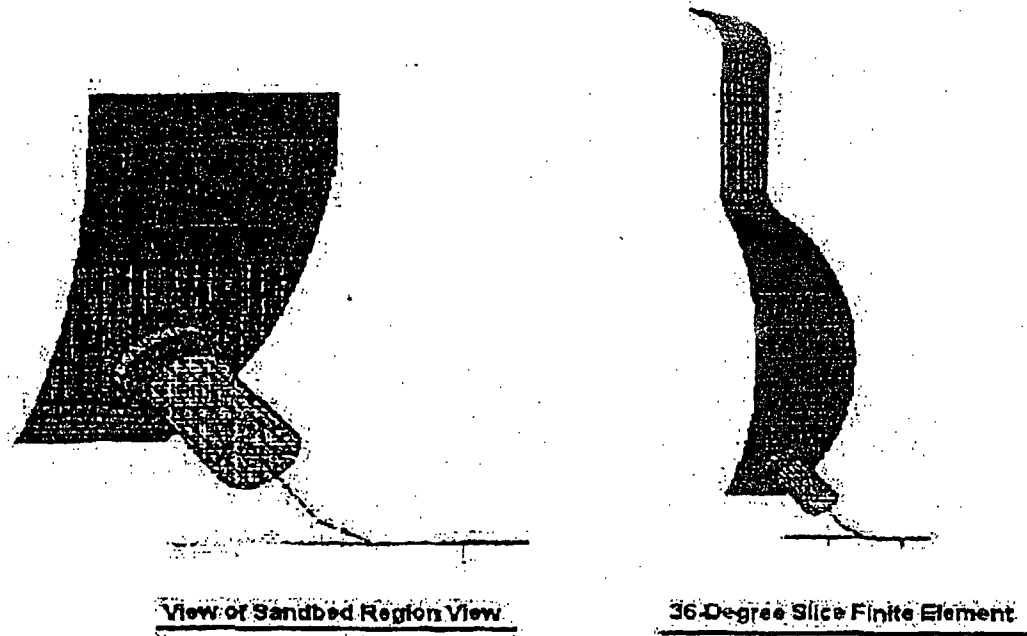
**Fig. 1 - Drywell Analysis ANSYS Finite Element Model**

An engineering analysis, based on ASME Code requirements, was conducted in the early 1990's to establish the minimum required general thickness without sand for both pressure and buckling stress (Ref [15], Ref [16], Ref [32]). The analysis was based on a partial finite element model (36-degree slice - Fig. 1) of the drywell. Loads and load combinations were in accordance with the original design basis requirements as follow: (Ref [16])
