Tennessee Valley Authority, Post Office Box 2000, Spring City, Tennessee 37381-2000

JAN 29 1996

WATTS BAR NUCLEAR PLANT (WBN) - RADIATION MONITORING SYSTEM  
ASSESSMENT, SUPPLEMENTAL INFORMATION

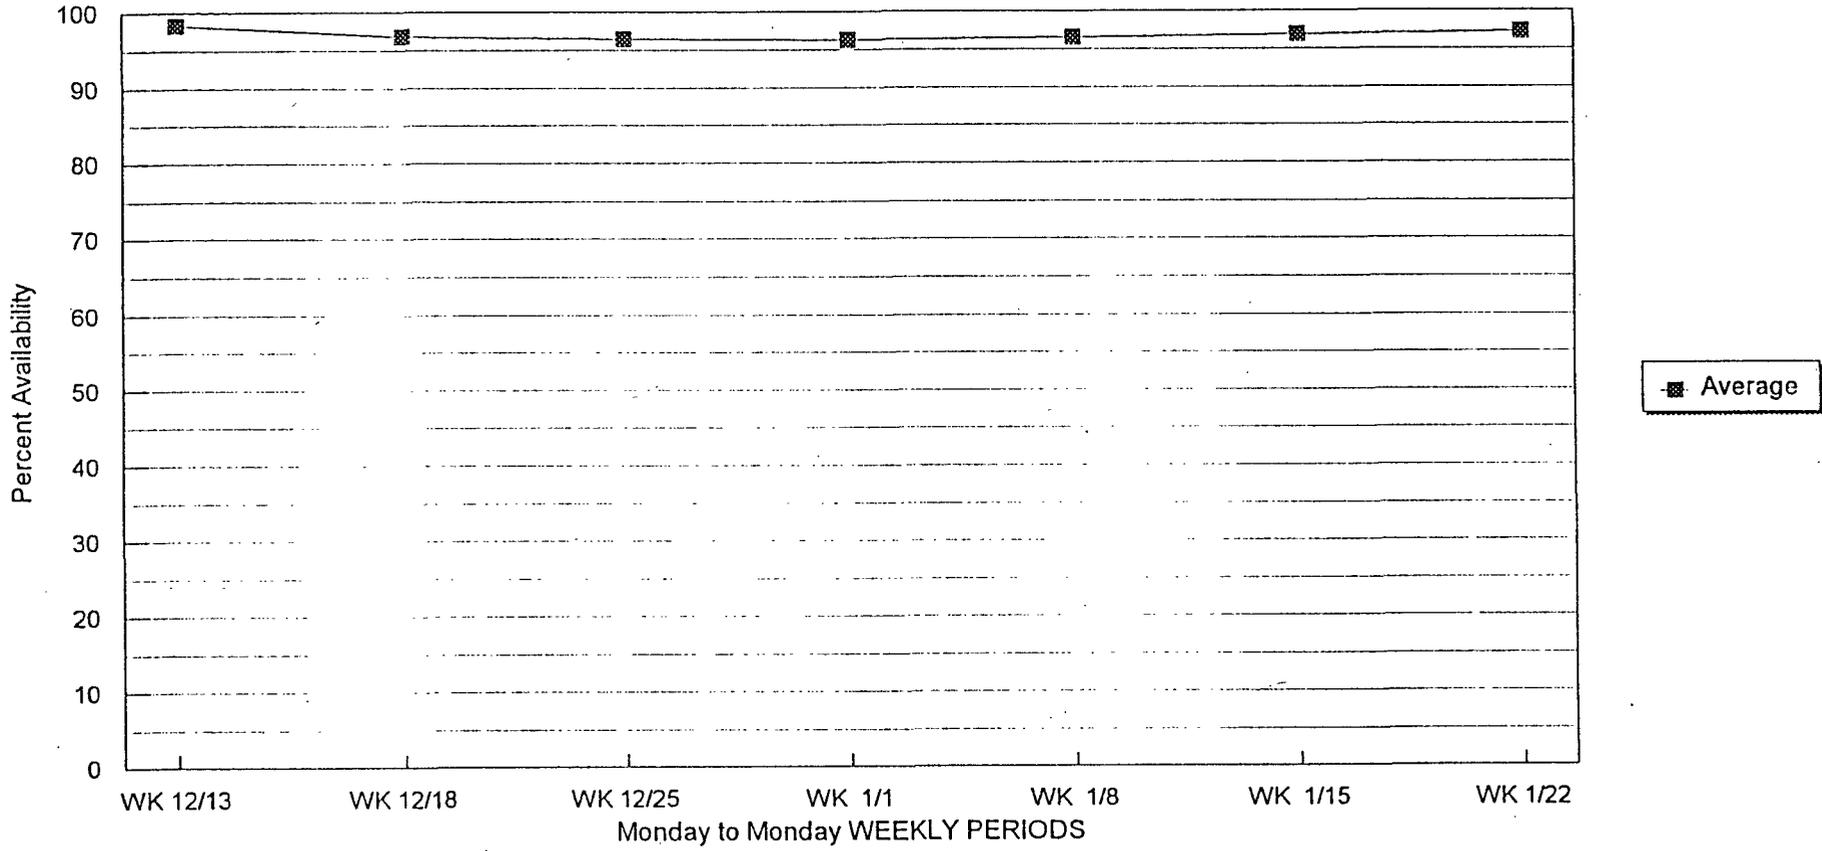
# TECH SPEC MONITORS

Principal cause for downward trend is the unavailability of monitors 1-RE-90-119, 1-LPR-90-120, and 121 to correct electronic noise issues.
