SUBJECT: Concerns Entergy's Vermont Yankee generating facility

Response to the Vermont Congressional Delegation Letter Dated September 21, 2007

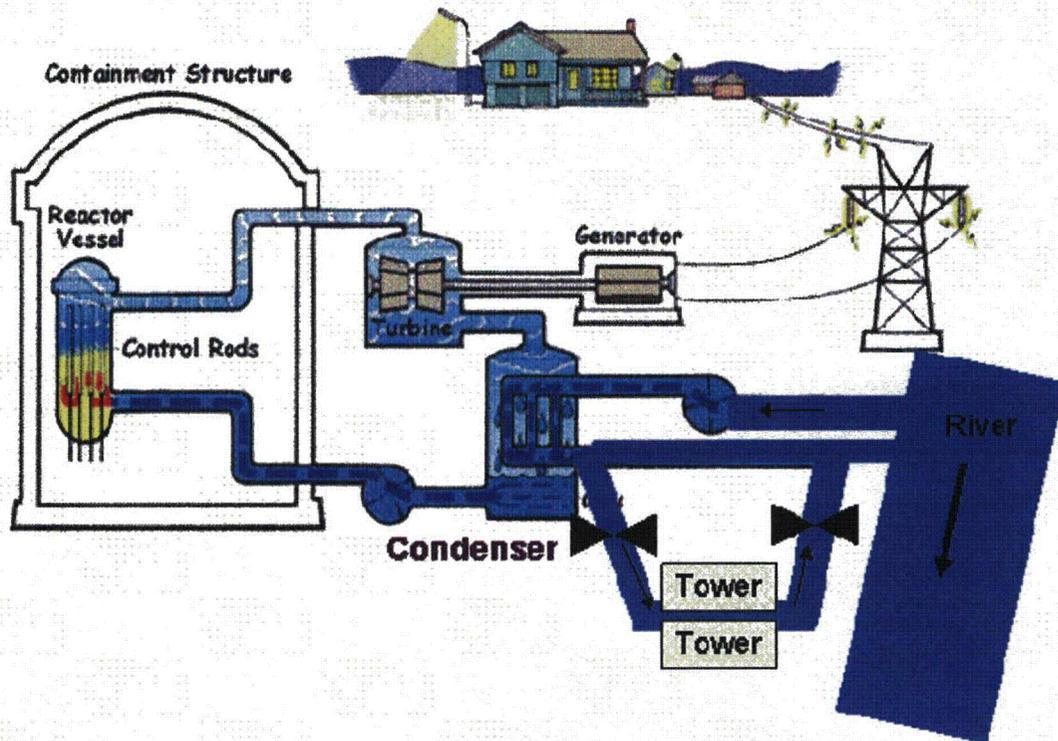
This diagram illustrates how river water circulates through the plant's condenser to cool steam and then goes through the plant's cooling towers before being returned to the river. At no time during or since the August 21 event did Vermont Yankee violate any environmental thermal limits in returning water to the river.
