TENNESSEE VALLEY AUTHORITY (TVA)
SEQUOYAH NUCLEAR PLANT (SQN)

Final Report
Metallurgical Examination Results for
Tube Pull During SQN Unit 2 Cycle 14 Refueling Outage

SG-CDME-07-21-NP
Revision 0

Examination of a Steam Generator Tube Removed from Sequoyah Unit 2

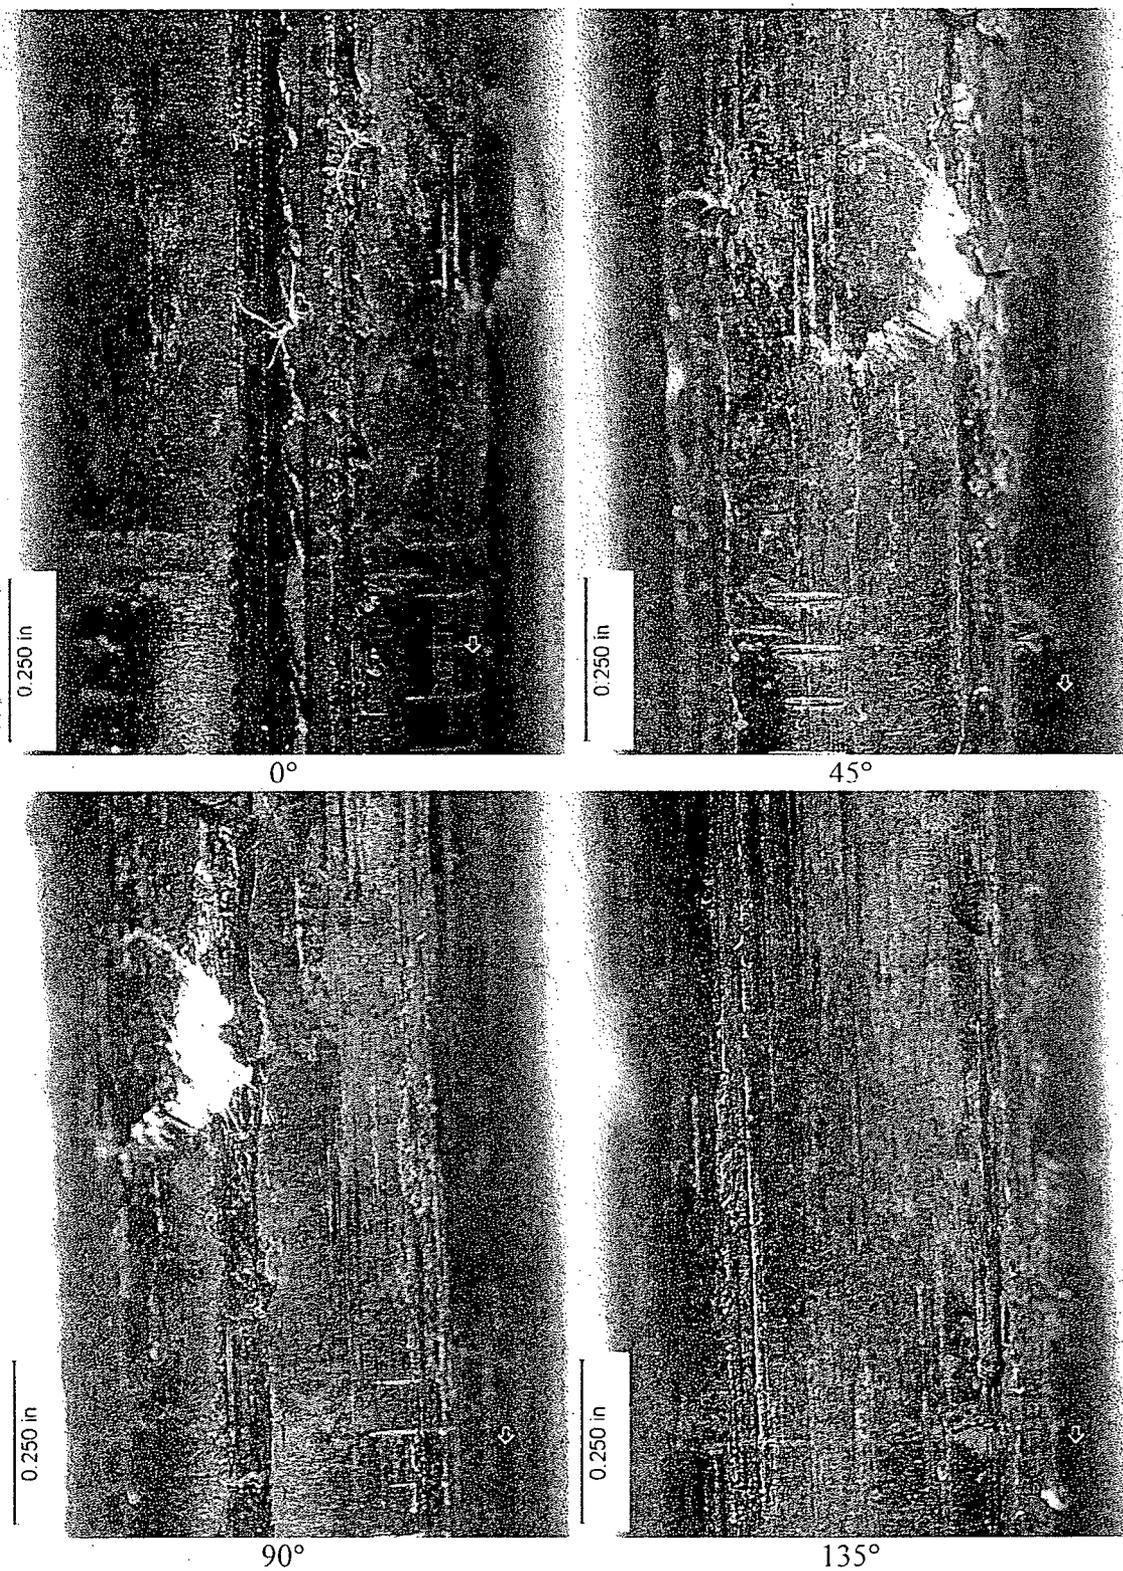
Figure 5-2: Post-Expansion Views of TSP#1 Region (Continued)

Figure 5-2 and Figure 5-3 present views around the circumference of TSP#1 and TSP#2, respectively. Figure 5-4 and Figure 5-5 present diagrams summarizing observations made on TSP#1 and TSP#2, respectively, after expansion.

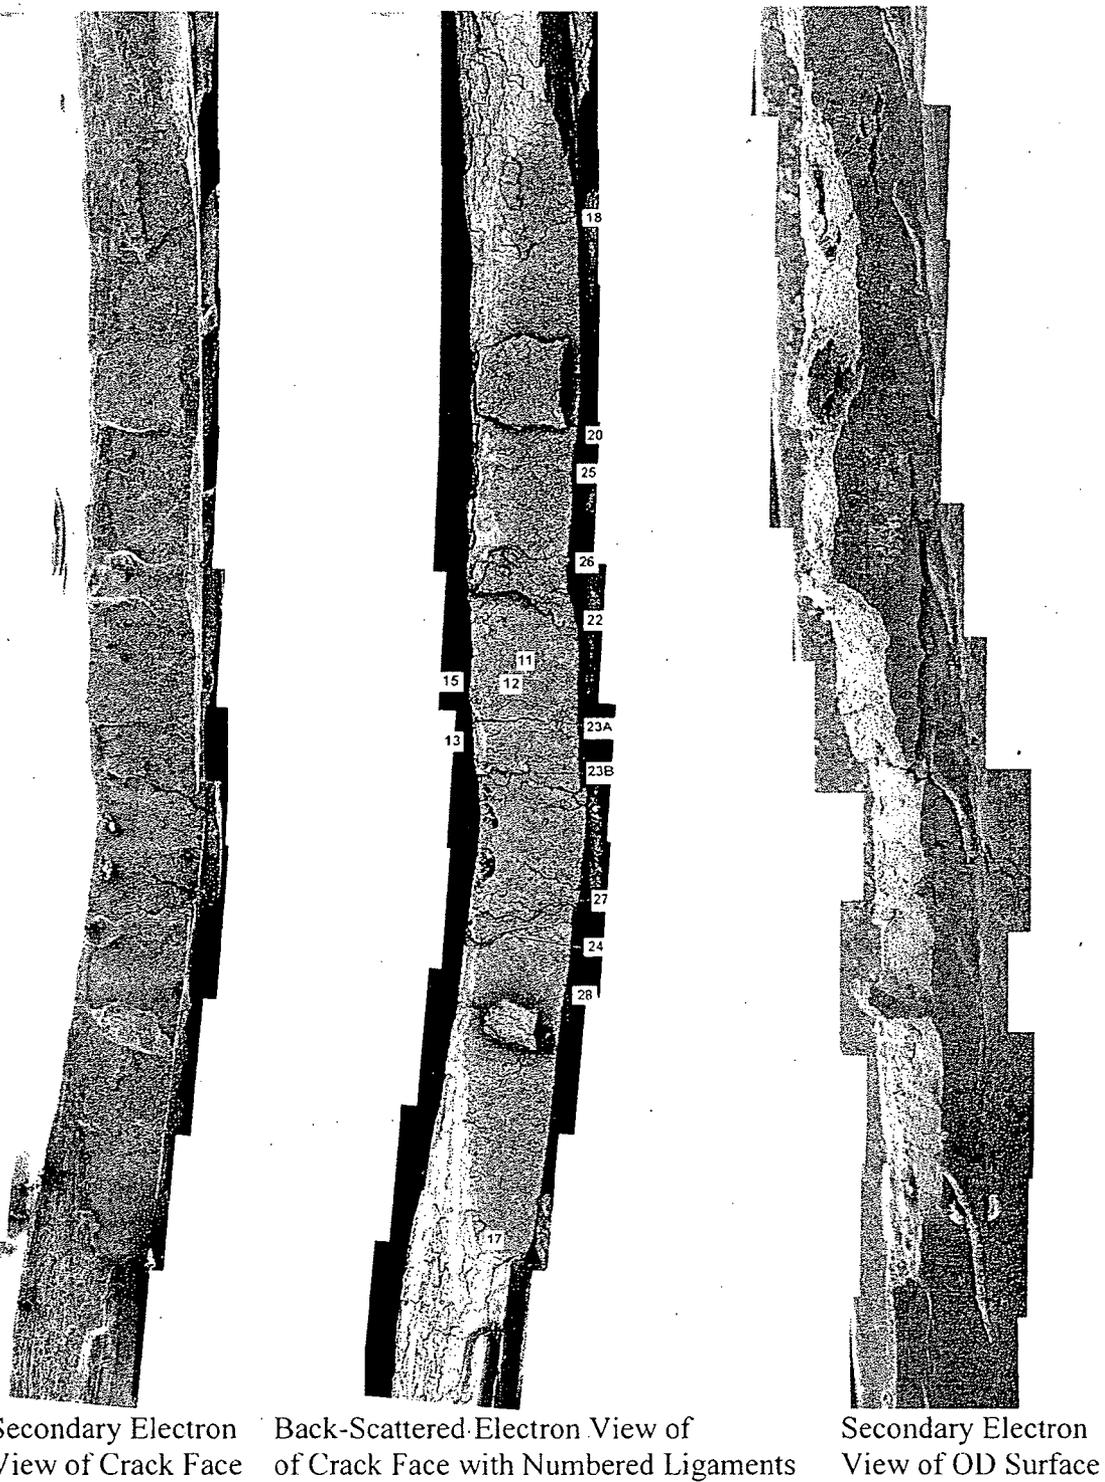
Figure 6-1: Overall Views of TSP#1 180° Crack (Sample 4C1)

Figure 6-1, Figure 6-2 and Figure 6-3 show a low magnification view of the crack samples, showing the cracks with different contrasts and viewing angles. The figures are each a montage of SEM fractographs taken at a higher magnification. The photomontages shown in these figures provided the starting point for the SEM examination as well as the data from which the depth profile and ligament size measurements were made.

Appendix A presents the crack depth and ligament size data. Figure 6-7, Figure 6-8 and Figure 6-9 present the crack depth profiles and uncorroded ligament sizing results for samples 4C1 (180° crack of TSP#1), 4C5 (110° crack of TSP#1) and 6B1 (180° crack of TSP#2), respectively. Table 6-5 summarizes some of the key characteristics of each of the three cracks.

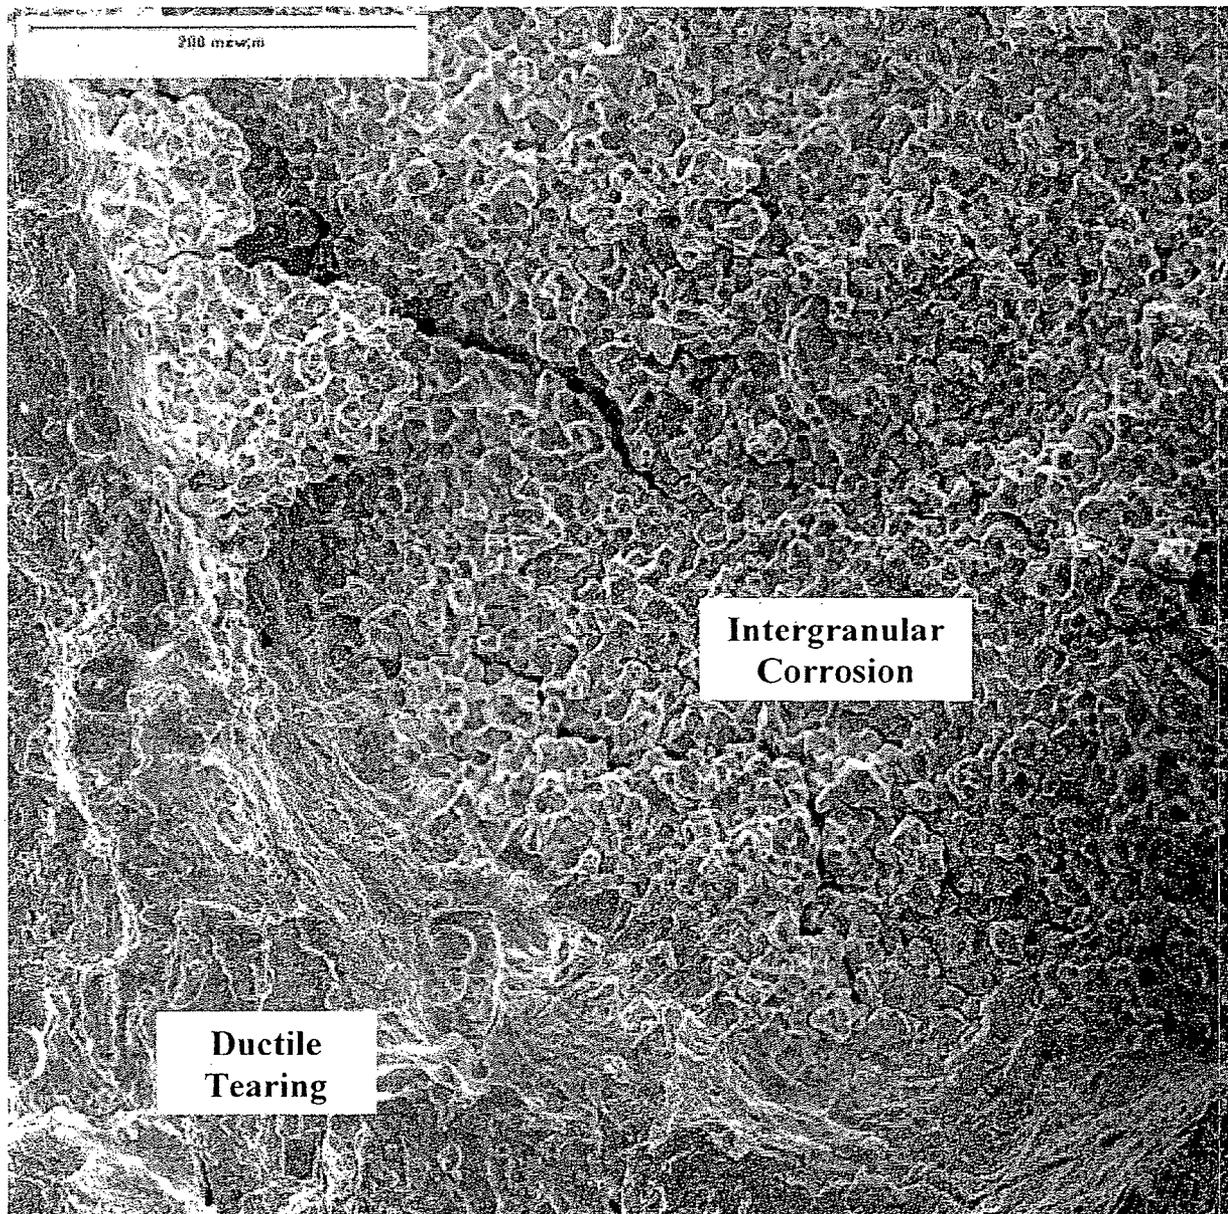
Figure 6-4: Example of Corrosion Surface (from Sample 4C1)

Figure 6-4 presents an example of the crack surface at a higher magnification view. The fractograph shows that the corrosion was intergranular, as was shown by the rock candy

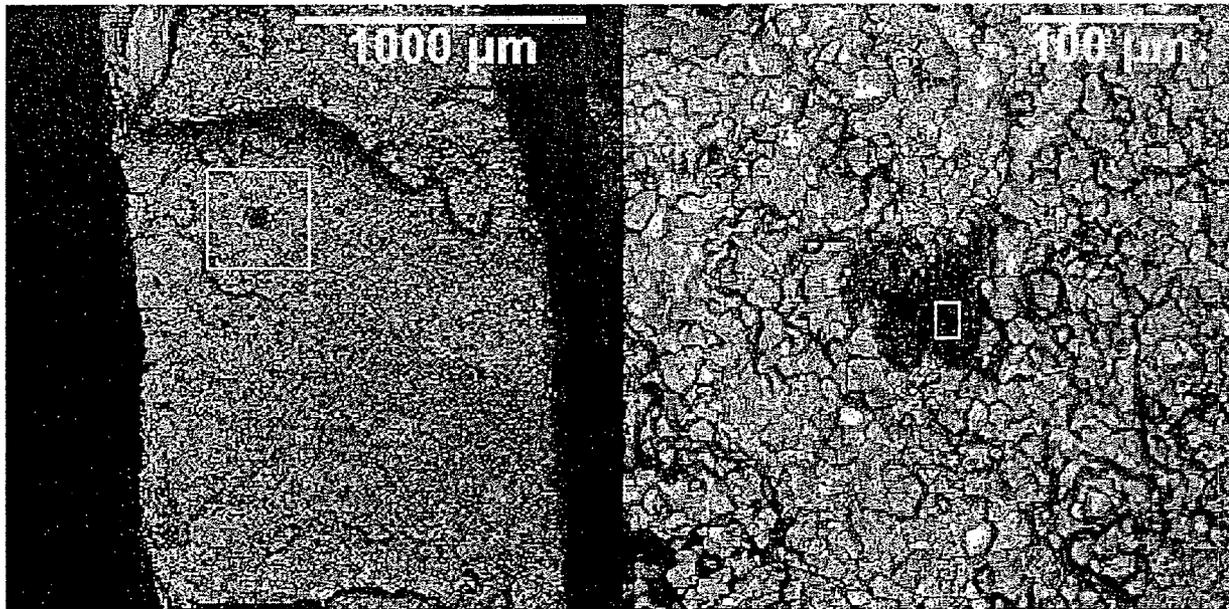
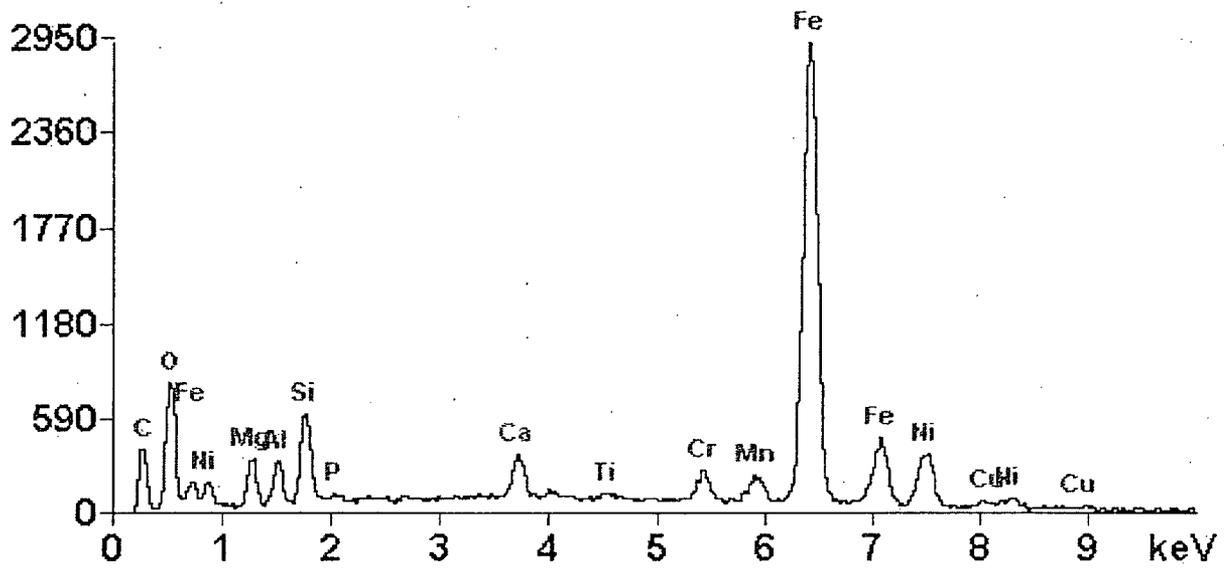
Figure 6-5: Example of EDS Analysis of Crack Surface (Dark Anomaly on Sample 4C1)

EDS analyses were performed on selected areas of each crack. Figure 6-5 presents an example of one of the areas that an EDS analysis was performed. The fractograph in the upper left shows the general area that was examined. The fractograph in the upper right shows the area on which the EDS analysis was performed. The spectrum is the result of the EDS analysis.

Figure 6-5 represents the only unusual artifact that was examined by EDS. A dark deposit or oxide patch was present in the middle of the crack.

The dark anomaly shown in Figure 6-5 was found to have a large amount of iron, as well as enhanced amounts of carbon and a significant amount of copper. It appears to have a composition similar to that of the deposits on the outer surface of the tube. This was the only area where copper was found on the crack surface.

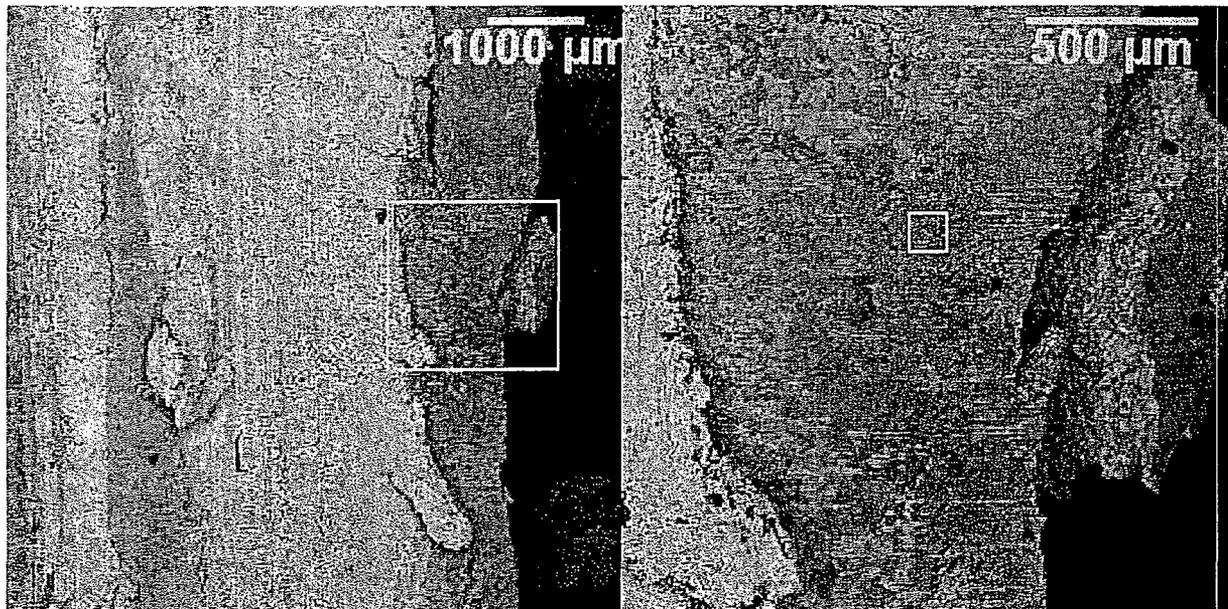
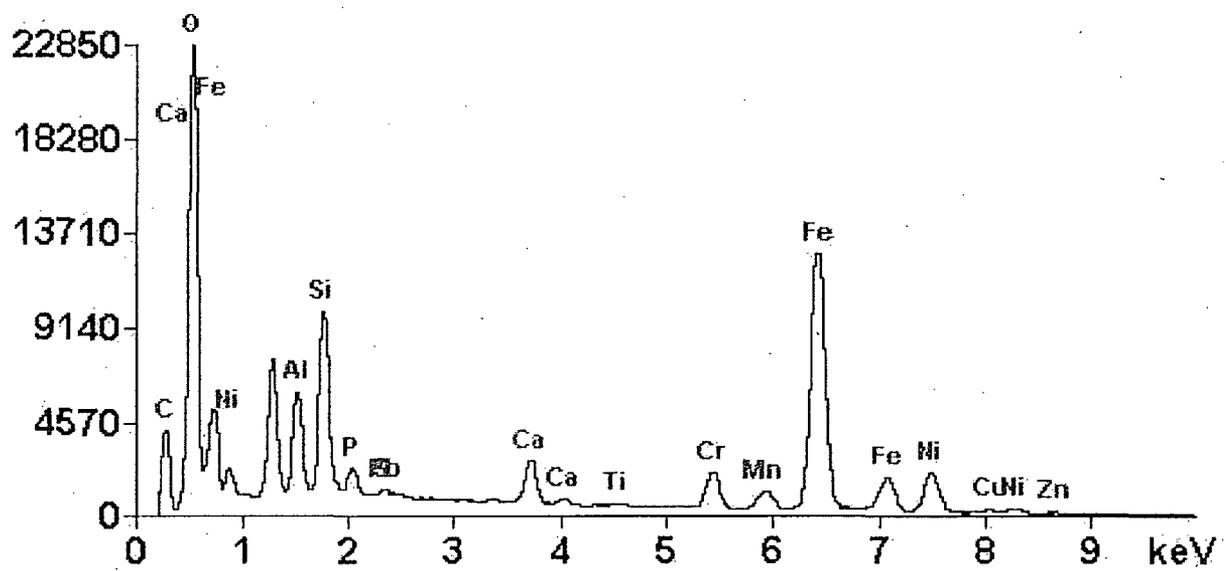
Figure 6-6: Example of EDS Analysis of OD Surface (Sample 4C1)

EDS analyses were performed on selected areas of the OD surface near the TSP#1 region cracks. Figure 6-6 presents an example of one of the areas that an EDS analysis was performed, an area of light deposits near the 180° crack. The fractograph in the upper left shows the general area that was examined, an area between a deep gouge and the crack. The fractograph in the upper right shows the area on which the EDS analysis was performed. The area shows the belt polish marks on the tube surface (the fine horizontal lines). The spectrum is the result of the EDS analysis of the area within the square.

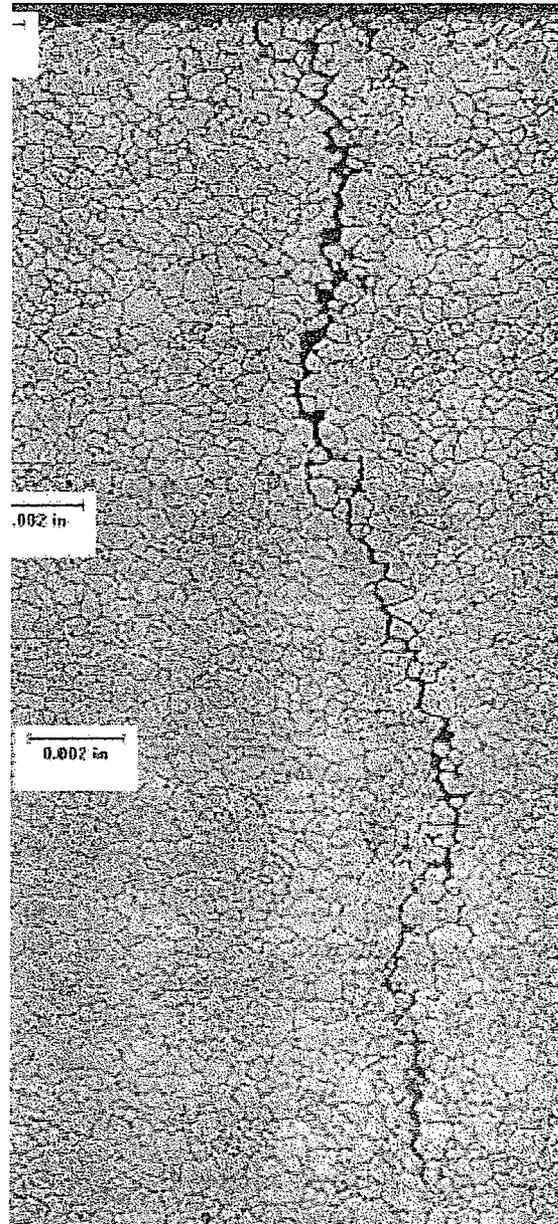
Figure 7-1: Typical Axial Crack (Sample 4C4 at $\sim 315^\circ$ Location)

Figure 7-1 shows a typical axial crack that was revealed by transverse metallography. The one shown in Figure 7-1 was taken from TSP#1 at approximately the 315° location (sample 4C4). The cracks in this location were composed of short, unlinked cracks. The crack shown in the figure was one of the deeper cracks examined by transverse metallography, 47%TW.
