From: "Stillwell, Daniel" <dwstillwell@STPEGS.COM>
To: "Mark Tonacci" <MET@nrc.gov>
Date: 11/15/2007 3:54:28 PM
Subject: Additional Information on Main Cooling Reservoir Breach
cc: "David Dujka" <dldujka@STPEGS.COM>,"Gregory T Gibson" <gtgibson@STPEGS.COM>,"John T Conly" <jtconly@STPEGS.COM>,"Steven Thomas" <sethomas@STPEGS.COM>,"William Mookhoek" <wemookhoek@STPEGS.COM>

The attached files contain additional information on the main cooling reservoir breach from the licensing of Units 1 and 2. Sediment deposit following a nonmechanistic breach of the main cooling reservoir was not considered during the licensing of Units 1 and 2, however, scour and erosion were the subject of several NRC meetings and much correspondence starting in 1983 when HL&P notified the NRC of a potentially reportable condition concerning erosion and scour associated with failure of the MCR embankment that had the potential to affect the structural backfill supporting the foundations of Seismic Category I structures (ST-AE-HL-1011, 9-28-83). This issue was the result of a revision to RG 1.59 to Rev. 2 that required consideration of erosion and scour for Design Basis Flood events. After discussion, the NRC ind

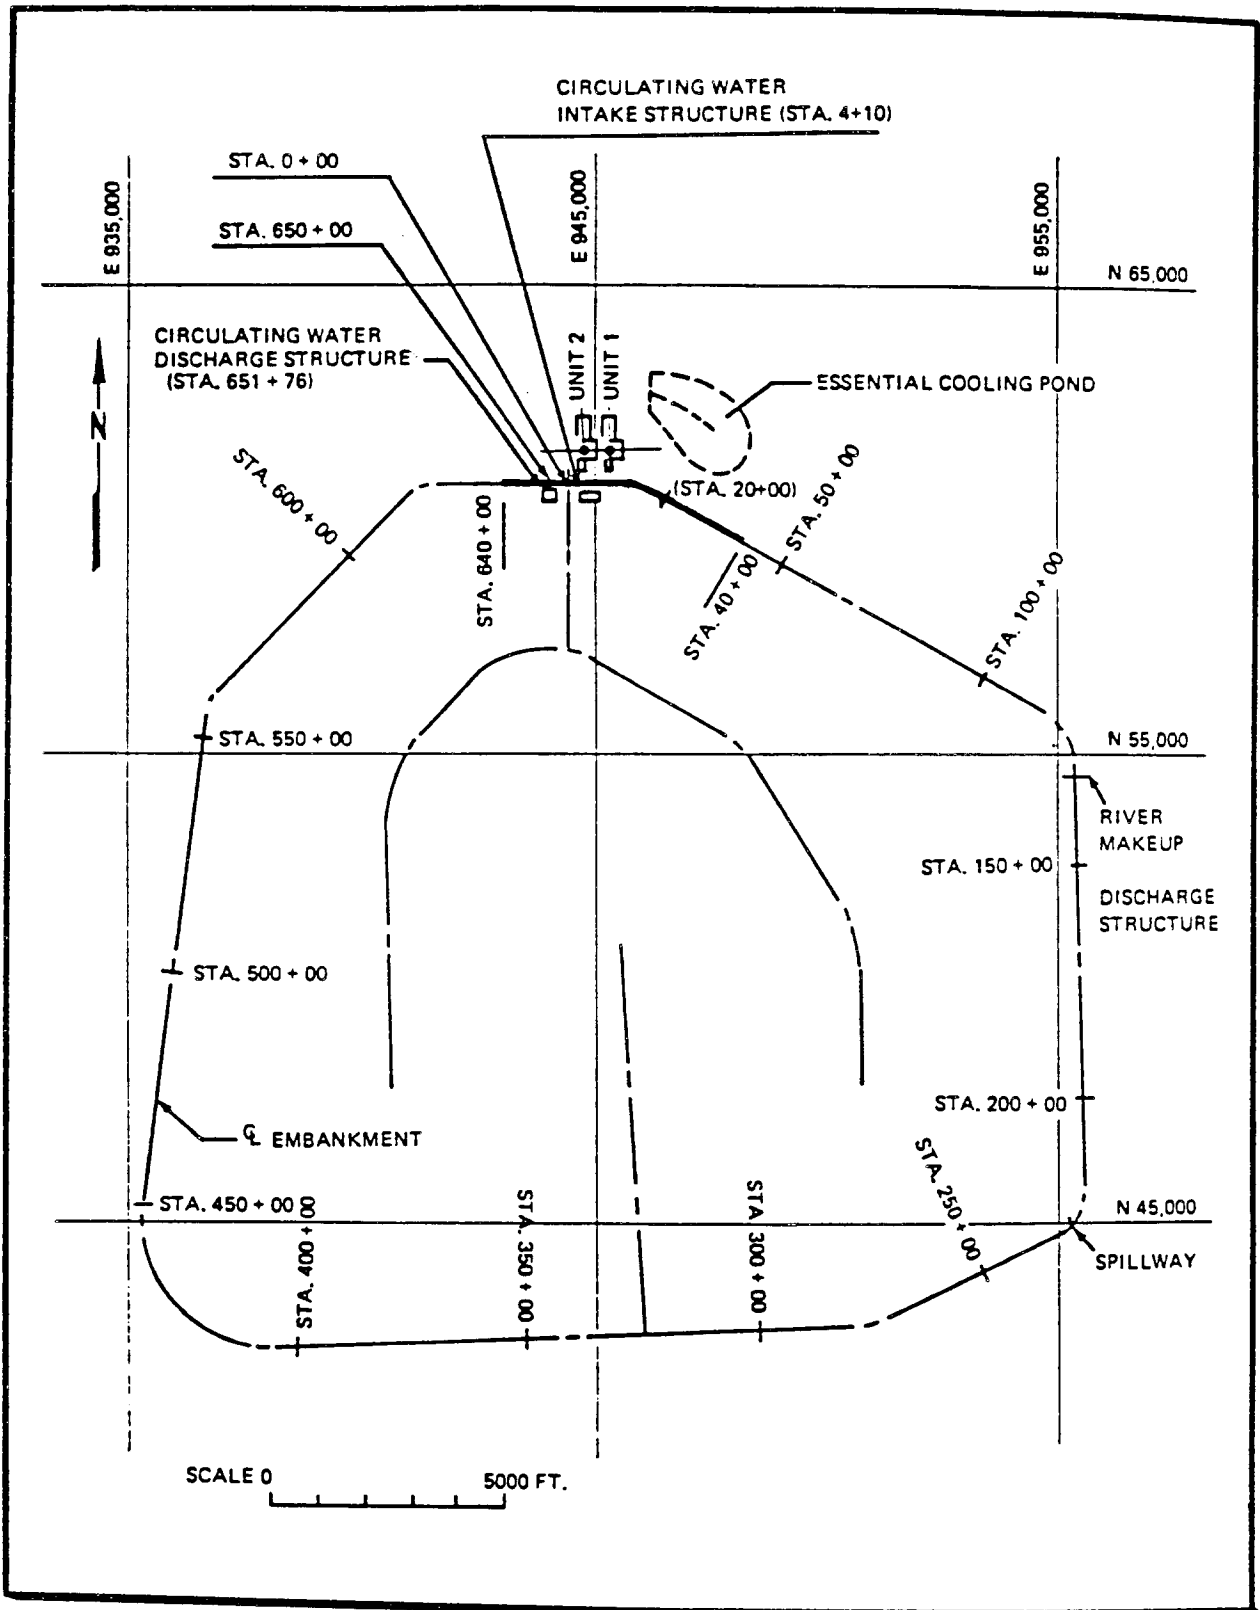
Figure 1 Main cooling reservoir--key plan
 Source: Provided at meeting between NRC and applicant,
 Bethesda, Maryland, April 2, 1985

To assist in the reevaluation of the completed MCR embankment and resolution of several of these items, Bechtel retained a Consulting Review Board (CRB). Emphasis was placed on the embankment section between stations 640+00 to 655+00 and 0+00 to 40+00 (see Figure 1) because of its proximity to the South Texas safety-related structures. During a meeting in Bethesda, Maryland, on April 2, 1985, between NRC staff and consultant and HL&P personnel, consultants, and architects/engineers, the applicant indicated that an embankment breach outside this section would not affect the safety-related structures. Each of the above-mentioned review items is discussed in the following paragraphs.

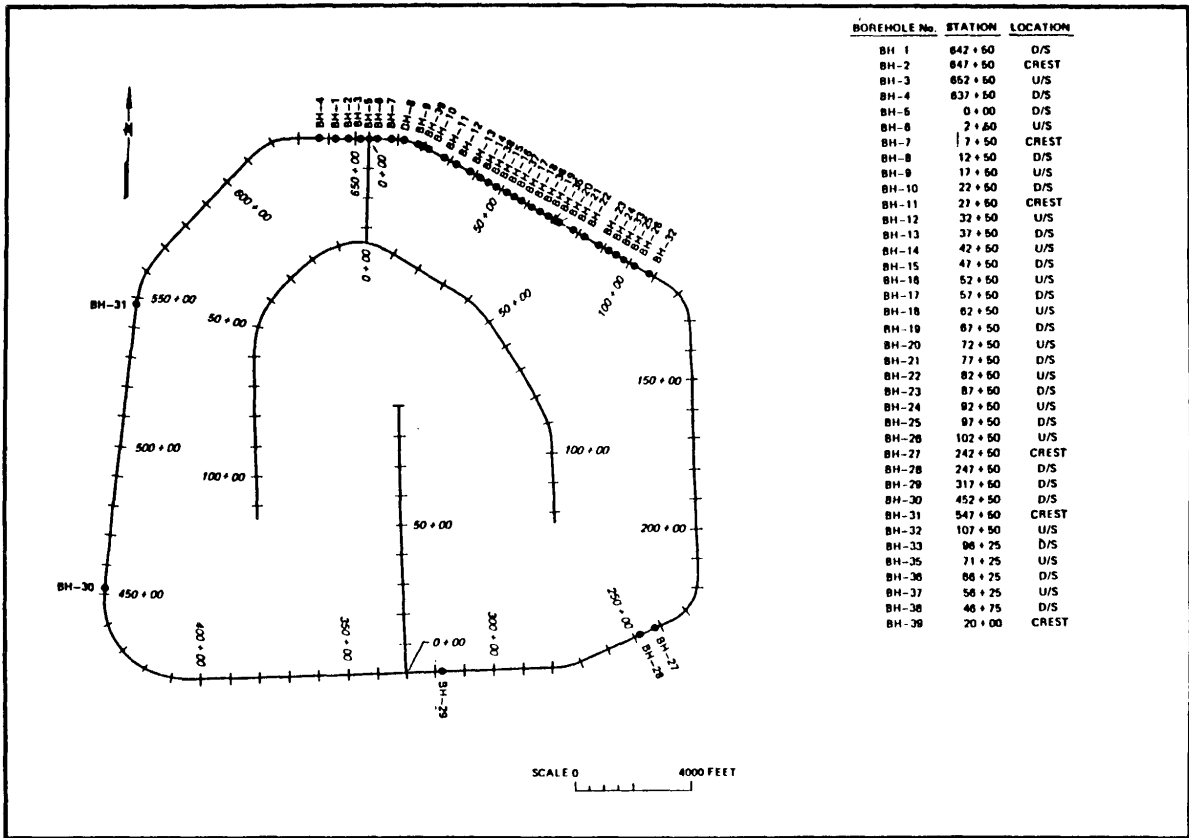
Figure 2 Confirmatory program--borehole location plan
 Source: Provided at meeting between NRC and applicant, Bethesda, Maryland, April 2, 1985.

Stability analyses were performed based on strength parameters established for the initial design. Additional field investigations (see Figure 2) and soil testing were performed to verify the original design parameters. A total of 48 borings were drilled to obtain undisturbed samples and to perform standard penetration tests. Laboratory testing included consolidation tests and triaxial and direct shear strength tests. These tests confirmed that strength parameters used in the stability analyses are conservative. Results of the field and laboratory programs are presented by Harza Engineering Company (Vols. 2 and 3, 1984). The stability of the embankment was studied for steady-state seepage, rapid drawdown, and seismic conditions. These analyses are presented in detail by Harza Engineering Company (Vol. 1, 1984) and summarized in Table 1. A typical embankment cross-section with selected material strengths is shown on Figure 3.

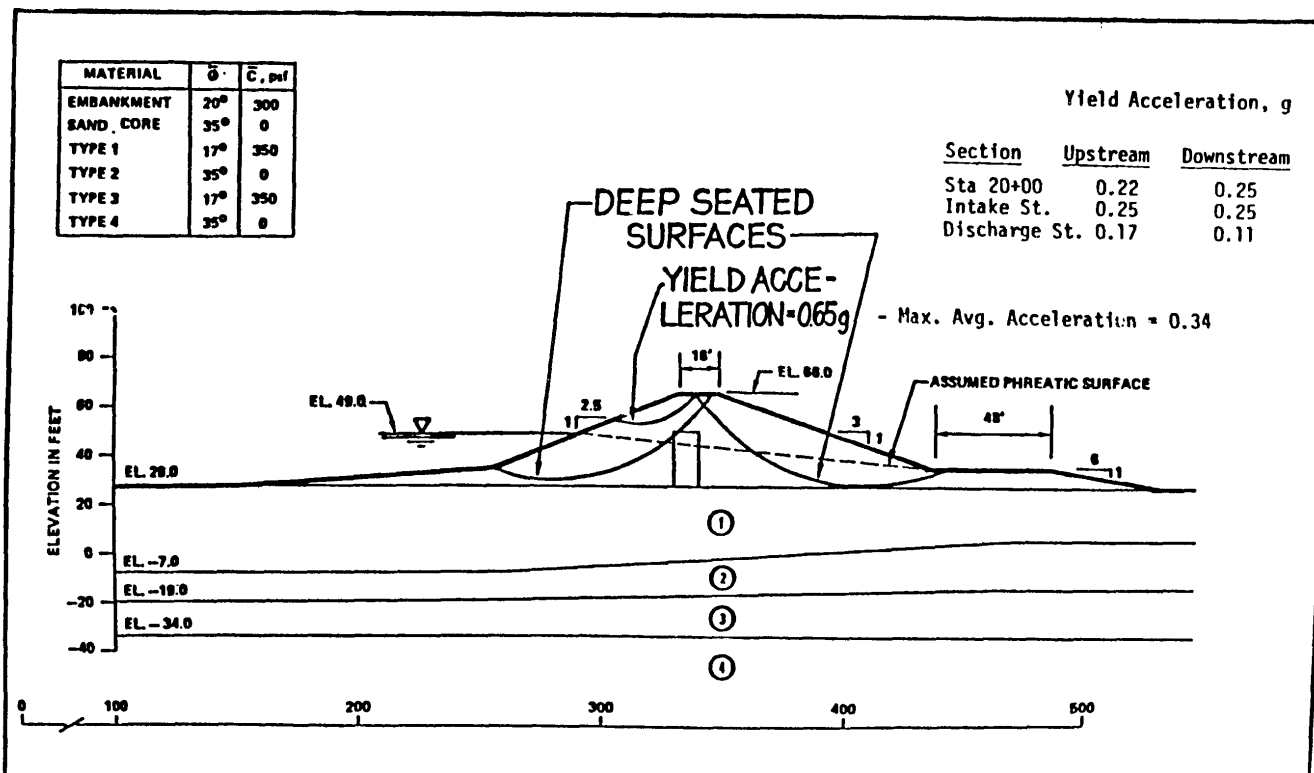
Figure 4 Seismic stability evaluation
 Source: Provided at meeting between NRC and applicant, Bethesda, Maryland, April 2, 1985

Because the project is located in a very low seismicity zone with the clay embankment founded on clays and medium dense to dense sands, a Newmark-type displacement analysis was performed. Also, a liquefaction potential analysis was performed for the embankment between stations 42+50 and 72+50 where low-blow-count sandy material was encountered. Results of the displacement analyses are presented on Figure 4 and show that permanent deformations will not occur because the yield accelerations are much greater than the safe shutdown earthquake (SSE)-induced accelerations. Also, clay embankments on clay or dense sand have successfully withstood earthquake accelerations much higher than the SSE for the South Texas plant with no significant effects (Seed, Makdisi, and DeAlba, 1978). Results of the liquefaction potential analysis are shown on Figure 5 with the cyclic strength determined for average corrected standard penetration values and the cyclic stress determined from a response spectrum analysis corrected for confinement pressures (depth) estimated for nonlevel ground near the embankment.

Station	Elevation	F.S. = $\frac{\text{Cyclic Strength}}{\text{Cyclic Stress}}$		
		Crest	D/S Berm	Free Field
637± to 10±	-13 to -3	Fines 15% - 35% 3.0 - 3.6	Fines 15% - 35% 1.8 - 2.1	Fines 15% - 35% 1.8 - 2.1
637± to 10±	+ 5 to +10	2.9 - 3.4	1.4 - 1.7	1.5 - 1.8
16± to 40±	+ 2 to +10	3.7 - 4.6	1.9 - 2.3	2.0 - 2.5
30± to 45±	+13 to +16	2.6 - 3.1	1.2 - 1.5	1.4 - 1.7

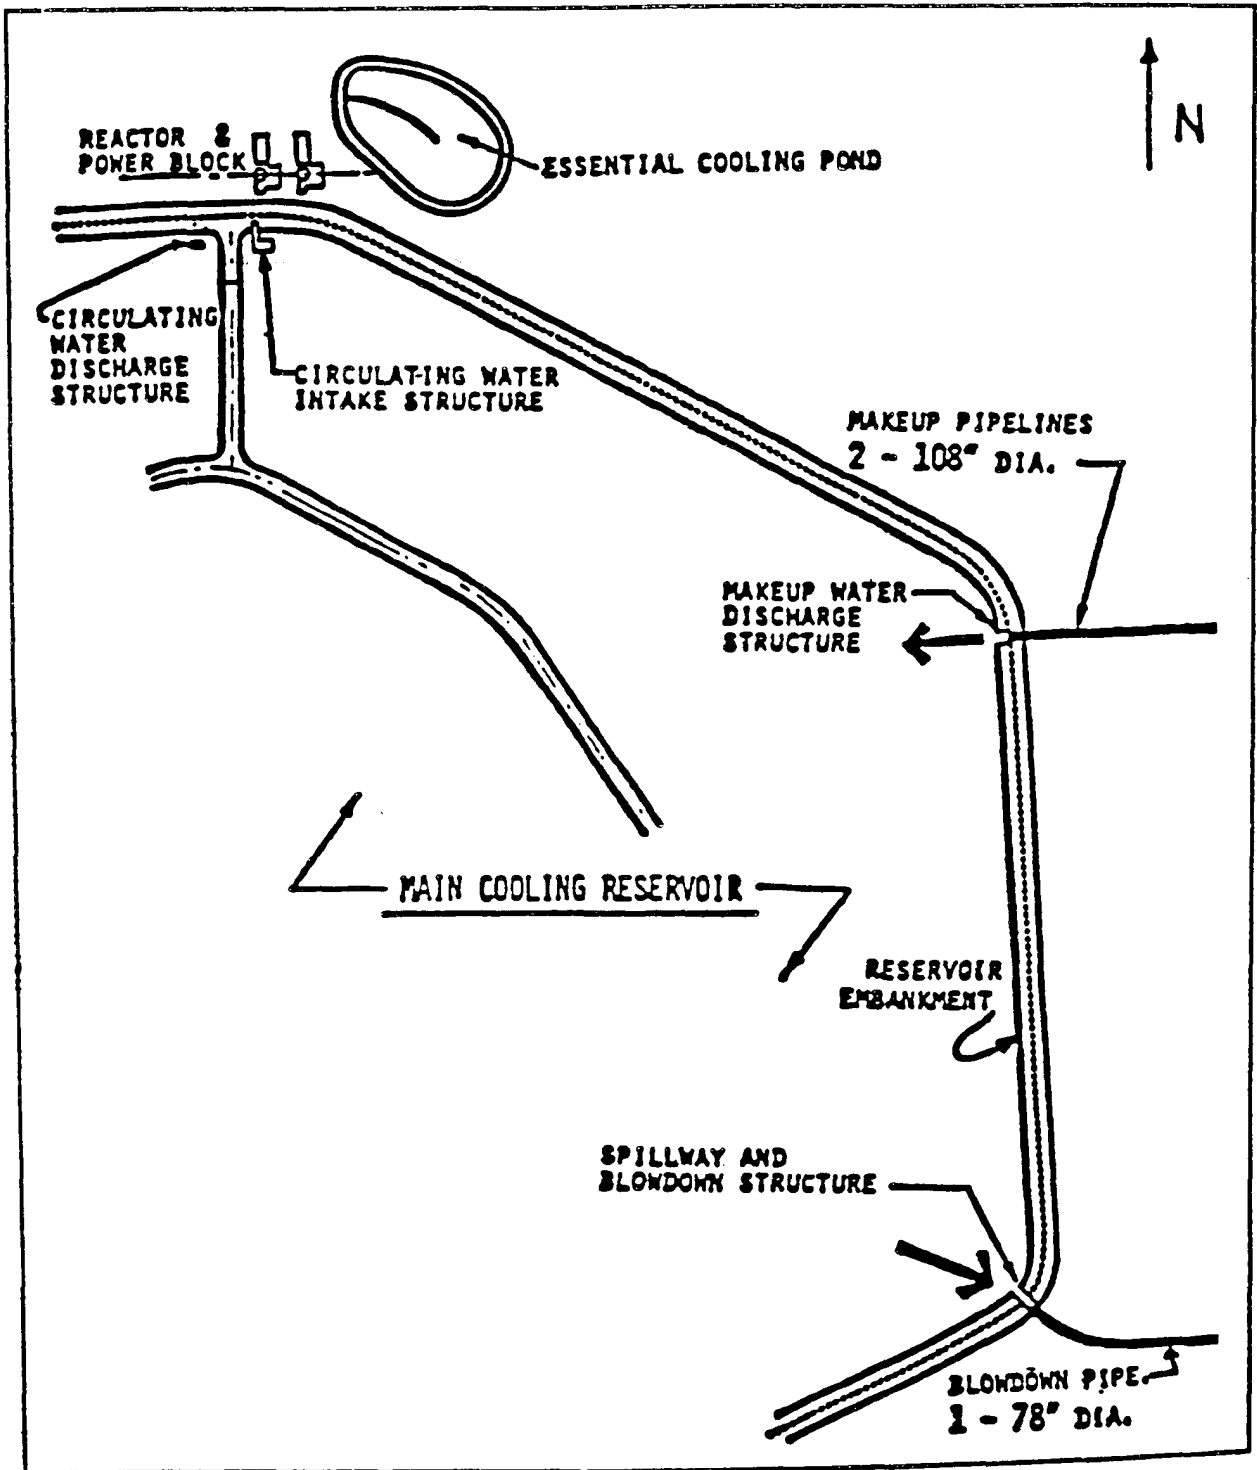
Figure 7 Penetration through the embankment
 Source: Provided at meeting between NRC and applicant,
 Bethesda, Maryland, April 2, 1985

There are a number of pipe and structural penetrations through the existing embankment as shown on Figure 7. Only the circulating water intake and discharge pipes are located in the section of the embankment opposite the power block. These pipes, shown on Figure 8, consist of eight 96-inch-diameter pipes for the intake that tap into four 138-inch-diameter pipes near the toe berm, and four 138-inch-diameter pipes of the same type for the discharge. The pipes that penetrate the embankment have bell and spigot joints with rubber gaskets and are embedded in sand and surrounded by embankment material. Some joints were welded at bends to provide thrust restraint, and some were harnessed to permit joint rotation. Major concerns related to these pipes included a lack of inspectability and lack of watertightness of joints that could open, causing leakage and subsequent embankment failure. Remedial measures to alleviate these concerns are currently in progress (see Figure 9). Measures consist of removing the existing pipes, installing new concrete pipes at the crest and slopes in concrete chutes to provide erosion protection and inspectability of joints, and installing additional piezometers along the existing pipes at the berm to detect any leakage that might develop.

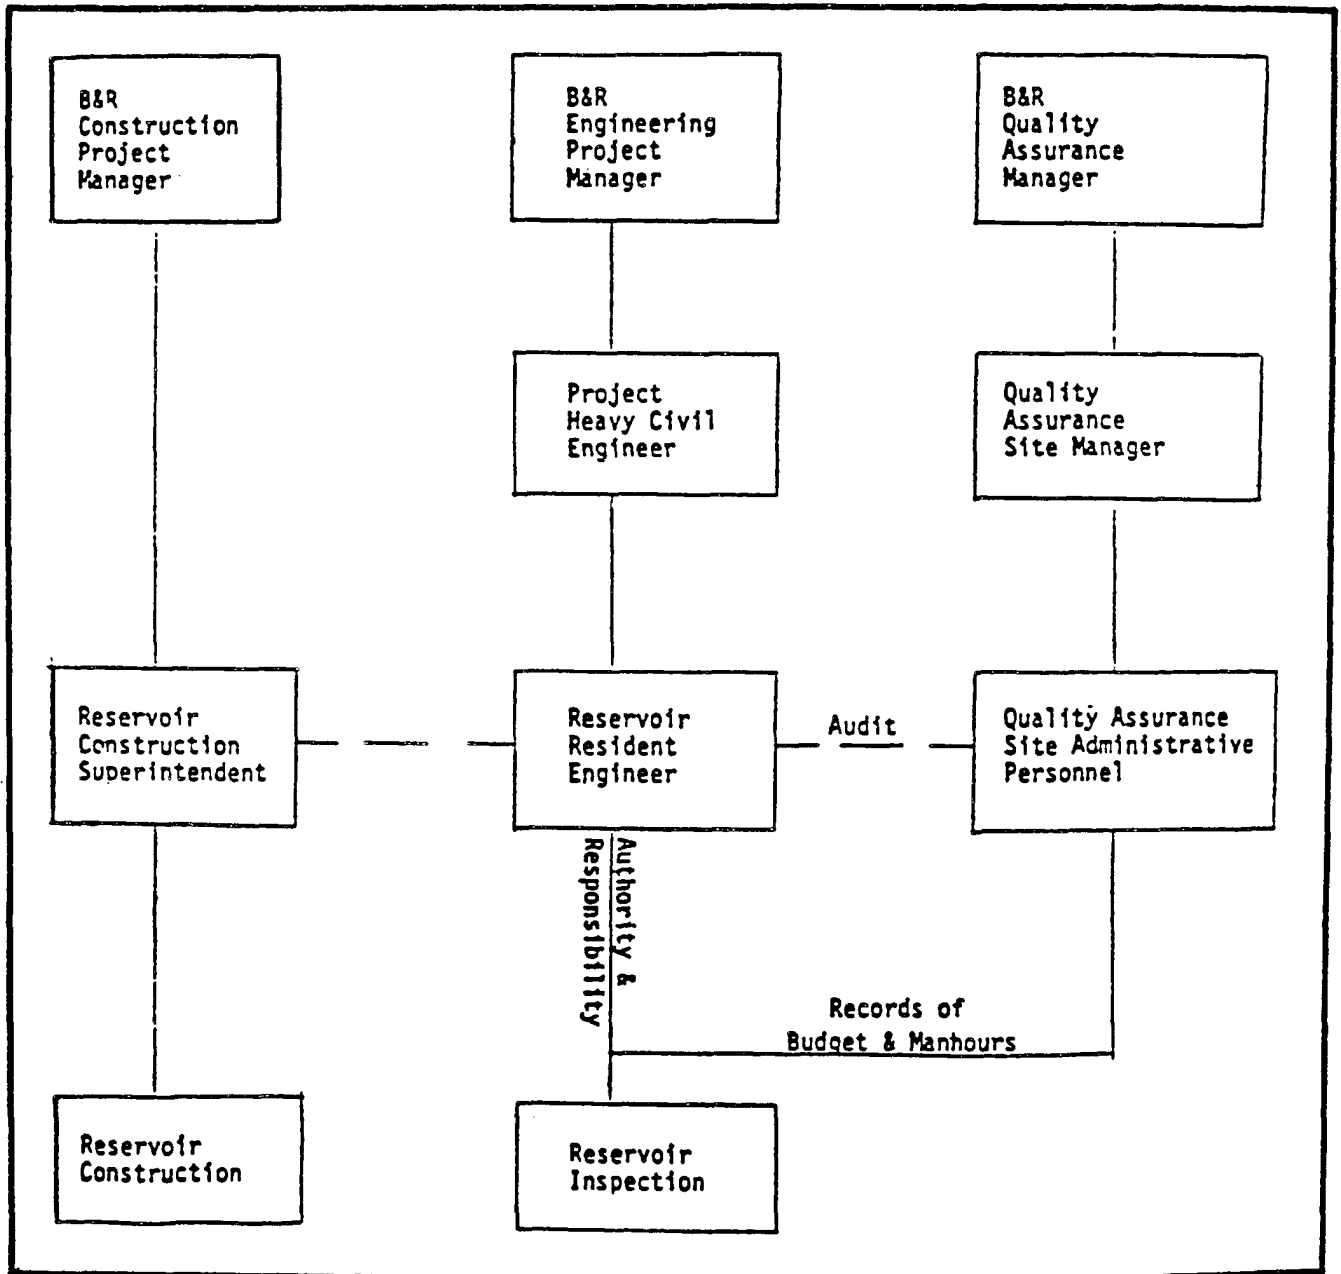
Figure 11 Basic project organization
 Source: Provided during site visit on March 19, 1985

The basic project organization is shown on Figure 11, which indicates that the resident engineer developed and technically administered the quality control program for reservoir construction. The quality control program, in turn, was subject to inspection and audit by Brown and Root quality assurance personnel and by HL&P personnel. Figure 12 shows the reservoir inspection and testing organization. Typical examples of reports prepared included a report by the
