REPORT NO. R-85-02-SQN/WBN
SEQUOYAH AND WATTS BAR NUCLEAR PLANTS
SPECIAL REVIEW OF MANUFACTURER-IDENTIFIED
POTENTIAL MISAPPLICATION OF SWAGELOK TUBE
FITTINGS AT WESTINGHOUSE REACTOR SEAL TABLES

NSRS REPORT NO. R-85-02-SQN/WBN

SUBJECT: SEQUOYAH AND WATTS BAR NUCLEAR PLANTS -
SPECIAL REVIEW OF MANUFACTURER-IDENTIFIED
POTENTIAL MISAPPLICATION OF SWAGELOK TUBE
FITTINGS AT WESTINGHOUSE REACTOR SEAL TABLES

DATES OF
REVIEW: JANUARY 22-23, 1985 - SEQUOYAH
JANUARY 24-25, 1985 - WATTS BAR

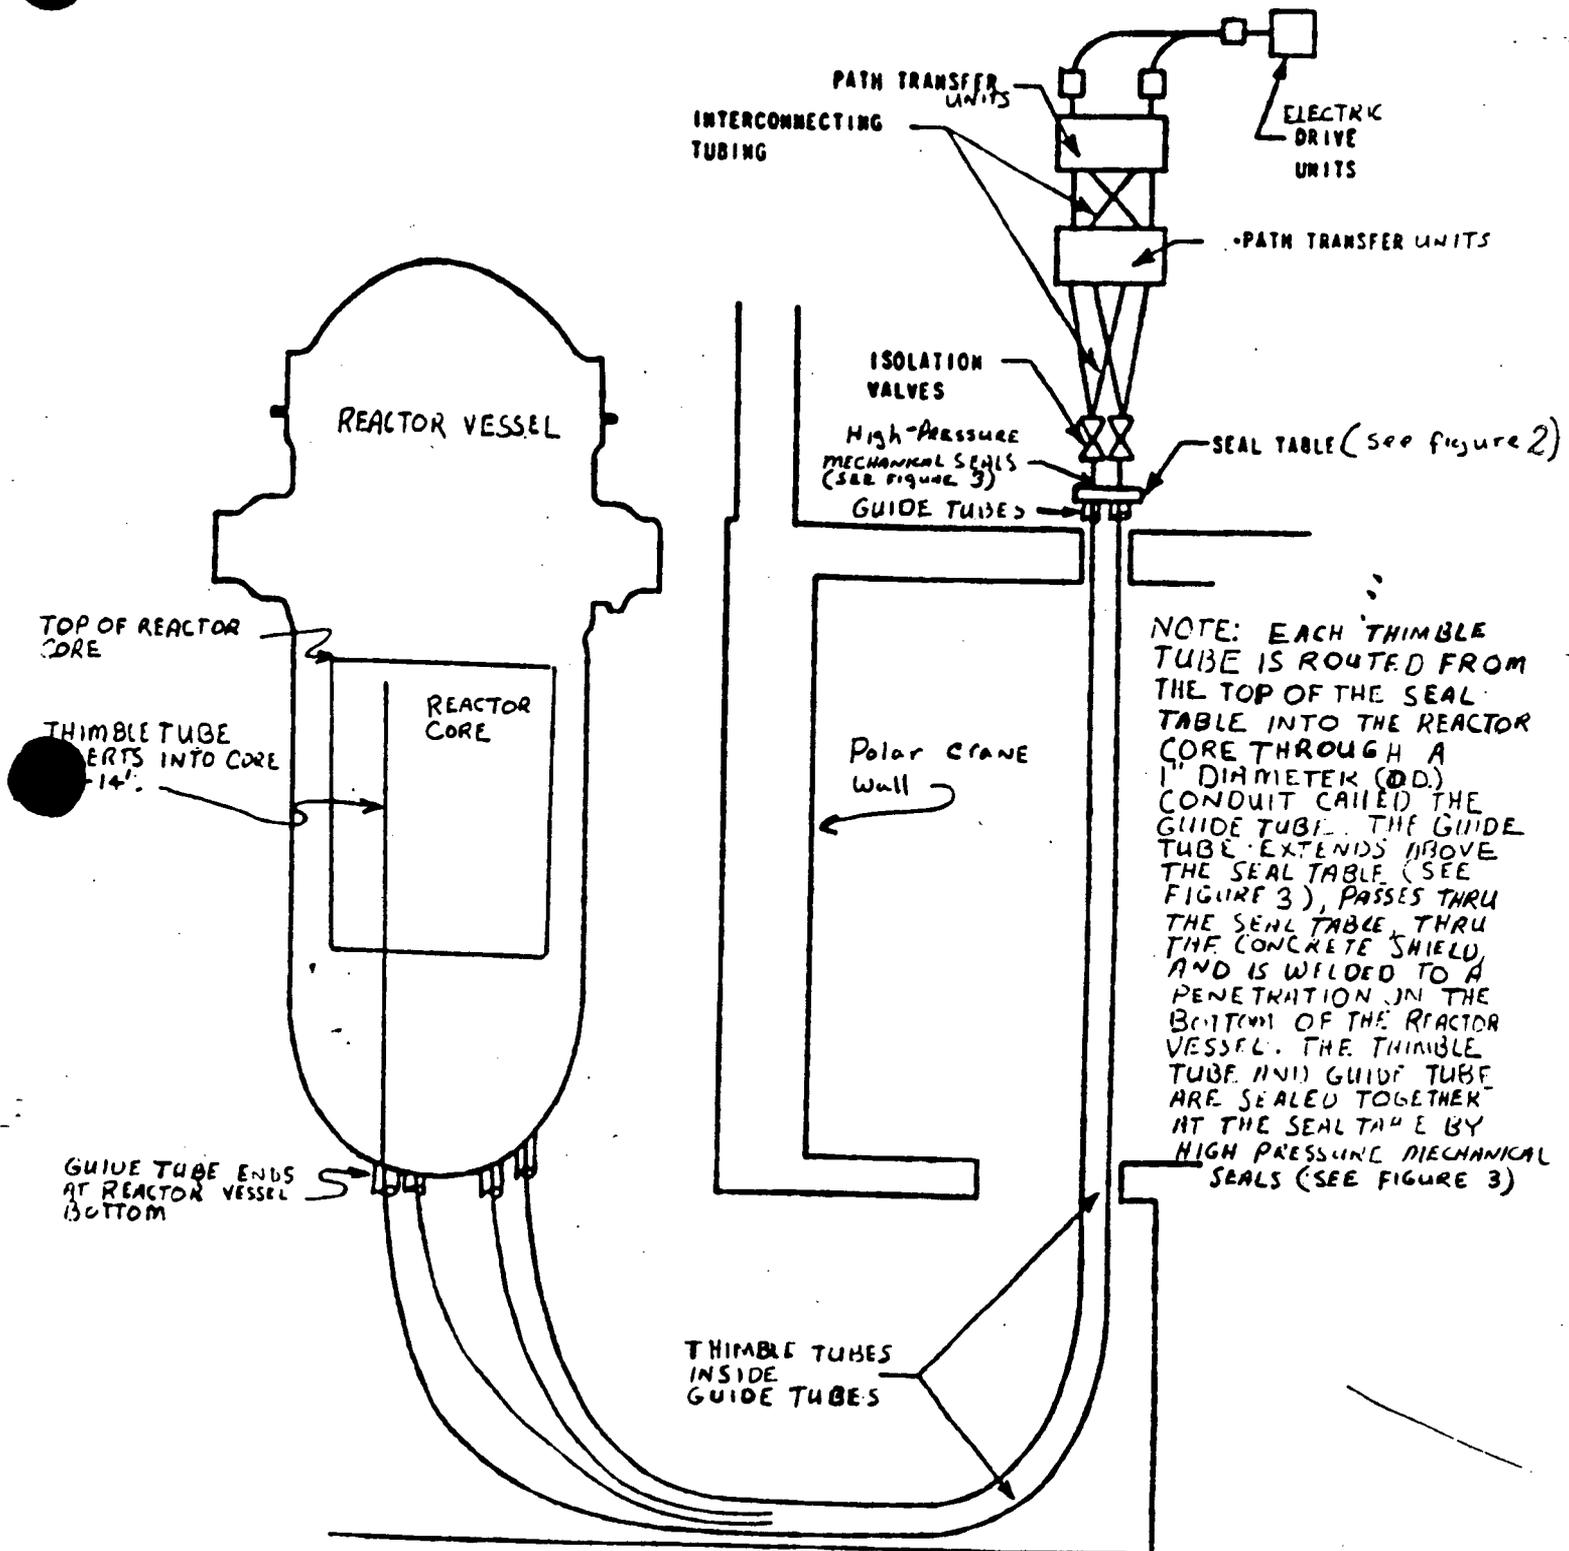
Figure 1 Bottom Mounted In-core Instrumentation System (BMIS)

NOTE: EACH THIMBLE TUBE IS ROUTED FROM THE TOP OF THE SEAL TABLE INTO THE REACTOR CORE THROUGH A 1" DIAMETER (O.D.) CONDUIT CALLED THE GUIDE TUBE. THE GUIDE TUBE EXTENDS ABOVE THE SEAL TABLE (SEE FIGURE 3), PASSES THROUGH THE SEAL TABLE THROUGH THE CONCRETE SHIELD, AND IS WELDED TO A PENETRATION IN THE BOTTOM OF THE REACTOR VESSEL. THE THIMBLE TUBE AND GUIDE TUBE ARE SEALED TOGETHER AT THE SEAL TABLE BY HIGH PRESSURE MECHANICAL SEALS (SEE FIGURE 3)

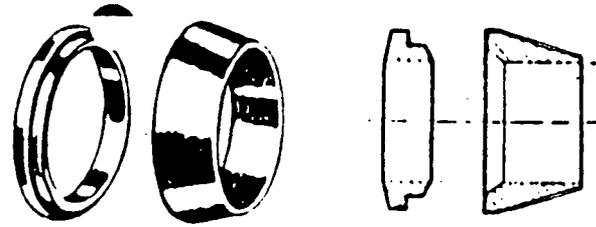
SWAGELOK UNION FLARE
FITTING FOR CONNECTION
TO TUBING FROM DRIVE
SYSTEM

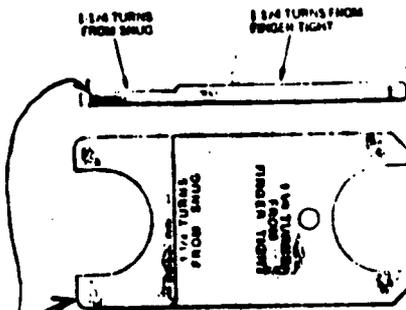
NOTE: THIS PART OF THE GAGE IS TO BE USED AFTER INITIAL ASSEMBLY OF SWAGELOK TUBE FITTINGS FOR HIGH PRESSURE APPLICATIONS, HIGH SAFETY FACTOR SYSTEMS

Gap Inspection Gage does not fit between nut and body hex. Fitting is sufficiently tightened.
