Electrical Insulation Research Center Institute of Materials Science, U-136 University of Connecticut Storrs, CT 06269-3136

> Performed for Tennessee Valley Authority contract TV-79850T

ANALYSIS OF DAMAGE TO INSTRUMENTATION CABLES REMOVED FROM WATTS BAR NUCLEAR PLANT

December 11, 1989

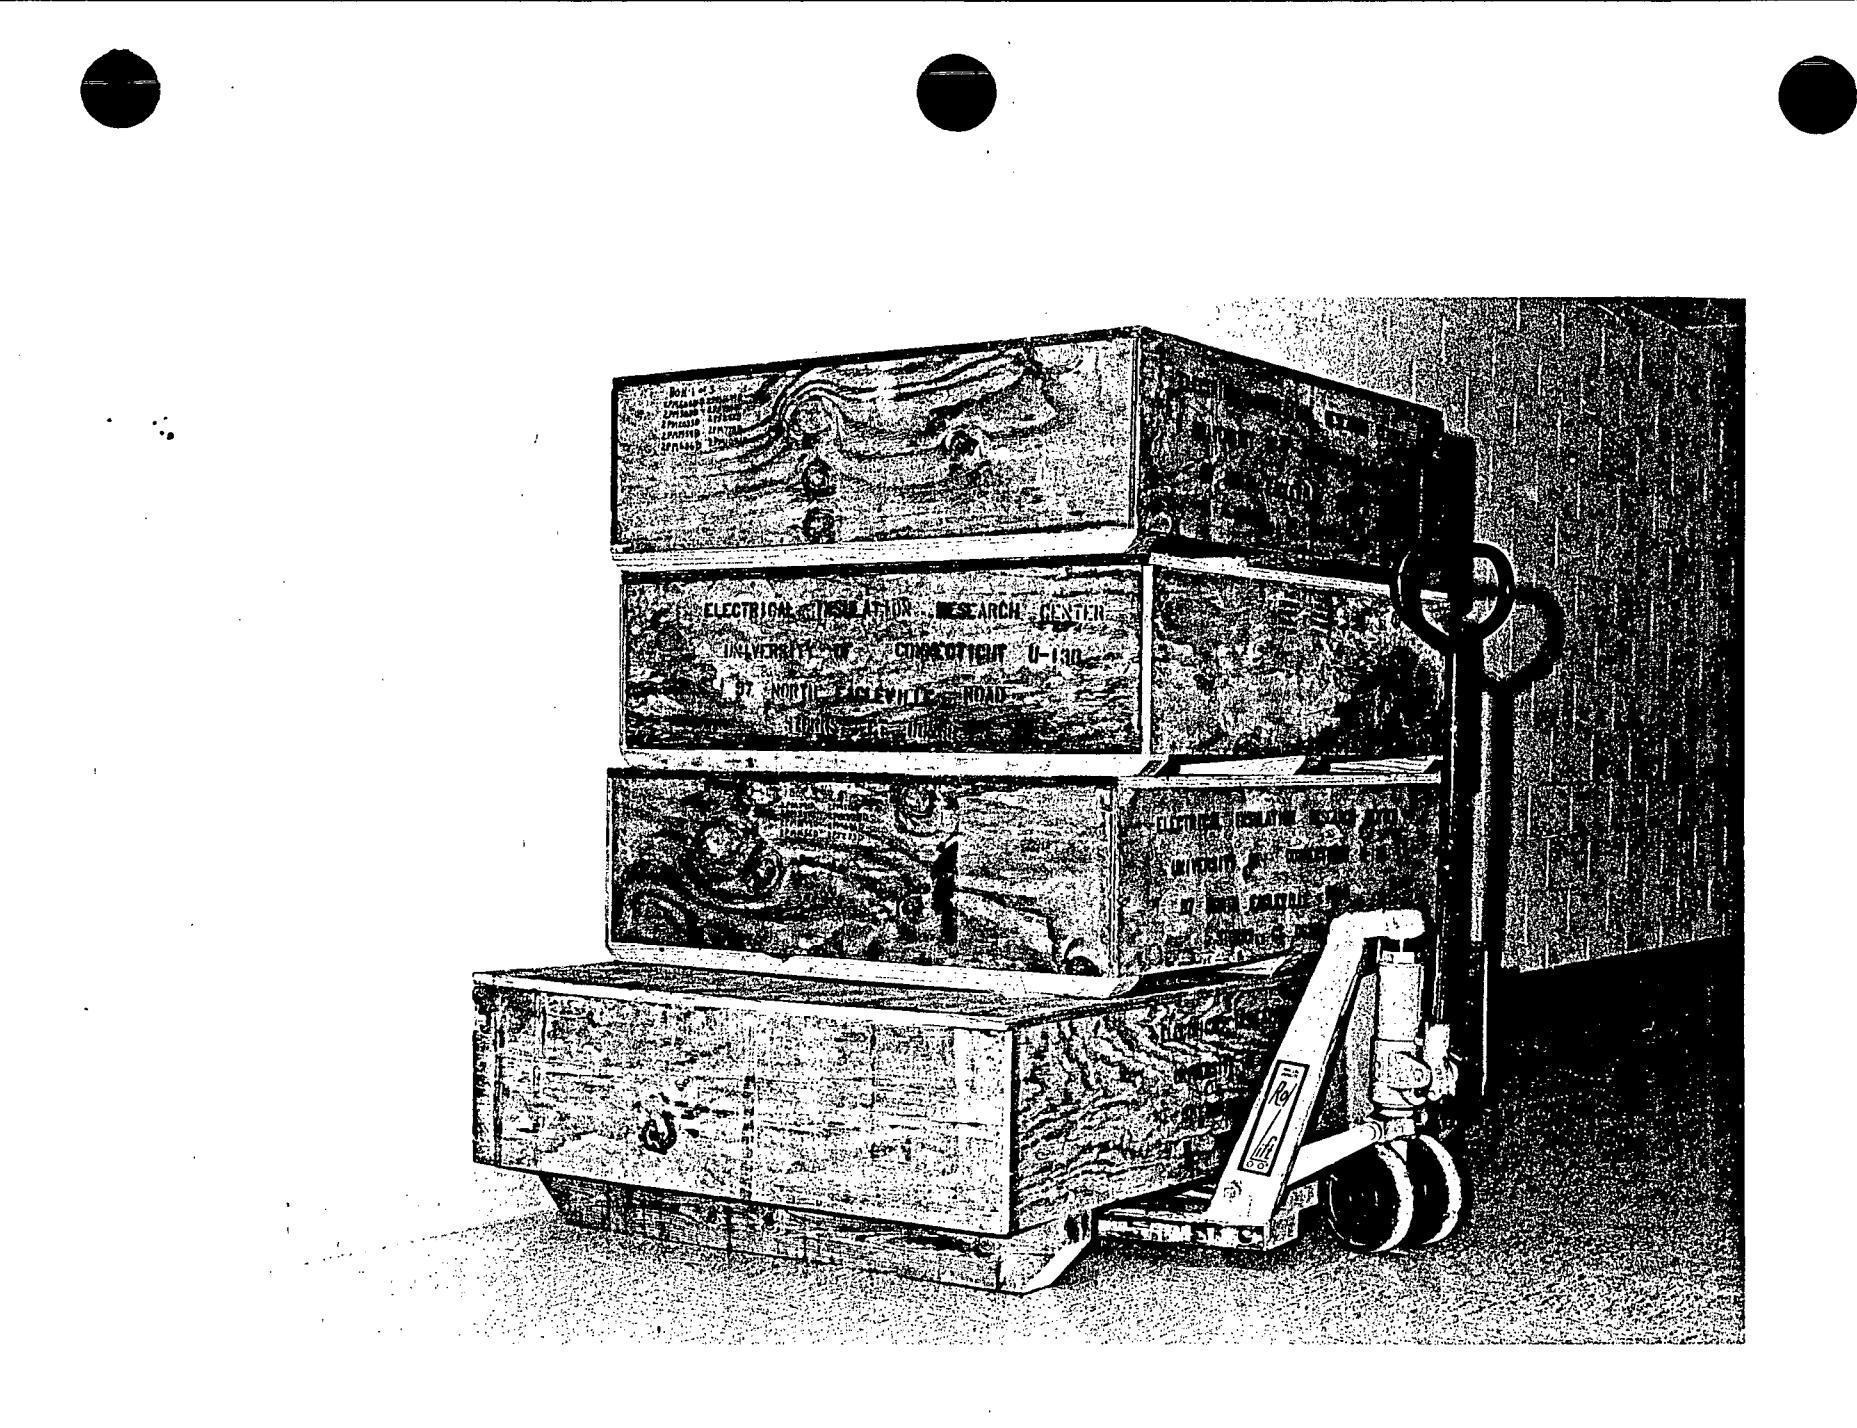
Figure 1 Shipping Containers with Cables Listed In Table 1

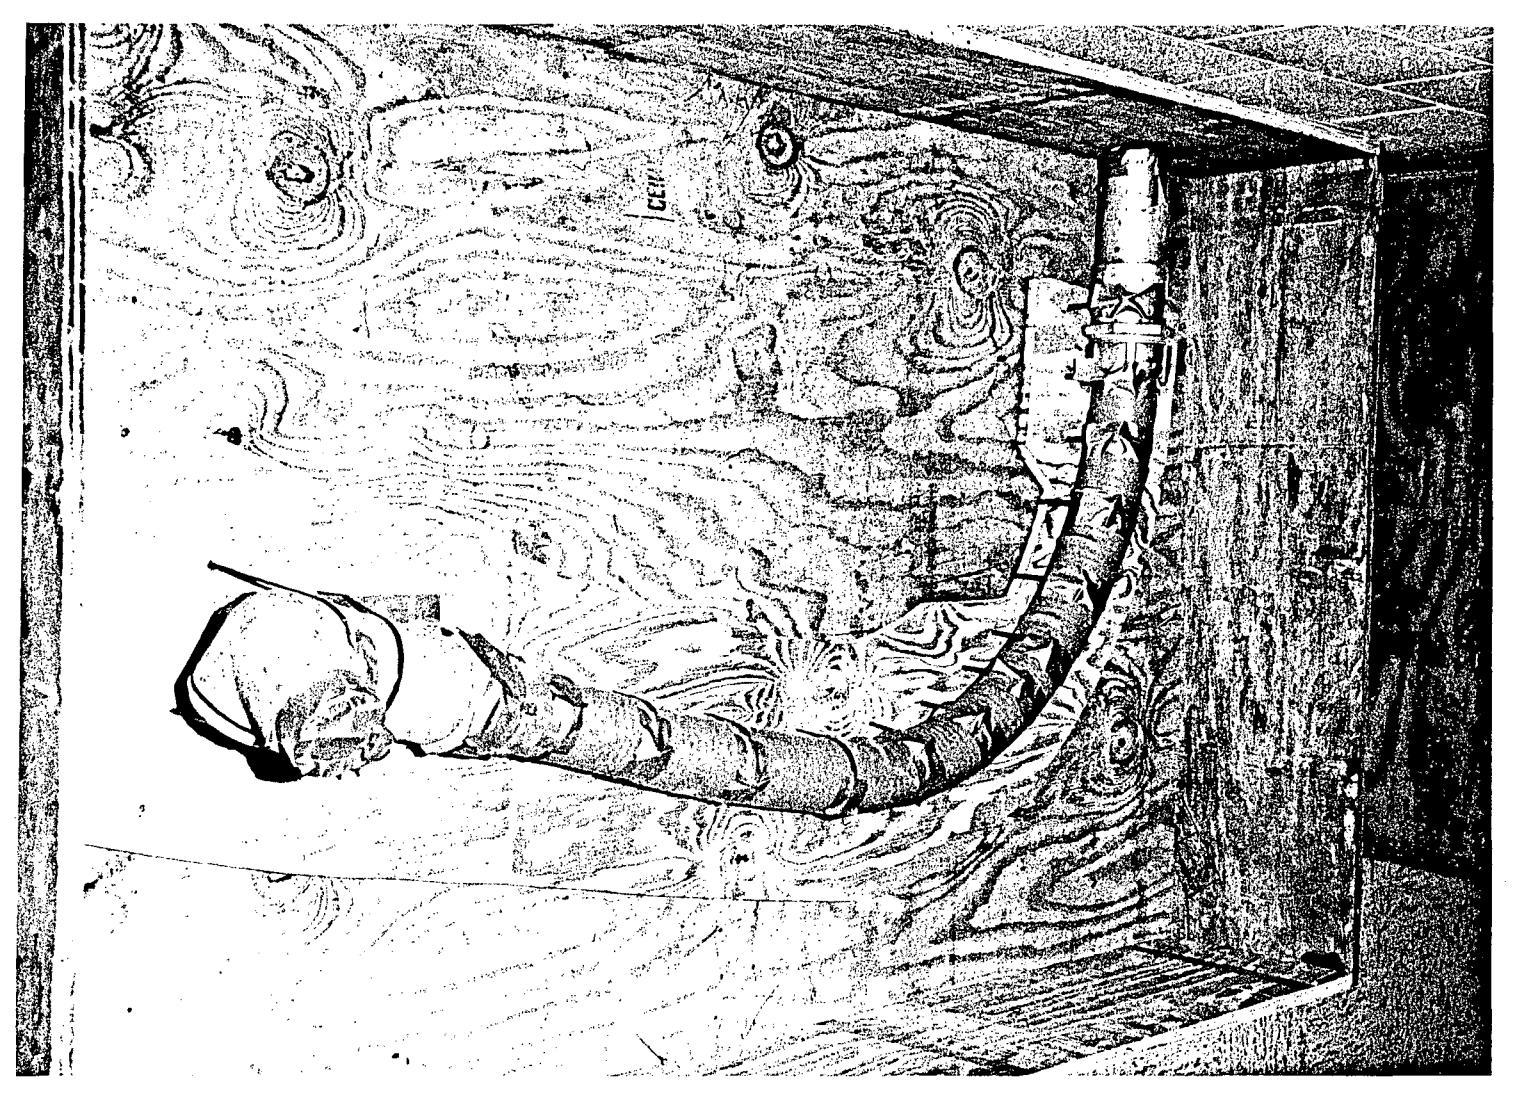
Figure 2 Flexible Conduit Strapped To Plywood Support In Order To Maintain Original Conformation

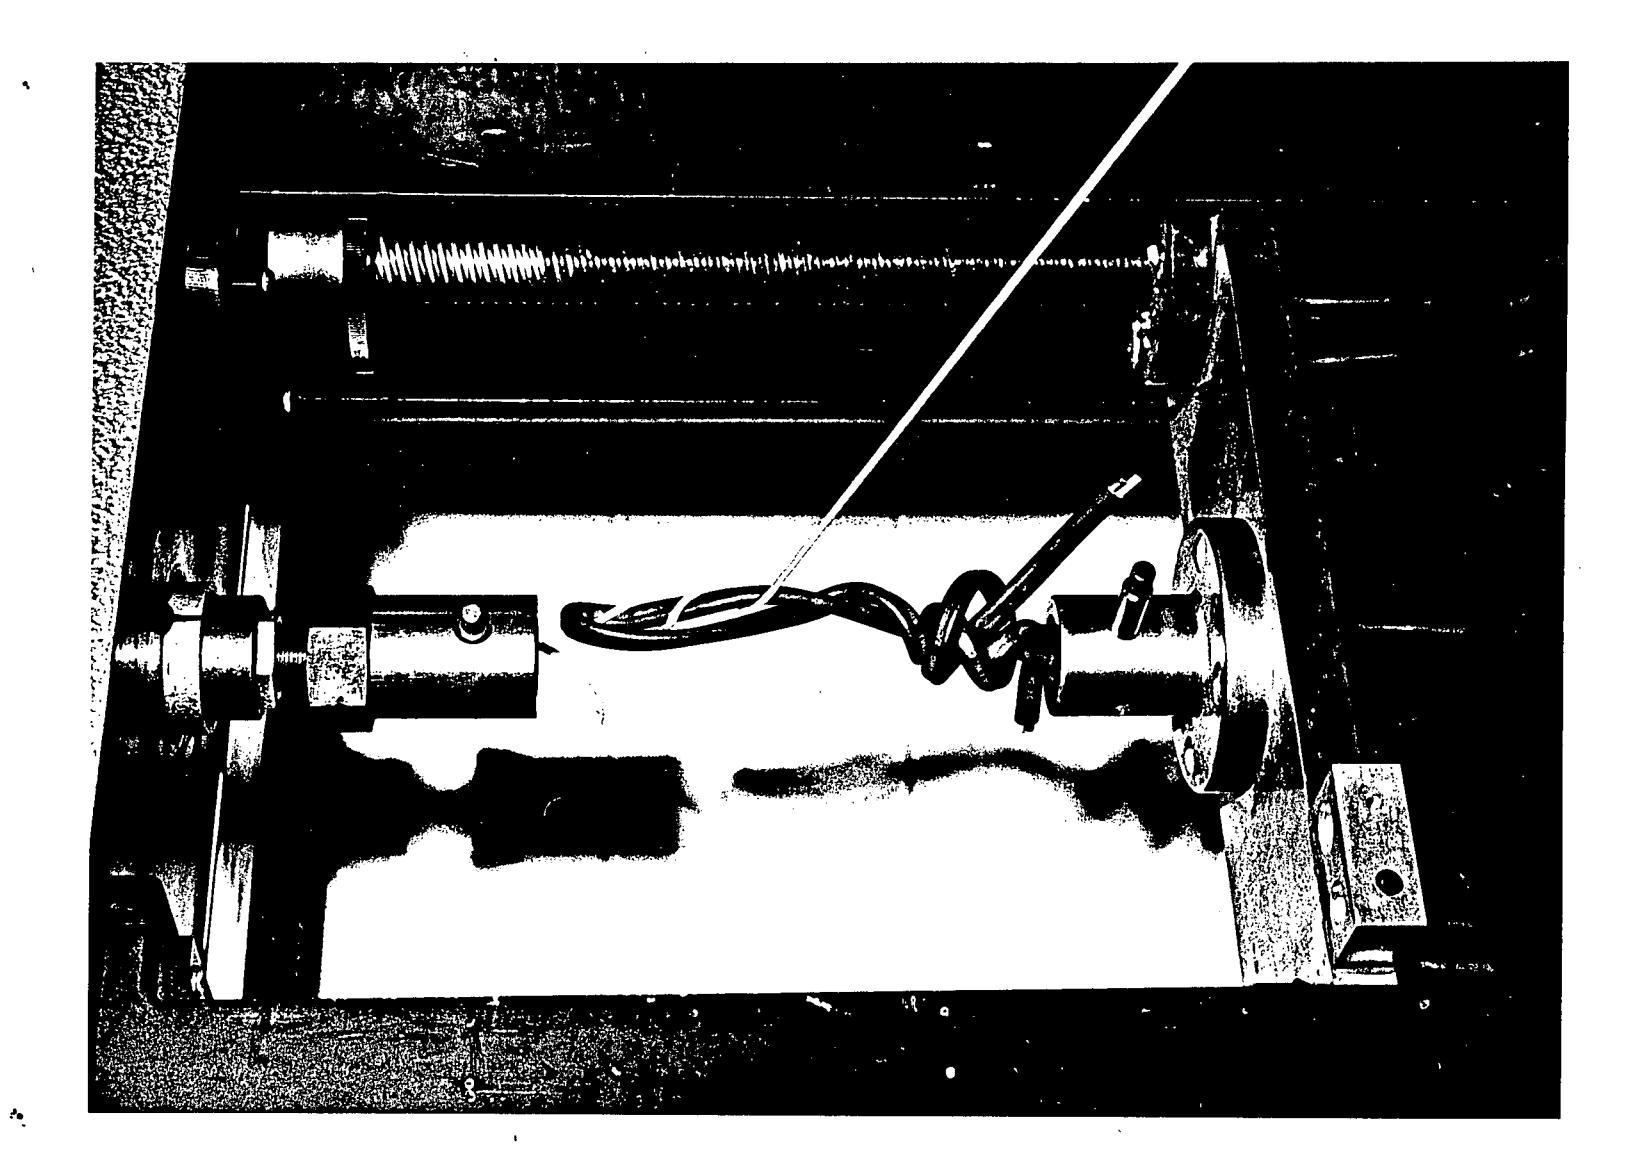
Figure 7 Pull-By Simulation Experiment with Parachute Cord Over 2-Conductor Cable

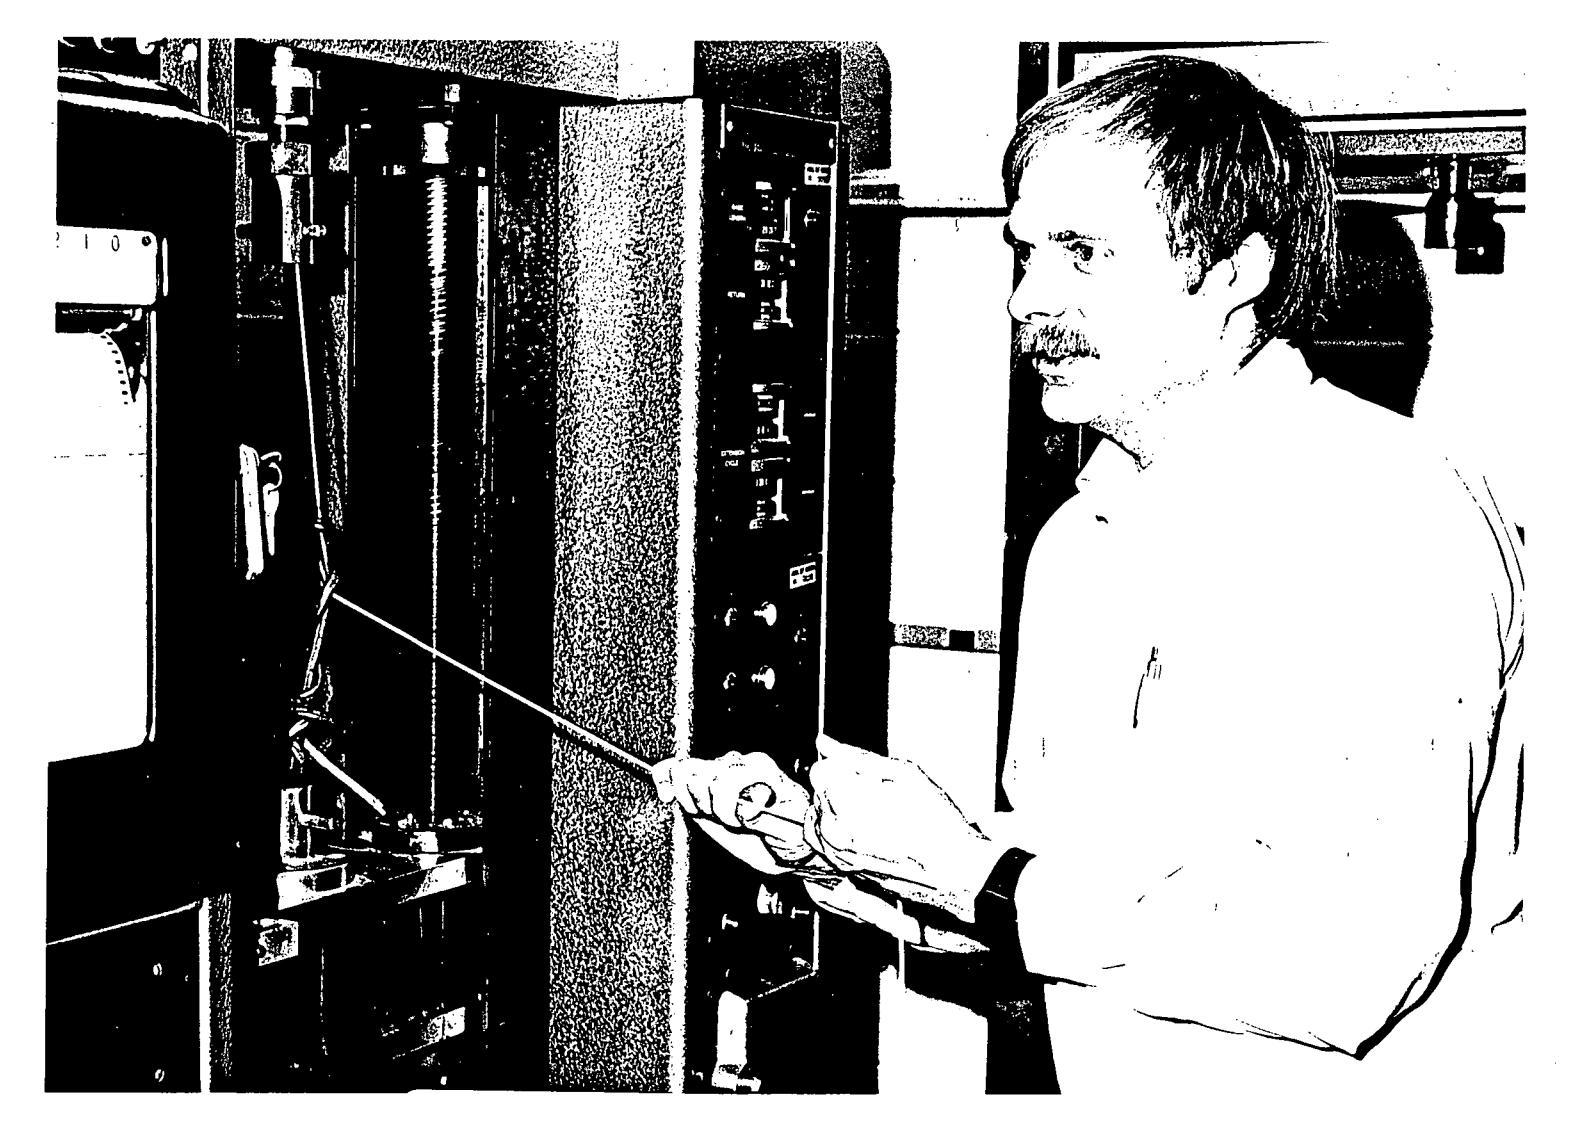
Figure 8 Pull-By Simulation In Progress- Parachute Cord Contacting 2-Conductor Cable

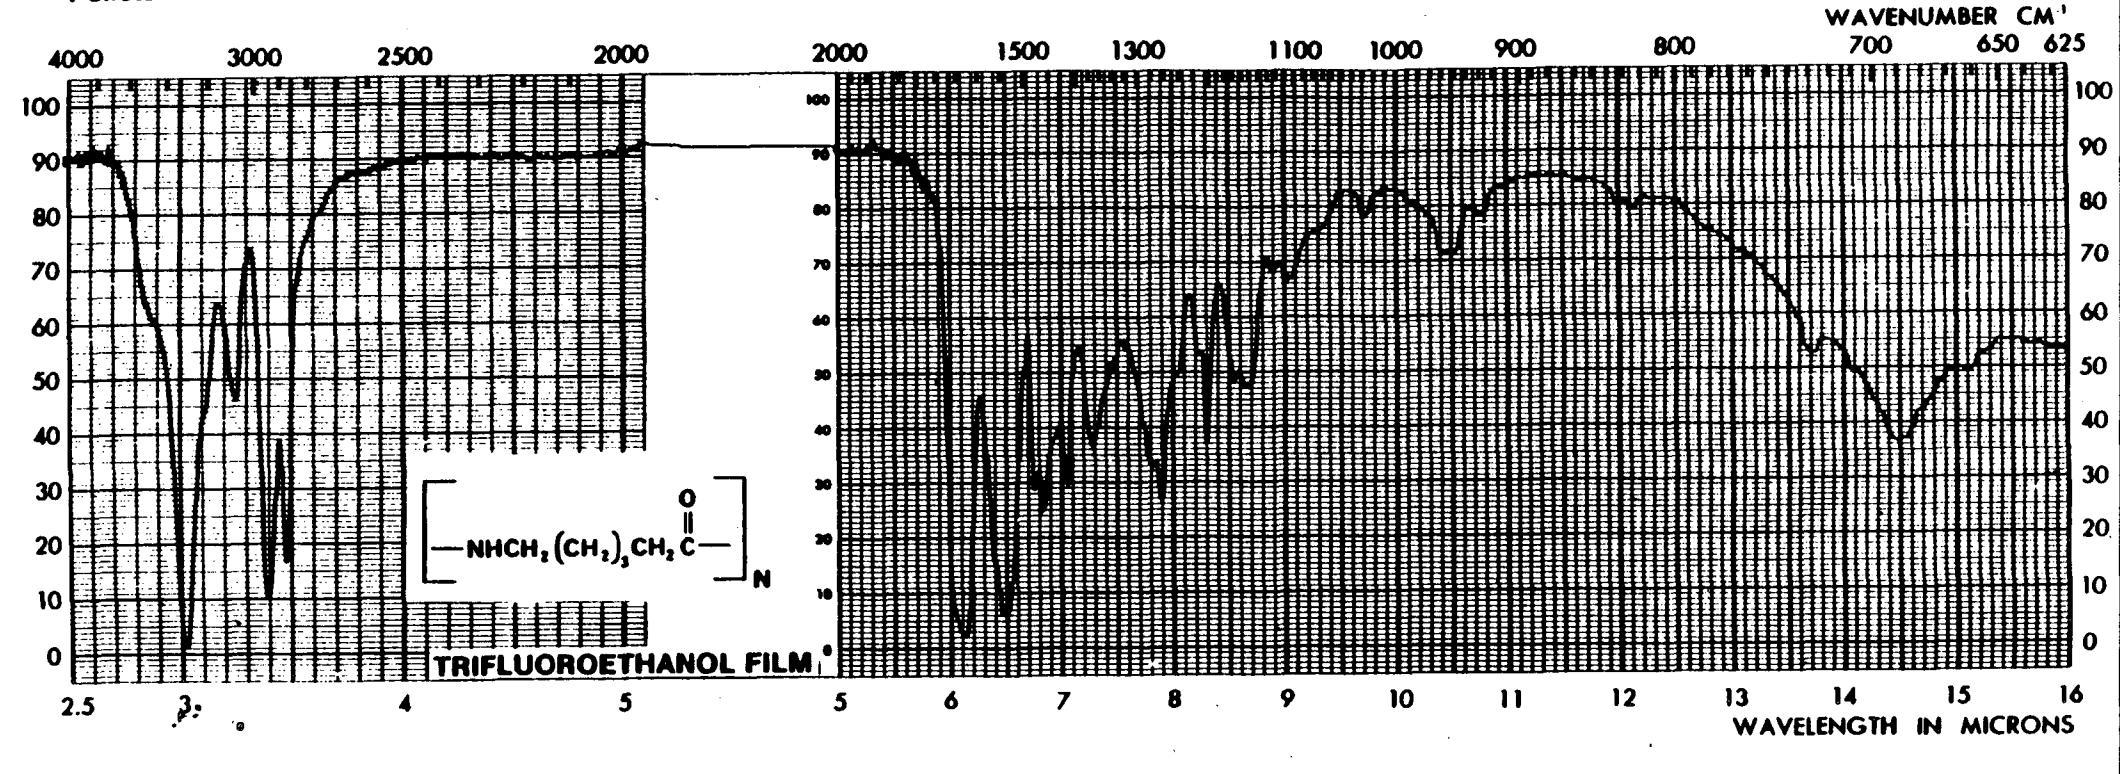
Small fibers of the parachute cord and pulling rope were removed for identification using the μ IR method. Figure 12 shows identical infrared spectra from two separate parachute cord fibers. Figure 13 is a spectrum for nylon 6,6, obtained from reference [1]. Figure 14 is the infrared spectrum from a fiber of the pull rope.

Figure 13 Infrared Spectrum from Reference [1] for Nylon 6

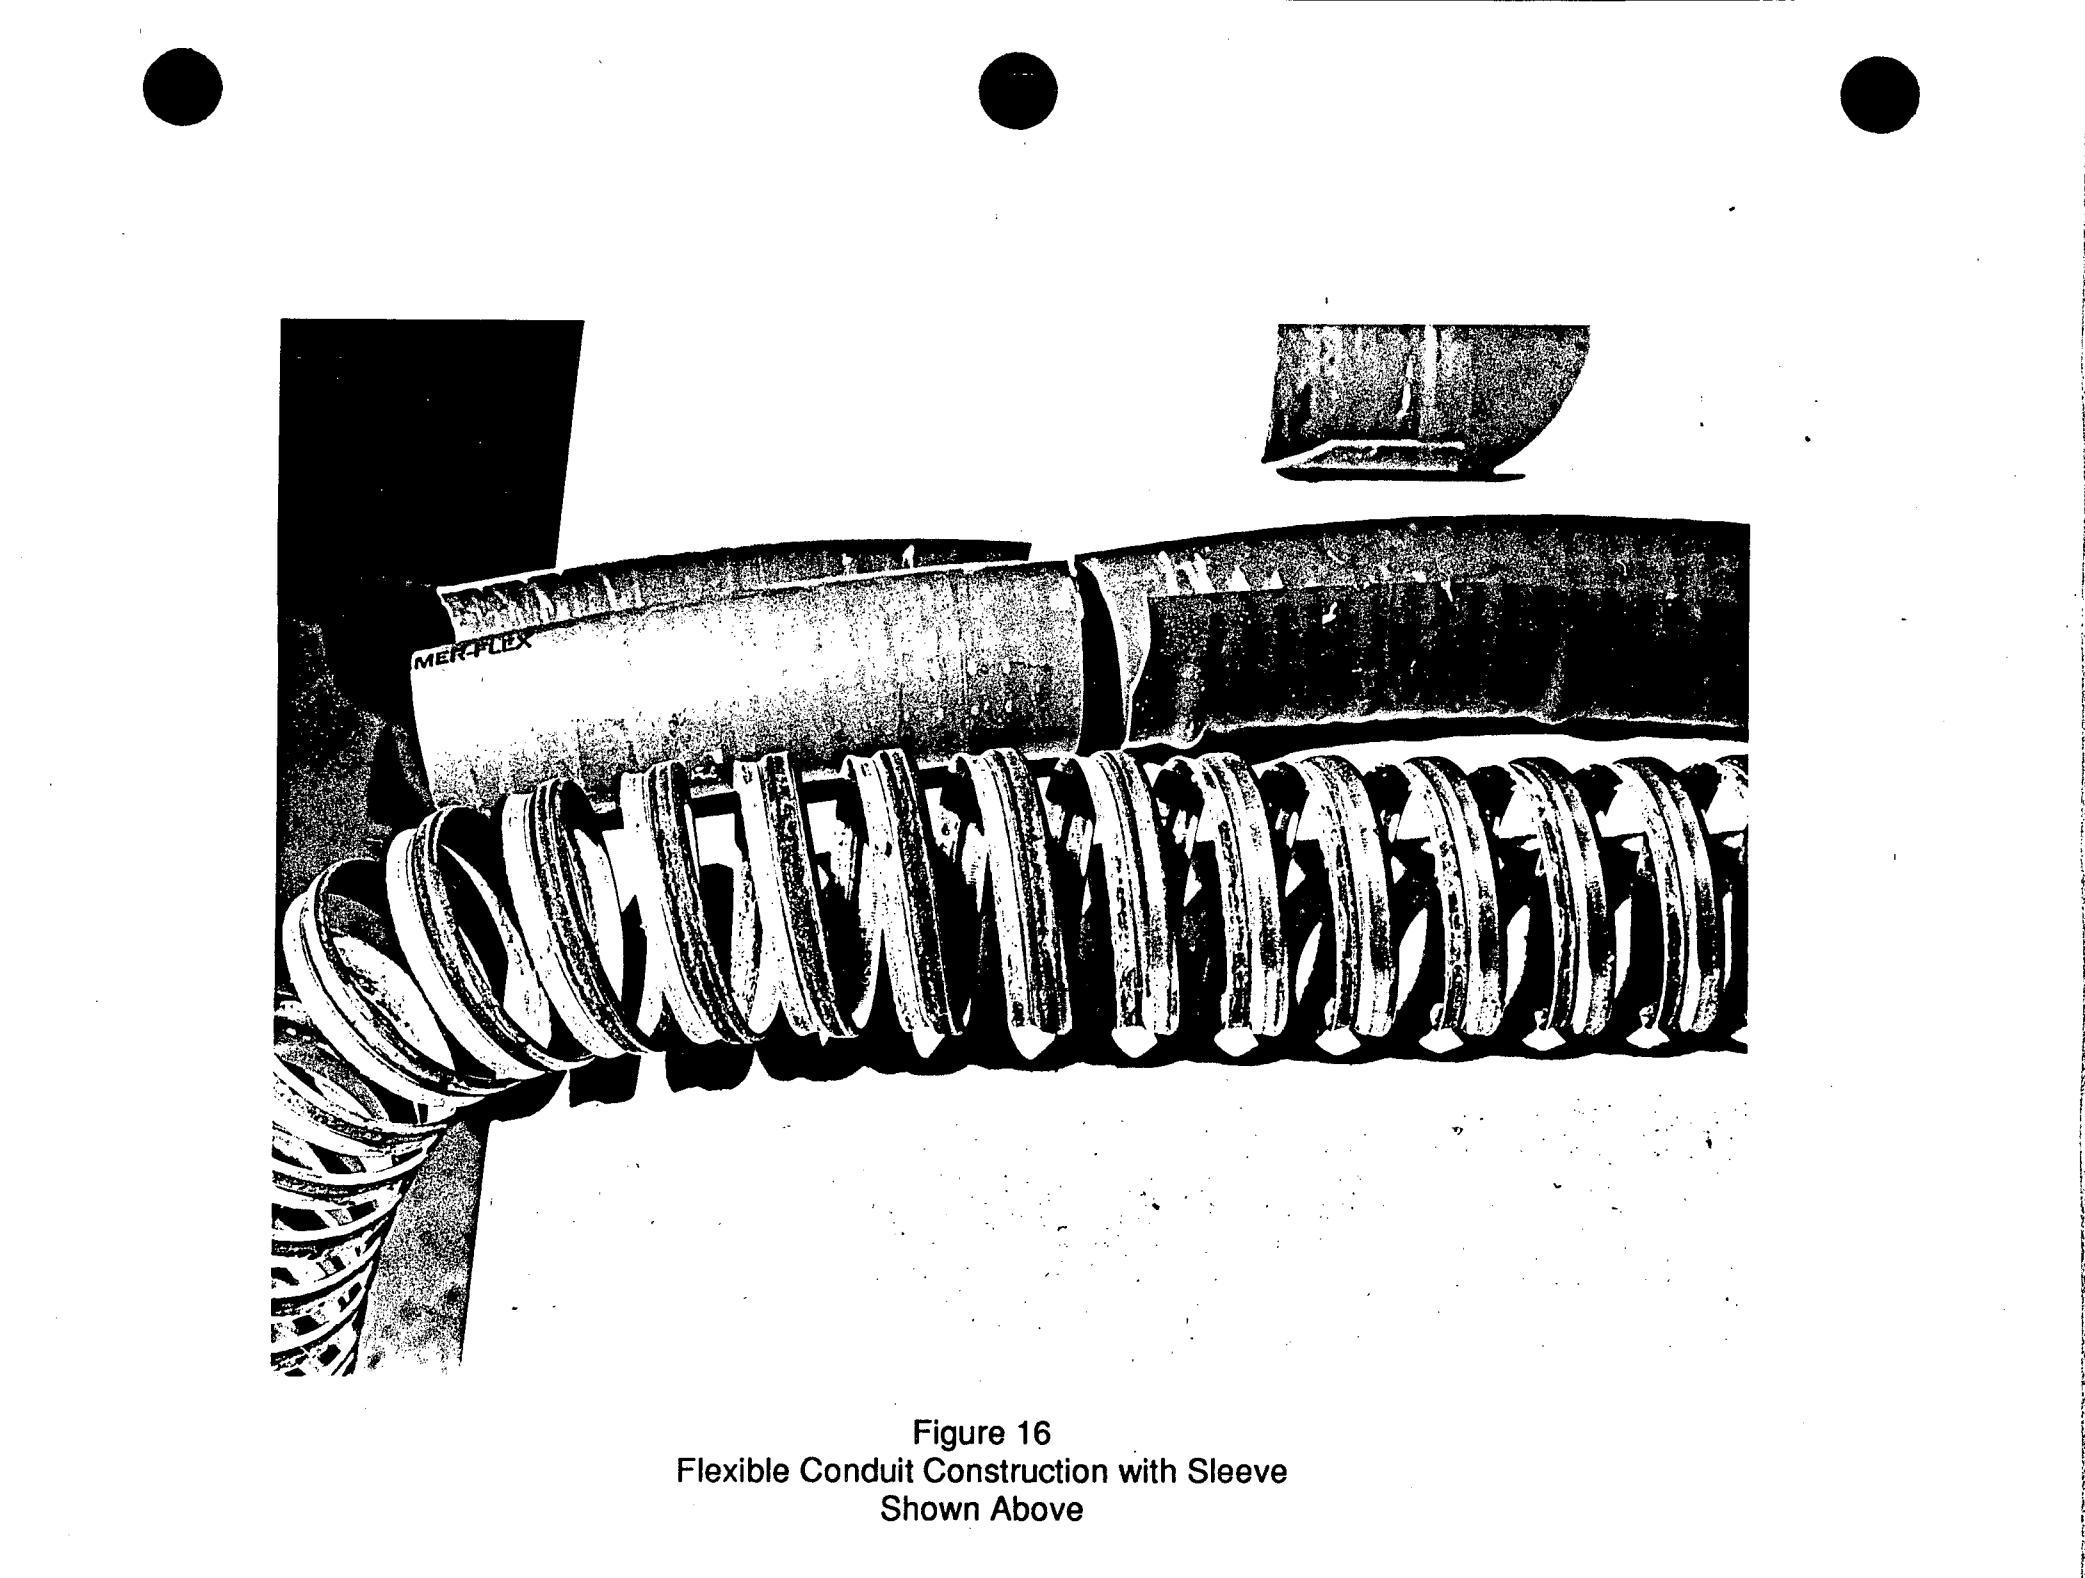
Though a significant amount of damage occurred to instrumentation cables located at the flexible conduit, as determined by TVA, little evidence for this was present in the form of transferred jacket material or jacket debris. The inner surface of the conduit is heavily corrugated, though it does not have a very sharp surface. Any debris produced by friction with the cable jackets may have been washed away when the conduit was flooded with pulling compound for purposes of removing the cables The outer and inner surfaces of the bend in the for inspection. conduit did exhibit some degree of surface polishing, indicating that the cables did preferentially contact these surfaces. Α simple hand rubbing of a CPE and a Hypalon[®] jacket over the surface of the conduit only produced a slight scuffing of either jacket, with no material transferred to the conduit. The only sharp area noted in the conduit was at the transition point shown in Figure 17.

Figure 17 Residue (Not Cable Jacket Material) At Transition Point At Felxible Conduit End

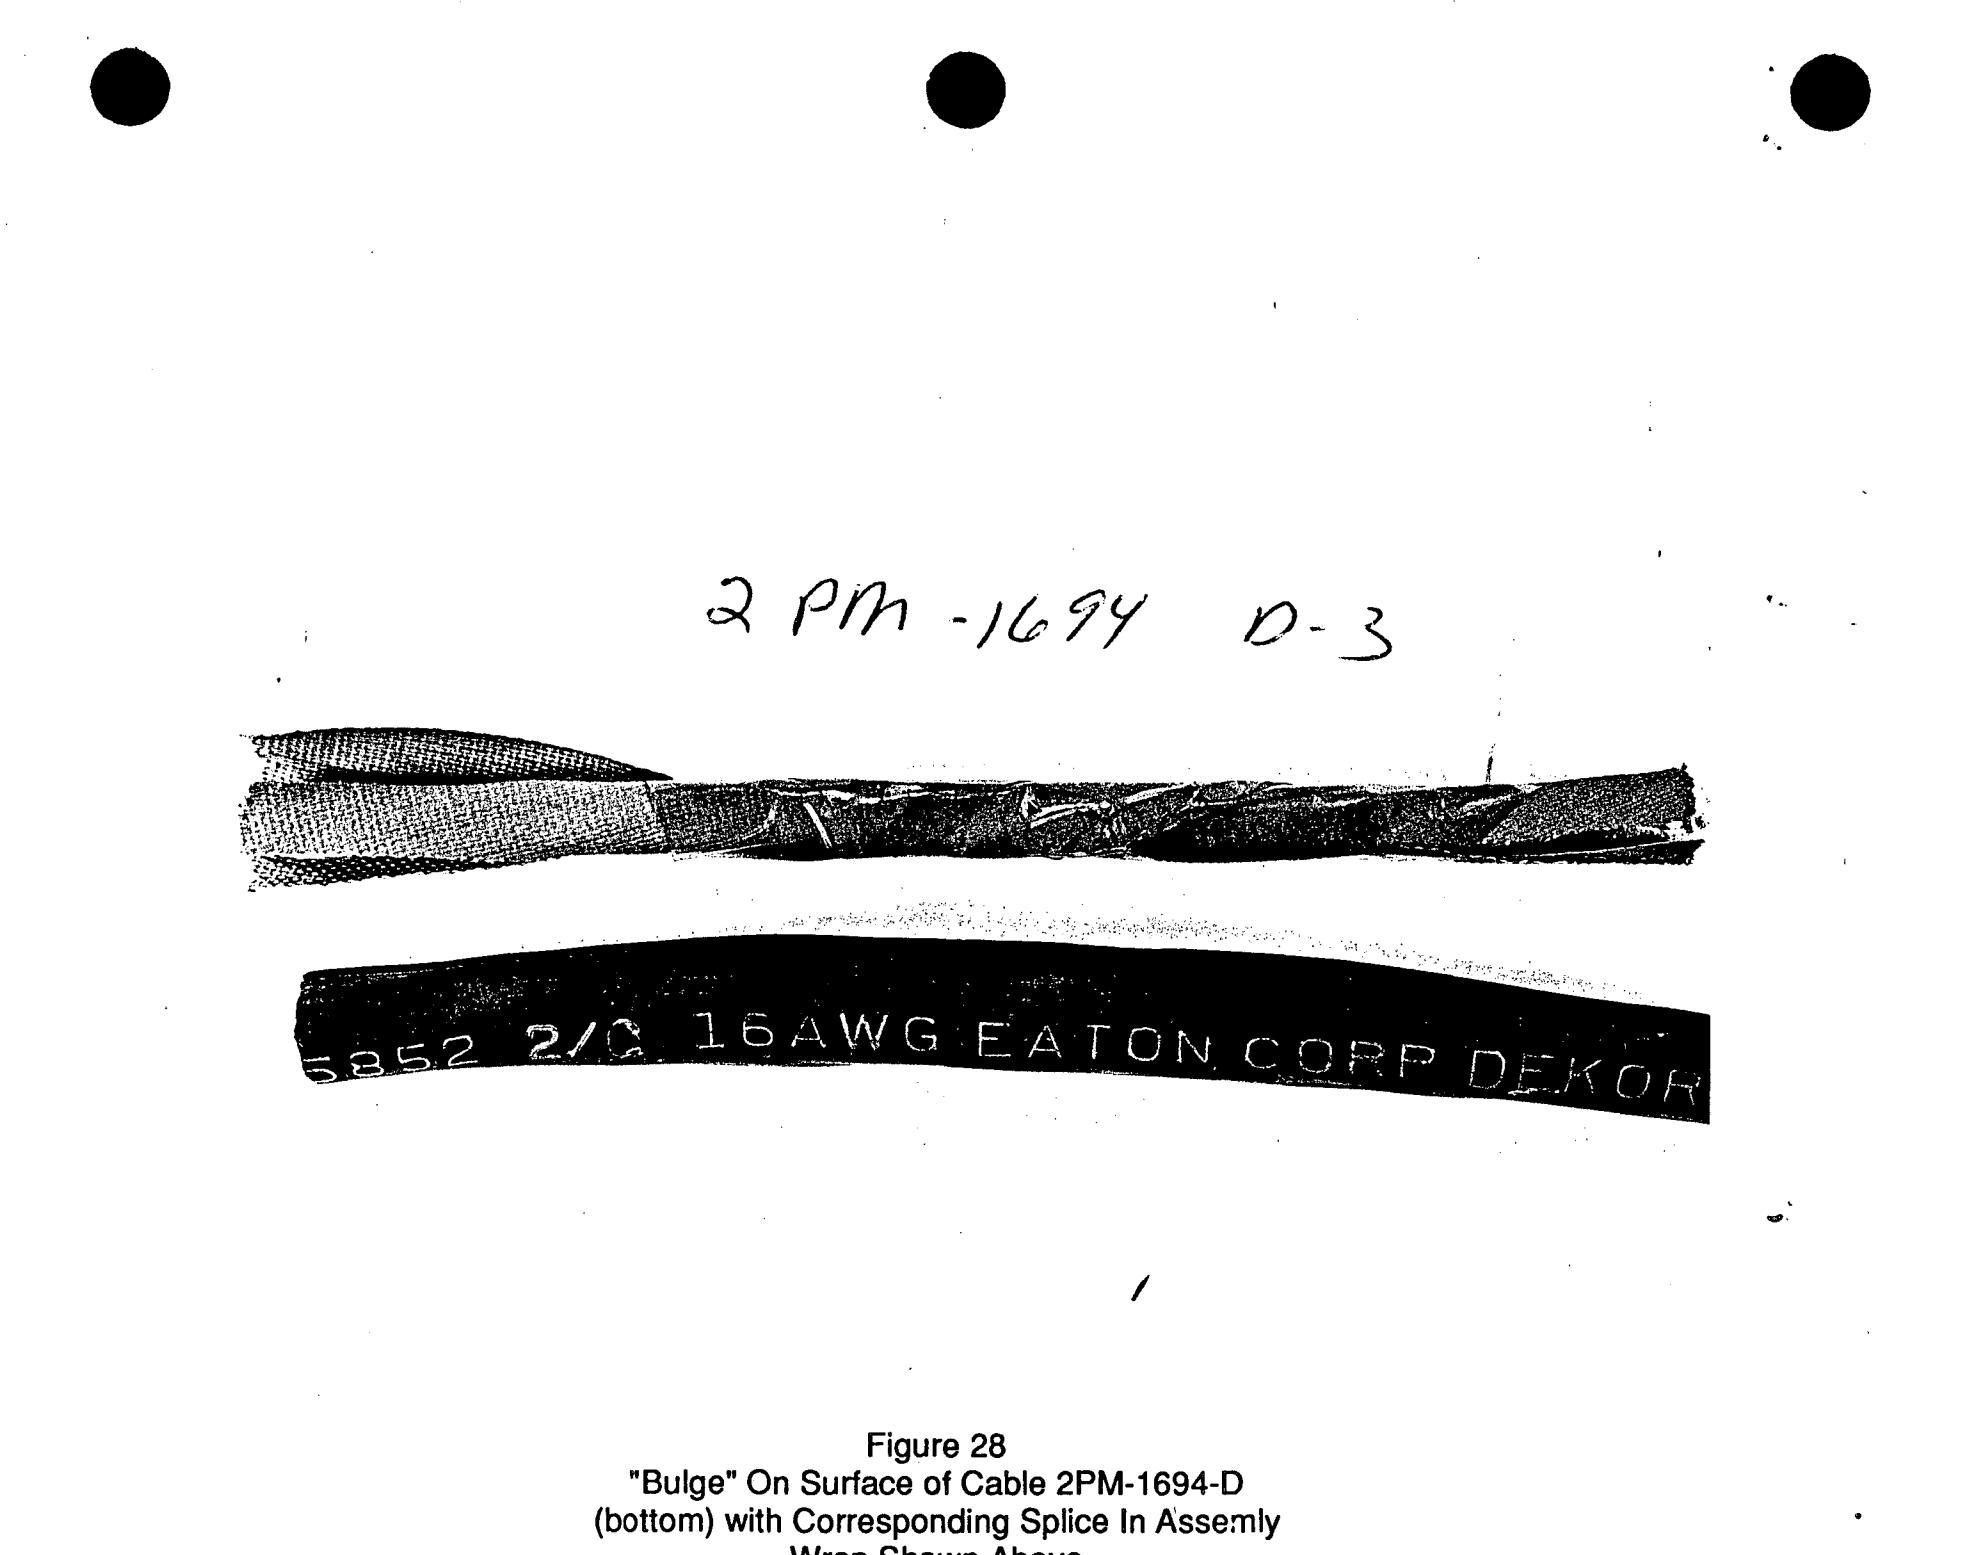
2 PM 1041 D-4

Figure 27 shows cable 2PM-4781-D and the corresponding "bulge" in its jacket. At the top of this figure, the splice in the assembly wrap is shown, including the black thread used to make the joint. This was found immediately under the "bulge". Figure 28 shows cable 2PM-1694-D with its jacket "bulge" at the bottom and the corresponding splice in its assembly wrap shown at the top of this figure. White thread was used to complete the Cable 2PM-1041-D (location 1) was found to contain a splice. similar "bulge" on the surface of its jacket, with a corresponding splice in the assembly wrap, also sewn with white thread. Figure 29 shows the "bulge" in the surface of cable 2PM-1041-D (location 2), with the corresponding joint in its assembly wrap shown at the top of this Figure. In this case, the joint was completed with a yellow Mylar tape. A cross-section through the jacket of the latter cable is shown in Figure 30. No anomalies were found in the wall of this jacket. X-radiographic inspection of the cables containing splices in their assembly wrap tapes disclosed that

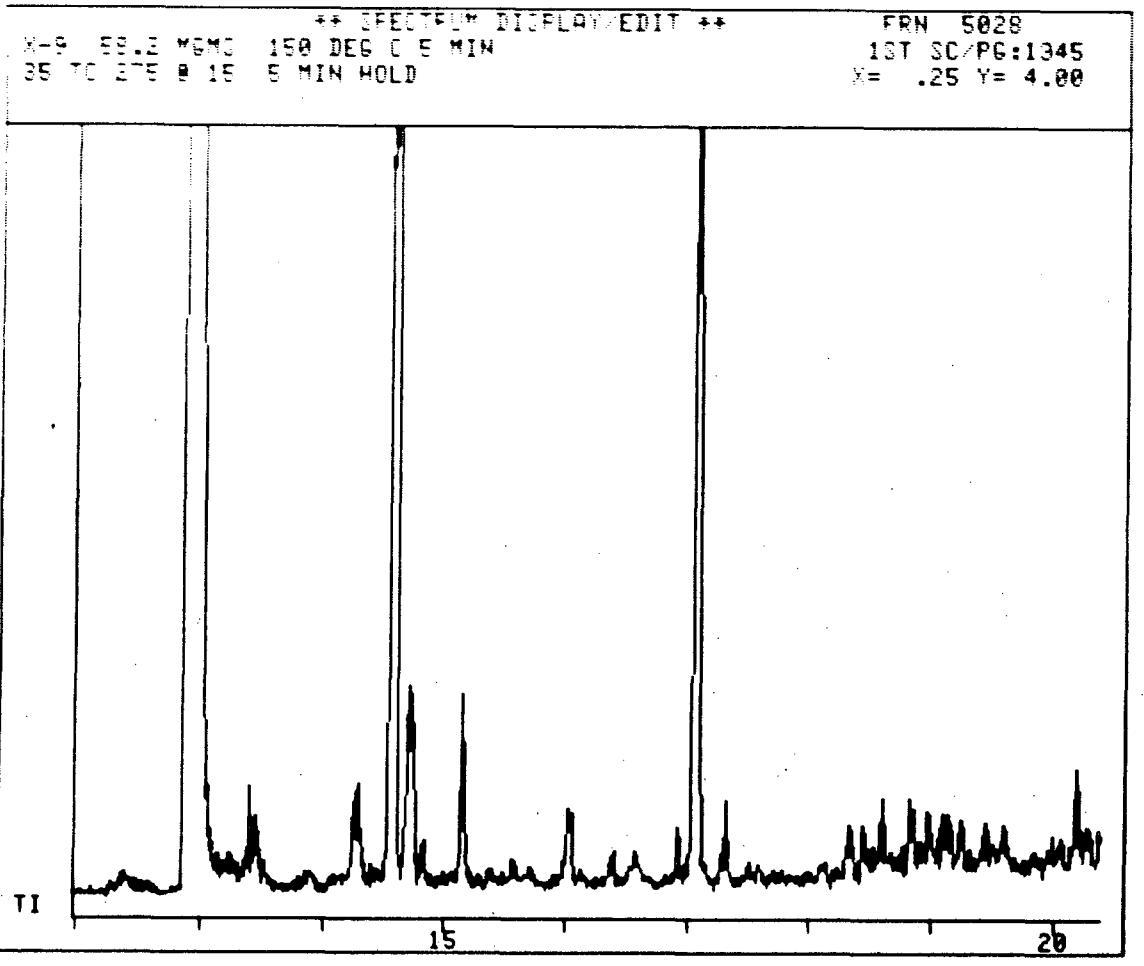
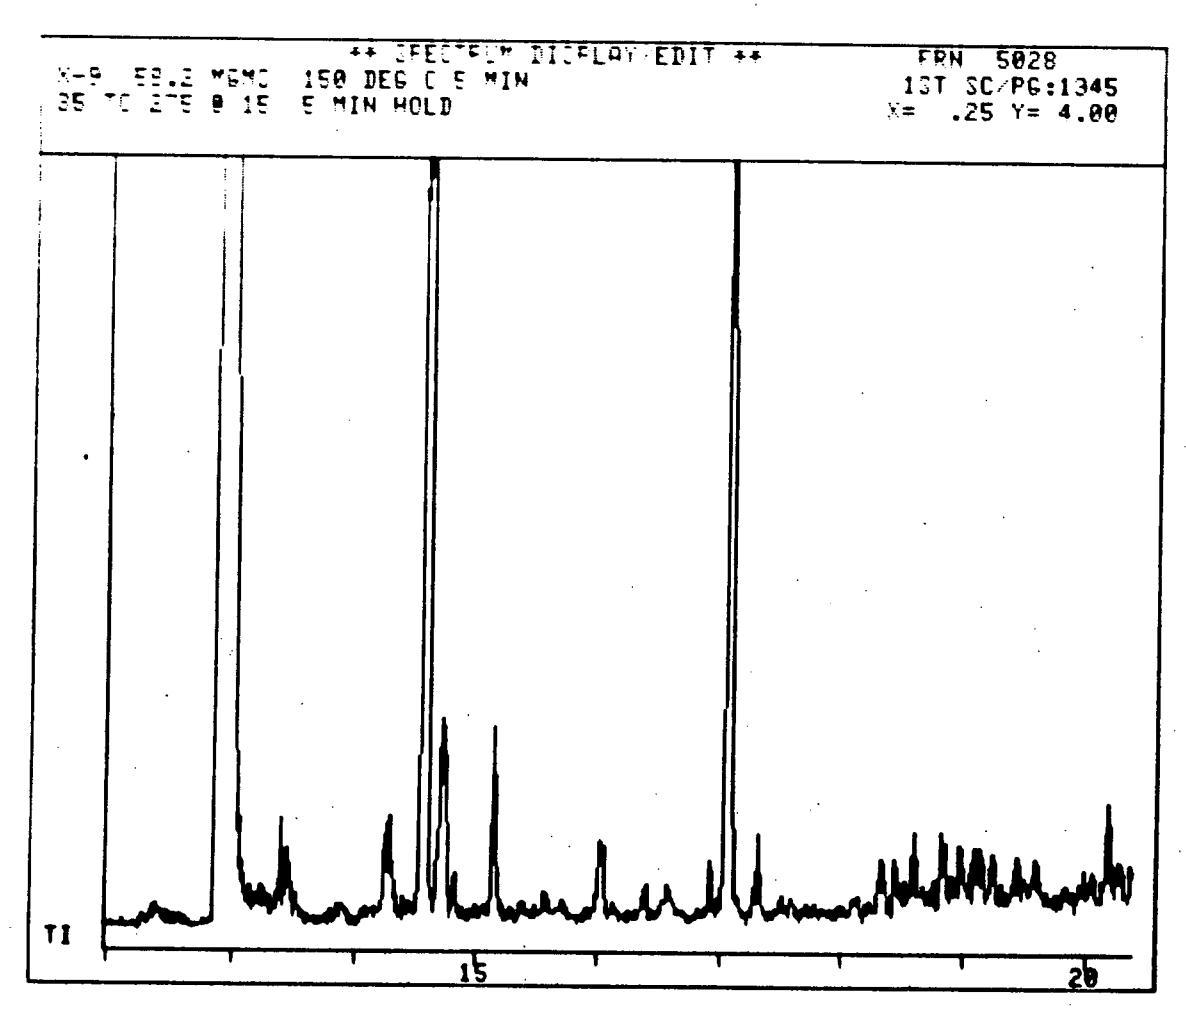
Gas chromatography/mass spectroscopy analysis of the jacket of cable 2V-2846-B, which contained visibly swollen areas, was conducted to identify the swelling agent(s). Figure 41 is the gas chromatogram of the swollen area of cable 2V-2846-B. The arrow indicates the only peak that did not appear when the non-swollen area of this jacket was similarly analyzed. Figure 42 shows the mass spectrum for the compound with a retention time of 15.9 minutes (indicated by the arrow in Figure 41). This mass spectrum was insufficient for a complete identification of the compound present, though some of its characteristics are similar to a glycol-containing compound. Figure 43 is the gas chromatogram for the non-swollen area of the jacket of cable X9. Figure 44 is the corresponding chromatogram for the swollen area. Again, a small difference is noted at approximately the same place as for cable 2V-2846-B. A complete analysis of this compound was not possible, due to its low concentration.

Figure 43 Gas Chromatogram of Non-Swollen Area of Cable Jacket X-9
