# TENNESSEE VALLEY AUTHORITY

## SEQUOYAH NUCLEAR PLANT

## ISOLATED PHASE BUS FAILURE REPORT

JANUARY 19, 1982 THROUGH FEBRUARY 8, 1982

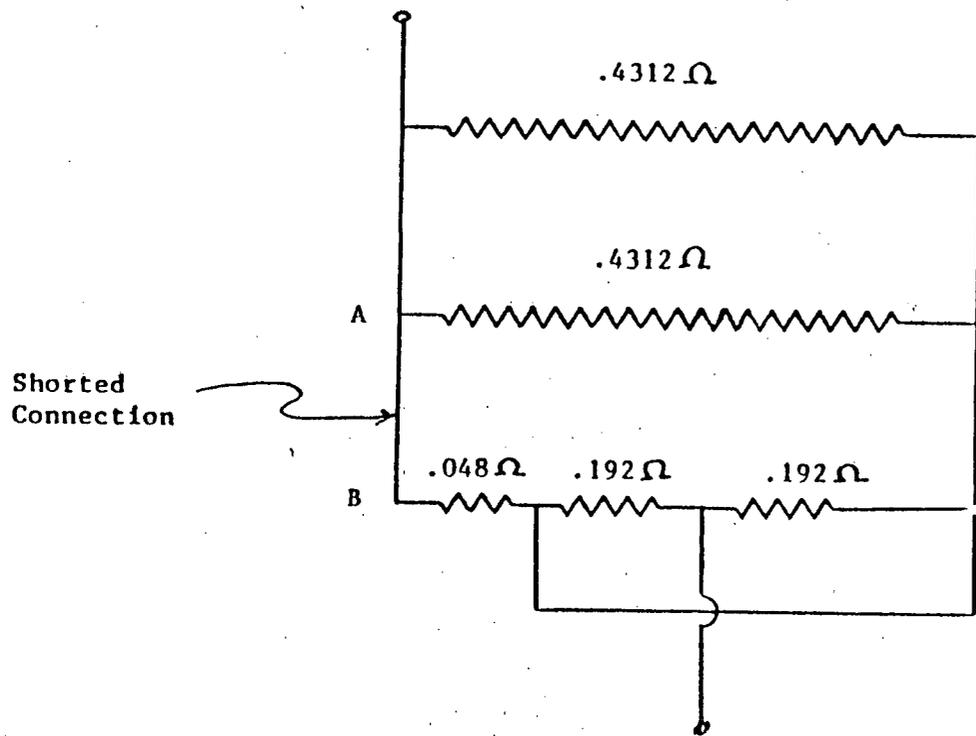
Figure 2. Neutral Overvoltage Relay Protective Circuit (a) ac schematic (b) dc schematic

Value measured with  
A to B shorted is 0.141 ohms

Value calculated with  
A to B open is 0.3116

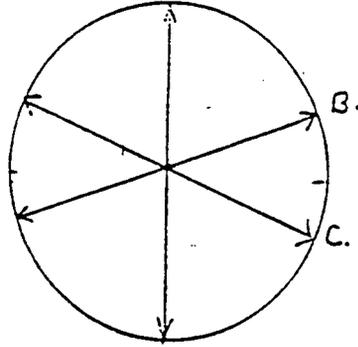
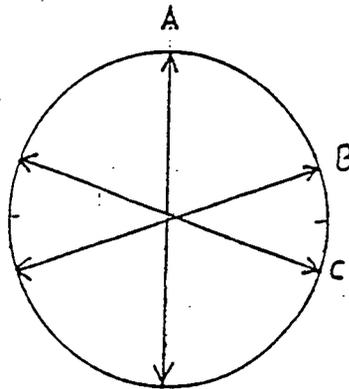
Unit 1/

A	27.952	AV.	27.95
B	27.949		
C	27.942		
SHAFT		27.942	
Clearance		.009

A	27.954	AV	27.94
B	27.941		
C	27.940		
SHAFT		27.938	
Clearance		.007

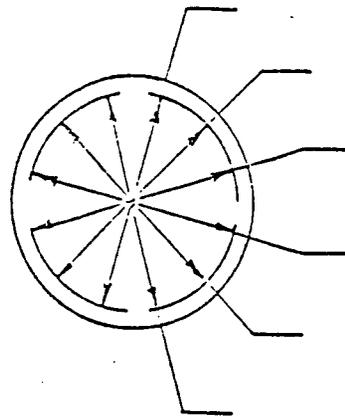
Exciter Bearing - Unit 1  
Bearing Clearances  
Date 1/31/82

Average Bearing id 14.023  
Average Shaft od 13.999  
Clearance .024  
Lead Check AV. 025  
Adjusted AV. 020

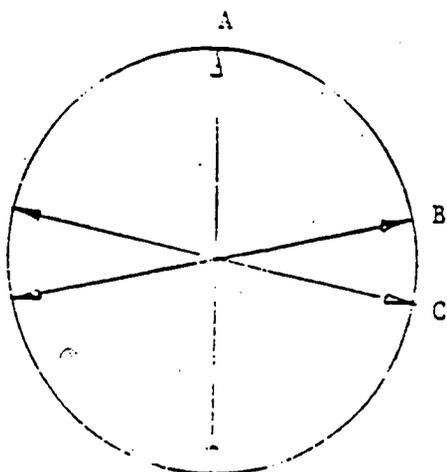
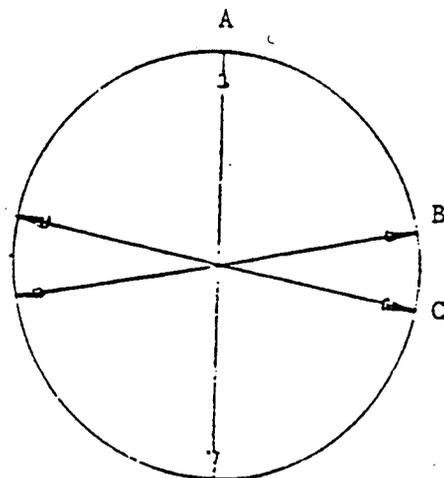
UNIT 1 TURBINE  
 CHECKED BY ED WALKER  
 DATE 1-25-82  
 ITEM  
 NAME #9 BEARING

A 27.988  
 B 27.995  
 C 27.999  
 AVERAGE 27.9945  
 (A+B+C/3)  
 SHAFT 27.941  
 CLEARANCE .0535

A 27.989  
 B 27.998  
 C 27.999  
 AVERAGE 27.995  
 (A+B+C/3)  
 SHAFT 27.942  
 CLEARANCE .053

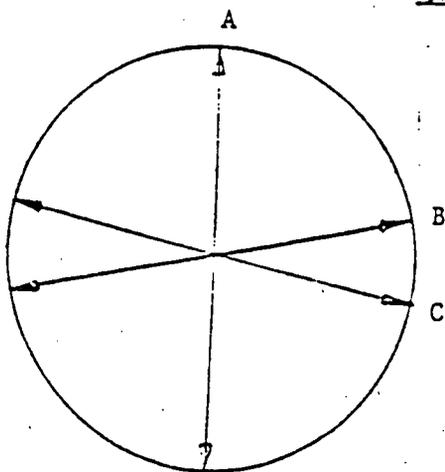
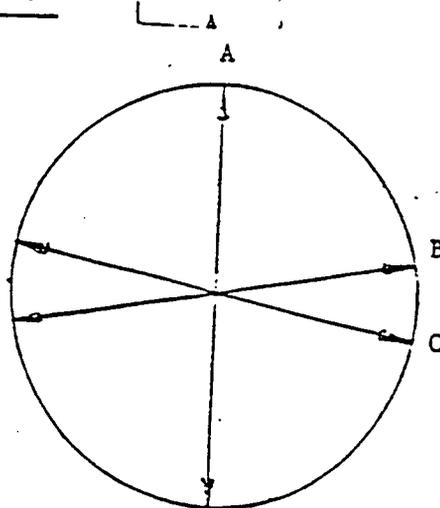
ITEM #10 BEARING  
 DATE 1-26-82

A 27.9915  
 B 27.995  
 C 27.999  
 AVERAGE 27.9952  
 (A+B+C/3)  
 SHAFT 27.9372  
 CLEARANCE .058

A 27.991  
 B 27.9965  
 C 27.9905  
 AVERAGE 27.9952  
 (A+B+C/3)  
 SHAFT 27.940  
 CLEARANCE .0552
