Special Report to the Tennessee Valley Authority

**Evaluation and Testing of Cables Removed from Watts Bar
and
Browns Ferry Nuclear Plants**

TVA Contract TV-82820V

prepared by:
The Electrical Insulation Research Center
University of Connecticut
Institute of Materials Science
Storrs, CT 06269-3136

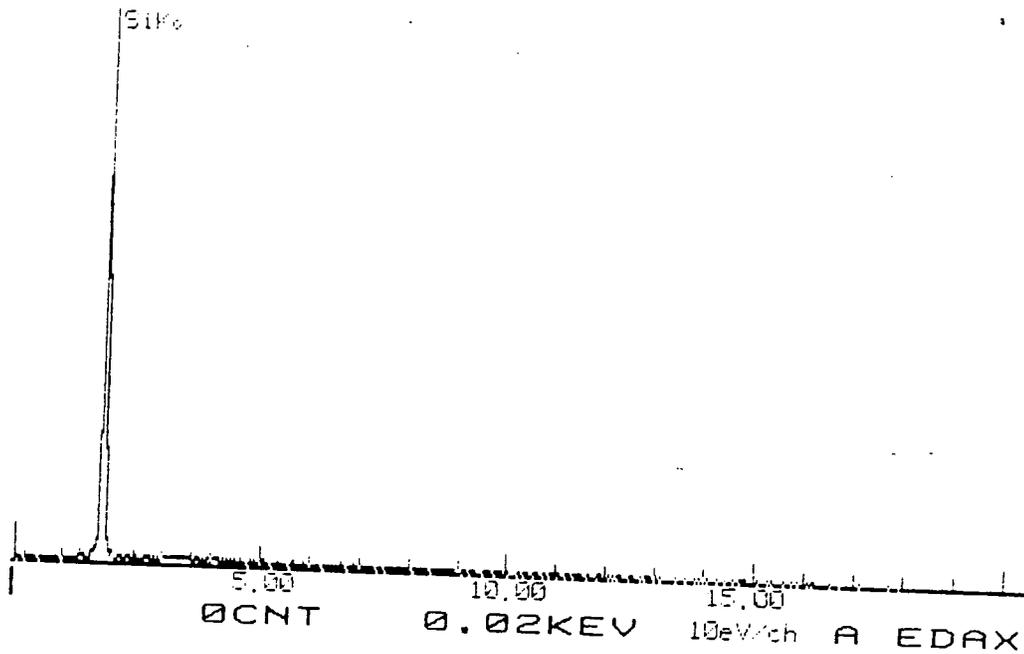
number of atypically large particles of inorganic materials. As noted in Table 7, the white particles consisted of silicon and the gray particles contained aluminum, silicon, antimony (Sb), with, in some cases, copper (Cu) and titanium (Ti). Figures 23 and 24 are X-ray analysis spectra corresponding to white particles from the fault site of cable 1PM2445B and a gray-black particle from the insulation at the fault site of the same cable, respectively. It should be noted that silicon, aluminum, titanium, and copper are all most likely present as oxides. This conclusion is based on the optical characteristics of these materials. The X-ray emission spectroscopy method used for the bulk of the particle analyses is not capable of detecting oxygen. Antimony, chlorine, and bromine are components of the flame retardant system in these cables, as described by the manufacturer, whose technical representative was present when these analyses were conducted. Titanium is an ingredient of many colorant systems used to color-code conductors. The source of silicon has not been unequivocally determined. The manufacturer stated that this is not a normal ingredient of the insulation system and this was verified based on analysis of the insulations, as cited in Table 7 and shown in the X-ray analysis spectrum corresponding to a non-pyrolized area of the insulation from cable 2V1011B, as shown in Figure 25. Copper found in the fault sites is presumed to have originated from evaporation of the copper conductor during the electrical discharge event. X-ray spectra not presented in this report will be provided to TVA.

Figure 23. X-ray Analysis Spectrum Showing the Composition of a Large White Particle Removed from the Insulation at the Fault Site of Cable 1PM2445B

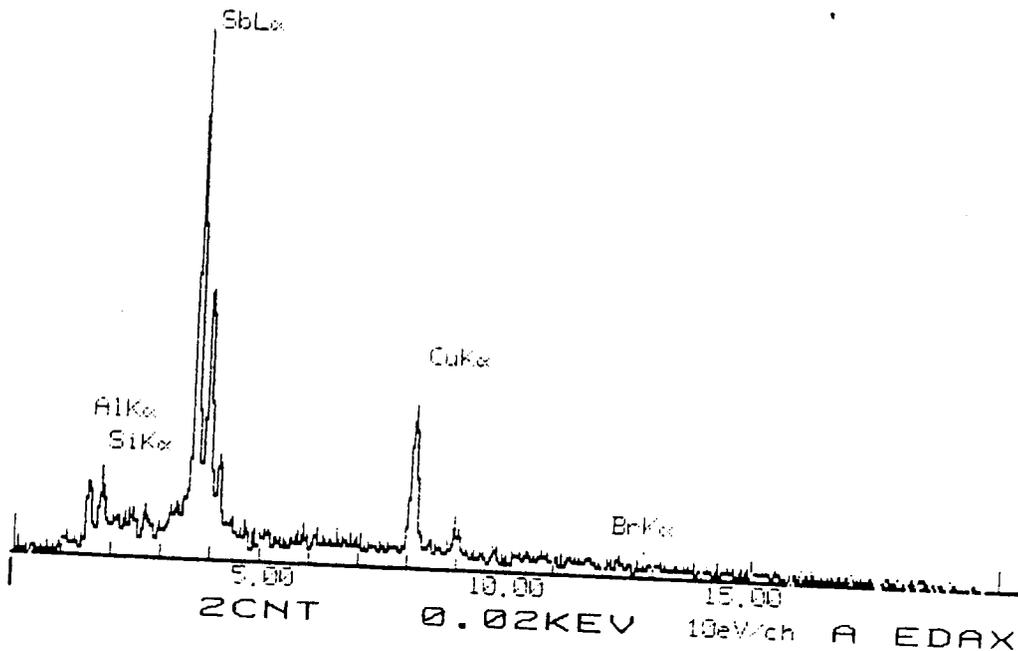
Figure 24. X-ray Analysis Spectrum Showing the Composition of a Large Gray-Black Particle Removed from the Insulation at the Fault Site of Cable 1PM2445B

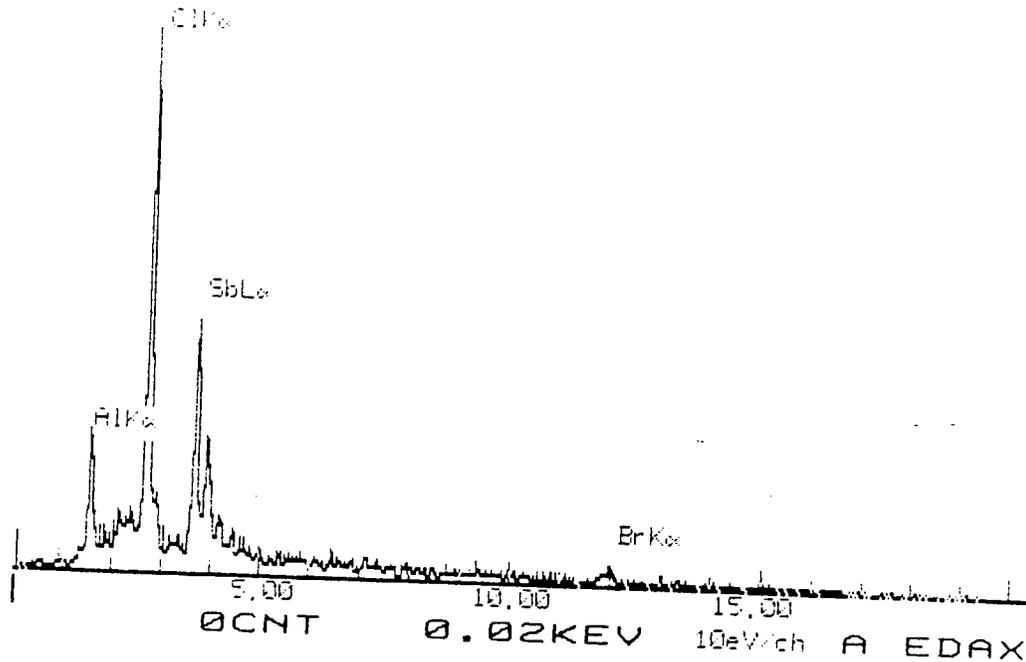
Figure 25. X-Ray Analysis Spectrum Showing the Composition of Non-Pyrolized Insulation from Cable 2V1011B

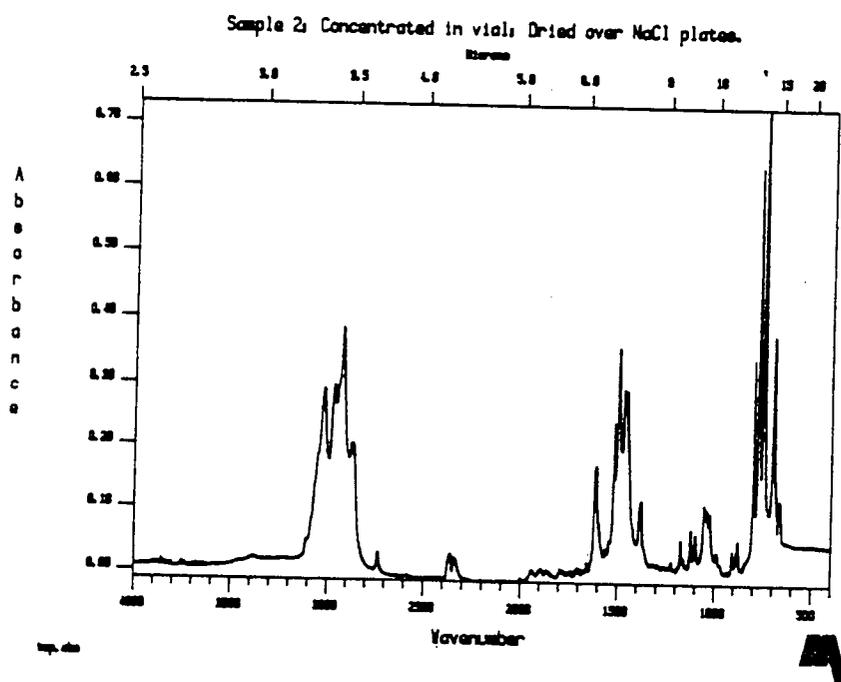
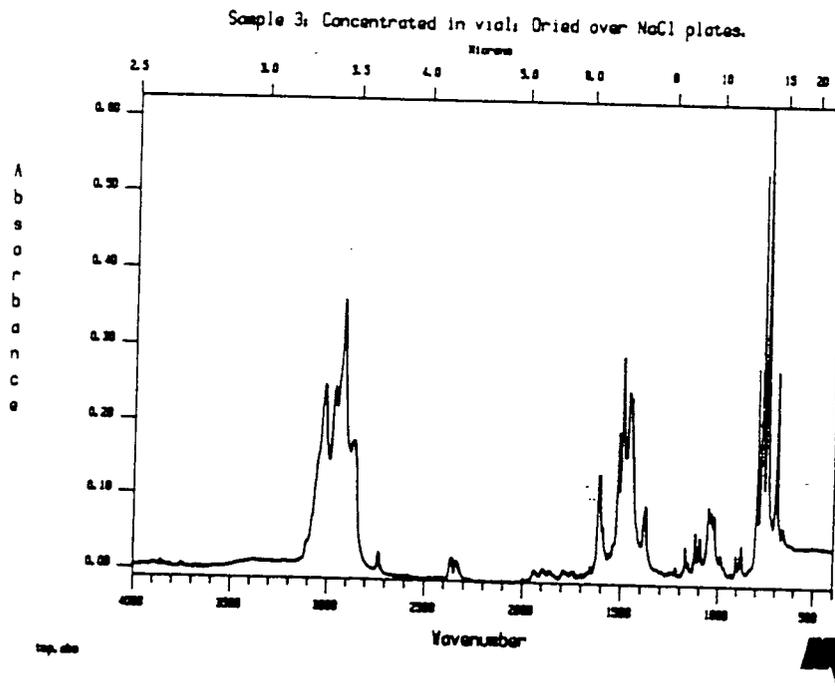
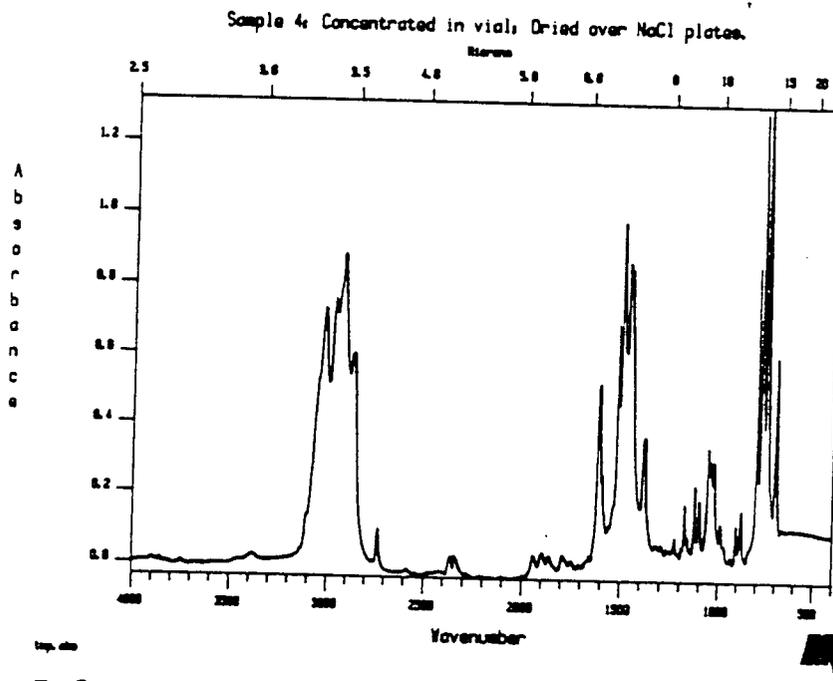
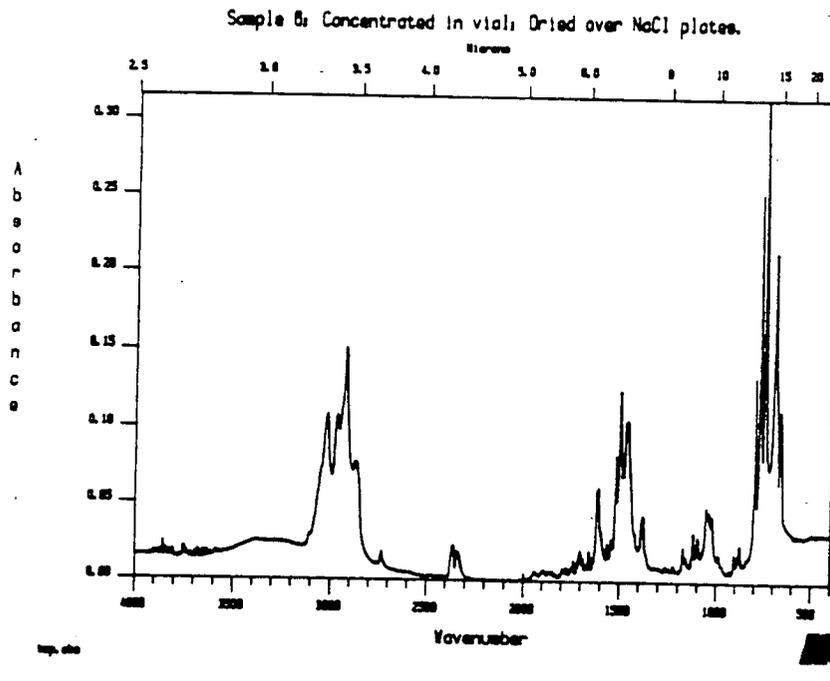
Figures 29 and 30 are infrared spectra corresponding to the insulations from cables 1PM2485B and 1PM2445B, respectively. When compared to Figure 31, a reference spectrum of pure polyethylene, it is apparent that the spectra in Figures 28 through 30 also show only polyethylene present. Spectra obtained from the insulation extractables of cable 1PM2080B were identical to those shown in Figures 28 through 30. Figure 31 is the infrared spectrum obtained from the solvent-extracted materials from the insulation of a cable manufactured under contract 79K5-824279-1. The spectrum from the insulation extractables of a cable manufactured under contract 82K5-830040-2 showed identical characteristics. Overall, the insulations from various vintages showed identical chemical characteristics and no anomalous ingredients were found near the fault sites of those cables that failed during testing.

Figure 28. Infrared Spectrum of Solvent-Extracted Materials from the Insulation of Cable 2V1011B

Figure 29. Infrared Spectrum of Solvent-Extracted Materials from the Insulation of Cable 1PM2485B

Figure 30. Infrared Spectrum of Solvent-Extracted Materials from the Insulation of Cable 1PM2445B

Figure 31. Infrared Spectrum of Solvent-Extracted Materials from Reference Specimen of Pure Polyethylene

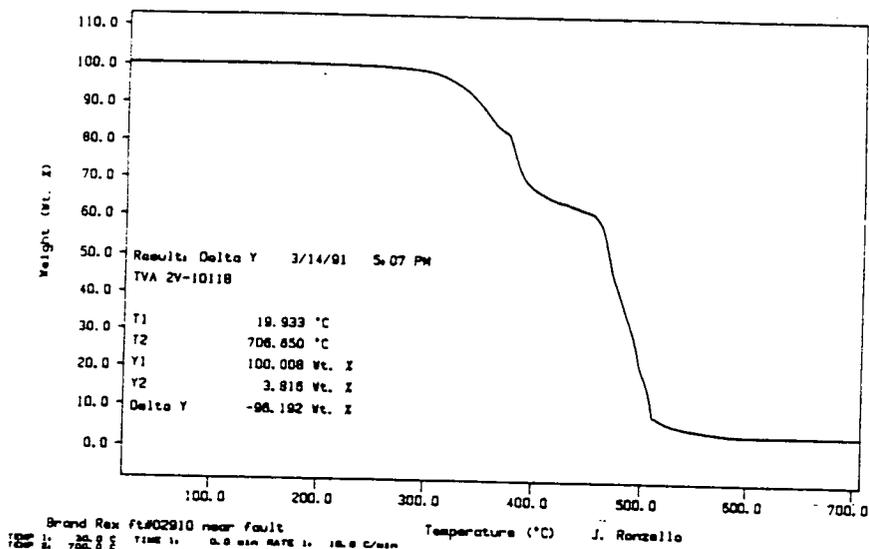
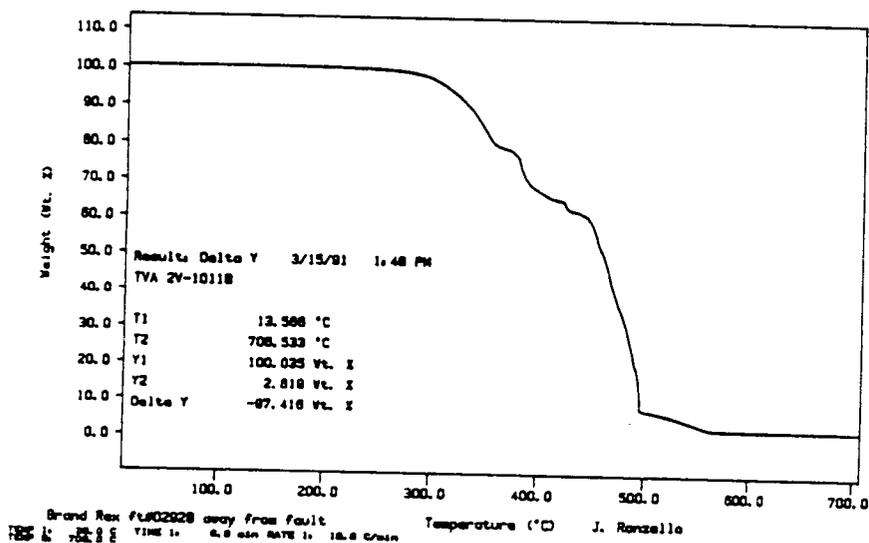
Thermogravimetric analysis of the insulations from the cables that failed during in-situ testing exhibited the weight loss vs. temperature characteristics shown in Figure 33 corresponding to cable 2V1011B, near the fault site. Figure 34 is a thermogram for the insulation of this cable away from the fault site. The two thermograms compare point-to-point with a high degree of correlation. Figure 35 shows the weight loss vs. temperature characteristics for the insulation of cable 1PM2445B near the fault site. The TGA scan for this cable away from the fault site is shown in Figure 36. The TGA scans for the insulations of cables 1PM2485B and 1PM2080B were almost identical to those shown in Figures 33 through 36, whether near or away from the fault sites. Figures 37 and 38 show the weight loss vs. temperature characteristics for the insulations of cables supplied under contacts 79K5-824279-1 and 82K5-830040-2, respectively. These results indicate that there are no detectable formulation differences between the various vintages of cable insulations and that no formulation anomalies are associated with the fault areas of the cables that failed during in-situ testing.

Figure 33. TGA Scan Showing Weight Loss vs. Temperature Characteristics of the Insulation from Cable 2V1011B, Near the Fault Site

Figure 34. TGA Scan Showing Weight Loss vs. Temperature Characteristics of the Insulation from Cable 2V1011B, Away from the Fault Site

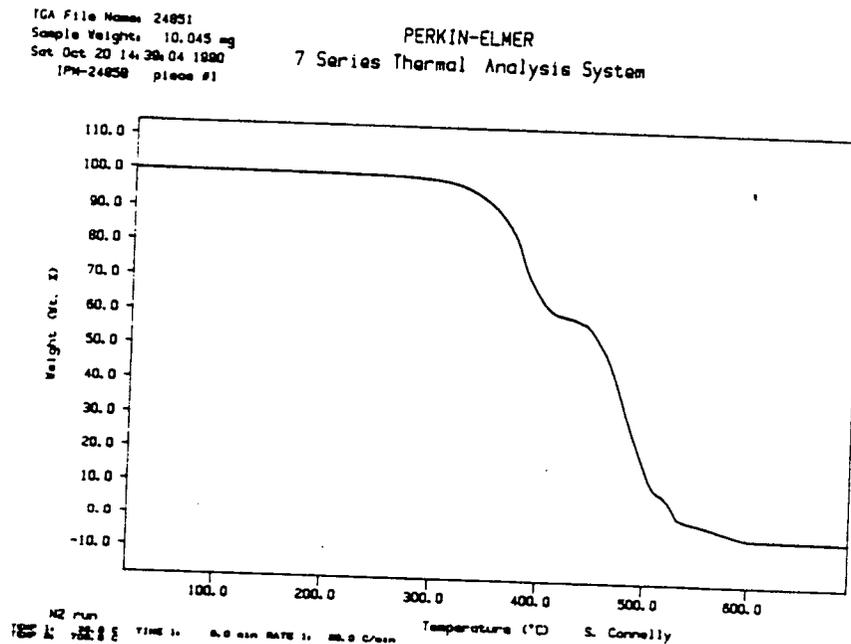
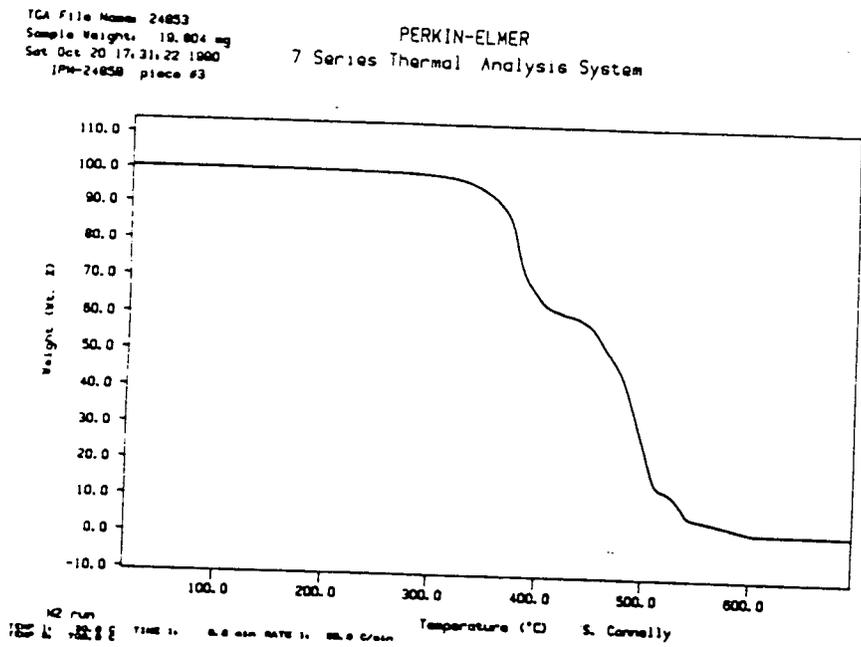
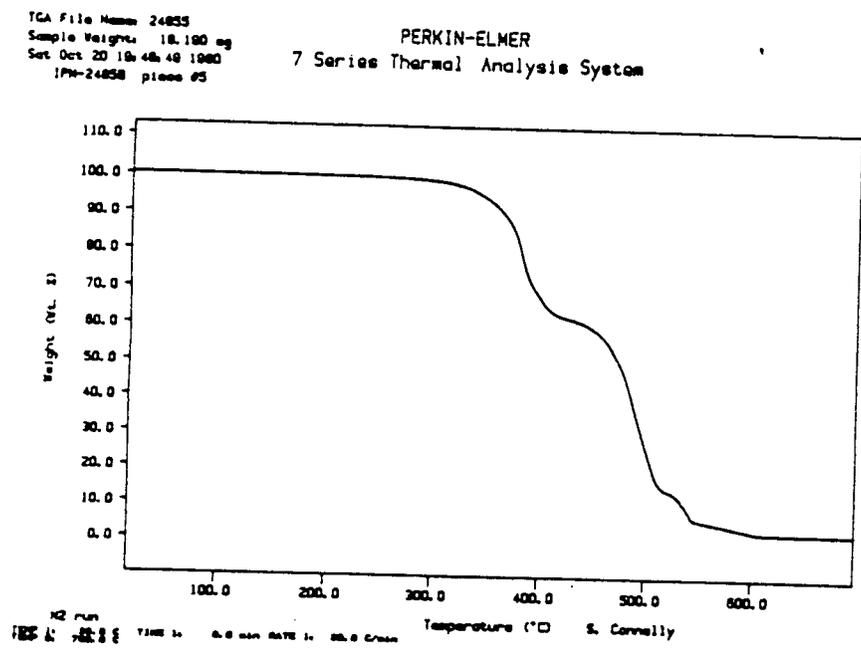
TGA scans were obtained at closely-spaced incremental locations along the length of cable 1PM2485B to assess whether significant variations in the local concentration of inorganic components could be detected. Figures 39, 40, and 41 are TGA scans corresponding to three locations near the fault site of this cable. Figure 39 shows the insulation characteristics nearest the fault site. Figures 40 and 41 correspond to locations 1.0 in. and 1.5 in. away from the fault site, respectively. When these figures are compared, no differences are indicated in the insulation formulation along the length of the cable near the fault site.

Figure 39. TGA Scan of the Insulation Compound within 0.5 in. of the Fault Site of Cable 1PM2485B

Figure 40. TGA Scan of the Insulation Compound within 1.0 in. of the Fault Site of Cable 1PM2485B

Figure 41. TGA Scan of the Insulation Compound within 1.5 in. of the Fault Site of Cable 1PM2485B

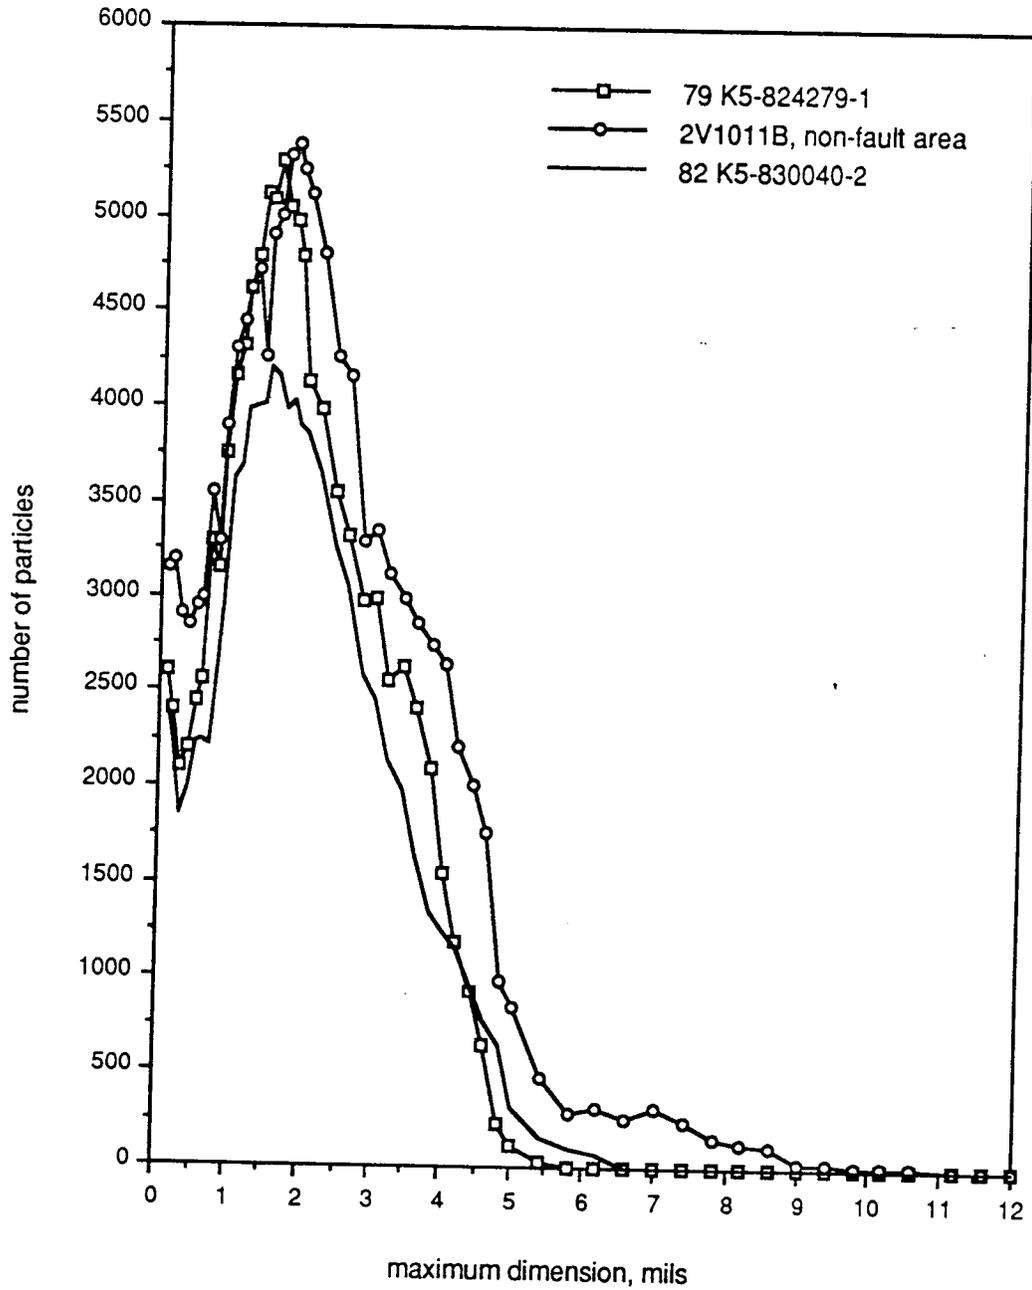
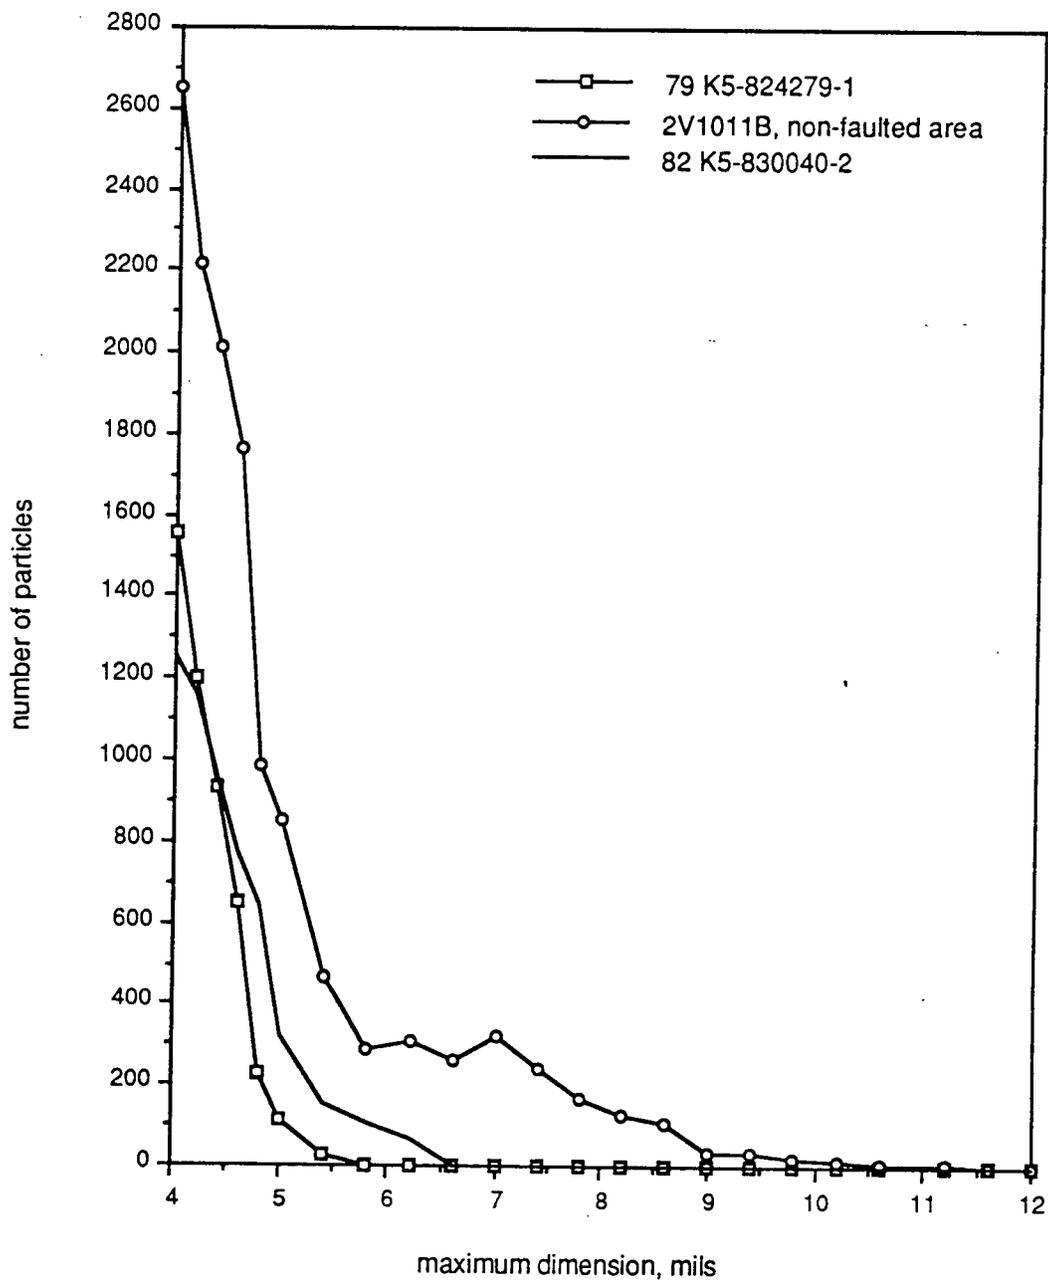
Figure 47. Size Distributions of Plasma-Extracted Inorganic Components of the Insulations, Comparing Failed Cable 2V1011B to Non-Failed Vintages

Figure 48. Size Distributions of Plasma-Extracted Inorganic Components of the Insulations, Comparing Failed Cable 2V1011B to Non-Failed Vintages (Expanded Scale)

Pyrolytic extraction of the insulations from the fault sites of the cables shown in Table 15 indicated that large particles of inorganic materials were present that were not otherwise present at remote locations in the same cables. These particles were identified with X-ray microanalysis and determined to be primarily antimony trioxide and silica. Antimony trioxide is a normal component of this insulation compound, as stated by the manufacturer, and serves as a component of the flame retardant system. Particles of antimony trioxide up to a maximum observed length of 59 mils were found at the fault site of one cable. Many had lengths in the range of 12 to 16 mils. Silica particles with a maximum dimension of 15 mils were also found near the fault sites of these cables. As shown in Figures 21, 22, 42, 43, 44, 45, 46, 54, 55, 58, 59, and 60, such antimony trioxide and silica particles are unique to the insulation compound corresponding to those cables that failed during in-situ electrical tests and supplied under contract 80K6-825419. This observation is further supported by the particle size measurements of the inorganic components of the various vintages of cable insulations as shown in Figures 47, 48, 51, 52, 56, and 57.

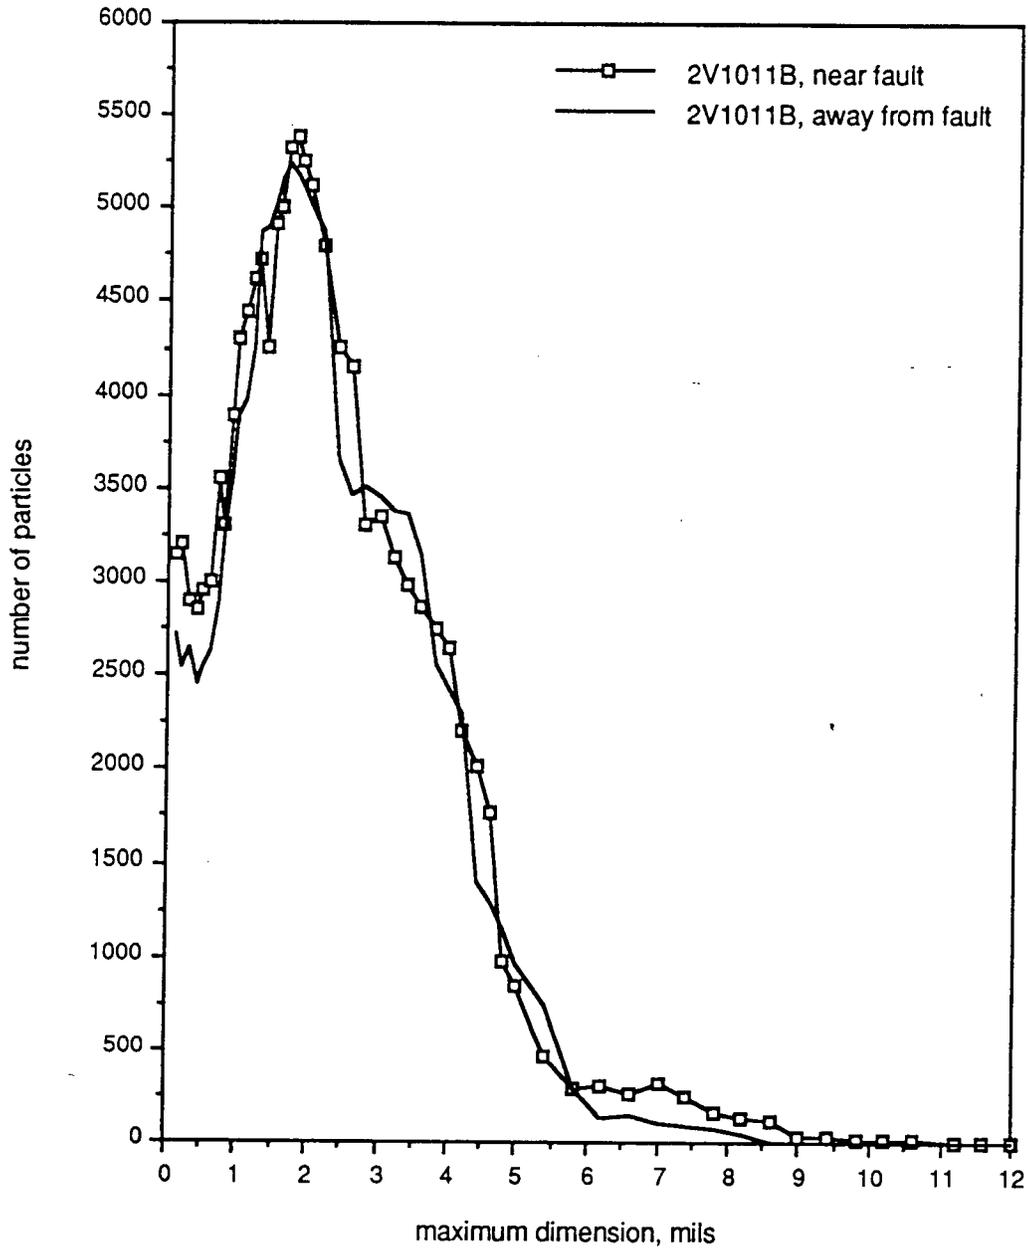
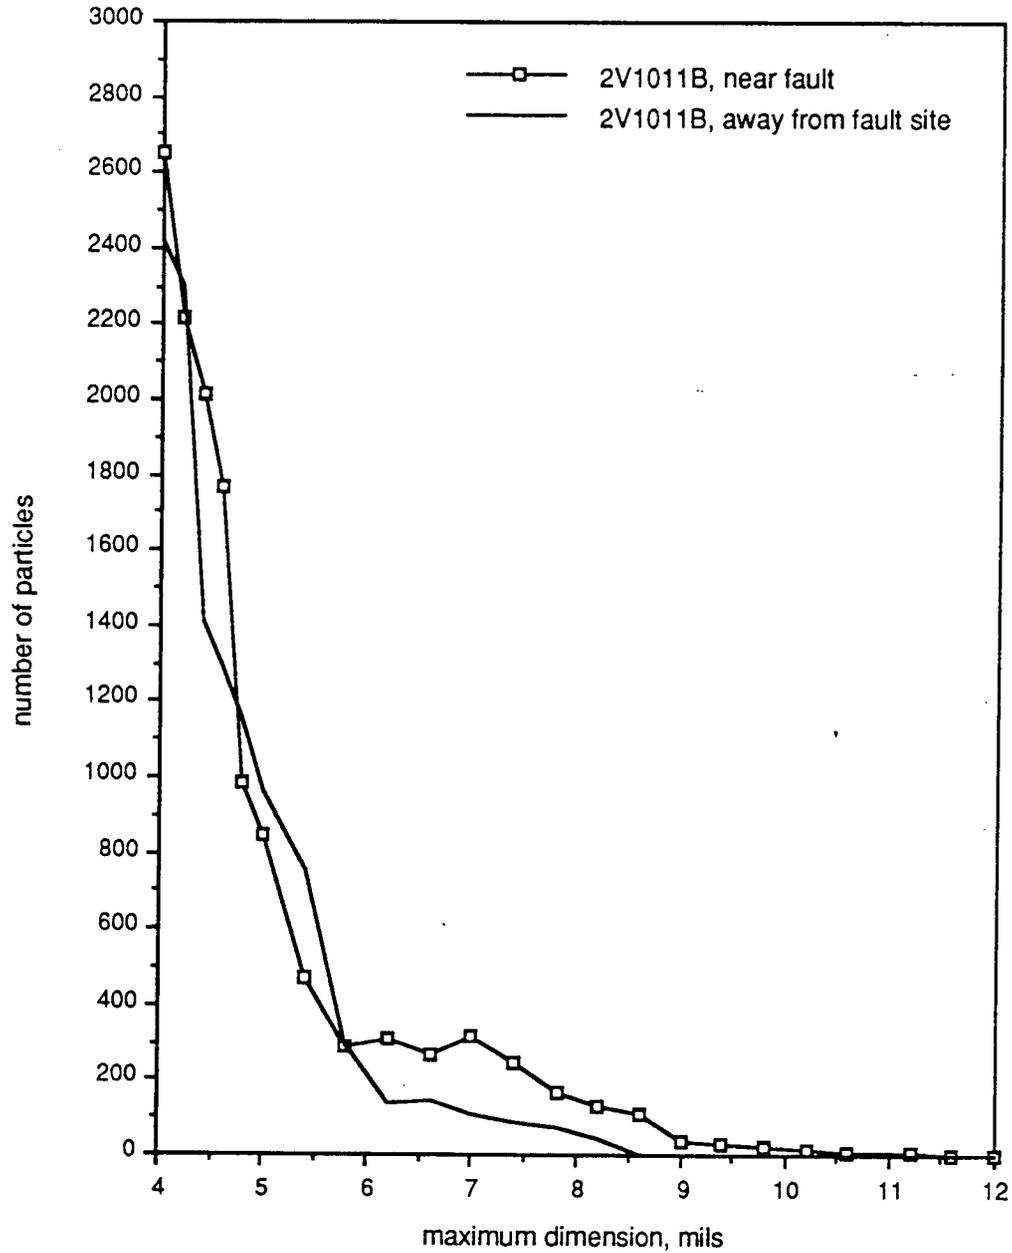
ultrasonically agitated in 10 ml ethyl alcohol. The cable sections were then returned to the plasma etcher for another 4 hours, then treated in the alcohol again. In this manner, the inorganic components of the insulations were completely separated. An identical procedure was used to prepare the insulations from cables 2V1011B and 1PM2445B. Areas near the fault sites were compared with areas on the same cables approximately 6 in. away from the fault sites. In Figure 47, the particle size distributions for an area of the insulation from cable 2V1011B, 6 in. away from the fault, are compared to particle size distributions from cable supplied to TVA under contracts 79K5-824279-1 and 82K5-830040-2. From these data, it is indicated that the insulation from the failed cable contains larger inorganic particles within the insulation than were found in either of the other vintage cables. This difference is shown more clearly in an expanded view of the particle size distributions, as shown in Figure 48. The two non-failed vintage cables compare quite closely with respect to their inorganic particle size distributions. Figure 49 compares the inorganic component particle size distributions for the insulation of cable 2V1011B near and away from the fault site. Figure 50 presents the same data shown in Figure 49, but with an expanded particle size scale. From these data, it appears that there are larger particles concentrated near the fault site than were found at an area remotely located.

Figure 49. Size Distributions of Plasma-Extracted Inorganic Components of the Insulation of Cable 2V1011B Comparing Failed to Non-Failed Locations

Figure 50. Size Distributions of Plasma-Extracted Inorganic Components of the Insulation of Cable 2V1011B Comparing Failed to Non-Failed Locations (Expanded Scale)

observations as well as the comparison of inorganic components of the insulations from selected cables near and away from the fault sites as shown in Figures 49, 50, 51, and 52. It is unfortunate that the loss of insulation at the fault sites led to a loss of evidence that might otherwise have directly revealed its cause. On the other hand, if areas of the insulation within 30 - 60 mils of the fault site exhibit properties that are distinctly different from those at randomly selected, non-faulted areas of the same cable, then it is reasonable to assume that this evidence is a fair indicator of the conditions that prevailed at the fault site.

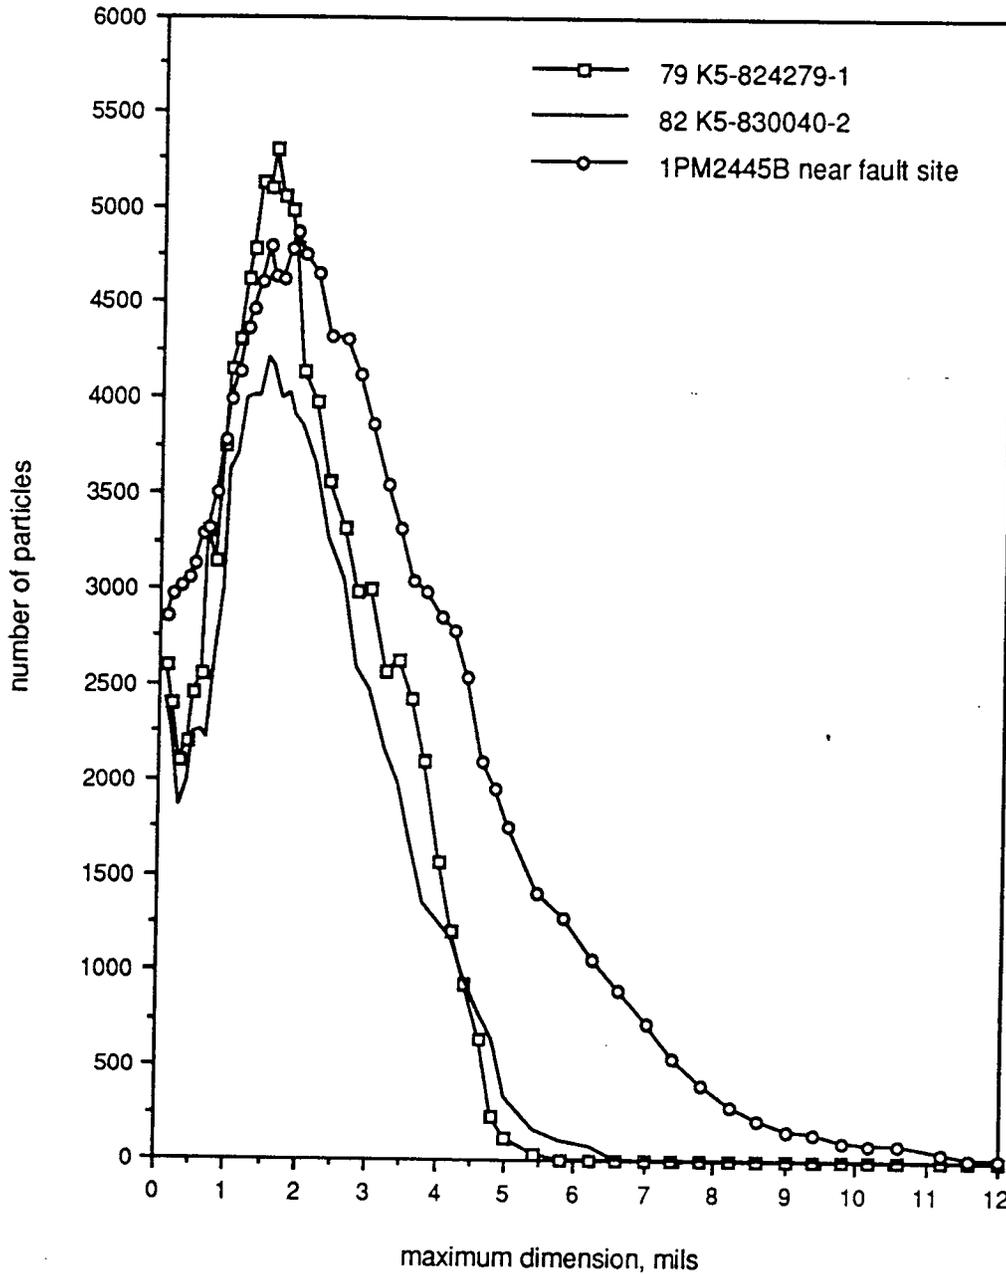
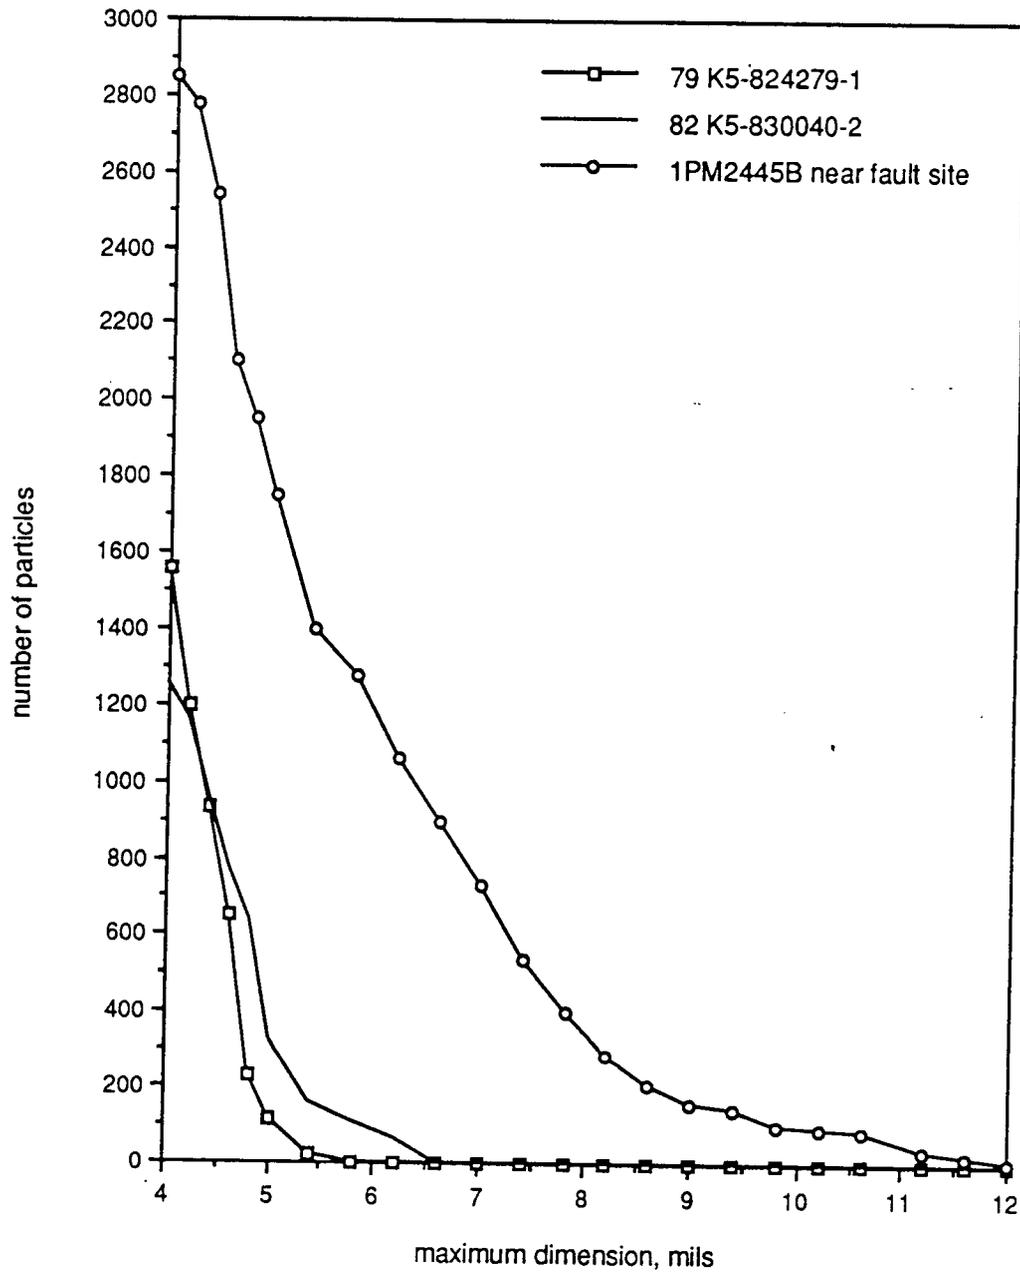
Similar measurements of the inorganic components from the insulation of cable 1PM2445B. Figure 51 compares the particle size distributions of the inorganic components of cable 1PM2445B to the insulations of cable provided under contracts 79K5-824279-1 and 82K5-830040-02. Figure 52 presents the same data on an

Figure 51. Size Distributions of Plasma-Extracted Inorganic Components of the Insulations, Comparing Failed Cable 1PM2445B to Non-Failed Vintages

Figure 52. Size Distributions of Plasma-Extracted Inorganic Components of the Insulations, Comparing Failed Cable 1PM2445B to Non-Failed Vintages (Expanded Scale)

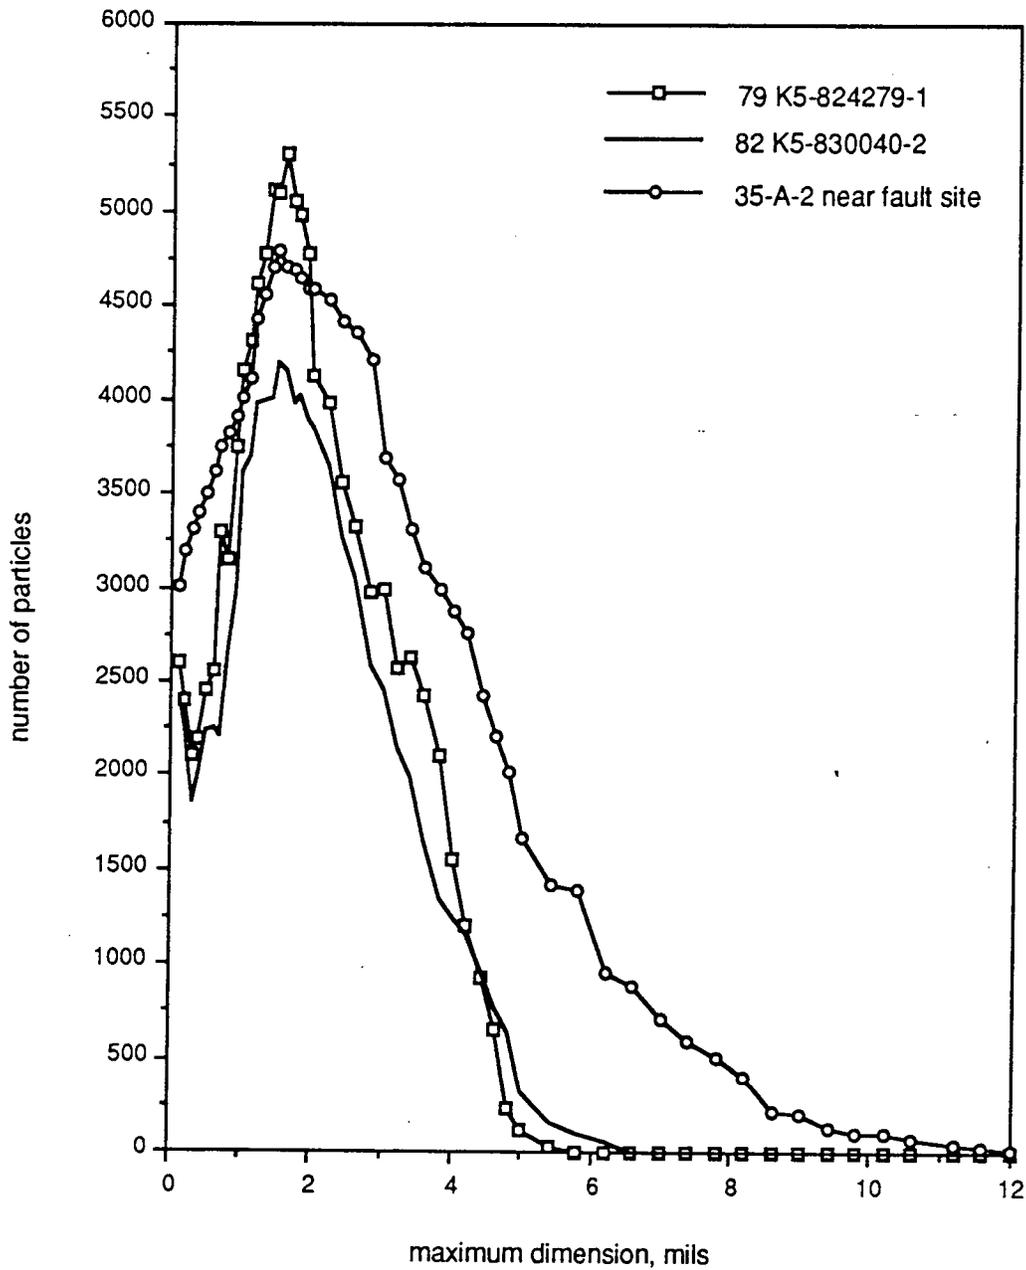
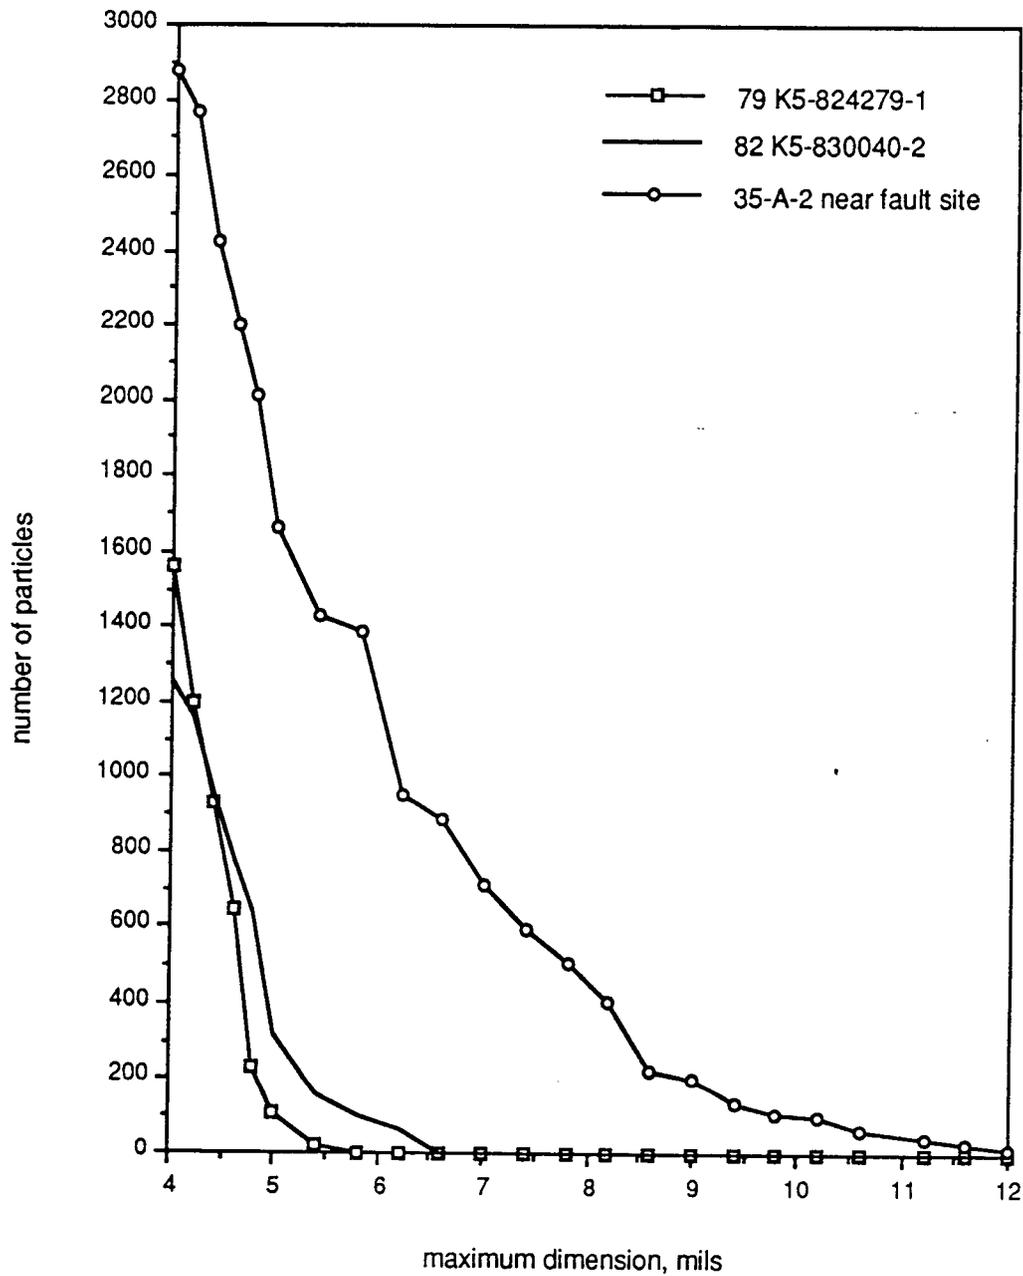
Size distributions of the inorganic components of the insulations were determined for cable 35-A-2 using computerized image analysis. Figure 56 compares the particle size distributions for cables supplied under contracts 79K5-824279-1 and 82K5-830040-2 to that from cable 35-A-2. These data indicate that there are considerably more large particles of inorganic materials in the insulations of the cable that failed electrical tests following LOCA aging. The differences between these vintages are shown in more detail in Figure 57. In Figures 56 and 57, the maximum displayed particle length is 12 mils. In fact, particles larger than this were found within the insulations of cables 01-A-2, 03-A-2, 35-A-2, and 36-A-2. Since there were only a few of these particles present, they would not have been resolved on the scales used to display the particle size distributions.

Figure 56. Size Distributions of Plasma-Extracted Inorganic Components of the Insulations, Comparing LOCA Tested Cable 35-A-2 to Non-Failed Vintages

Figure 57. Size Distributions of Plasma-Extracted Inorganic Components of the Insulations, Comparing LOCA Tested Cable 35-A-2 to Non-Failed Vintages (Expanded Scale)

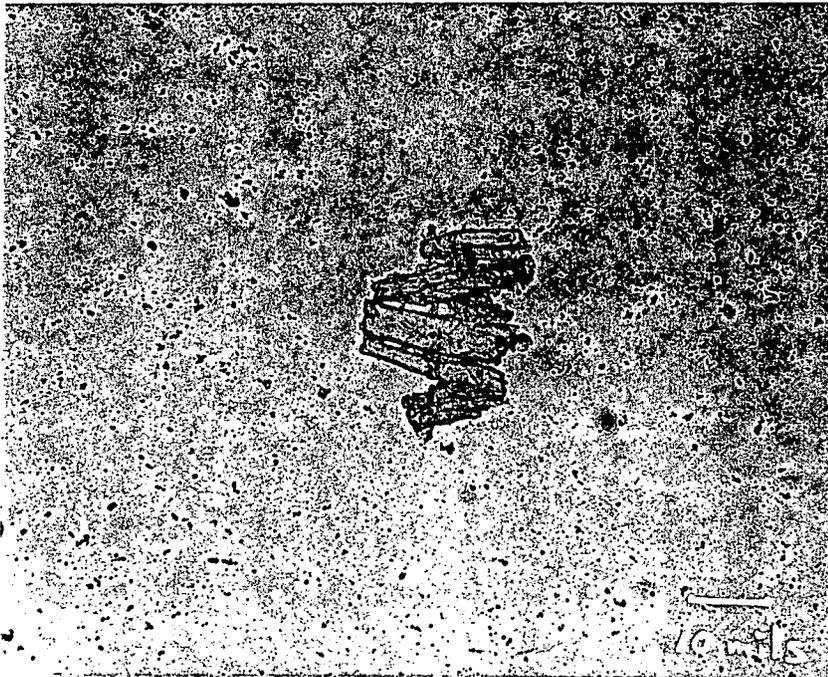
The polarizing microscope was used to inspect the plasma-extracted inorganic particles from the insulations of the LOCA-tested cables. This disclosed a number of large particles, such as those shown in Figures 58 and 59, from the insulation of cable 35-A-2. The particle shown in Figure 58 has a maximum dimension of 14 mils and that in Figure 59 is approximately 15 mils. Figure 60 shows one of the large particles found in the plasma-extracted residue near the fault site of cable 01-A-2. The insulation of cable 01-A-2 was found to contain several large particles between 15 and 17 mils in maximum dimension near the fault site. Similarly, the insulation of cable 03-A-2 also contained a number of large particles between 10 and 14 mils in maximum dimension.

Figure 58. Plasma-Extracted Particles from the Insulation of Cable 35-A-2, Near the Fault Site, 100x Magnification

Figure 59. Plasma-Extracted Particles from the Insulation of Cable 35-A-2, Near the Fault Site, 100x Magnification
