Subject 2007 Annual Site Inspection and Monitoring Compliance Report for UMTRCA Title II
Disposal Sites

2007 Annual Site Inspection and Monitoring Report for Uranium Mill Tailings Radiation Control Act Title II Disposal Sites

November 2007

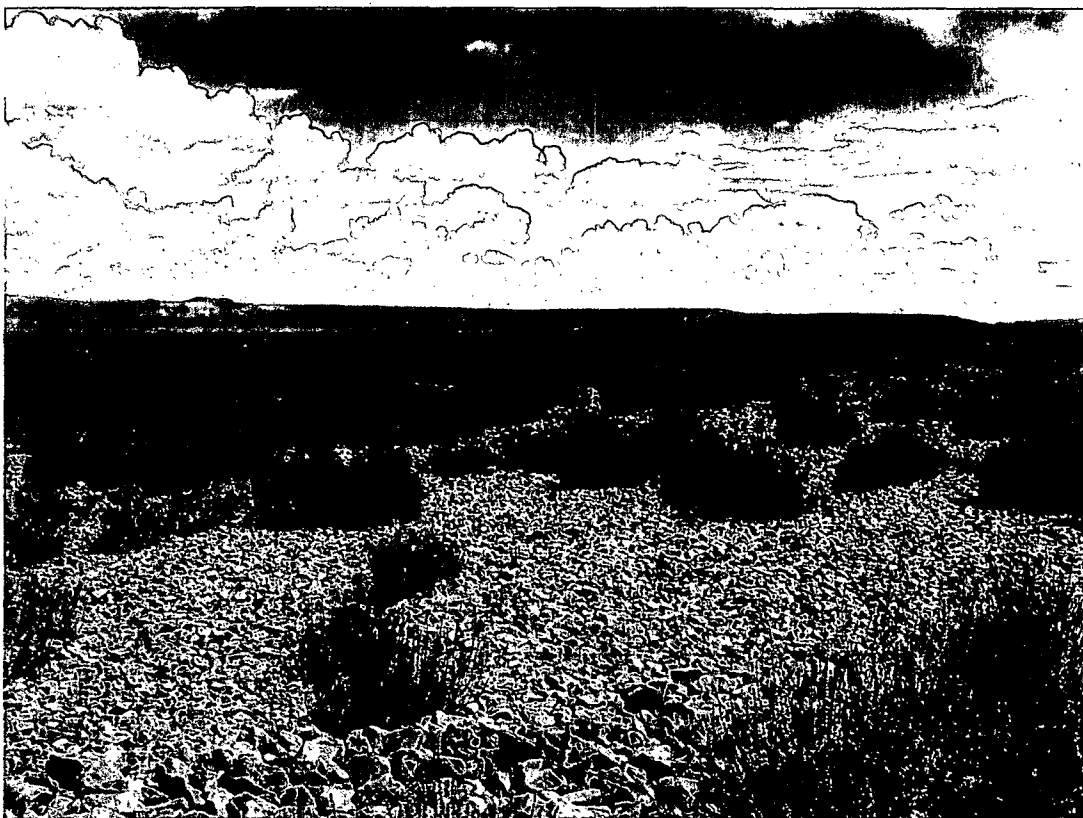
BLU 8/2007. PL-4. The southwest edge of the main tailings disposal cell cover.

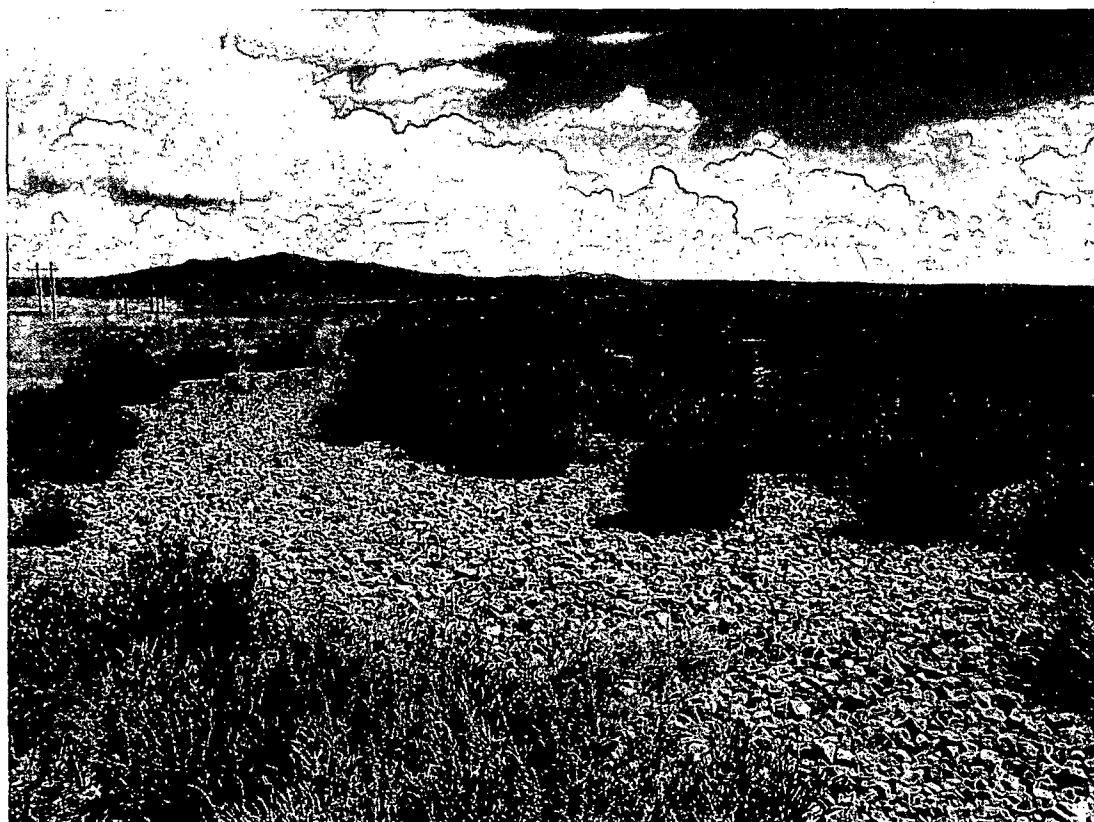
Carbonate Tailings Disposal Cell, Asbestos and PCB Disposal Areas, and Landfills—The top and side slopes of the carbonate tailings disposal cell are covered by basalt riprap. The top, for the most part, slopes gently eastward. The small northwest and southeast extensions slope in their respective directions. Annual weeds and scattered woody shrubs were present on the cell and its extensions (PL-6). The carbonate tailings disposal cell was in excellent condition.

BLU 8/2007. PL-6. View across the northwest extension of the carbonate tailings disposal cell.

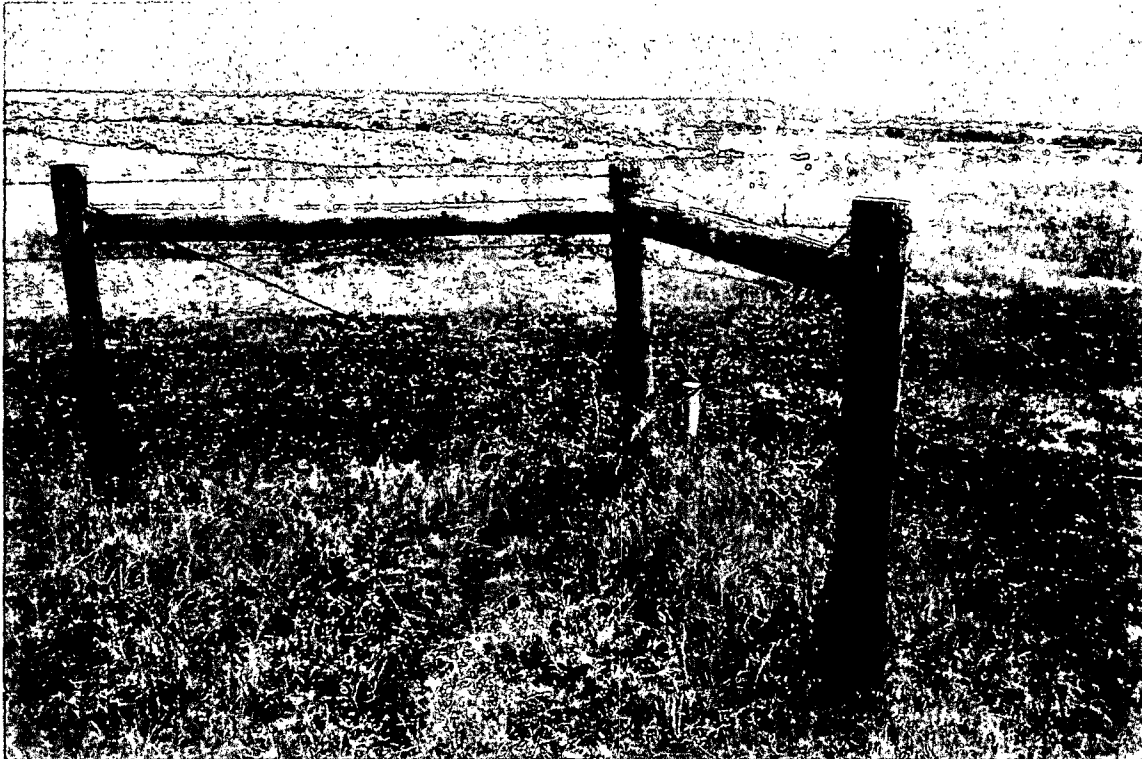
Diversion and drainage channels are grass-covered on their upgradient portions (these are gentle swales on each side of the disposal cell) and riprap-armored on their downgradient portions and on steeper slopes. Grass in the vegetated portions of the channels is dense and healthy, and there was no evidence of erosion. Minor amounts of vegetation occur in the riprap (PL-4). The vegetation density does not appear to have increased significantly in the last few years and does not pose a threat to the function of the channels. The riprap-armored surface drainage channel just outside the northwest corner of the property, designed to prevent headward erosion onto the disposal site, was also stable and in good condition (PL-3).

EDG 6/2007. PL-3. Boundary monument BM-1; riprap-armored surface drainage northwest of the site in background.

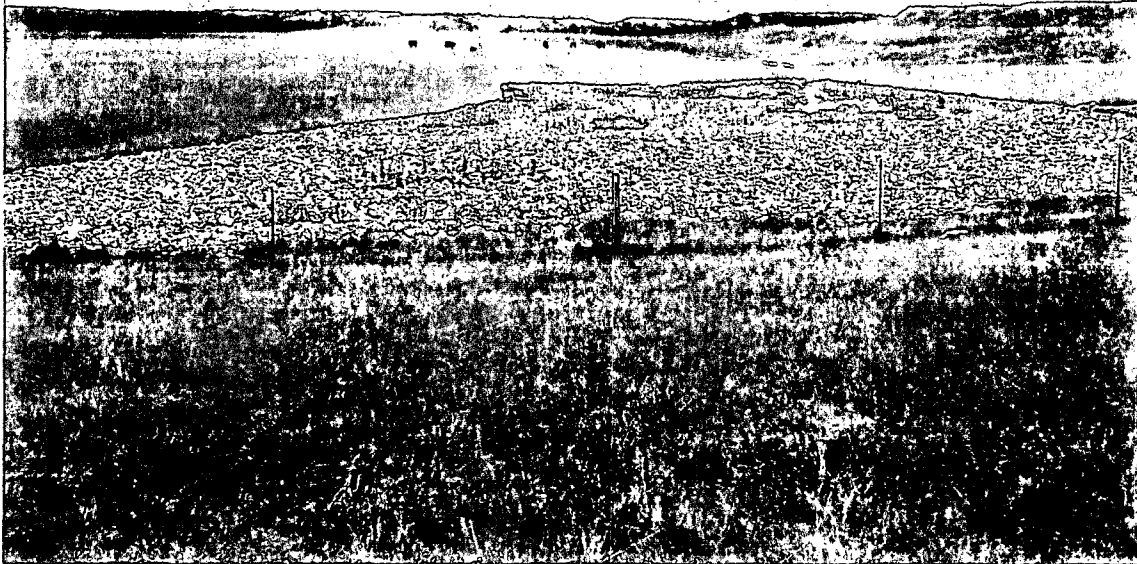
Top of the Disposal Cell—The 100-acre top of the disposal cell, completed in 1989, is grass-covered and was in excellent condition (PL-4). DOE manages the grass cover through controlled grazing. The grass is well established and was not overgrazed when inspected. Numerous cattle trails are present on the cell top, but there were no indications of erosion, settlement, or other modifying processes that might affect the integrity of the cell.

EDG 6/2007. PL-4. The west diversion channel and the grass-covered disposal cell.

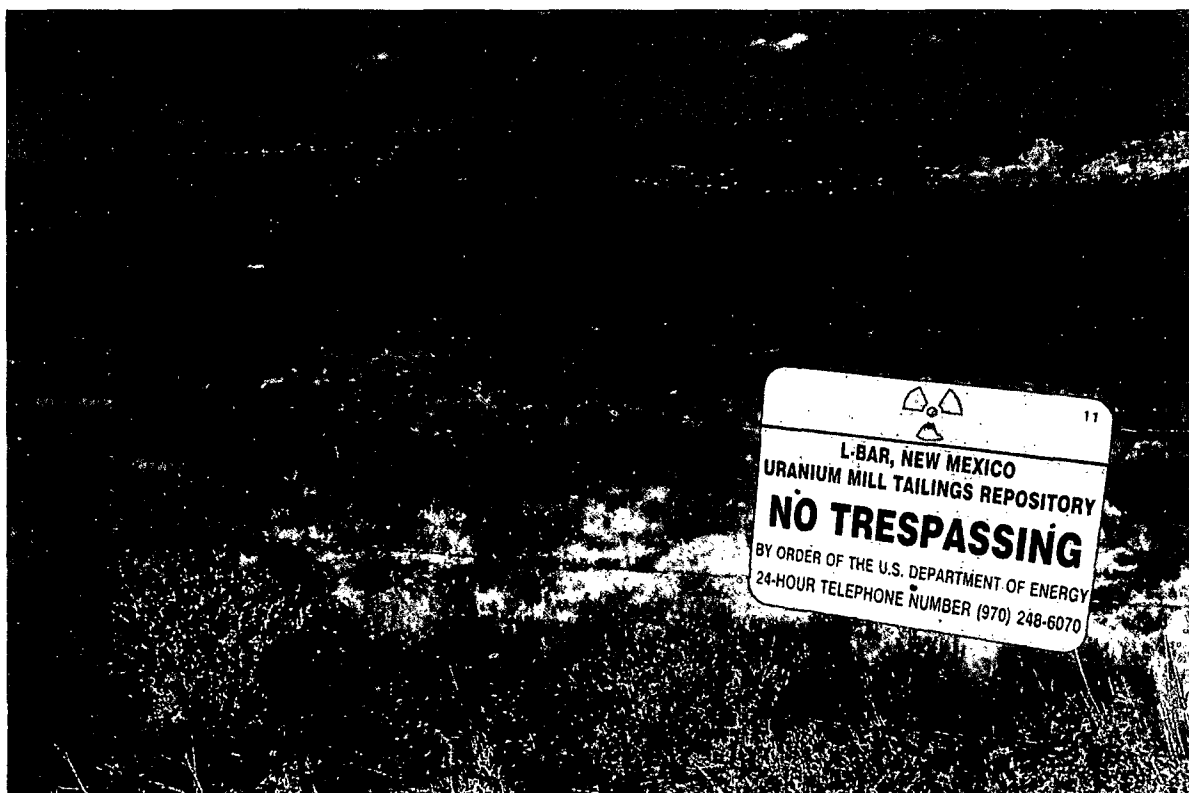
- Thirty perimeter warning/no trespassing signs are attached to the barbed-wire fence at approximately 500-foot intervals (PL-4). The perimeter signs were in excellent condition. Three
- 3D entrance signs were installed on steel posts set in concrete at former chain-link fence gate locations along the site boundary after the inspection.

BAR 8/2007. PL-4. The site viewed from perimeter sign P11.

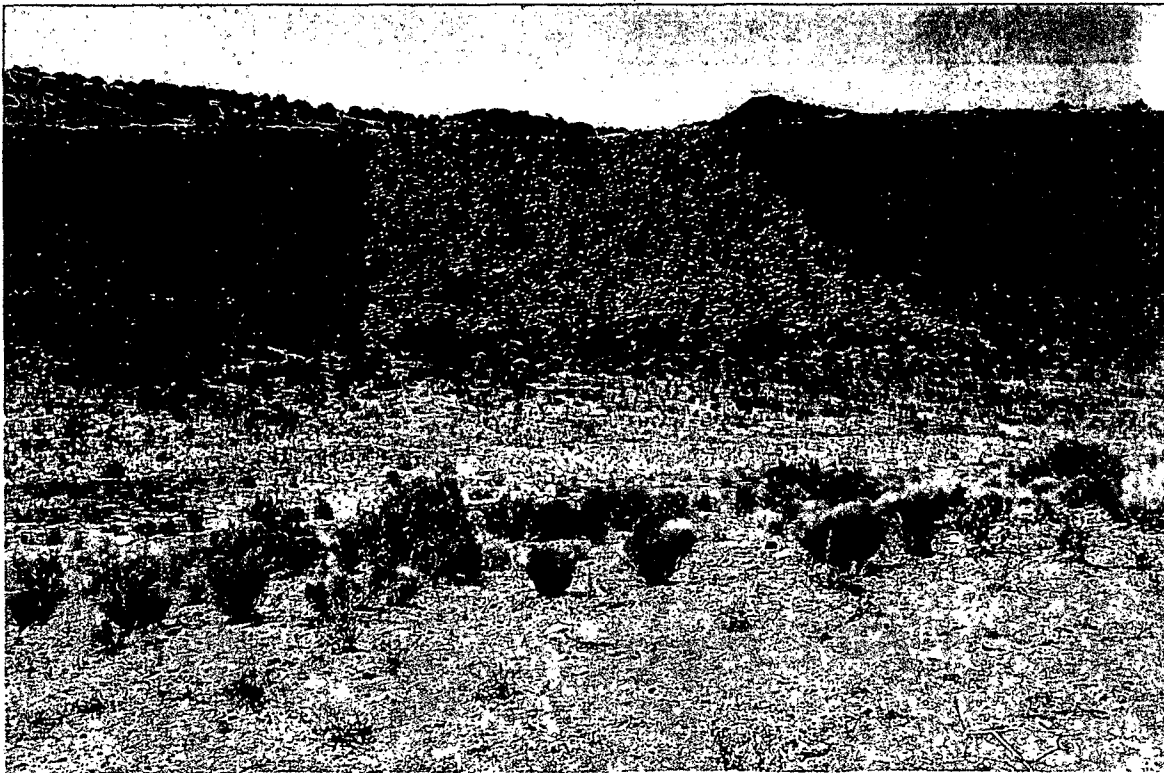
BAR 8/2007. PL-8. Riprap apron for erosion control on the south slope of the South Channel.

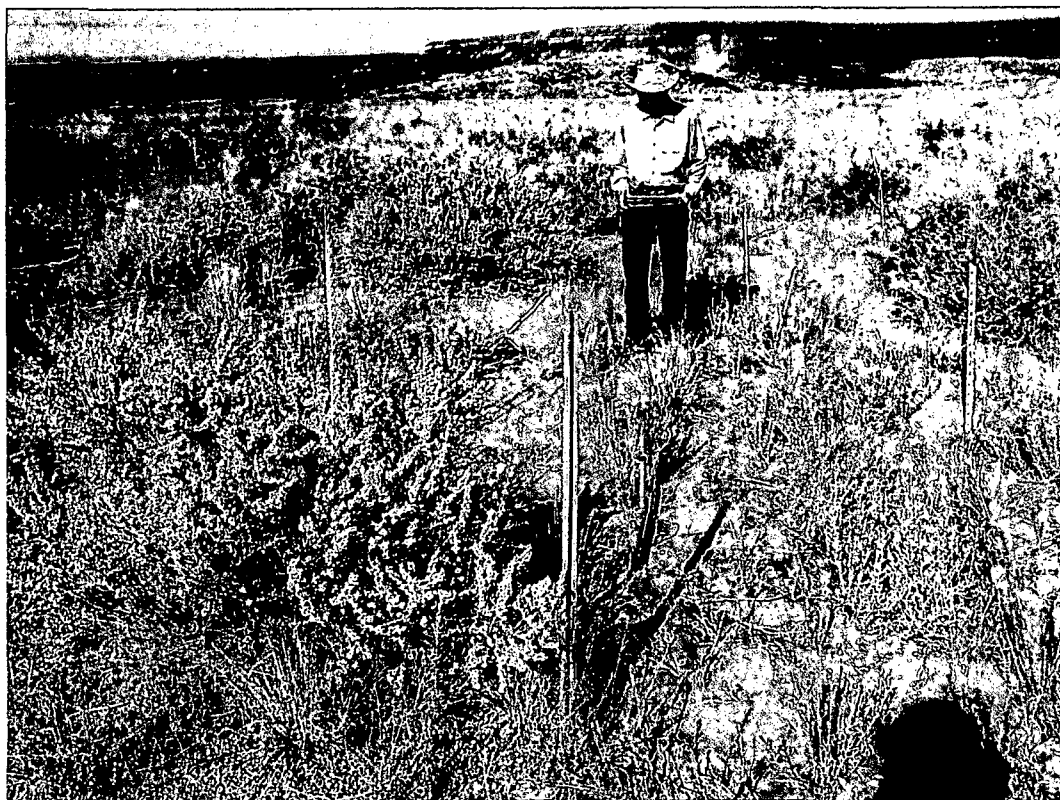
BAR 8/2007. PL-10. Vegetation at erosion monitoring point and vegetation plot A3.

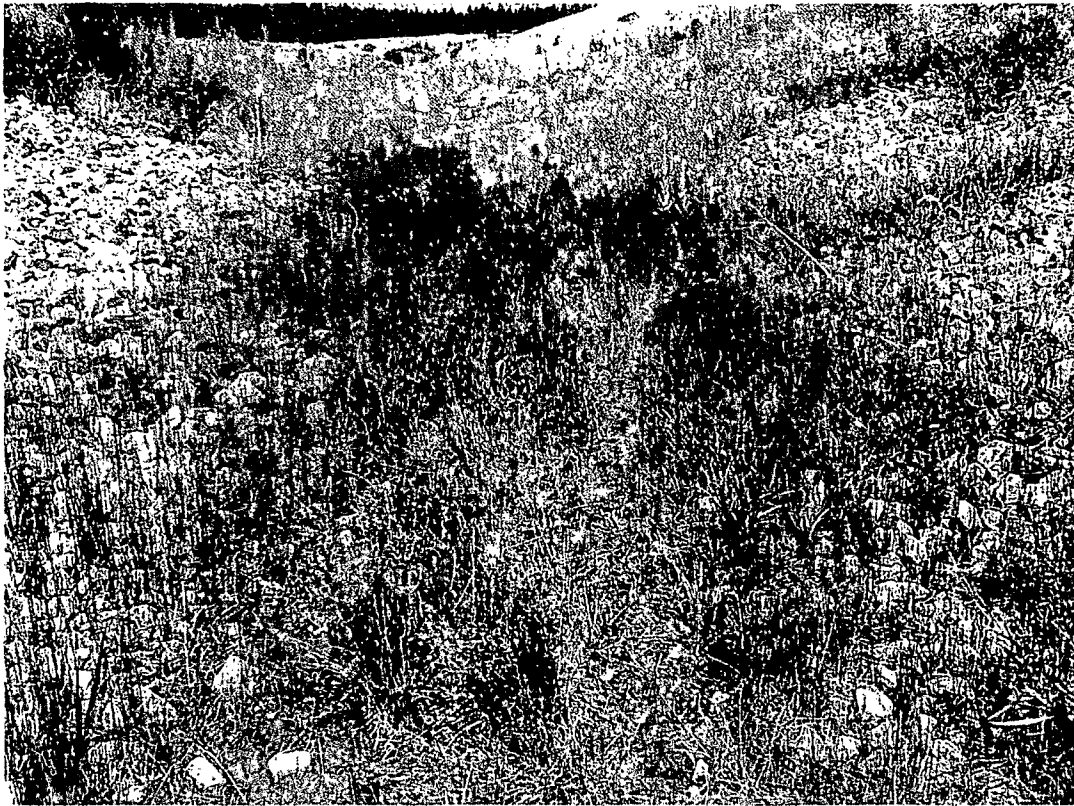
SHE 7/2007. PL-3. Wetland area within the armored diversion channel containing visible surface water.

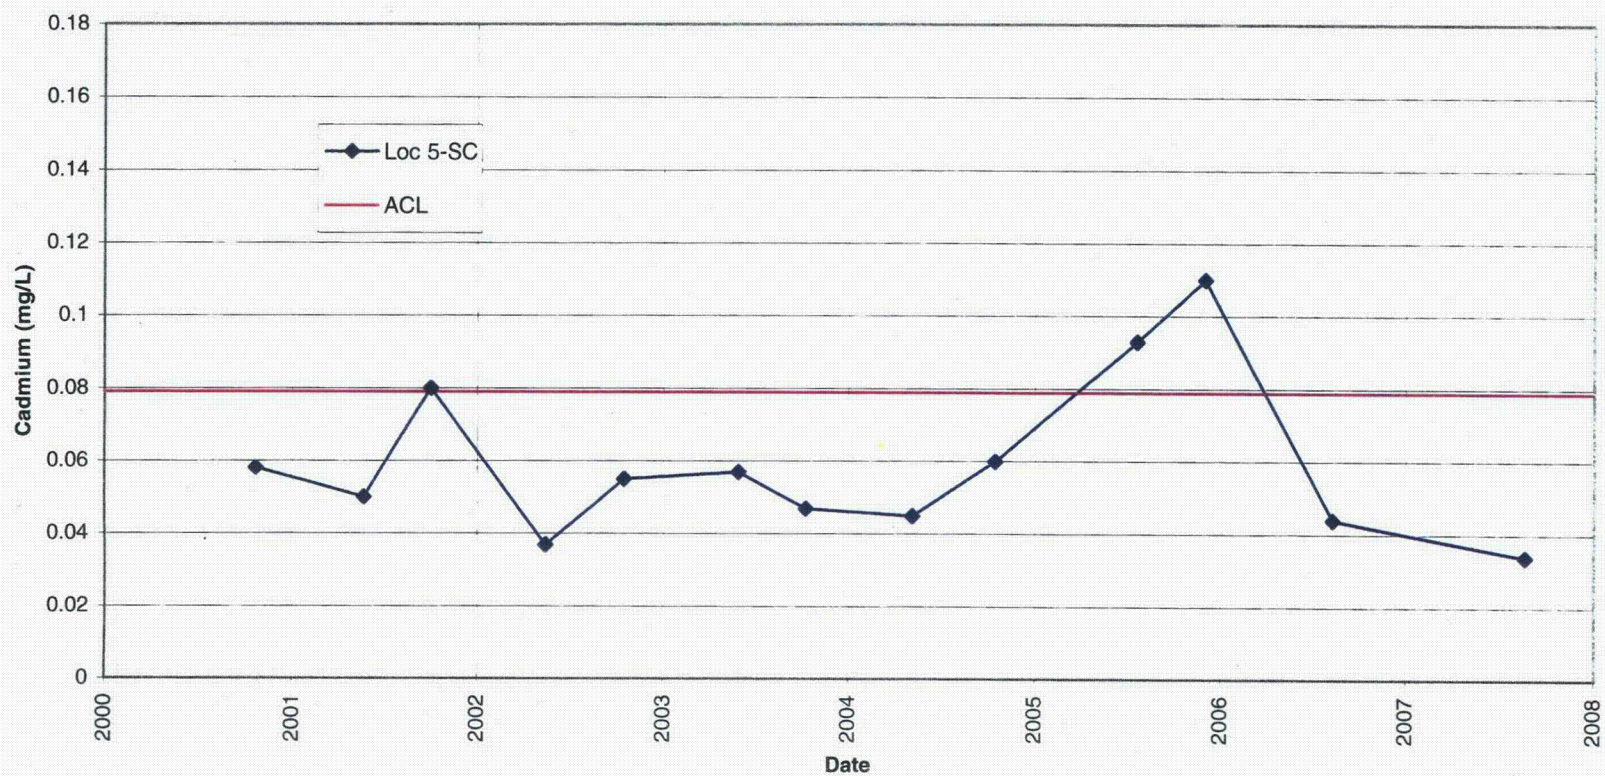
Figure 5-2. Cadmium Concentration in Well MW-5-SC Since Completion of the Disposal Cell

- 5E The cadmium concentration in MW-5-SC dropped below the ACL in 2006, but radium-228 increased in both MW-5-DC and MW-54-SC. Analytical results for the 2007 sampling event conducted in August 2007 are provided in Table 5-4. The concentration for cadmium in MW-5-SC remained below the ACL and was lower than the 2006 result (Figure 5-2). However, radium-228 continued above the ACL in an upward trend in both MW-5-DC and MW-54-SC (Figure 5-3). No other ACLs were exceeded.

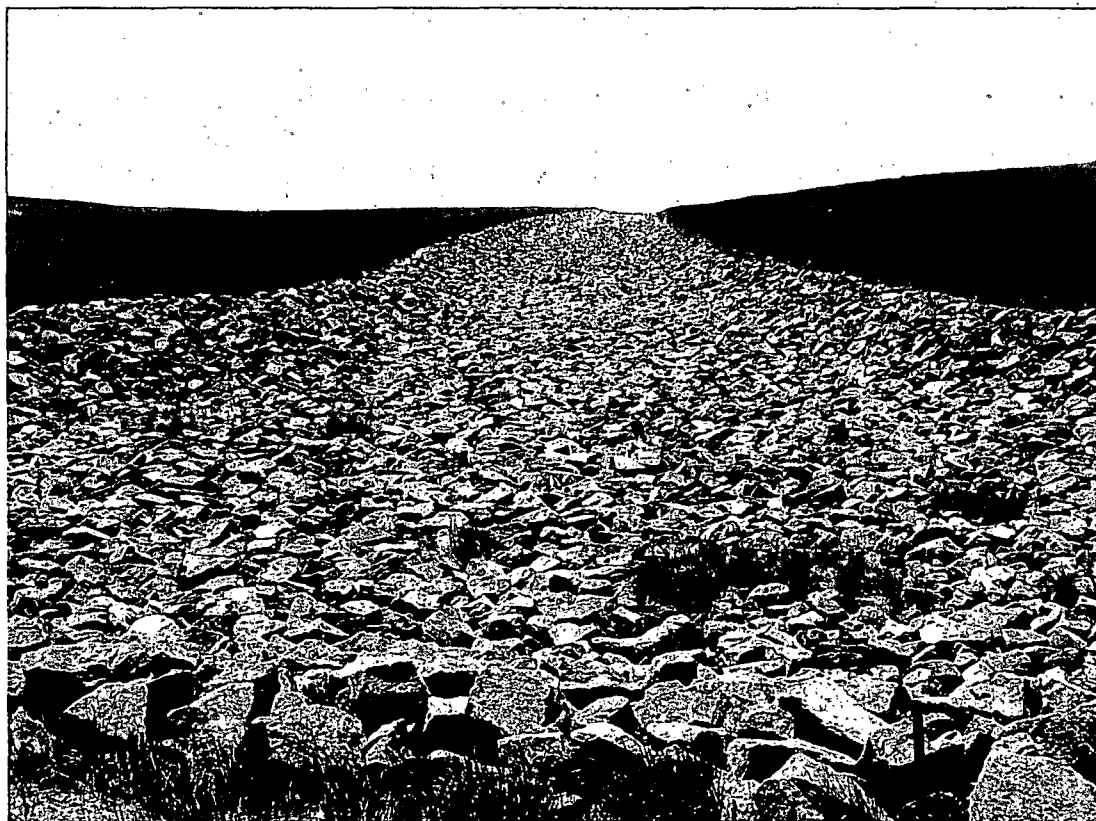
SBS 6/2007. PL-6. Rock-armored erosion control structure west of the disposal cell.
