Re: Turkey Point Unit 3  
Docket No. 50-250  
Inservice Inspection Report

TURKEY POINT PLANT  
UNIT 3

2007 REFUELING OUTAGE INSERVICE INSPECTION REPORT

35<sup>th</sup> Year Tendon Surveillance At Turkey Point

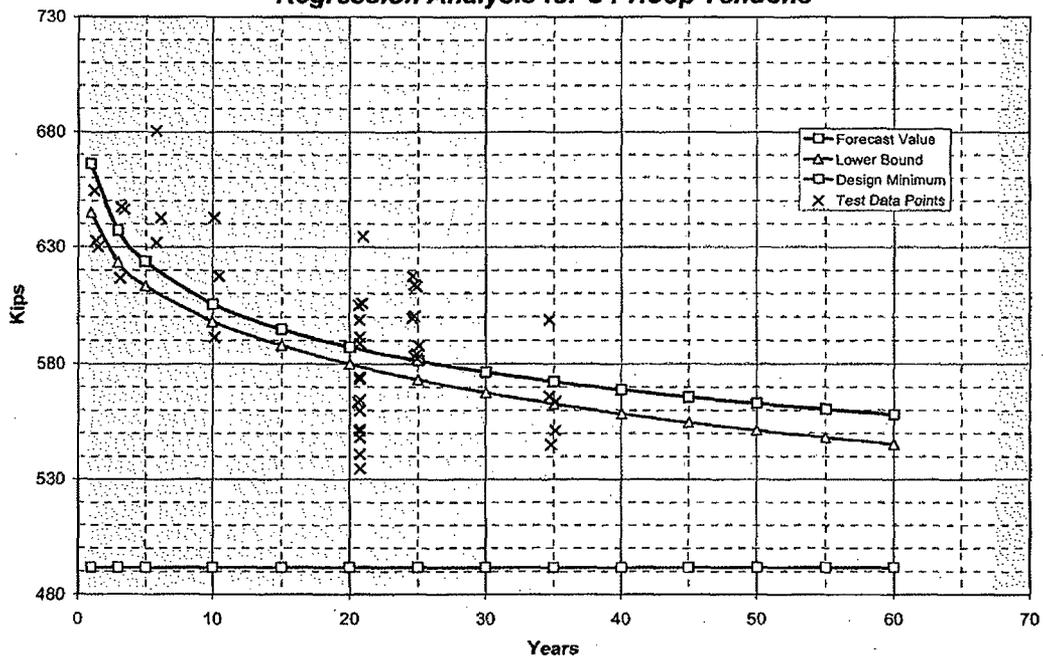
**Turkey Point 2007 Tendon Surveillance  
Regression Analysis for U4-Hoop Tendons**

UNIT 4 HOOPS- REGRESSION ANALYSIS OUTPUT DATA					
REGRESSION		Forecast Years	Forecast Value	Lower Bound	Design Minimum
Slope:	-26.3613	1	666	645	491.6
Intercept	666.0811	3	637	623	491.6
Sigma	26.48927	5	624	613	491.6
Count	42	10	605	598	491.6
T-value	1.683852	15	595	588	491.6
Mean Ln(t)	2.666335	20	587	580	491.6
Var Ln(t)	0.822964	25	581	573	491.6
		30	576	568	491.6
		35	572	563	491.6
		40	569	558	491.6
		45	566	555	491.6
		50	563	551	491.6
		55	560	548	491.6
		60	558	545	491.6

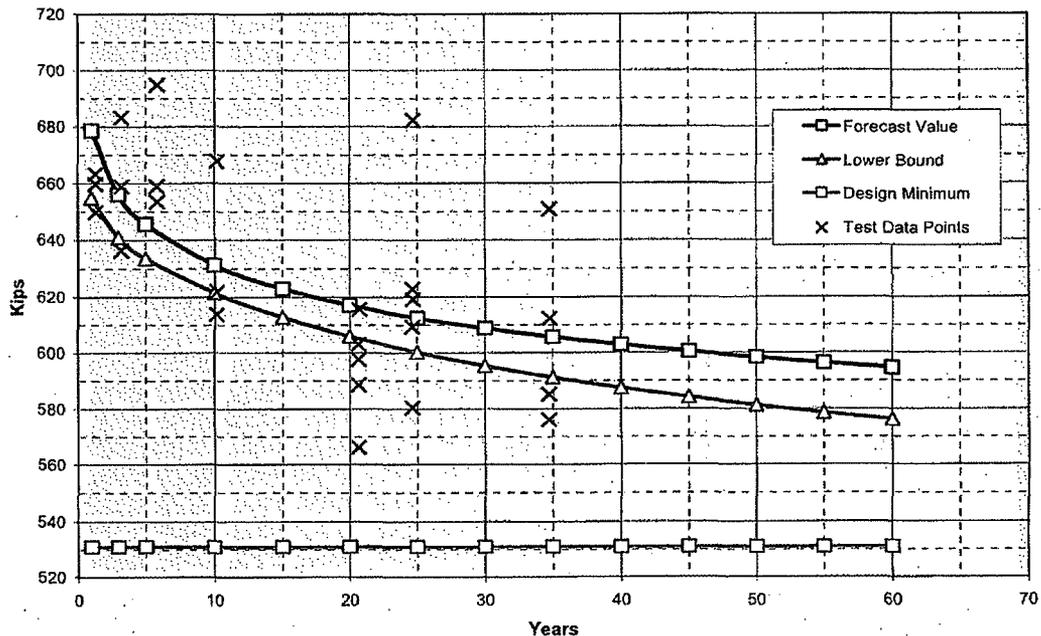
**Turkey Point 2007 Tendon Surveillance  
Regression Analysis for U4-Dome Tendons**

UNIT 4 DOMES- REGRESSION ANALYSIS OUTPUT DATA					
REGRESSION		Forecast Years	Forecast Value	Lower Bound	Design Minimum
Slope:	-20.5315	1	679	655	531
Intercept	678.5597	3	656	641	531
Sigma	28.92199	5	646	634	531
Count	26	10	631	622	531
T-value	1.710882	15	623	613	531
Mean Ln(t)	2.382738	20	617	606	531
Var Ln(t)	1.144819	25	612	600	531
		30	609	595	531
		35	606	591	531
		40	603	588	531
		45	600	584	531
		50	598	581	531
		55	596	579	531
		60	594	576	531
