# Preliminary report of the July 16, 2007 Niigata prefecture Chuetsu Off shore (Niigata-ken Chuetsu-Oki), Japan, Earthquake

Based on the reconnaissance conducted from July 17-19, 2007  
(Strong motion records by K-NET are acknowledged.)

Disaster Prevention Research Institute  
Kyoto University, Japan

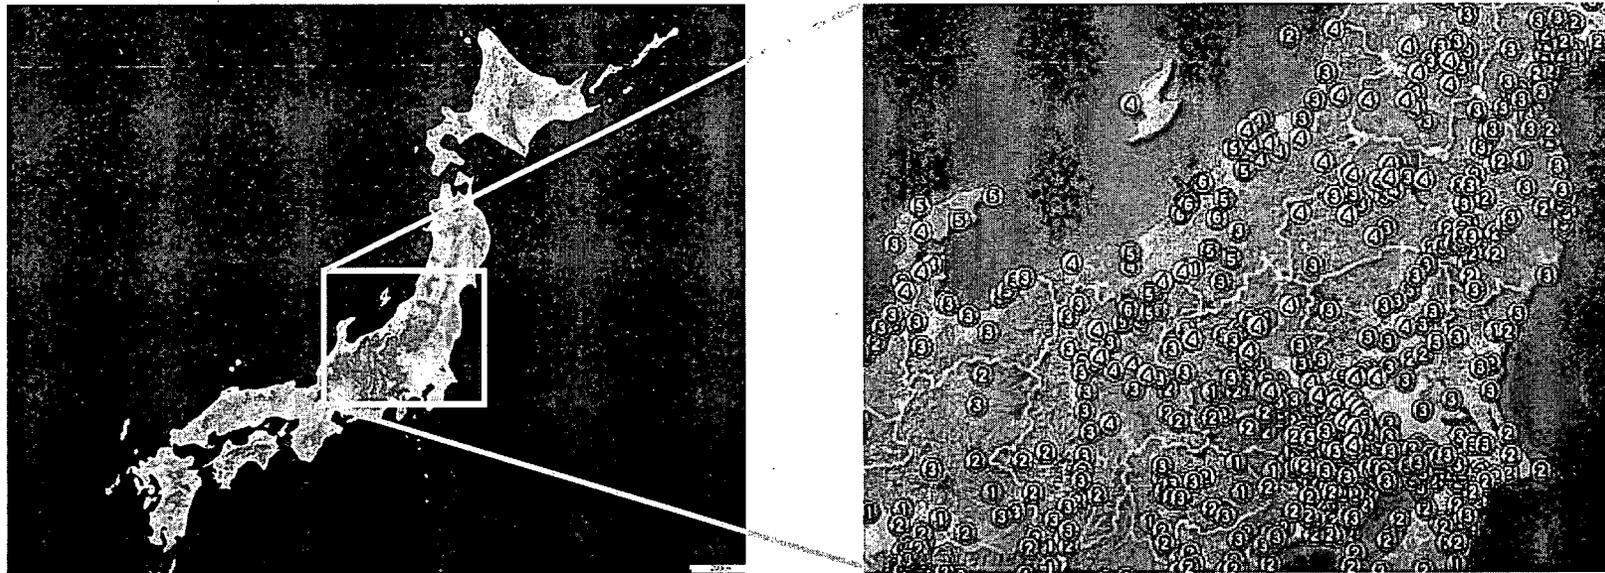
Figure 1 Location of the epicentral area

The instrumental JMA seismic intensity (Fig. 1) was 6+ (IX in MMI) in Kariwa village, Kashiwazaki city, Nagaoka city, in Niigata prefecture, and Ohzuna-machi in Nagano prefecture.

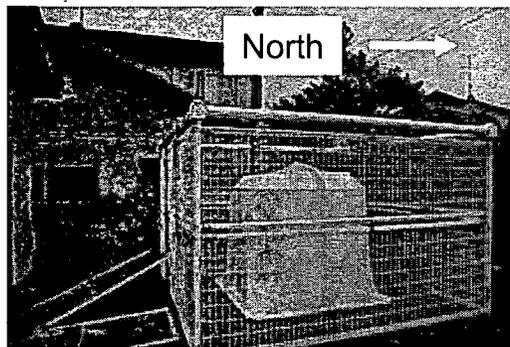
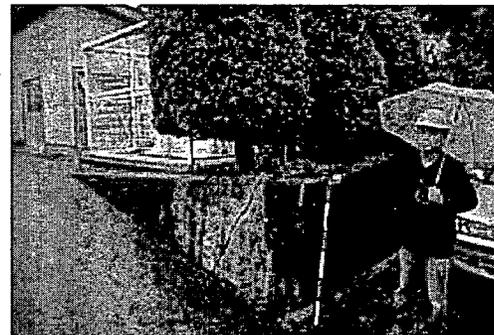
NIG018 (K-NET) site Behind trees:  
37.3724N,  
138.5579E  
Elevation: 10.00m

Near the K-Net site, major cracks on road asphalt may indicate occurrence of lateral spreads toward down-slope. (Fig. 5).

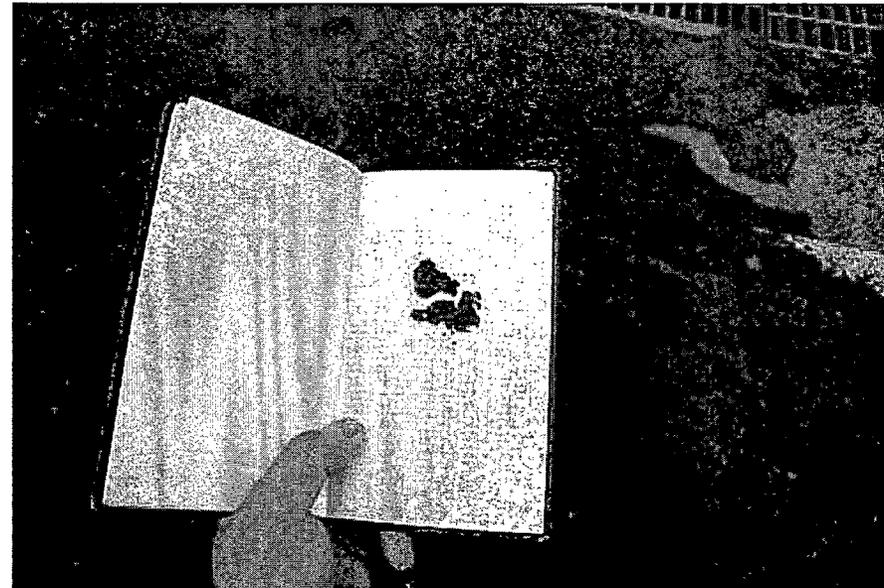
Matsunami 2: 7/18/07

Damage on utility poles, asphalt roads, houses due to liquefaction were found in Matsunami 2, Kashiwazaki city. The site which was originally farm lands and sand dunes was developed as a residential site in 1973-1976. The area is 14 ha and east part of the developed land suffered heavy damage due to liquefaction. Eye witness accounts of evidence confirms the occurrence of liquefaction after the large shaking with an eruption of muddy water at 2 m high.

Erupted sand was medium to coarse sand

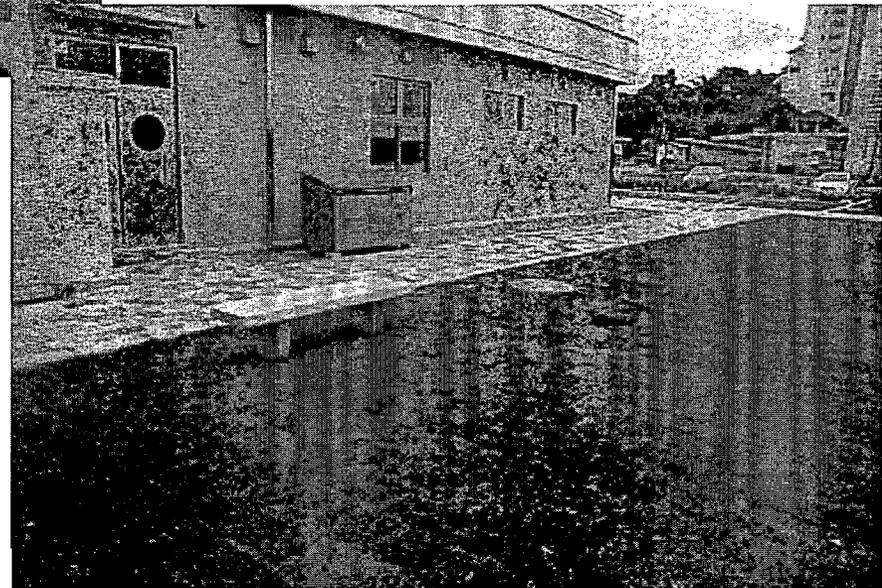
Kashiwazaki ferry terminal: 7/17/07

Kashiwazaki ferry terminal building:  
Building suffered no damage but evidence of liquefaction was found.  
Pavement blocks were separated and settled.

Sand volcanoes at the back of the building
