St. Lucie Pressurizer Nozzle DM Weld Examination Project

Internal Office Report

St. Lucie Pressurizer DM weld examinations

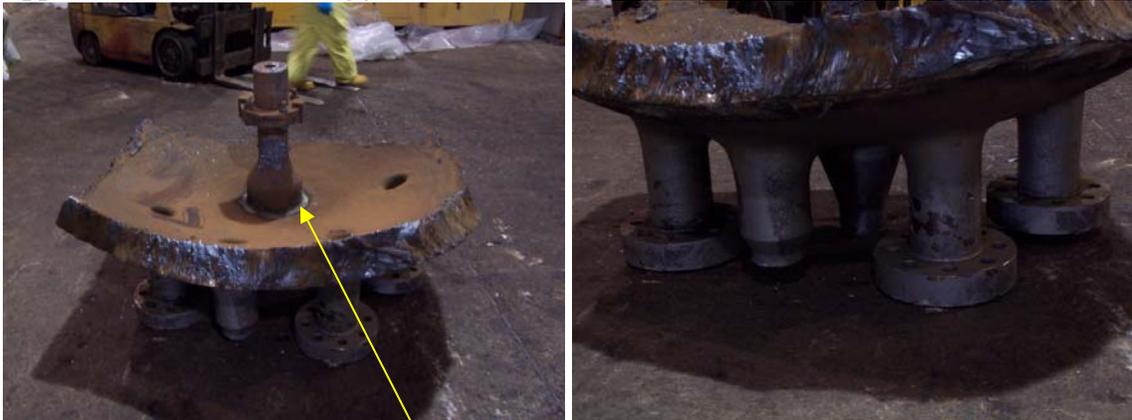
Upper Head Piece showing five nozzles and the internal portion of the Spray nozzle

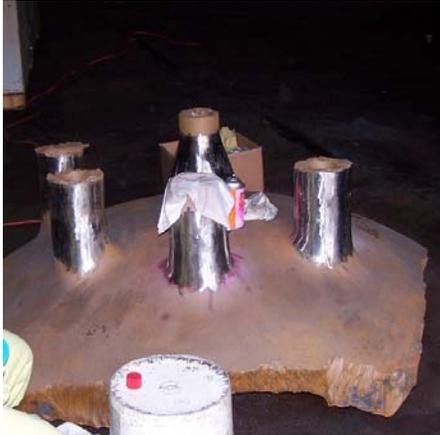
We had brought our own side grinder and flapper wheels, so we proceeded to prepare the outside surfaces of the nozzle weld areas to remove the rust and smooth out the rough surfaces. By the end of the first day, we had managed to adequately prepare the outside surfaces of the welds for PT and UT examinations.

Upper head after flapping

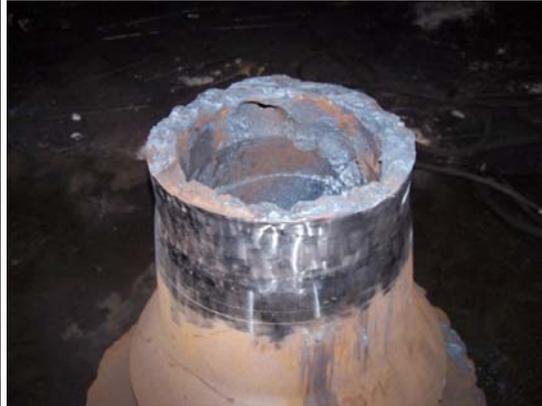
An assessment of the Surge nozzle, after complete plug removal showed that a great deal of the ID of the weld had been damaged by flame cutting.

Surge nozzle after flapping and plug removal
