# **Fabrication Flaw Density and Distribution In Repairs to Reactor Pressure Vessel and Piping Welds**

The Pacific Northwest National Laboratory is developing a generalized fabrication flaw distribution for the population of nuclear reactor pressure vessels and for piping welds in U.S. operating reactors. The purpose of the generalized flaw distribution is to predict component-specific flaw densities. The estimates of fabrication flaws are intended for use in fracture mechanics structural integrity assessments. Structural integrity assessments, such as estimating the frequency of loss-of-coolant accidents, are performed by computer codes that require, as input, accurate estimates of flaw densities. Welds from four different reactor pressure vessels and a collection of archived pipes have been studied to develop empirical estimates of fabrication flaw densities.

This report describes the fabrication flaw distribution and characterization in the repair weld metal of vessels and piping. This work indicates that large flaws occur in these repairs. These results show that repair flaws are complex in composition and sometimes include cracks on the ends of the repair cavities. Parametri

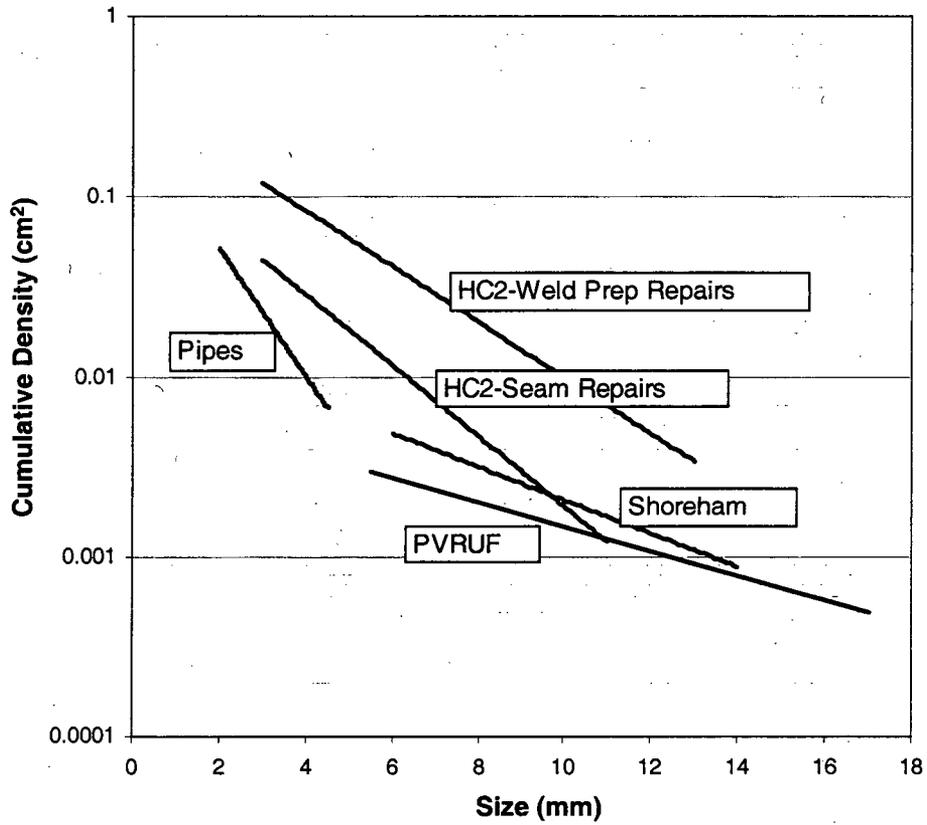
The weld repairs found in the dissimilar metal weld did not contain large flaws located on the ends of the repair cavities as PNNL found for the reactor pressure vessel repairs. One explanation for the difference is that the welding procedures used to make the repairs may have been significantly different—possibly the piping procedure required a repair cavity that allowed the weld pass to start and stop at the surface of pipe. Perhaps the repair metal we studied is not representative of all the repairs in piping.

**Figure E.1 Comparison of Flaw Density and Through-Wall Size Distributions for Repair Flaws in Three Reactor Pressure Vessels and in a Dissimilar Metal Piping Weld. HC2 stands for the Hope Creek Unit 2 vessel. No weld repairs were found in the weld segments from the River Bend Unit 2 vessel.**

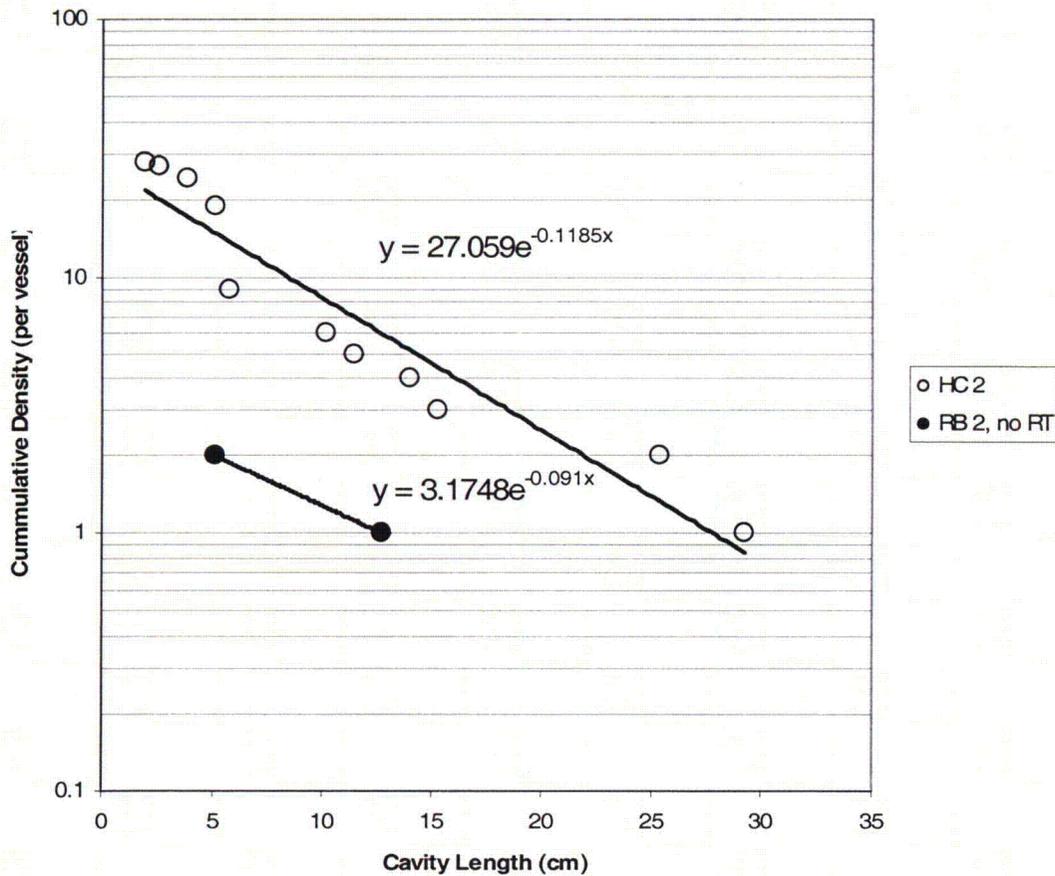
Figure 2.4 shows a comparison of the cladding repairs length distributions for the Hope Creek Unit 2 and River Bend Unit 2 RPVs. Changes in the weld procedure specification, the quality of the base metal, and other factors may explain the different defect densities in the cladding for the two vessels. Figure 2.5 shows a comparison of estimated repair frequency in the cladding of the PVRUF, Hope Creek Unit 2, and River Bend Unit 2 RPVs. The earlier vessel, Hope Creek Unit 2 RPV, had many more repairs to the cladding than the PVRUF and River Bend Unit 2 RPVs, which were fabricated later.

Figure 2.4 Comparison of Cavity Length of Cladding Repairs in the Hope Creek Unit 2 and River Bend Unit 2 RPVs

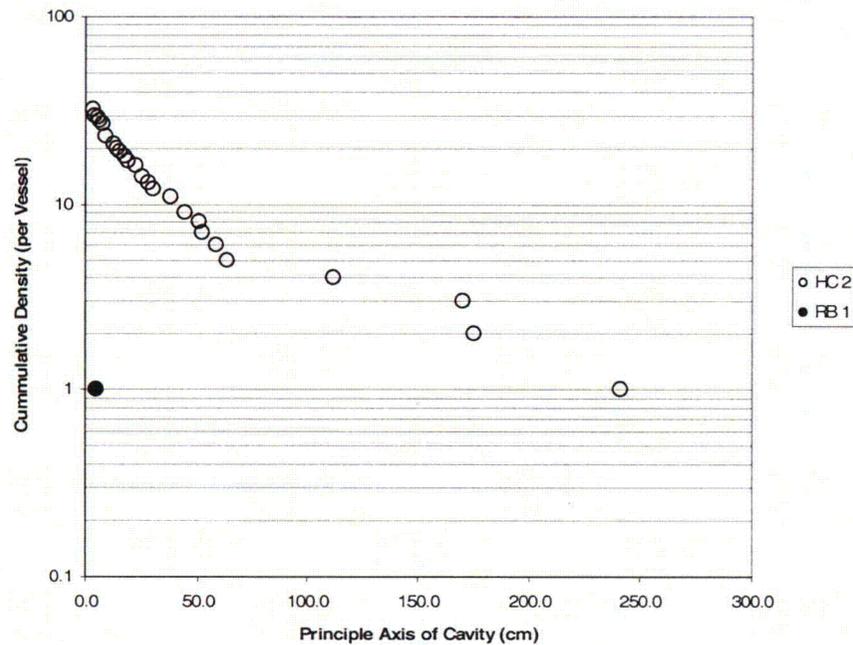
Figure 2.6 shows a comparison of base metal repairs principal axis (length) distributions in the Hope Creek Unit 2 and River Bend Unit 2 RPVs. Most of the difference in the defect densities in the base metal for the two vessels can be explained by changes in the quality of the base metal. Other factors (such as NDE of base metal) may contribute to the defect densities in the base metal for the two vessels. Figure 2.7 shows a comparison of estimated repair frequency in the base metal of the three RPVs. The 11 repairs to the base metal of the nozzle forgings of the PVRUF RPV is an interesting case of a repair frequency unusually high for a more recently manufactured vessel.

**Figure 2.6 Comparison of Cavity Length in the Base Metal of Hope Creek Unit 2 and River Bend Unit 2 RPVs. Dimensions as described in the text.**

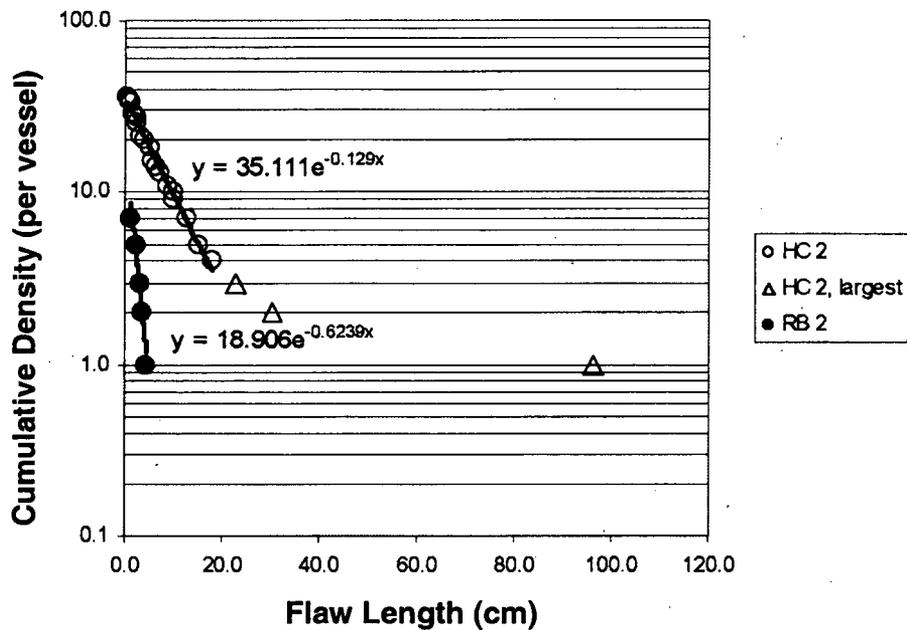
Seam weld flaw length distributions in the Hope Creek Unit 2 and River Bend Unit 2 RPVs are compared in Figure 2.10. The flaw length distribution for flaws found during the repair process is shown to emphasize the change in weld quality between the vessels. Changes in the weld procedure specification, the quality of the weld materials, and other factors may explain the different defect densities in the seam welds for the two vessels.

**Figure 2.10 Comparison of Defect Length in the Seam Welds of the Hope Creek Unit 2 and River Bend Unit 2 RPVs**

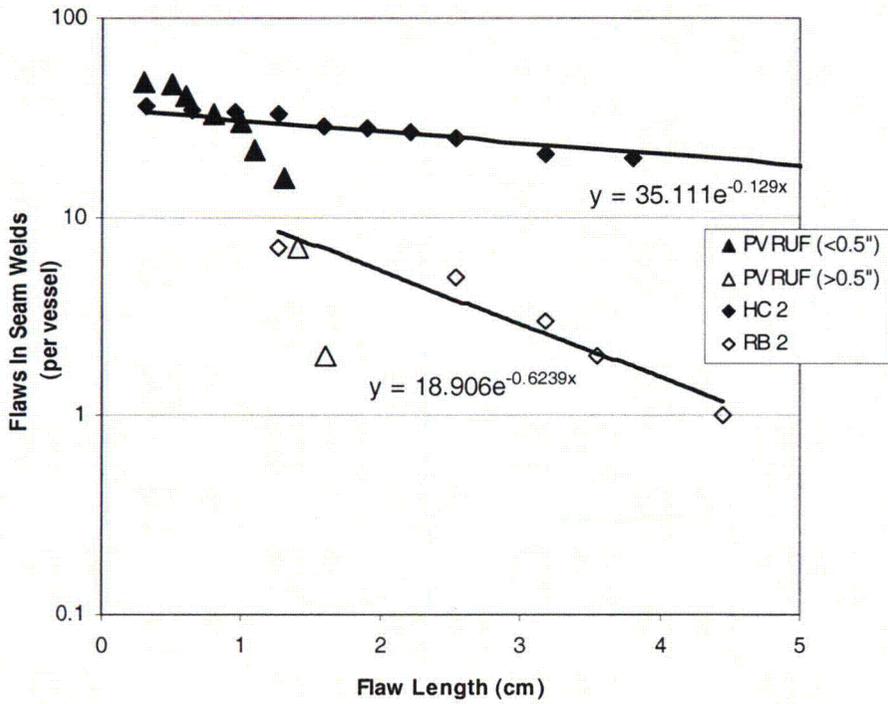
Figure 2.11 shows a comparison of flaw length in the seam welds of all three RPVs. The first 5 cm of length for the cumulative flaw density for PVRUF, Hope Creek Unit 2, and River Bend Unit 2 are shown. The exponential fits from Figure 2.10 are shown again. The cumulative length data for acceptable nonporosity indications found in PVRUF by RT also are shown. The PVRUF data are divided into two distributions—less than 13 mm and greater than 13 mm. Most radiographic indications greater than 13 mm long were repaired and not reported (because they were removed) in the RT indication data, so the data points for that distribution in Figure 2.11 are artificially low. For acceptable nonporosity with lengths less than 1 cm, the distributions for PVRUF and Hope Creek Unit 2 RPV are similar. Figure 2.12

Figure 2.11 Comparison of Flaw Length in the Seam Welds of Three RPVs

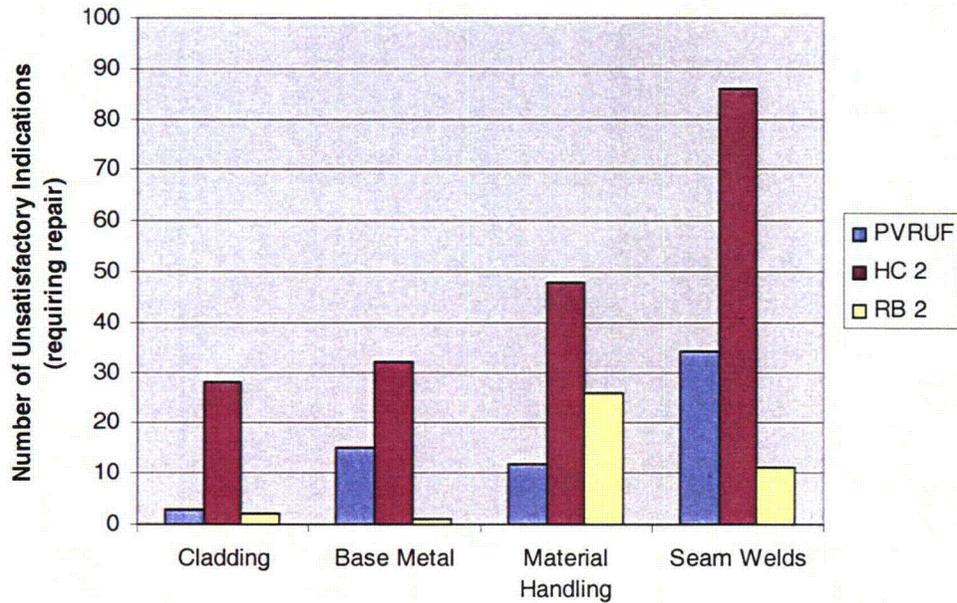
From the construction records, it is possible to extract the number of defects requiring repair. Figure 2.13 provides data by product form—cladding, base metal, and seam welds. Material handling is also included in the analysis. Material handling defects that required repair were typically caused by damage during temporary attachment removal. The construction records for three vessels—PVRUF, Hope Creek Unit 2, and River Bend Unit 2—were analyzed to obtain the information provided in Figure 2.13. The data show that vessel-to-vessel variation in the number of defects requiring repair can be as much as a factor of 10.

**Figure 2.13 Summary of Repair Frequency for Three Reactor Pressure Vessels**

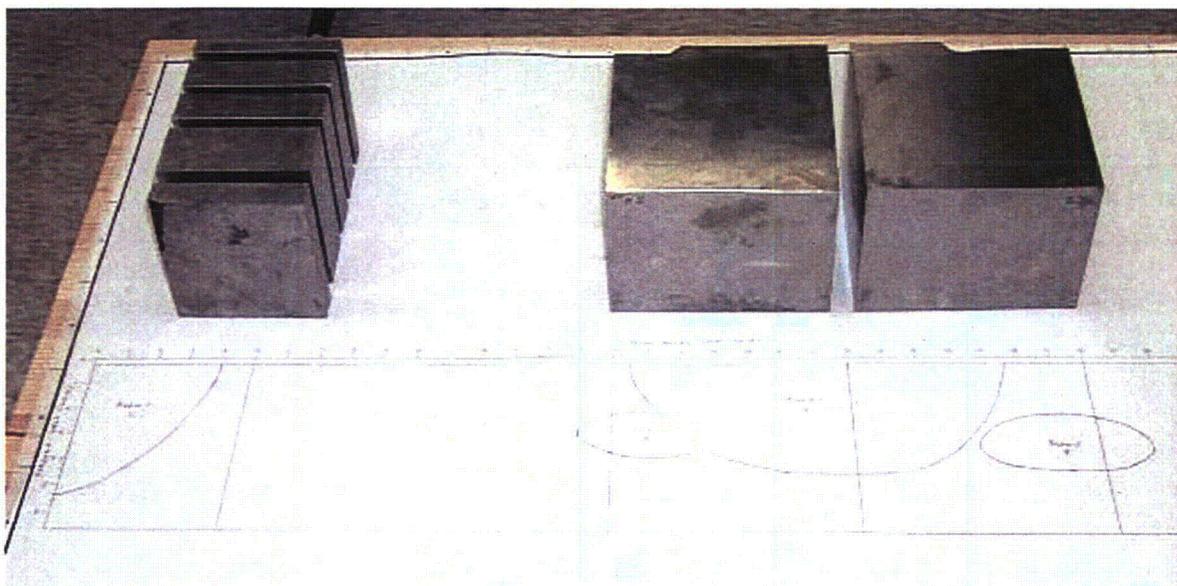
Figure 3.3 shows some of the sectioning of repair metal from a Hope Creek Unit 2 specimen. The repairs were found in the images produced using the Synthetic Aperture Focusing Technique for Ultrasonic Testing (SAFT-UT) because of reflections from the small welding flaws in the repairs. Enough small flaws are present in the fusion zone of the repair metal with the surrounding material to permit the mapping of the cavity surface. Once this is done, the sectioning of the repair metal can take place for the validation measurements of the flaws. Figure 3.4 shows an example of validation using film radiography of a repair flaw in PVRUF. Information on PNNL's validation methodology can be found in Doctor and Schuster (2001).

**Figure 3.3** Sectioning of Repair Metal from Hope Creek Unit 2

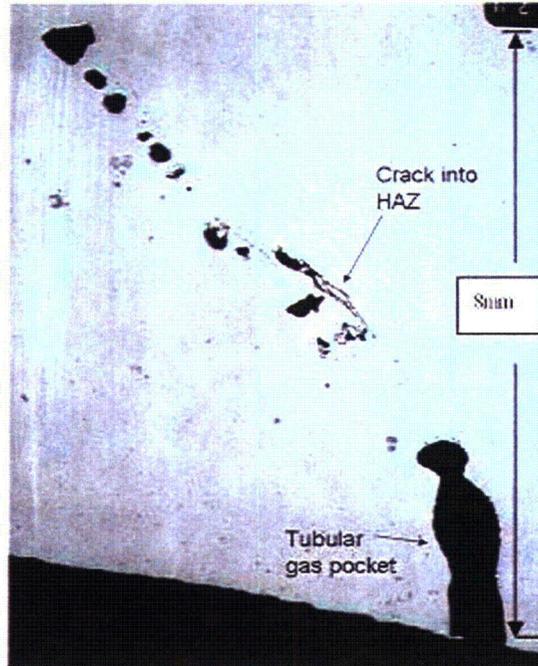
The largest repair flaw found in a seam weld of the PVRUF reactor pressure vessel had a through-wall dimension of 17 mm. Figure 4.1 shows radiographic images of this PVRUF 17-mm flaw in a repair to the beltline weld of PVRUF reactor pressure vessel. The repair was made from the outside diameter (OD) of the vessel to a depth of 16.5 cm. The start of the flaw is labeled on Figure 4.1, and the flaw continues for three weld passes. The individual weld passes are labeled in Figure 4.1. At the end of the third weld pass, the flaw changes from side-wall lack of fusion to inter-run lack of fusion (between the repair metal weld passes). Figure 4.2 is a micrograph of a portion of the PVRUF 17-mm flaw. The heat-affected zone, base metal, repair metal, and machine-made submerged arc weld (SAW) are labeled. The location of this portion of the PVRUF 17-mm flaw is in the fusion zone of the repair metal. The composition of the flaw is slag, porosity, and contamination. Figure 4.3 is a micrograph showing a magnified view of a portion of the PVRUF 17-mm flaw. A crack-like discontinuity is visible. Figure 4.4 is another micrograph showing a magnified view of a crack-like portion of the PVRUF 17 mm flaw. The crack originates from a small contaminated region between the weld beads. Figure 4.5 is a weld-normal UT C-Scan image of the weld fusion zone showing the profile of the weld repair cavity containing the PVRUF 17-mm flaw. The cavity profile is a low-energy signature produced by an absence of small discontinuities in the repair metal. The PVRUF 17-mm flaw is labeled in Figure 4.5.

**Figure 4.3** Micrograph Showing Magnified View of Portion of PVRUF 17-mm Flaw

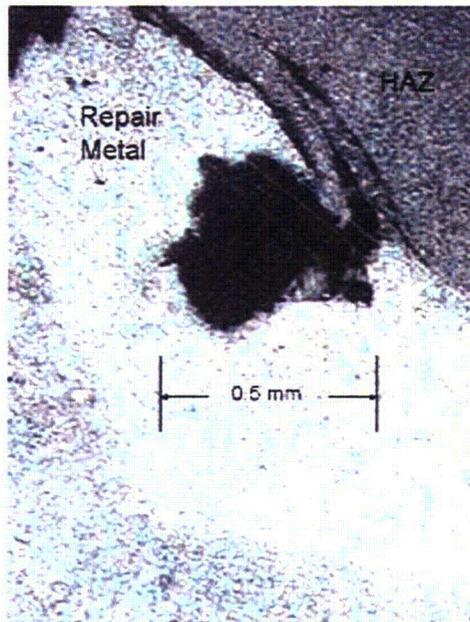
**Figure 4.4** Micrograph Showing Magnified View of Crack-Like Portion of PVRUF 17-mm Flaw

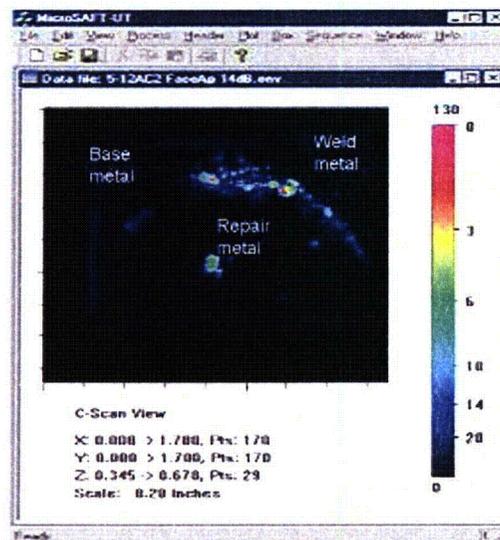
The second largest flaw found in a seam weld repair in PNNL's specimens from the PVRUF reactor pressure vessel had a through-wall dimension of 12 mm. Figure 4.6 is a focused ultrasound (10 MHz) image showing the top view of the PVRUF 12-mm repair flaw. Like all large repair flaws, it is located on the end of the repair in the fusion zone of the repair metal with surrounding metal. Vessel through-wall direction is into the page. The distance along the beltline weld is on the ordinate. This image shows that the flaw is oriented principally in the axial direction. Figure 4.7 is a focused ultrasound (10 MHz) image showing a side view of the PVRUF 12-mm flaw. The vessel through-wall direction is on the ordinate. Distance from weld center is into the page. Distance along the beltline weld is on the abscissa. Figure 4.8 is a focused ultrasound (10 MHz) image showing an end view of the PVRUF 12-mm flaw. Vessel through-wall direction is on the ordinate. Distance from weld center is on the abscissa. Distance along the beltline weld is into the page.

**Figure 4.6 Focused Ultrasound (10 MHz) Result Showing Top View of PVRUF 12-mm Repair Flaw. To convert to centimeters, multiply by 2.54.**

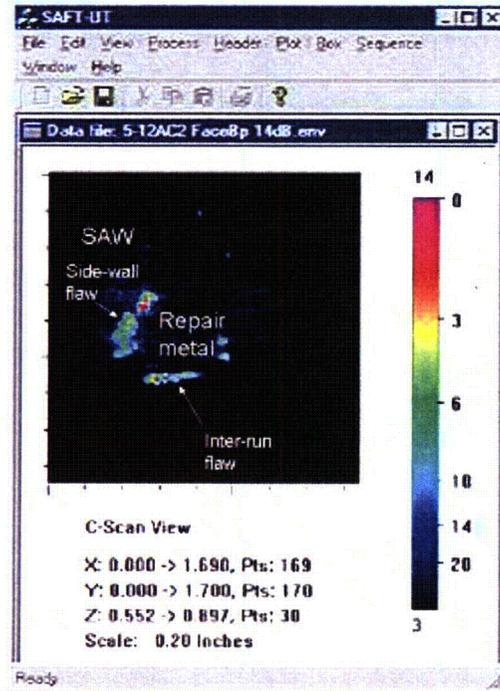
**Figure 4.7 Focused Ultrasound (10 MHz) Result Showing Side View of PVRUF 12-mm Flaw. To convert to centimeters, multiply by 2.54.**

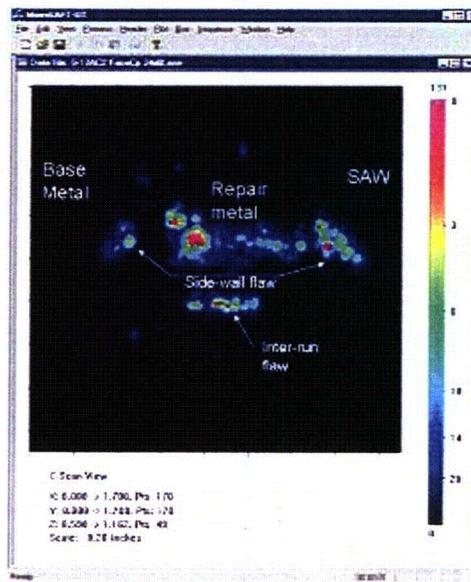
**Figure 4.8 Focused Ultrasound (10 MHz) Result Showing End View of PVRUF 12-mm Flaw. To convert to centimeters, multiply by 2.54.**

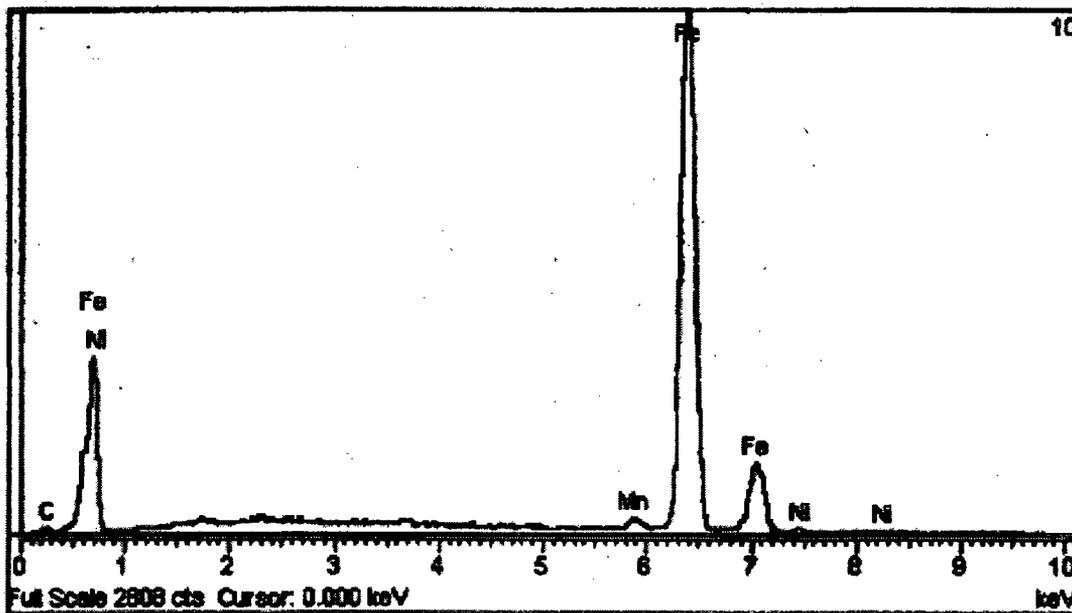
Figure 4.14, an electron image of a portion of two cracks in Hope Creek 2 RPV Specimen C2CC, shows the location, just above the lower crack, of the measurement of the elemental composition of the weld metal. Figure 4.15 gives the elemental composition of weld metal near the crack, and Figure 4.16 provides the x-ray spectrum from that elemental analysis.

Figure 4.16 X-Ray Spectrum from Elemental Analysis of Weld Metal in Hope Creek Unit 2 RPV Specimen C2CC

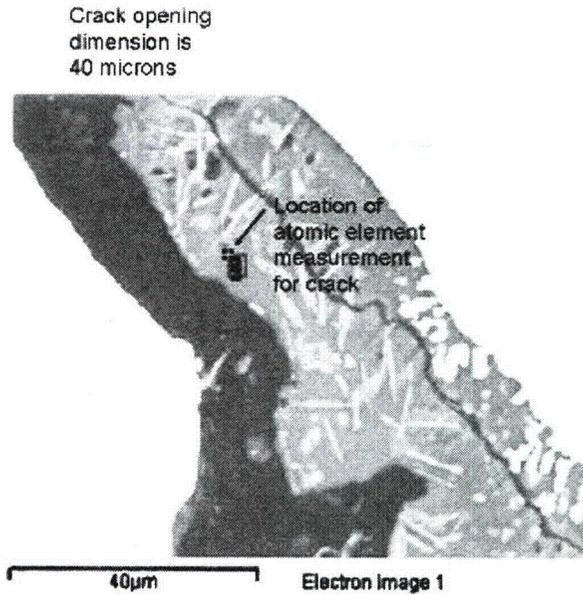
Figure 4.17, an electron image of a portion of a crack in Hope Creek 2 RPV specimen C2CC, shows the location, inside the upper crack, of the measurement of the elemental composition of the contamination in the crack. Figure 4.18 gives the elemental composition of contamination in the crack in Hope Creek 2 RPV Specimen C2CC; Figure 4.19 provides the x-ray spectrum from that elemental analysis.

Figure 4.17 Electron Image of Portion of Crack in Hope Creek Unit 2 RPV Specimen C2CC

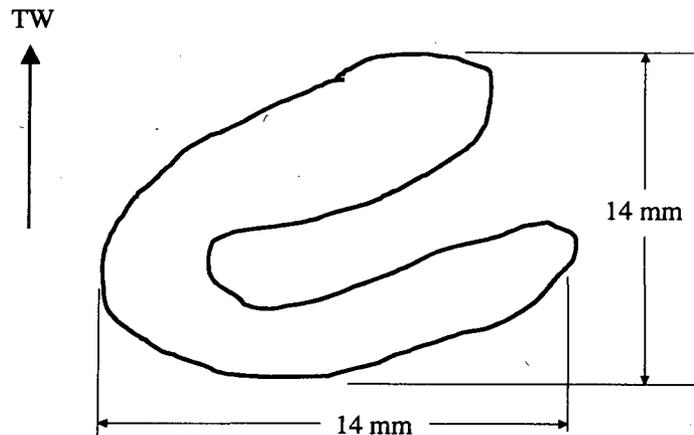
- **14-mm Shoreham Repair Flaw.** The original measurements characterized this flaw with dimensions in vessel coordinates having a maximum through-wall dimension of about 14 mm. The more refined SAFT examinations showed a more complex shape having two major subregions that could be connected (Figure 4.20) or unconnected (Figure 4.21). Fracture mechanics calculations would show that the flaw interpretation of Figure 4.21 would give a significantly smaller impact on structural integrity because the critical flaw dimensions have been reduced from a single flaw of 14 mm to separate flaws with dimensions of 4 mm and 5 mm. There are uncertainties regarding the separation distance between the legs of the complex flaw and with the structural soundness of the region joining the ends of the two subregions. The recommendation, subject to change based on further steps in the validation effort, is to describe the flaw with a dimension of 14 mm.

**Figure 4.20 Shoreham 14-mm Repair Flaw with More Conservative Treatment A of Flaw Dimensions**

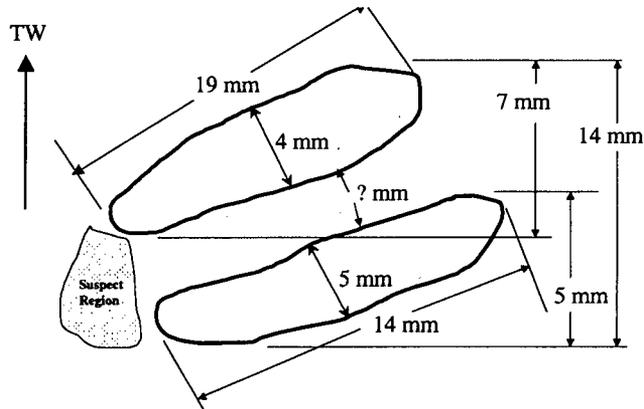
**Figure 4.21 Shoreham 14-mm Repair Flaw with Less Conservative Treatment B of Flaw Dimensions**

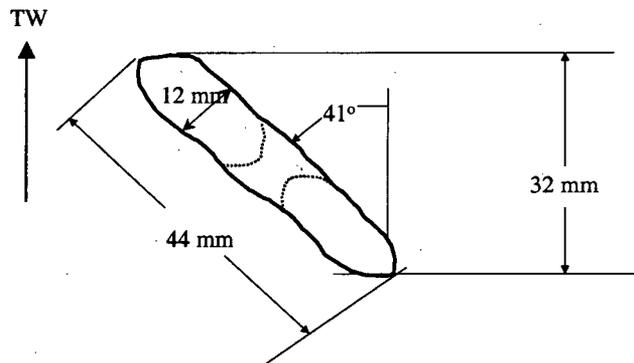
- **32-mm Shoreham Repair Flaw.** The original measurements characterized this flaw with dimensions in vessel coordinates having a maximum through-wall dimension of about 32 mm. The more refined SAFT examinations showed a flawed region bounded by dimensions of 12 mm and 44 mm. The 32-mm maximum through-wall extent was confirmed showing an elongated flaw at an angle of about 45 degrees. The proper characterization of this flaw for fracture mechanics calculations of stress intensity factors would be a smaller flaw with dimensions having a depth of 12 mm and a length of 44 mm. There are uncertainties regarding the possible separation of the single elongated flaw into separate flaws as indicated in Figure 4.23. However, the dimension of the ligament between the separate flaws is subject to uncertainties such that ASME Code flaw proximity rules would need to combine the two flaws into one flaw. The recommendation, subject to change based on further steps in the validation effort, is to describe the flaw as a single flaw with dimensions of 12 mm and 44 mm. This characterization removes a large measure of conservatism from the earlier evaluation by dealing with the large apparent through-wall dimension of 32 mm with recognition of the 42-degree flaw orientation or rotation. The rotation decreases the measured maximum through-wall dimension of the flaw but does nothing to increase the value of the calculated crack-tip stress intensity factor.

**Figure 4.22 Shoreham 32-mm Repair Flaw with More Conservative Treatment A of Flaw Dimensions**

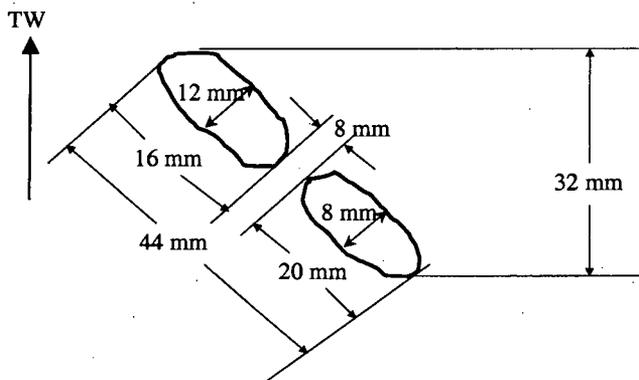
**Figure 4.23 Shoreham 32-mm Repair Flaw with Less Conservative Treatment B of Flaw Dimensions**

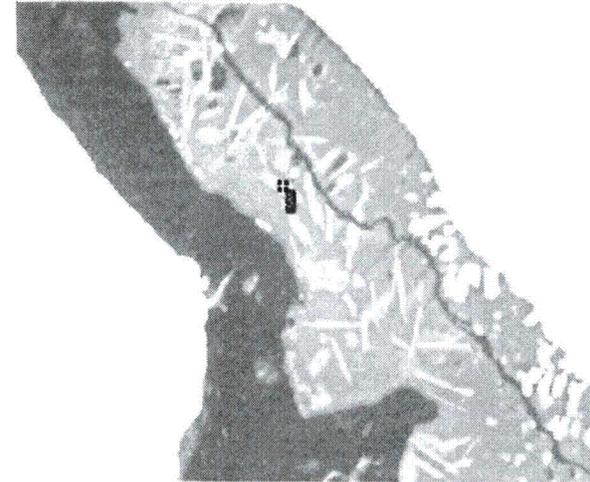
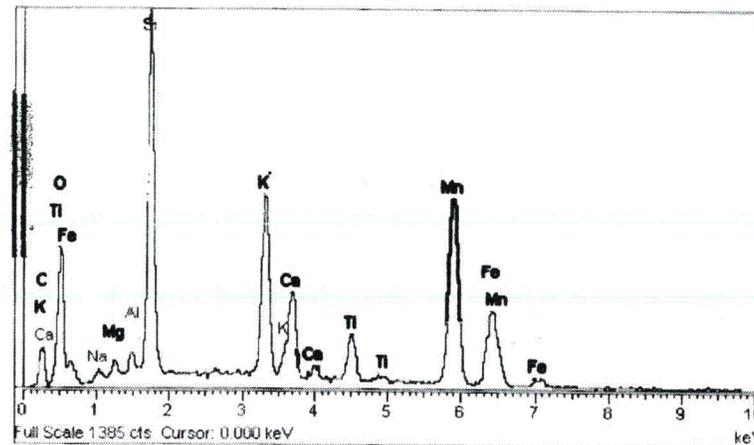
Figure B.9 Elemental Analysis of Flaw in C2CC on the End of Seam Repair C

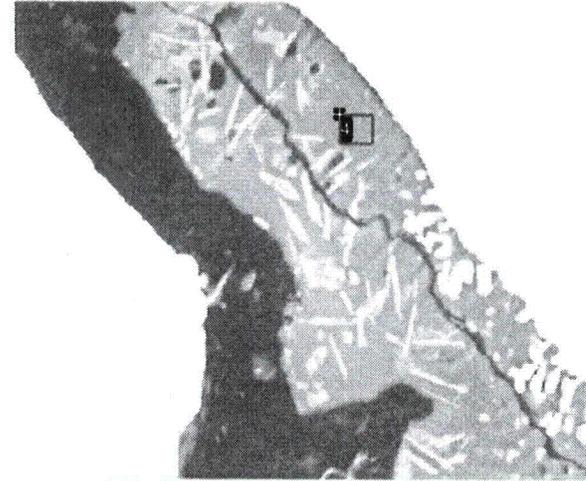
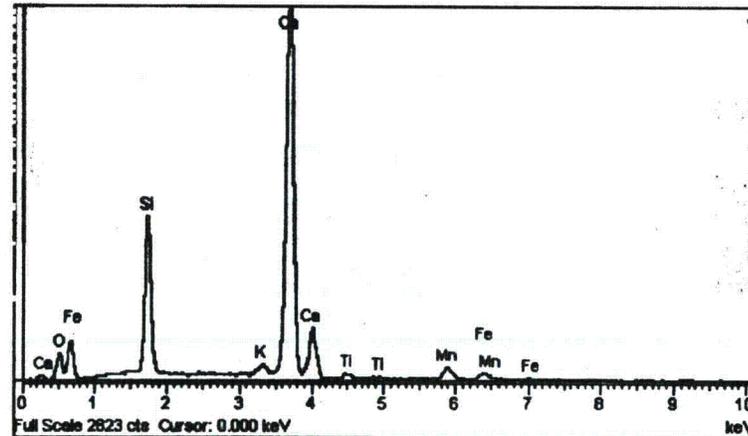
Figure B.10 Elemental Analysis of Flaw in C2CC on the End of Seam Repair C

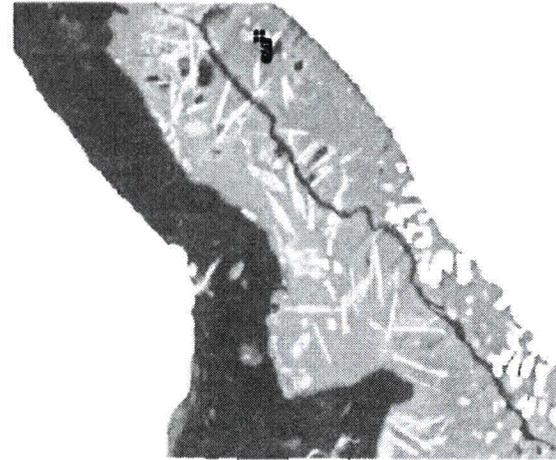
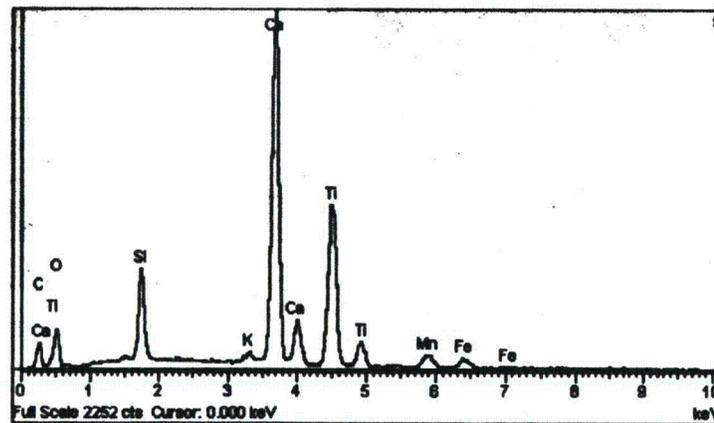
Figure B.12 Elemental Analysis of Flaw in C2CC on the End of Seam Repair C

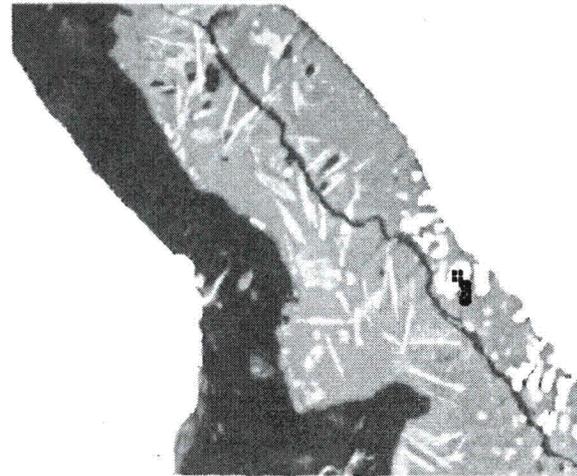
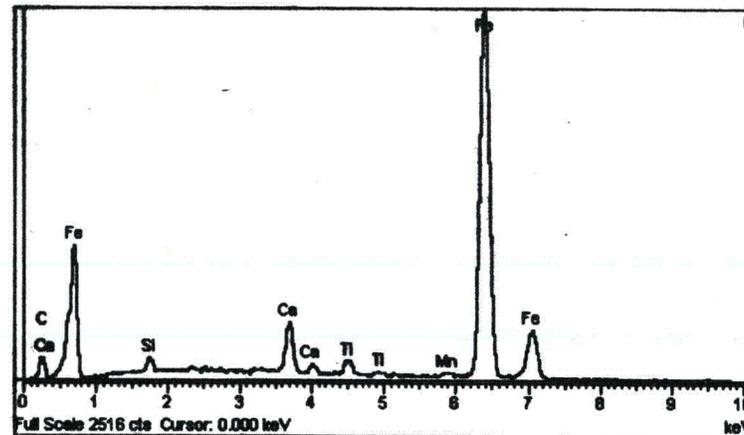
Figure B.13 Elemental Analysis of Flaw in C2CC on the End of Seam Repair C

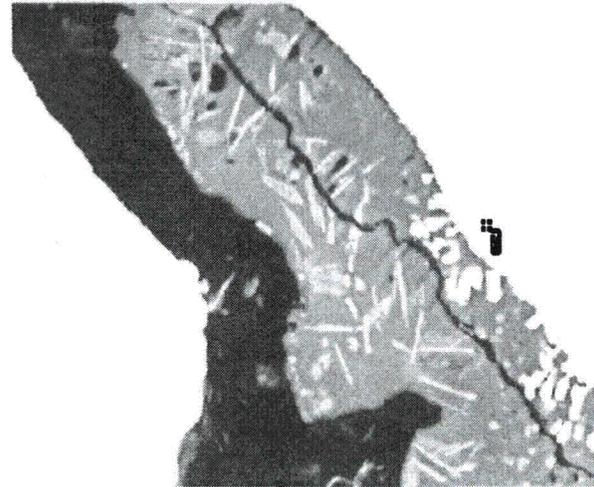
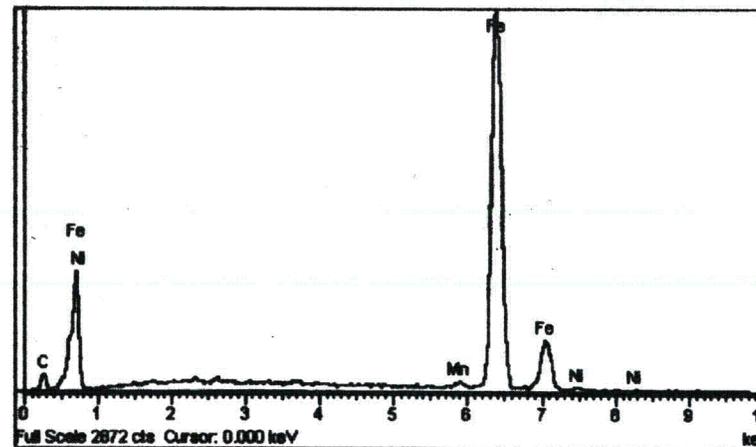
Figure B.15 Elemental Analysis of Flaw in C2CC on the End of Seam Repair C

Element	App	Intensit	Weight	Weight	Atomic
	Conc.	y	%	%	%
		Corrn.		Sigma	
Mn K	0.98	0.9778	0.96	0.16	0.97
Fe K	102.83	1.0011	97.96	0.27	98.00
Ni K	1.00	0.8800	1.08	0.22	1.03
Totals			100.00

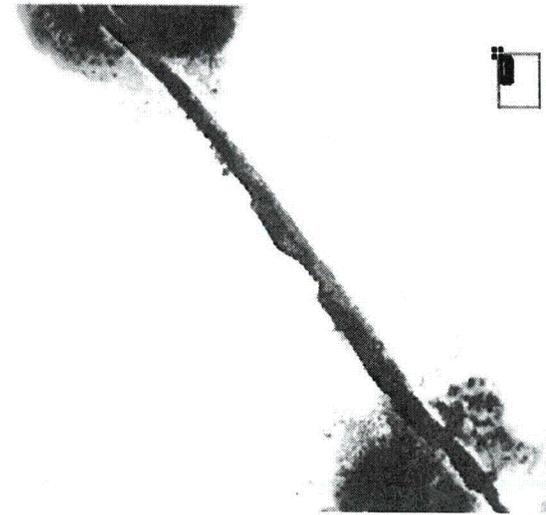
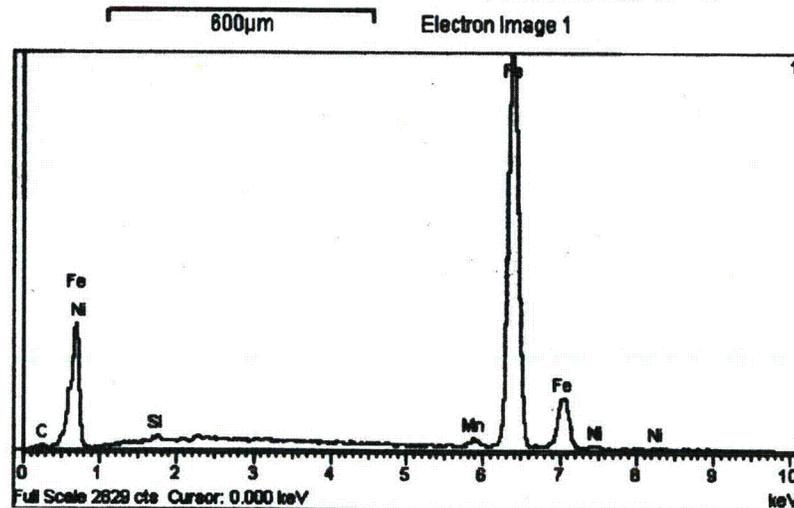
Figure B.16 Elemental Analysis of Flaw in C2CC on the End of Seam Repair C

Element	App Conc.	Intensit y Corrn.	Weight % Sigma	Weight % Sigma	Atomic %
Si K	0.33	0.6325	0.49	0.11	0.98
Mn K	1.41	0.9773	1.35	0.16	1.38
Fe K	102.70	1.0012	95.80	0.45	96.14
Ni K	1.19	0.8830	1.26	0.21	1.20
Ti M	0.85	0.7202	1.10	0.36	0.30
Totals			100.00
