2008-128 _____ BWR Vessel & Internals Project (BWRVIP)

Subject: Additional BWRVIP commitments to revise BWRVIP-139

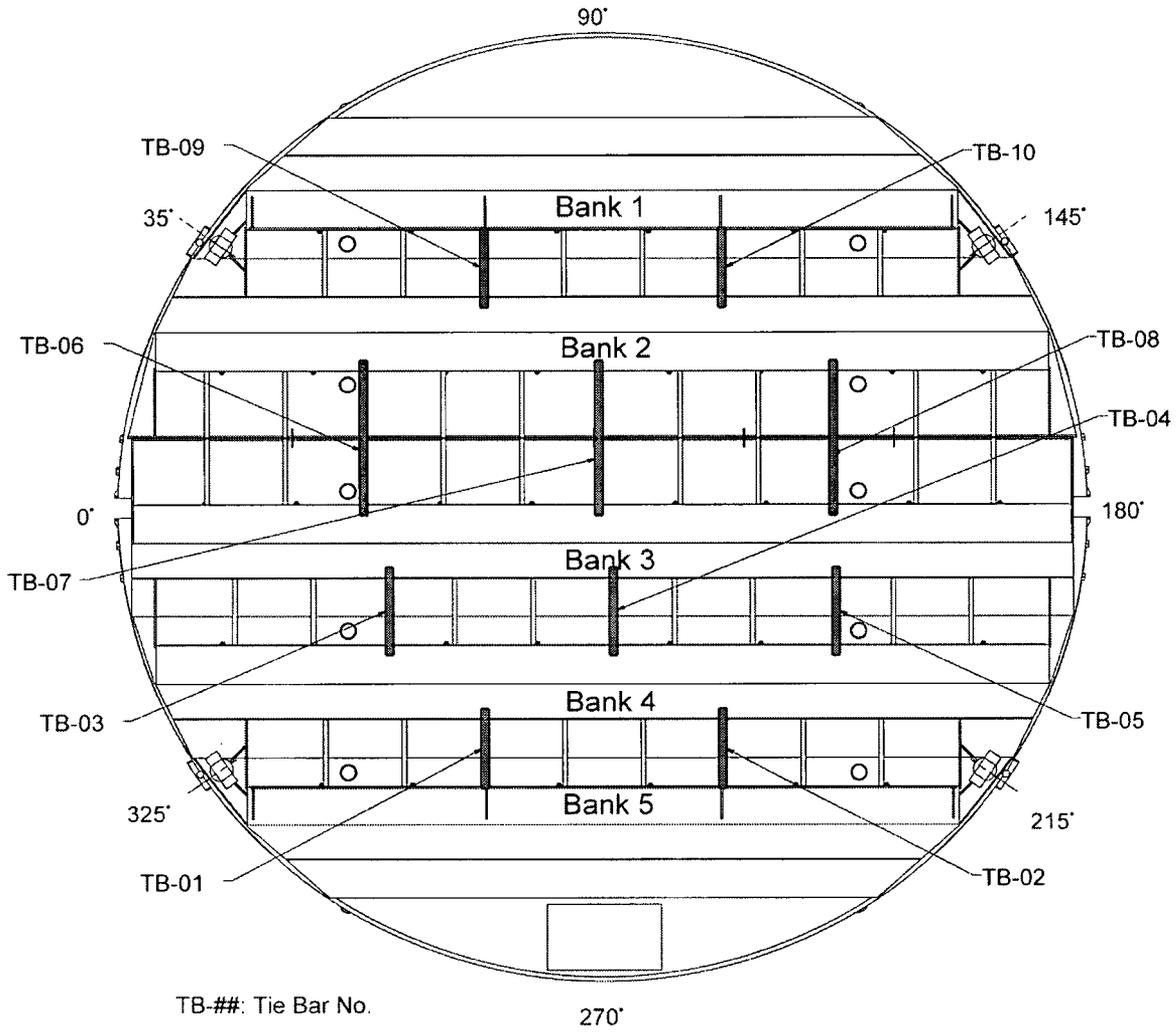
Figure C-10: Tie Bar Locations (Slanted Hood Dryers)

In addition to the outer bank and interior bracket locations, tie bars also require inspection. Figure C-10 provides a schematic of the tie bar locations joining the tops of each set of banks. The primary concern is the presence of fatigue cracking through the bar base material cross-section at axial location where the tie bar is attached to the bank.

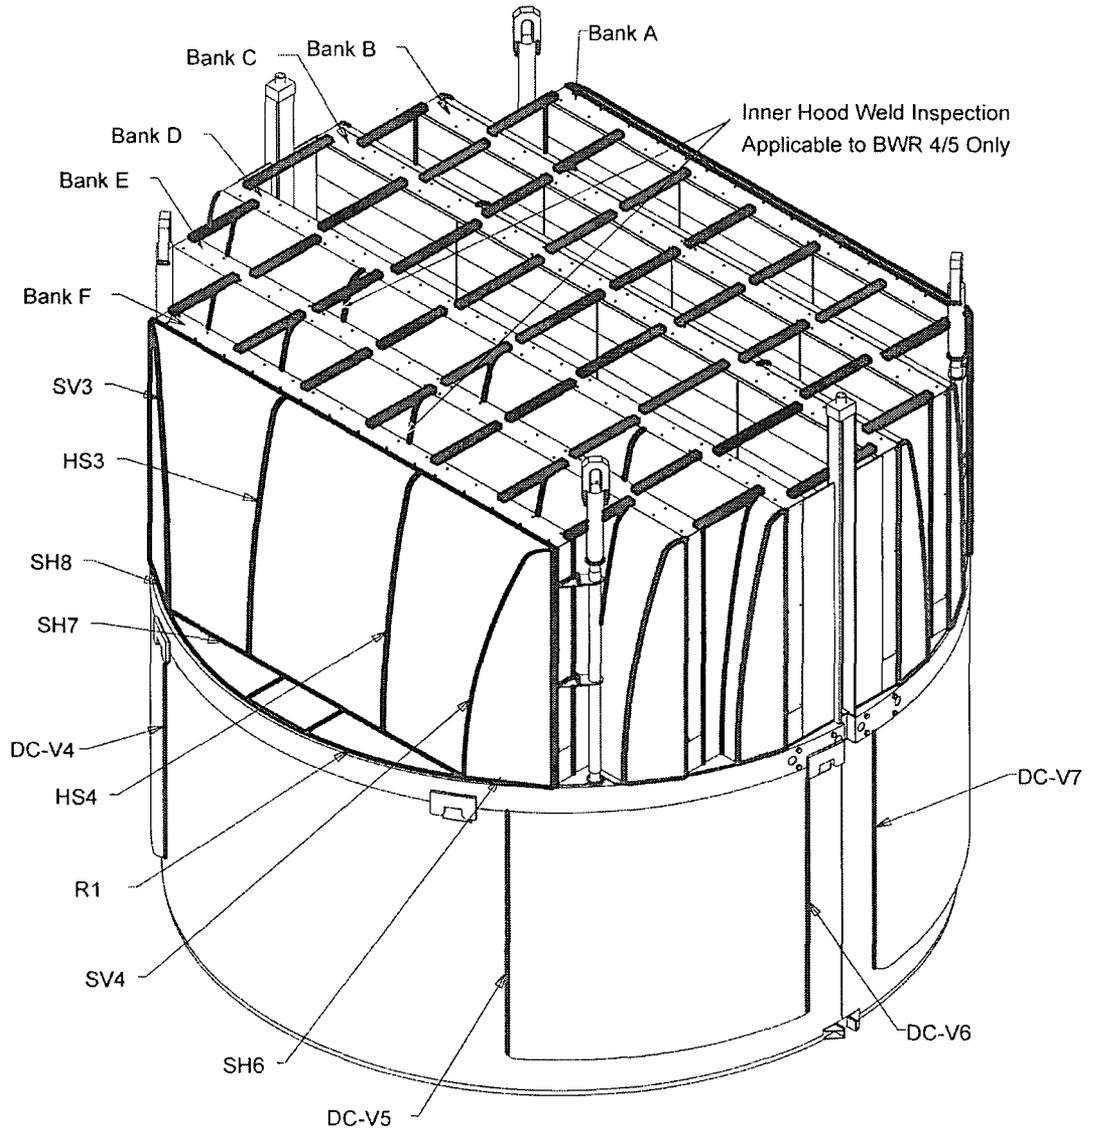
Figure C-11: Inspection Locations (Curved Hood Dryer)

Cracking has been detected in the end panels in later design dryers. Therefore, these additional weld seams associated with the outer side of the inner banks should also be inspected in that this represents a steam path through the dryer. These areas are shown in green in Figure C-11. Cracking has been observed in these locations in dryers of this design. The other locations of interest are primarily associated with IGSCC in drain channels (refer to SIL No. 474 “Steam Dryer Drain Channel Cracking” issued October 26, 1988) and lifting rod attachments.
