# **Grain Boundary Damage in Alloy 690 after One Dimensional Cold Rolling *Preliminary Observations***

*Matt Olszta, Dan Edwards and Steve Bruemmer  
Pacific Northwest National Laboratory*

**2008 ICG-EAC**

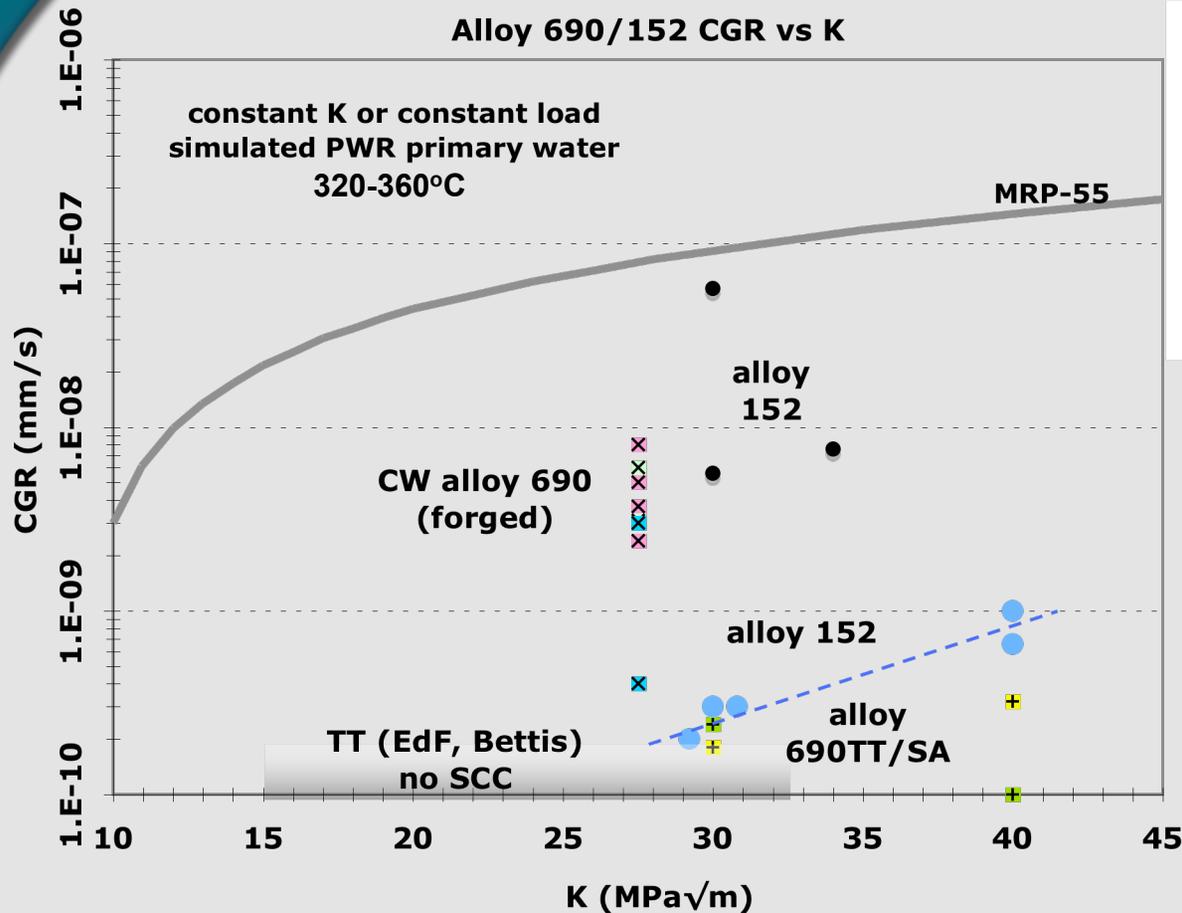
# Alloy 690/152 Data (Excluding 1D Rolled)

*Limited CGR data for LWR material conditions of alloy 690/152/52. Many tests report no SCC.*

➤ As-received, thermally treated or solution annealed alloy 690 exhibits extremely low constant K, CGRs ( $<5 \times 10^{-10}$  mm/s) or no SCC. Cold work by forging increases CGRs, still  $<1 \times 10^{-8}$  mm/s.

➤ Alloy 152 weld metal has shown variable behavior.

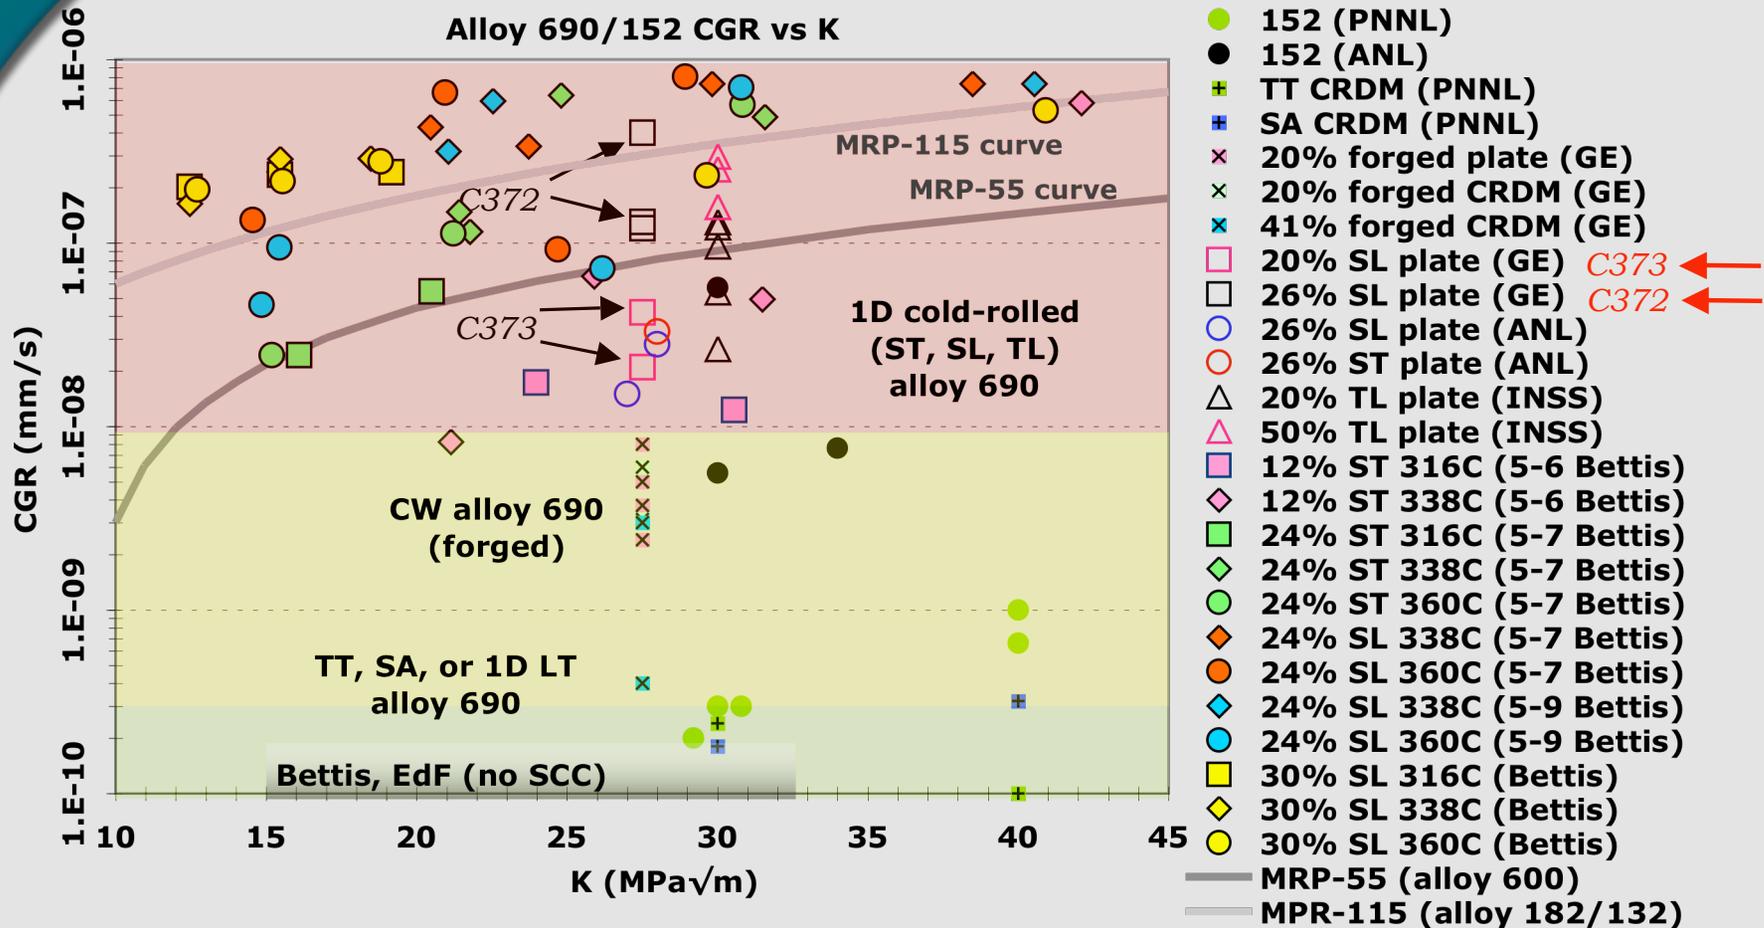
# All Alloy 690/152 Data - K Dependence

- 1D cold-rolled (S-L, S-T, T-L) materials exhibit high CGRs at constant  $K$  or constant load even at lower  $K$  values.
- Are 1D rolled materials relevant for LWR service components? Must understand high SCC susceptibility.

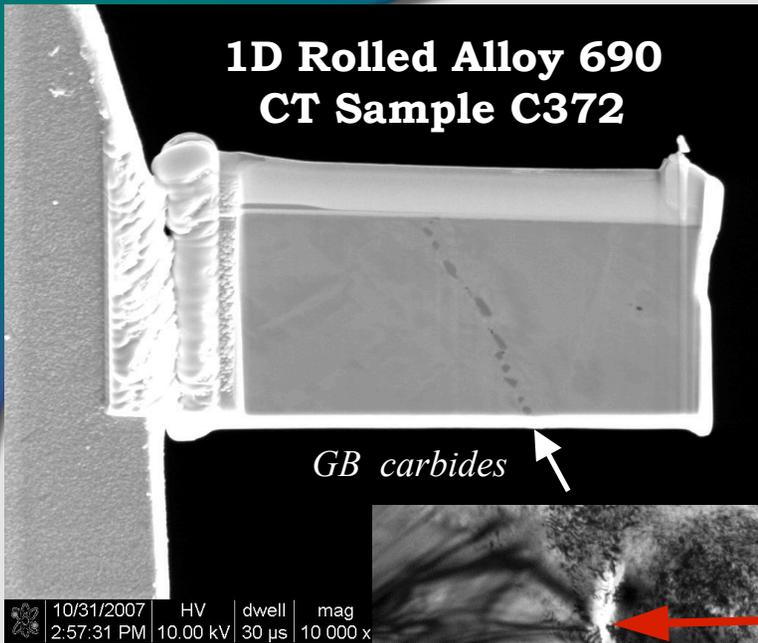
# 1D Rolled Alloy 690 CT Sample C372

FIB is being used to evaluate nm-scale damage along grain boundaries in 1D-rolled alloy 690 that show high IGSCC crack-growth rates during tests in PWR primary water. **Nanoscale cracks and/or voids** found by TEM at grain boundary carbide interfaces.

FIB has removed samples from regions far from the CT fracture surface. Samples cut from several different section orientations in an attempt to assess the 3D grain boundary characteristics.
