Grain Boundary Damage in Alloy 690 after One Dimensional Cold Rolling

Preliminary Observations

Matt Olszta, Dan Edwards and Steve Bruemmer
Pacific Northwest National Laboratory

2008 ICG-EAC

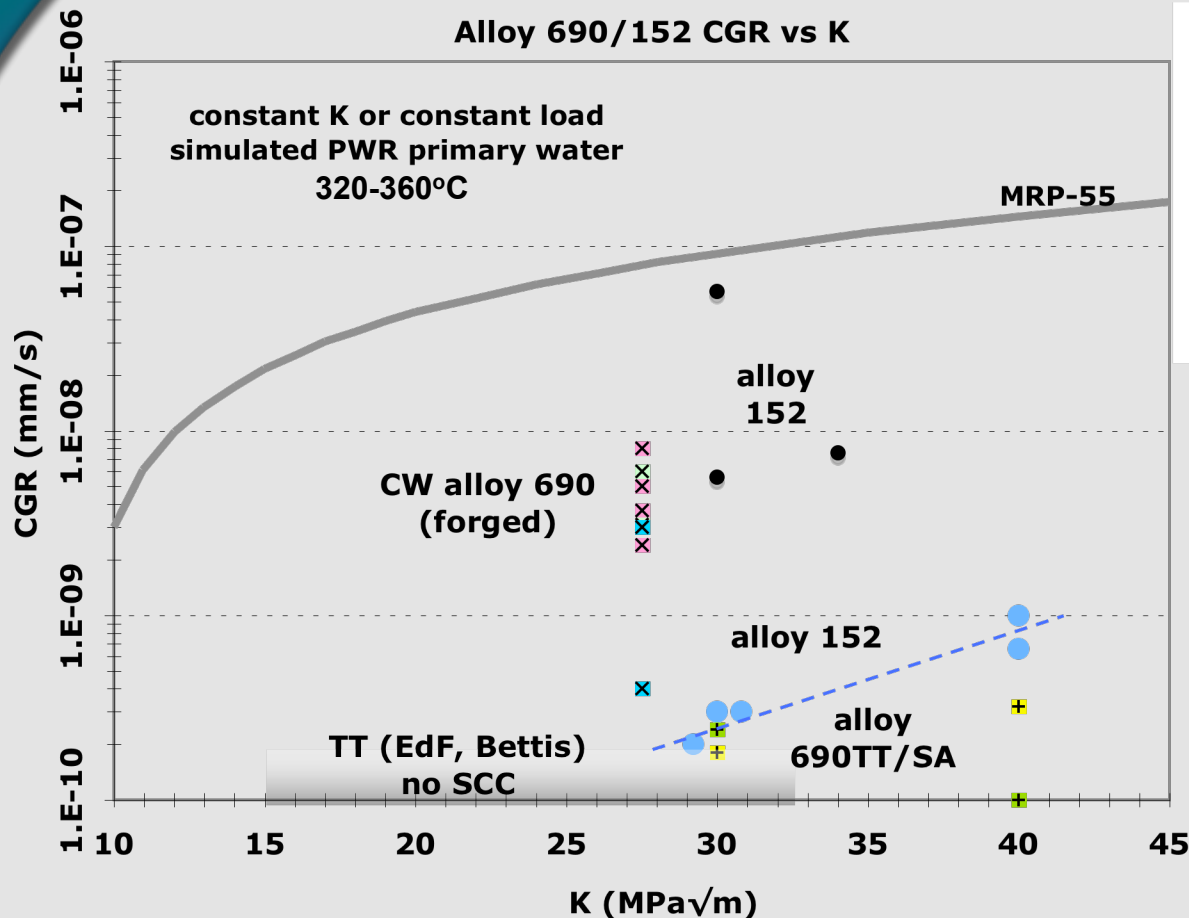
Alloy 690/152 Data (Excluding 1D Rolled)

Limited CGR data for LWR material conditions of alloy 690/152/52. Many tests report no SCC.

- As-received, thermally treated or solution annealed alloy 690 exhibits extremely low constant K, CGRs ($<5 \times 10^{-10}$ mm/s) or no SCC. Cold work by forging increases CGRs, still $<1 \times 10^{-8}$ mm/s.

➤ Alloy 152 weld metal has shown variable behavior.

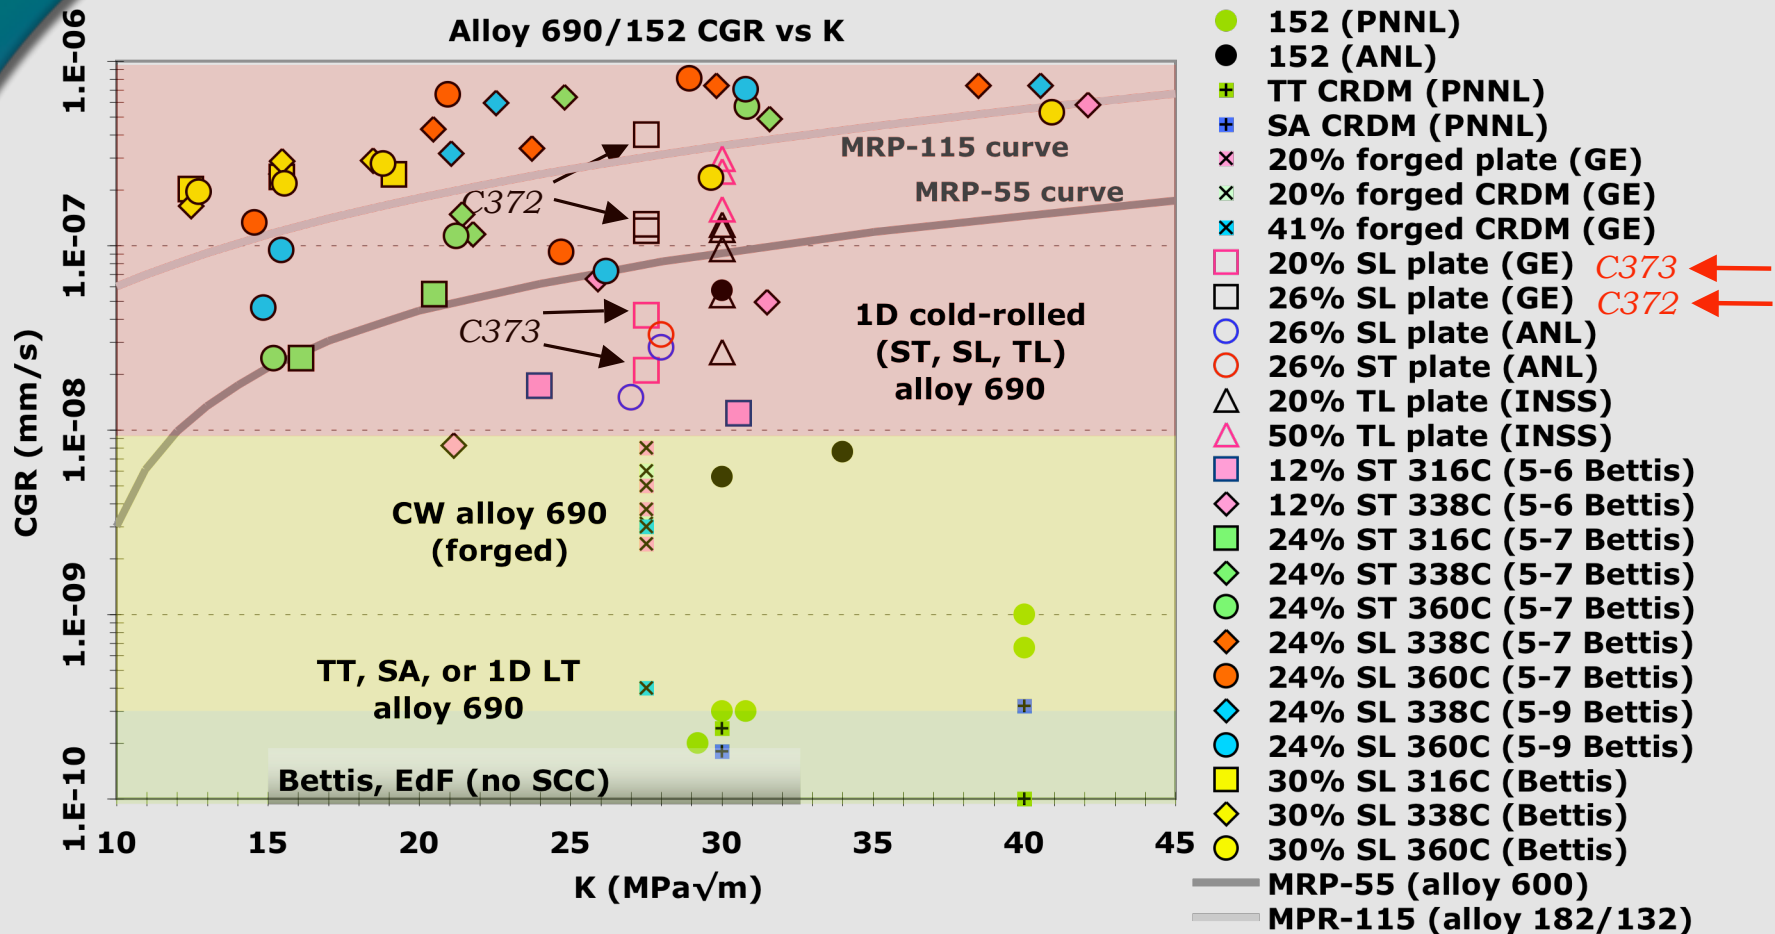
All Alloy 690/152 Data - K Dependence

- 1D cold-rolled (S-L, S-T, T-L) materials exhibit high CGRs at constant K or constant load even at lower K values.
- Are 1D rolled materials relevant for LWR service components? Must understand high SCC susceptibility.

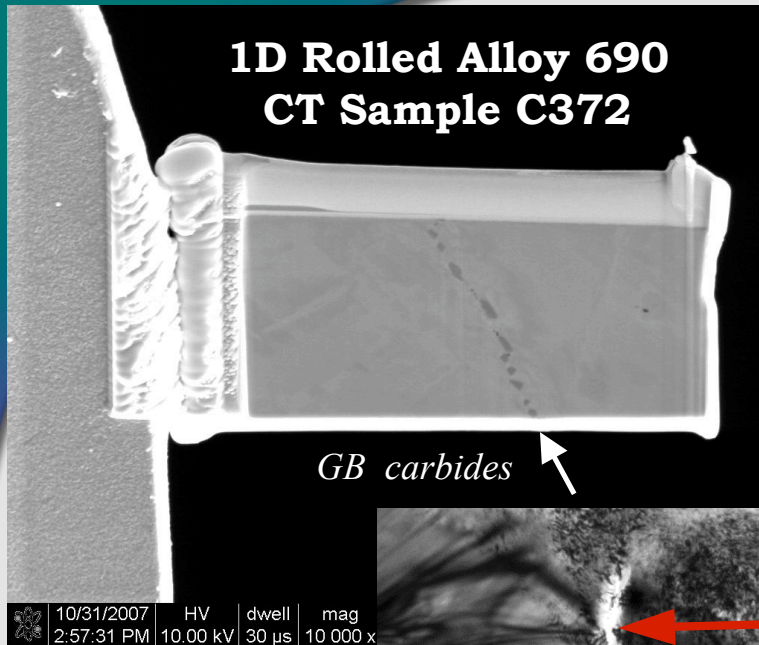
1D Rolled Alloy 690 CT Sample C372

*FIB is being used to evaluate nm-scale damage along grain boundaries in 1D-rolled alloy 690 that show high IGSCC crack-growth rates during tests in PWR primary water. **Nanoscale cracks and/or voids** found by TEM at grain boundary carbide interfaces.*

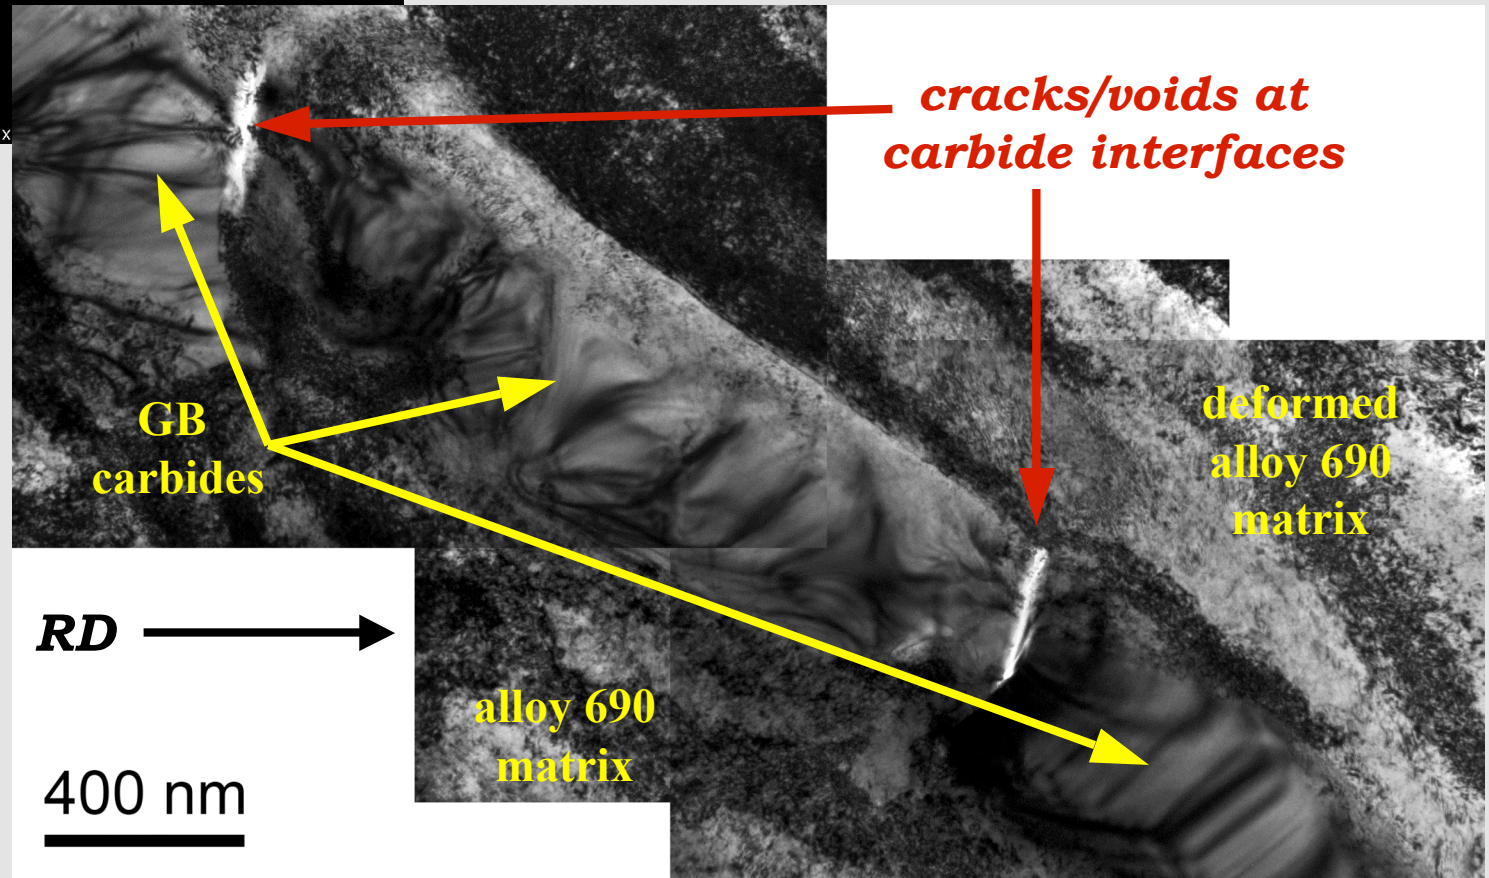
Alloy 690 Plate Heat NX3297HK12 ANL 26% Cold Rolled

TEM image from third series of FIB samples; crack separating carbides, high local strain at all carbide interfaces. EDS maps illustrating GB Cr carbides and Cr depletion.
