W3F1-2008-0039

SUBJECT: Steam Generator Conditions Observed at Waterford 3 During Refueling Outage 15 Waterford Steam Electric Station, Unit 3 Docket No. 50-382

SG31 Secondary Side Inspection Results Summary and Conclusions - Spring 2008 RF15 Outage

SG32 Secondary Side Inspection Results Summary and Conclusions - Spring 2008 Refuel 15 Outage

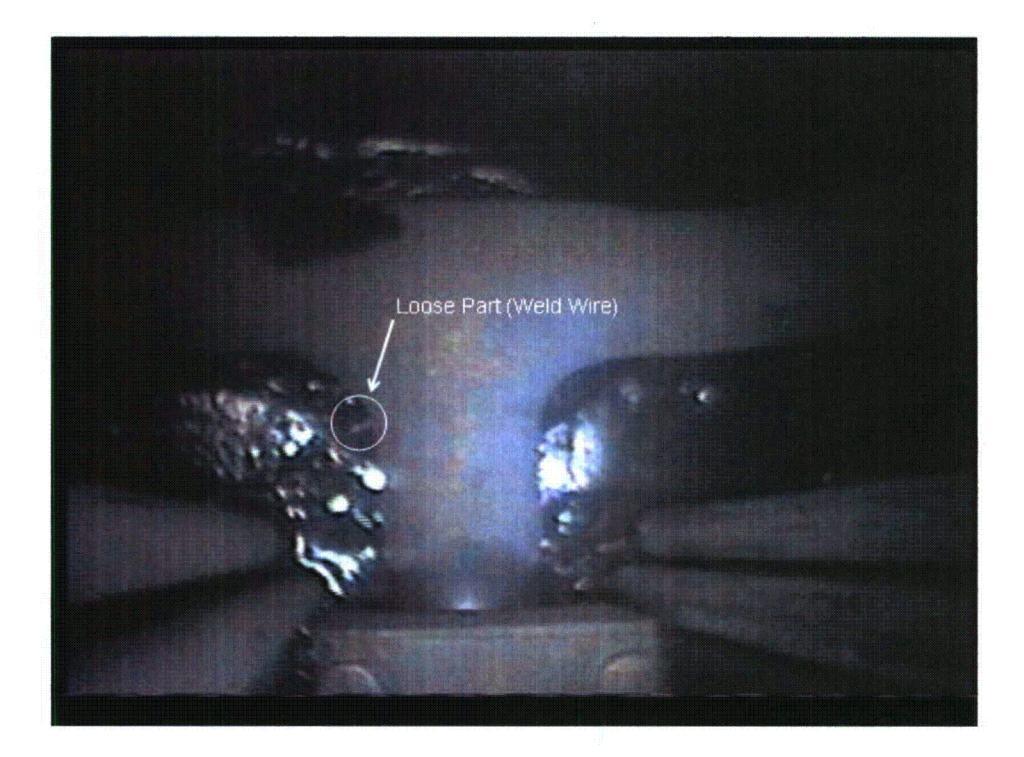
A Foreign Object Search and Retrieval inspection was performed following all secondary side work. The FOSAR inspection followed sludge lancing and included all accessible regions of the tube sheet secondary surface including the central cavity, tube lane and annulus regions. One piece of what appears to be weld wire was seen trapped under the blow down pipe. This piece was observed in the same location during RF13. Many attempts to remove it at that time were unsuccessful because it was lodged under the blowdown pipe. Retrieval during RF15 was not successful, and the part was evaluated and determined to be acceptable.

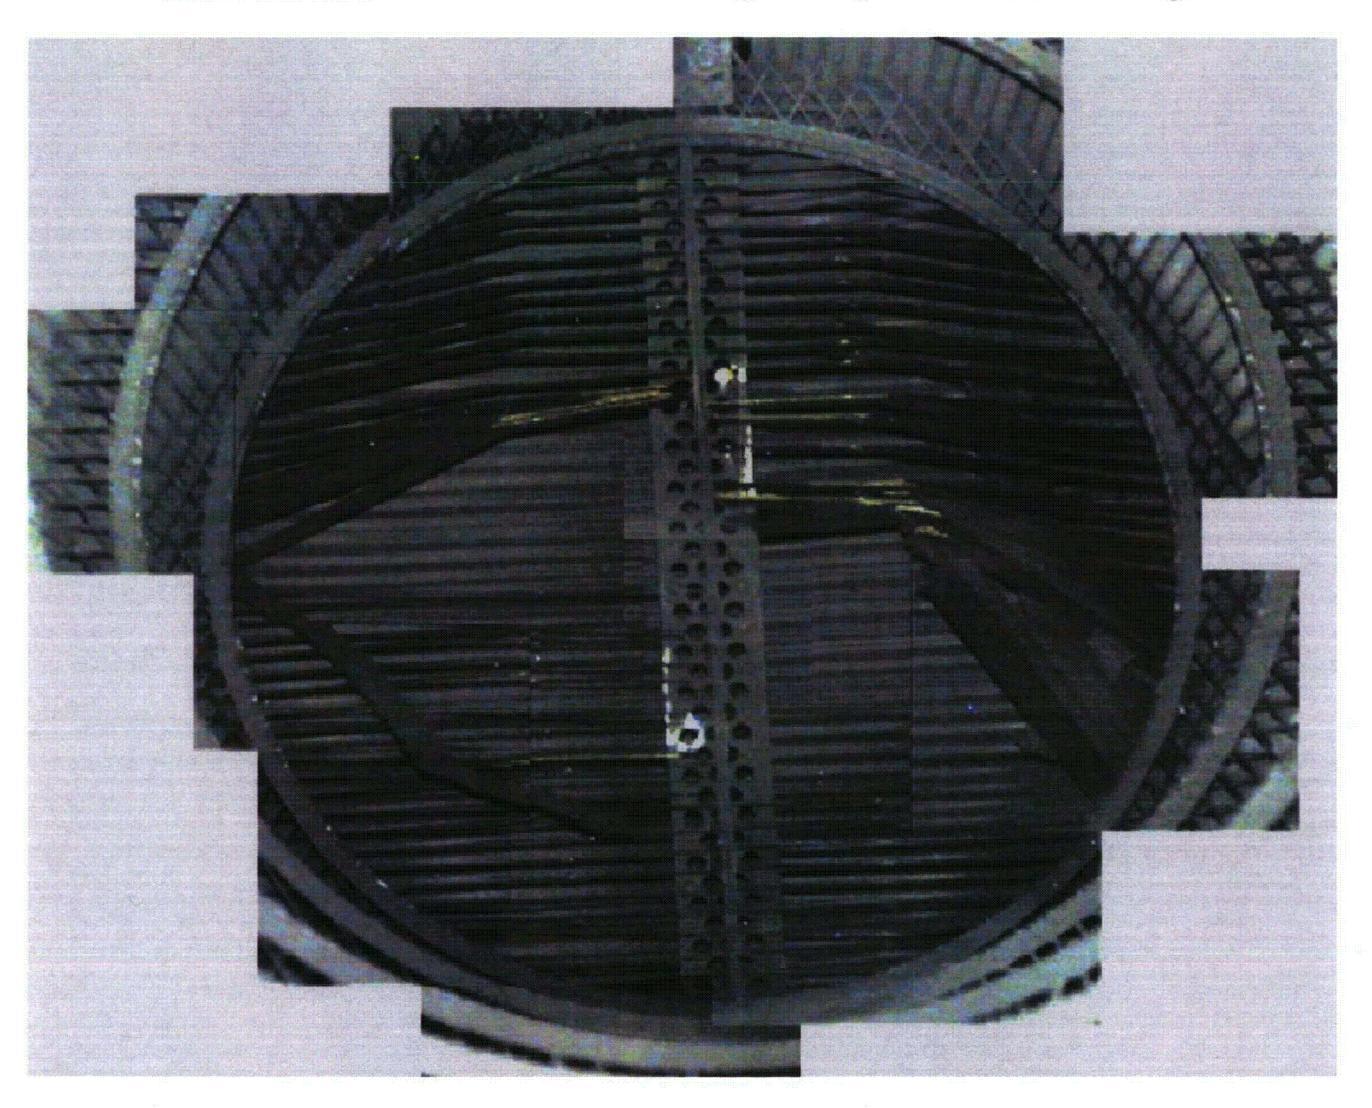
Indication 32-24

Second Row Tube Wear: Through wall batwing wear in second row out from the center cavity; Appears to be 'old' batwing wear.

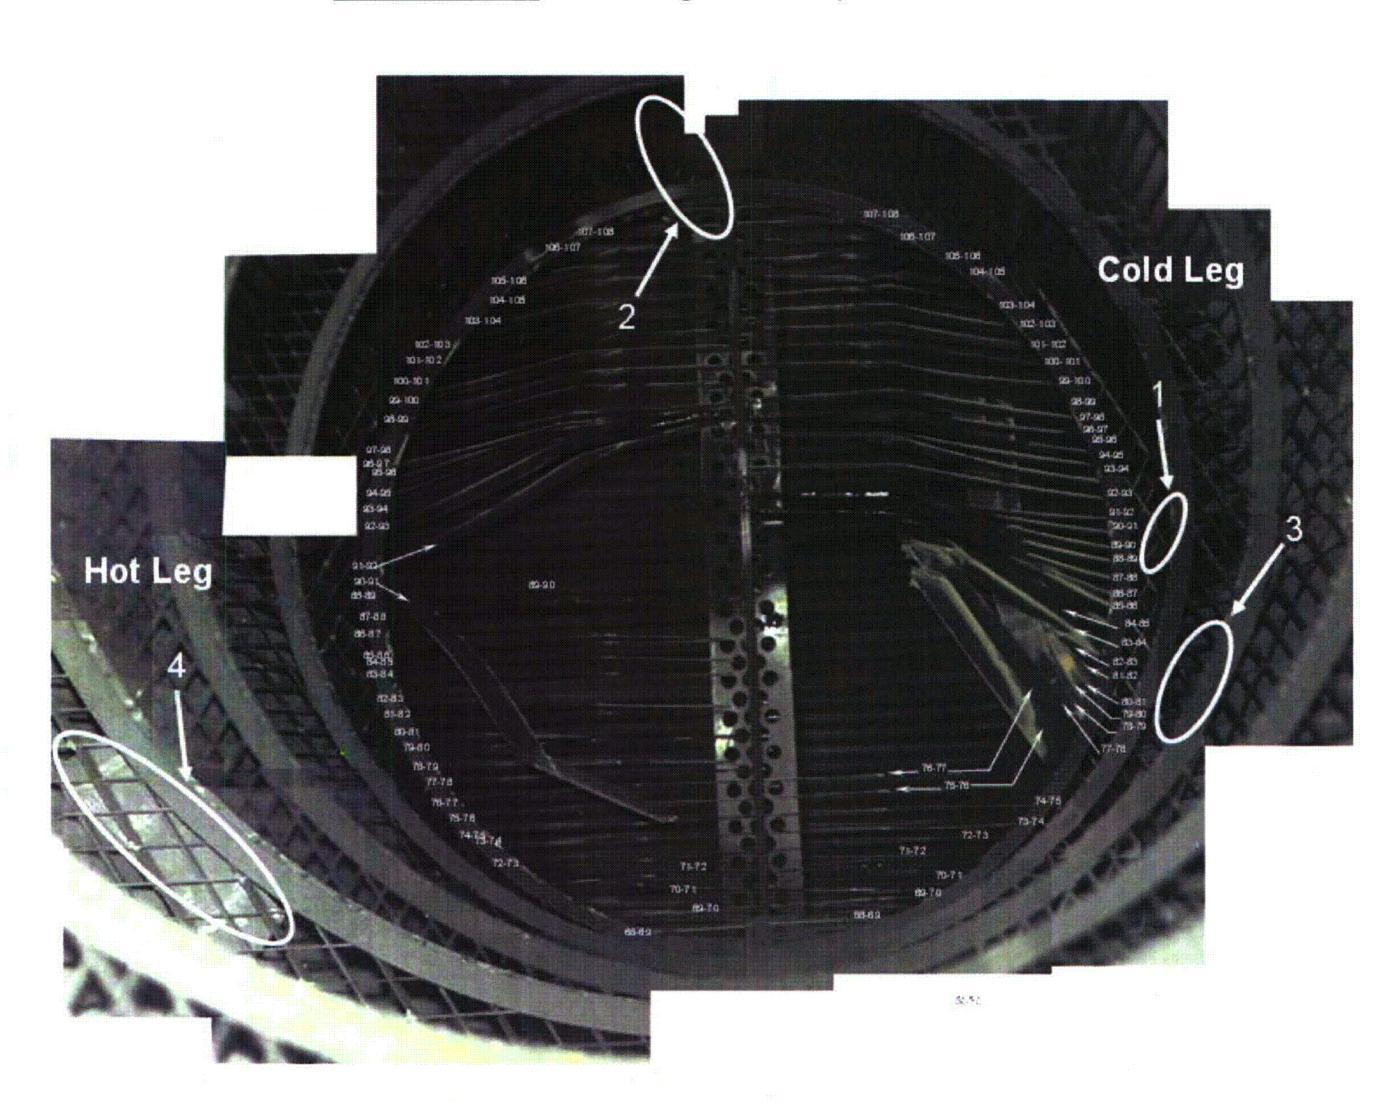
RF15 – SG32 Bottom-Up Inspection Composite Photo

The results indicate there has been very little change in the batwings since the PO-07-01 outage. For comparison, the PO-07-01 composite photograph is included. The hot leg side is essentially identical to that found during PO-07-01. The cold leg side is also essentially the same with the exception that the loose part on egg crate #6 has moved. It is believed that this part has entered the tube bundle and is lodged in place.
