SUBJECT: CERTIFICATION OF THE MINUTES OF THE ACRS SUBCOMMITTEE  
MEETING ON THE OYSTER CREEK GENERATING STATION LICENSE  
RENEWAL APPLICATION, JANUARY 18, 2007 - ROCKVILLE,  
MARYLAND

# Oyster Creek Generating Station License Renewal – ACRS Review

Reference  
Material from  
January 18,  
2007 ACRS  
Subcommittee  
Meeting

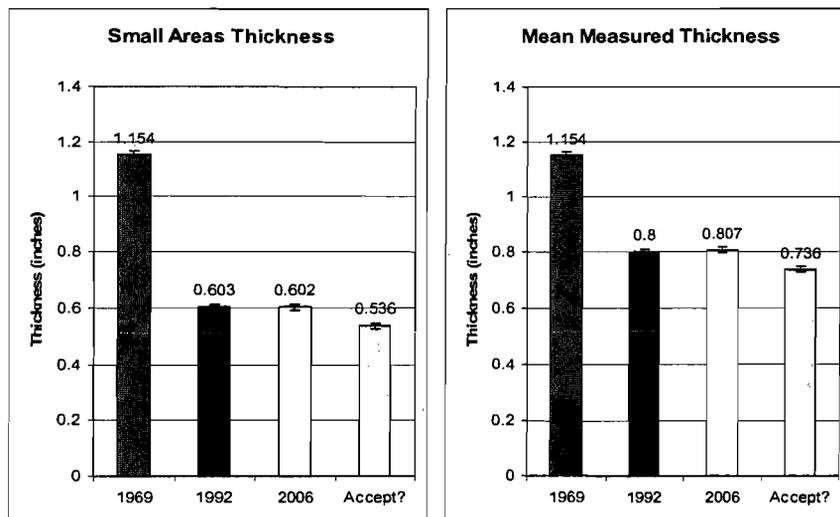
## Claimed Safety Margins Based on 6 By 6 Grids

- Instead of using area acceptance criterion, Exelon has applied point acceptance for exterior measurements without justification
- If area acceptance criterion were applied to external and internal results, the drywell failed in 1992 – worst 0.25 sq ft area measured externally had average thickness of around 0.62 inches, 0.12 inches under 0.736
- Margin failure has increased by around 0.02 inches since 1992, so worst 0.25 sq ft is now around 0.6 inches thick
- If adjust grid criterion to 0.844 inches, 4 of 12 grids fail significantly, and margin is insignificant for 2 others
- Now have no valid acceptance criteria except for 0.844 inches

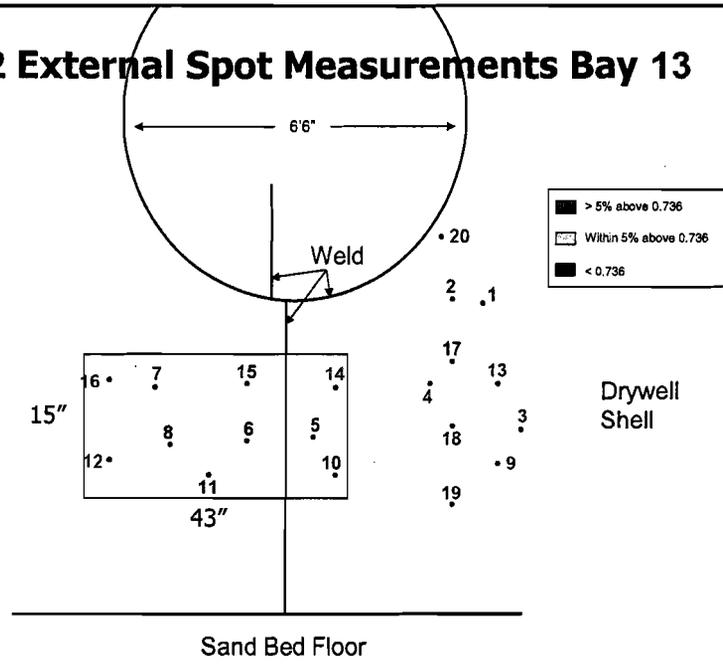
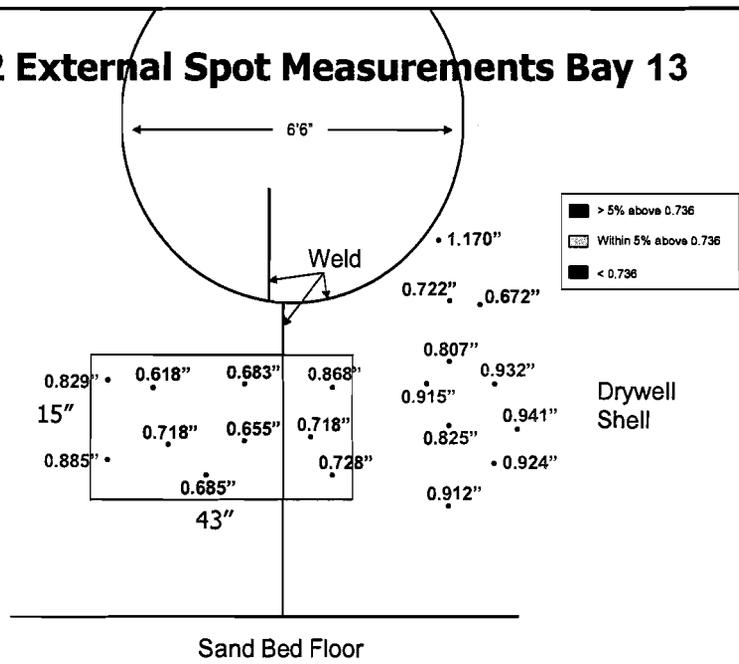
### 1992 External Spot Measurements Bay 13

- 1992 average thickness of Bay 13 estimated at 0.800 inches – not clear how
- Margin was assessed as 0.064 inches by comparing to 0.736 inches uniform thickness prediction
- Bay 13 is now around 0.02 inches thinner
- NRC documents confirm operator also needs to track extent of corroded areas e.g. April 4, 1992 - “In order to consider the corroded area as a discontinuity in NE-3213.10 the extent of the reduction in thickness due to corrosion should be known”
- Sandi cautioned area measured is “limited” and “in many cases, the raw data was not available”<sup>23</sup>

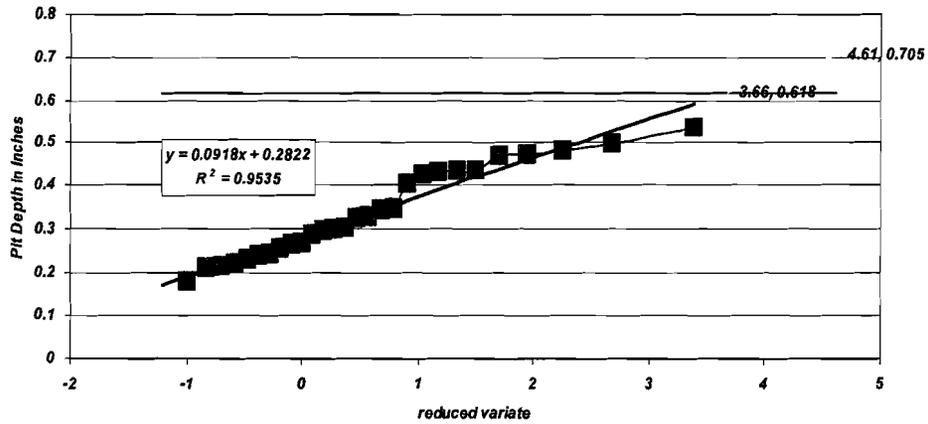
## Extreme Value Statistics for 1992 Exterior UT Results in Bay 13

2.5% chance a single point measurement would give thickness less than 0.536"  
At 99% certainty shell thickness at each point is > 0.449 inches

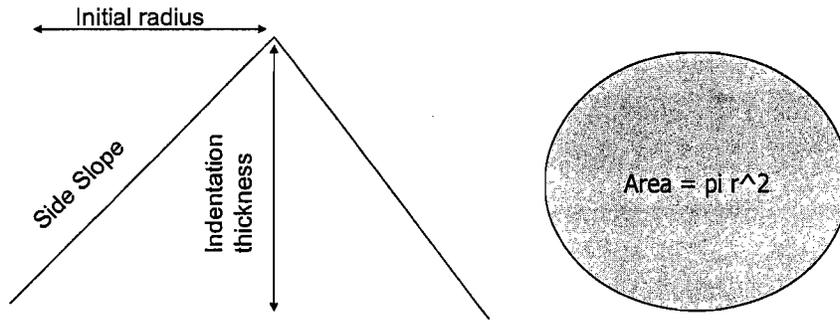
## Sensitivity of Area Below 0.736 Inches to Thinning

For illustration assume constant side slope and conical shape  
 Use known result that Point 7 in Bay 13 has min thickness of 0.618 inches and area below 0.736 inches of 0.25 sq. ft

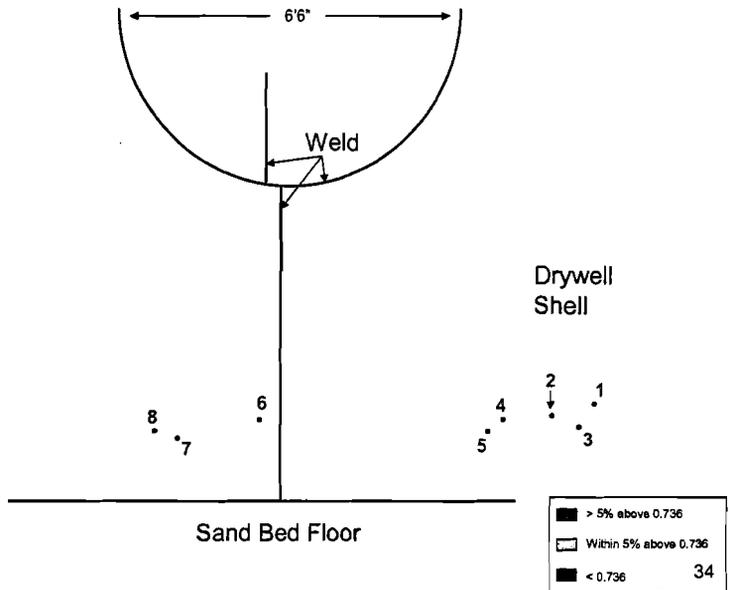
### BAY #5 DATA

- First measurements taken in Bay 5 in Oct. 2006
- Grid of 42 measurements showed loss in thickness of 0.041 inches
- Corrosion in the embedded region has occurred
- Corrosion in Bay 5 is not bounding - Bay 5 was one of the least corroded bays in the sandbed region
- Shows need for measurement in most corroded bays and for monitoring of conditions in the embedded region
- No assurance of margin at present

- **Perform visual inspection of the drywell shell inside the trenches in bay #5 and bay#17 and take UT measurements inside these trenches in 2008 at the same locations examined in 2006. Repeat (both the UT and visual) inspections at refueling outages during the period of extended operation until the trenches are restored to the original design configuration using concrete or other suitable material to prevent moisture collection in these areas.**
- **Perform visual inspection of the moisture barrier between the drywell shell and the concrete floor/curb, installed inside the drywell during the October 2006 refueling outage, in accordance with ASME Section XI, Subsection IWE during the period of extended operation.**

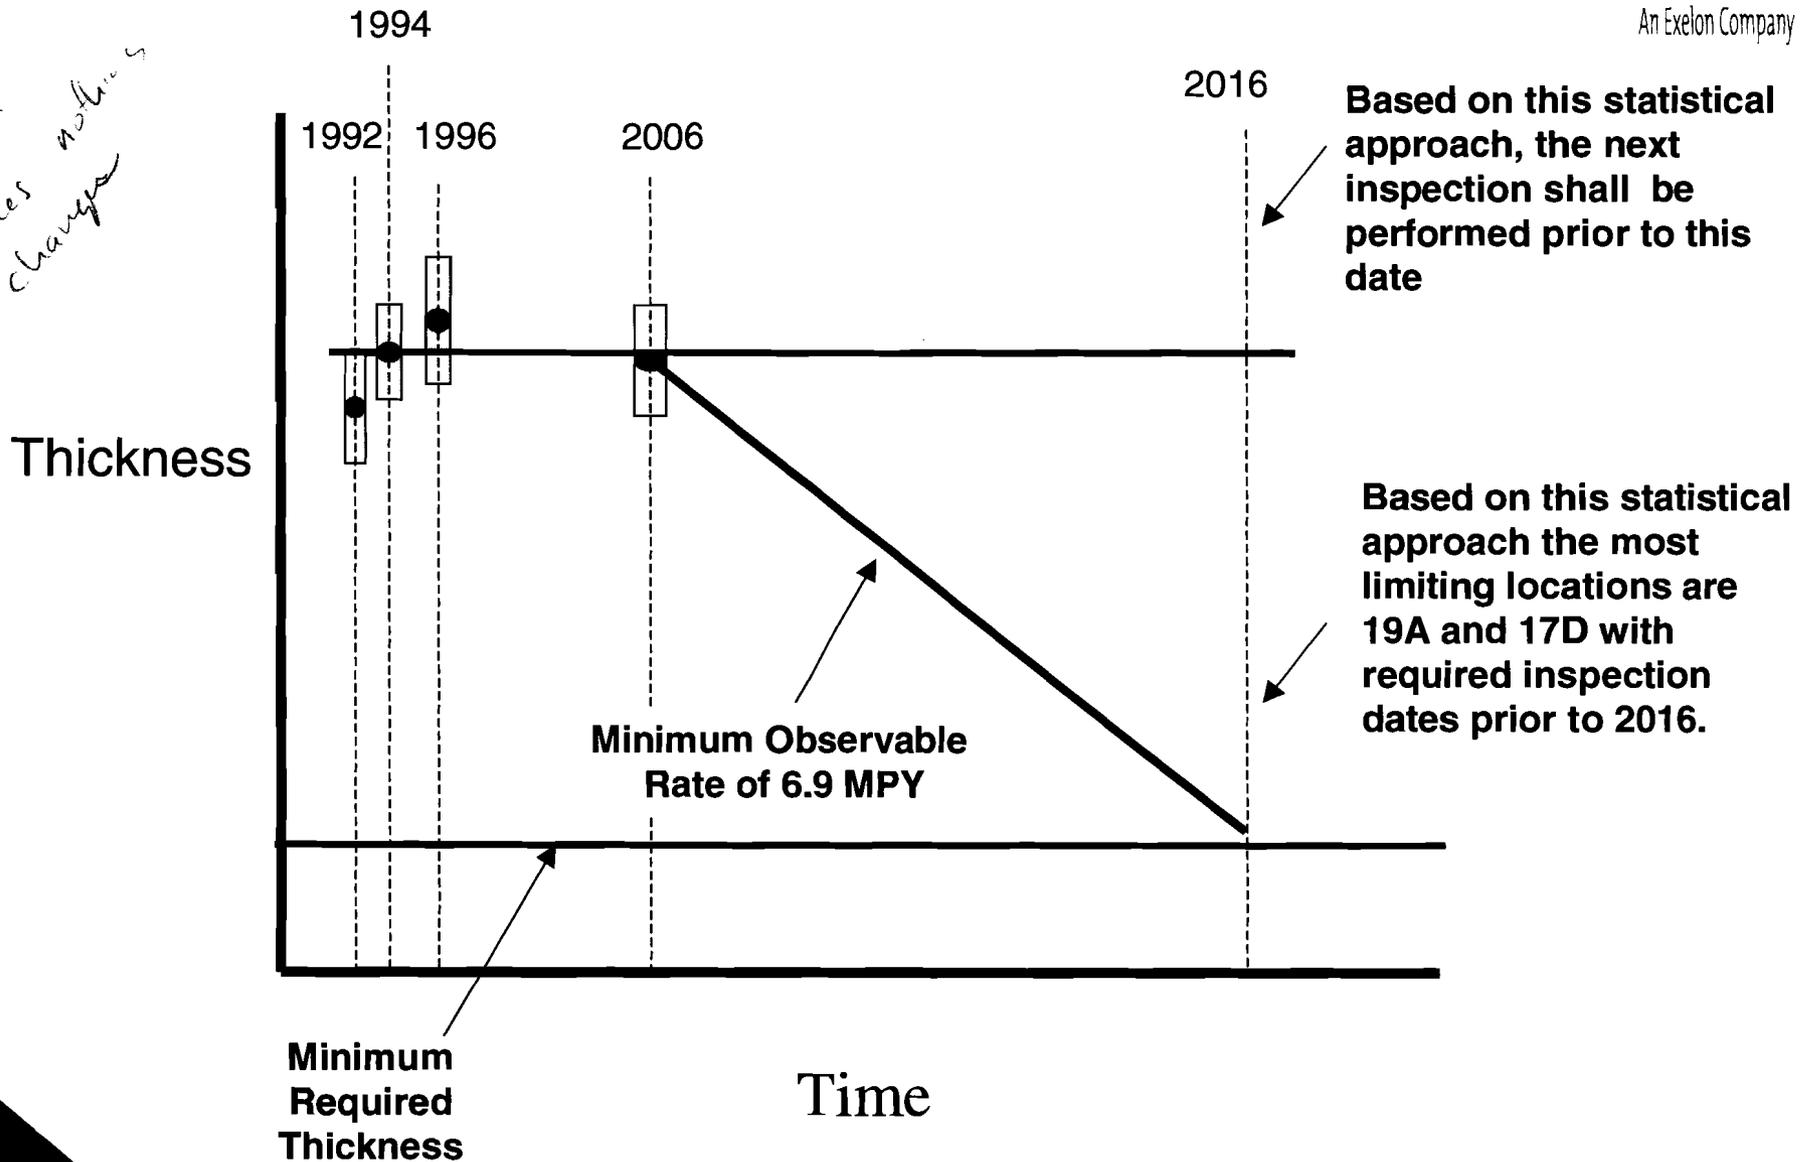
# Next Required Inspection Based on the Minimum Observable Rate

- The most limiting locations are 19A and 17D, with required inspections prior to 2016
- Therefore, the next inspection scheduled for 2010 is appropriate
- Analysis after future inspections will be used to determine the appropriate inspection frequency

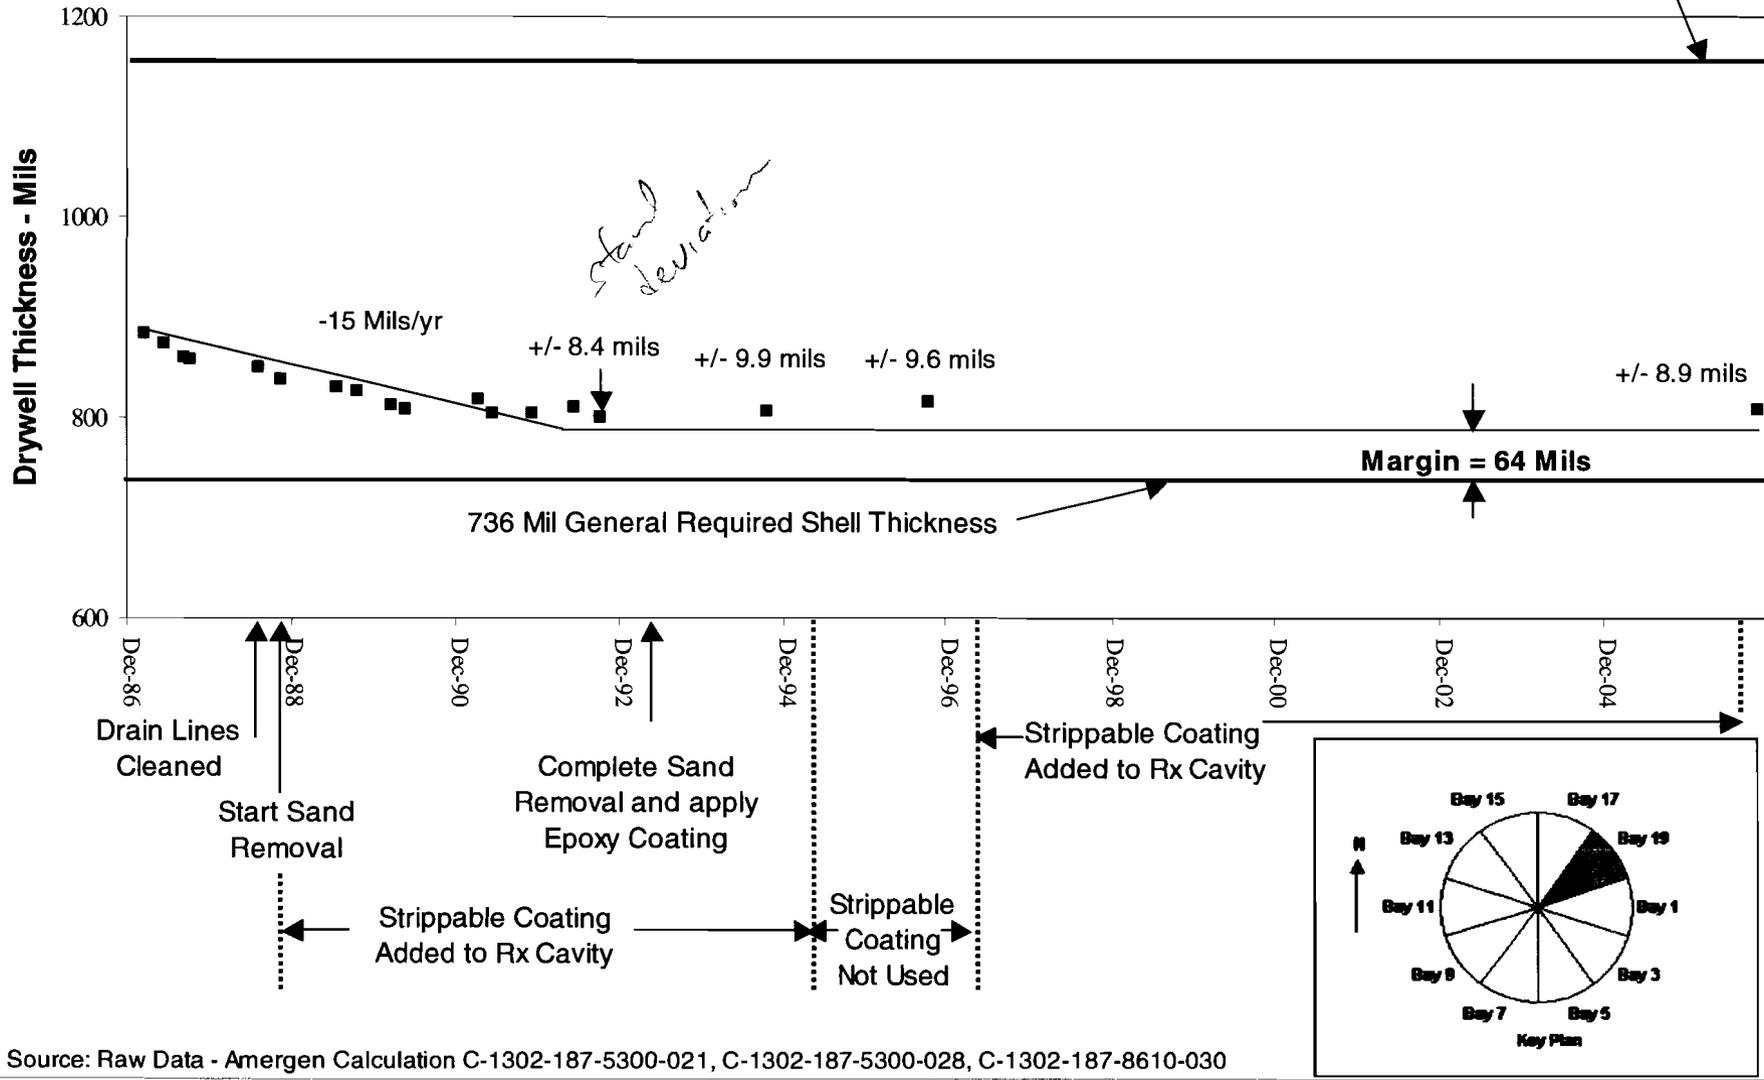
### Figure 21 Sandbed Bay # 19A

1154 Mil Nominal Shell Plate Thickness
