SUBJECT: NRC INSPECTION REPORT 050-00312/08-001

Docket No.: 050-00312
License No.: DPR-54
Report No.: 050-00312/08-001
Licensee: Sacramento Municipal Utility District
Facility: Rancho Seco Nuclear Generating Station
Location: 14440 Twin Cities Road
Herald, California
Dates: April 14 through May 16, 2008
Inspectors: Emilio M. Garcia, Health Physicist
James L. Montgomery, Health Physicist
Accompanied by: Thomas H. Youngblood, Jr., Health Physicist Reactor
Decommissioning Branch, Office of Federal and State
Materials and Environmental Management Programs
Approved By: Jack E. Whitten, Chief
Nuclear Materials Safety Branch B
Attachments: Supplemental Information
Partial List of Documents Reviewed

Rancho Seco Nuclear Generating Station NRC Inspection Report 050-00312/08-001

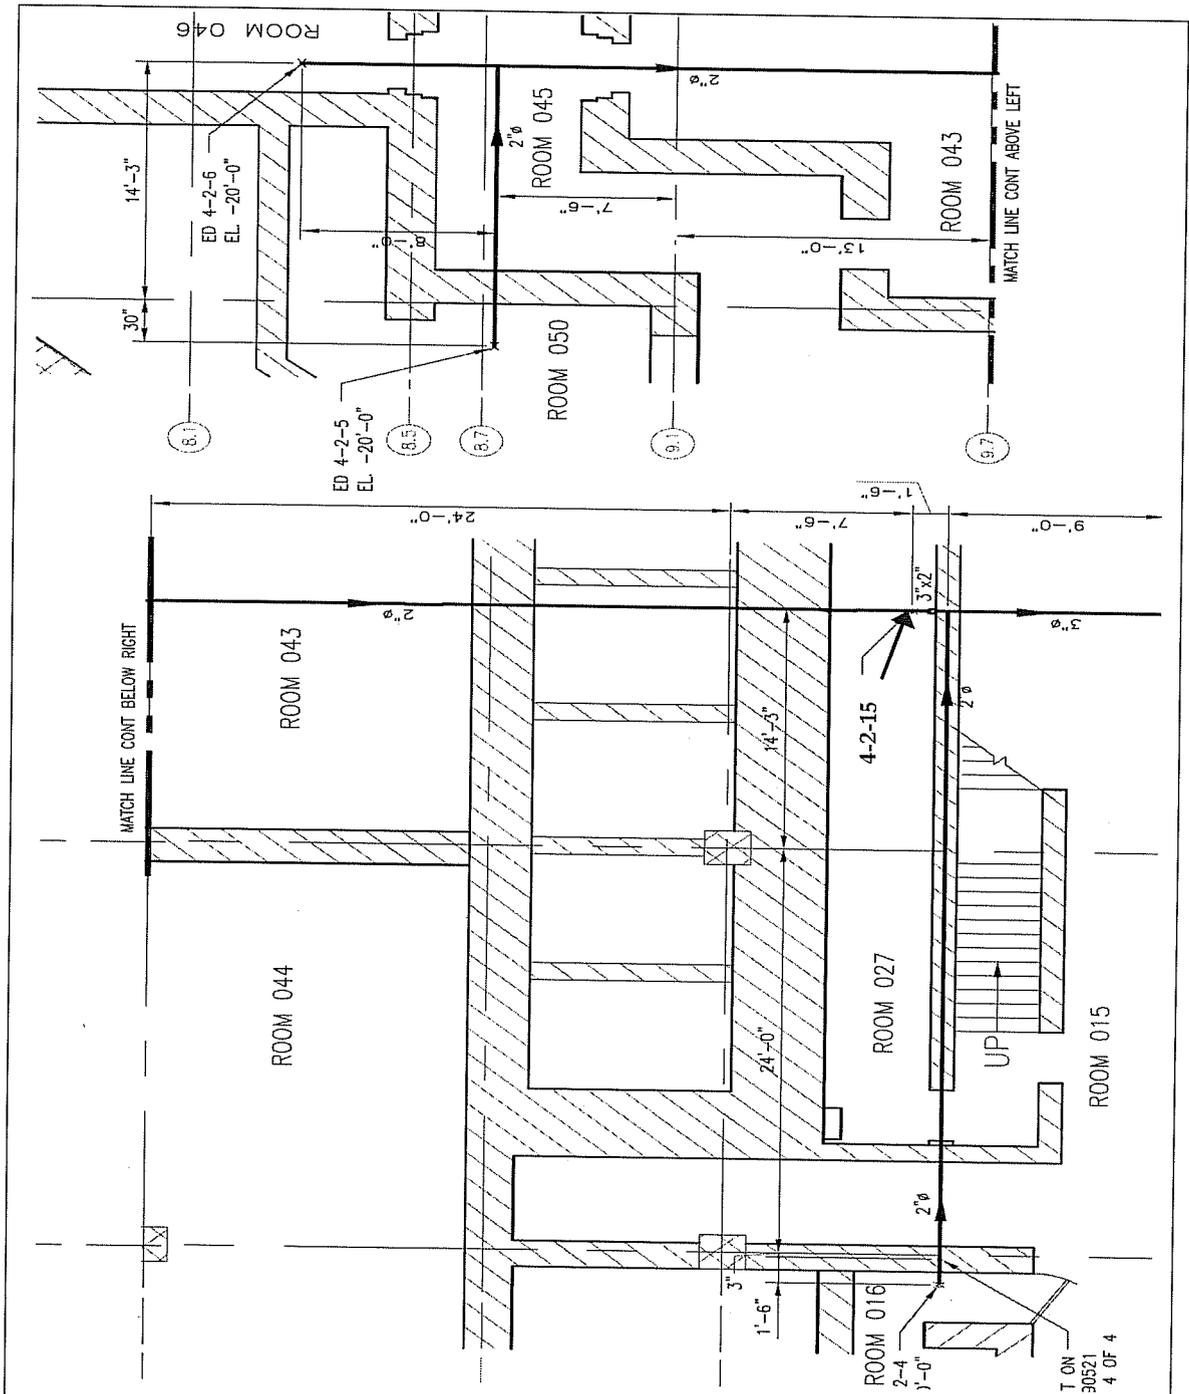
Figure 10: Survey Unit F8990521, Acid Waste Drains – Surveyed Drain 4-2-15

Gamma surface scans of the evaluated Auxiliary Building pipe penetrations did not indicate any areas of elevated gamma radiation levels; the scan results within Acid Waste System Drain Line 4-2-15 were consistent with the results presented in the preliminary FSS data packages for that drain. However, the gamma scan results for Acid Waste System Drain Line 4-1-12, Segment 1 were not in agreement with the preliminary FSS results. Further investigations by SMUD indicated that Drain Line 4-1-13 had been removed and the preliminary FSS results for Drain Line 4-1-12, Segment 1 were erroneously reported as the results for 4-1-13 (Refer to Figure 9). Due to this discrepancy, SMUD re-surveyed Segments 1 and 2 of Drain Line 4-1-12 and provided preliminary results to ORISE on February 12, 2008.³ SMUD's gamma scan range for the 0 to 8 foot length of Segment 1 is thirteen times higher and not in agreement with ORISE's gamma scan results (Table 3). Based on the discrepancy between the ORISE confirmatory and SMUD FSS gamma scan ranges and the confusion with the incorrect numbering of the drain line, ORISE recommends that a side-by-side instrument comparison be performed in this drain line during a subsequent confirmatory survey trip.
