BROWNS FERRY NUCLEAR PLANT

UNITS 1 AND 2

APPROXIMATE TEMPERATURE ZONES

CEB-75-12

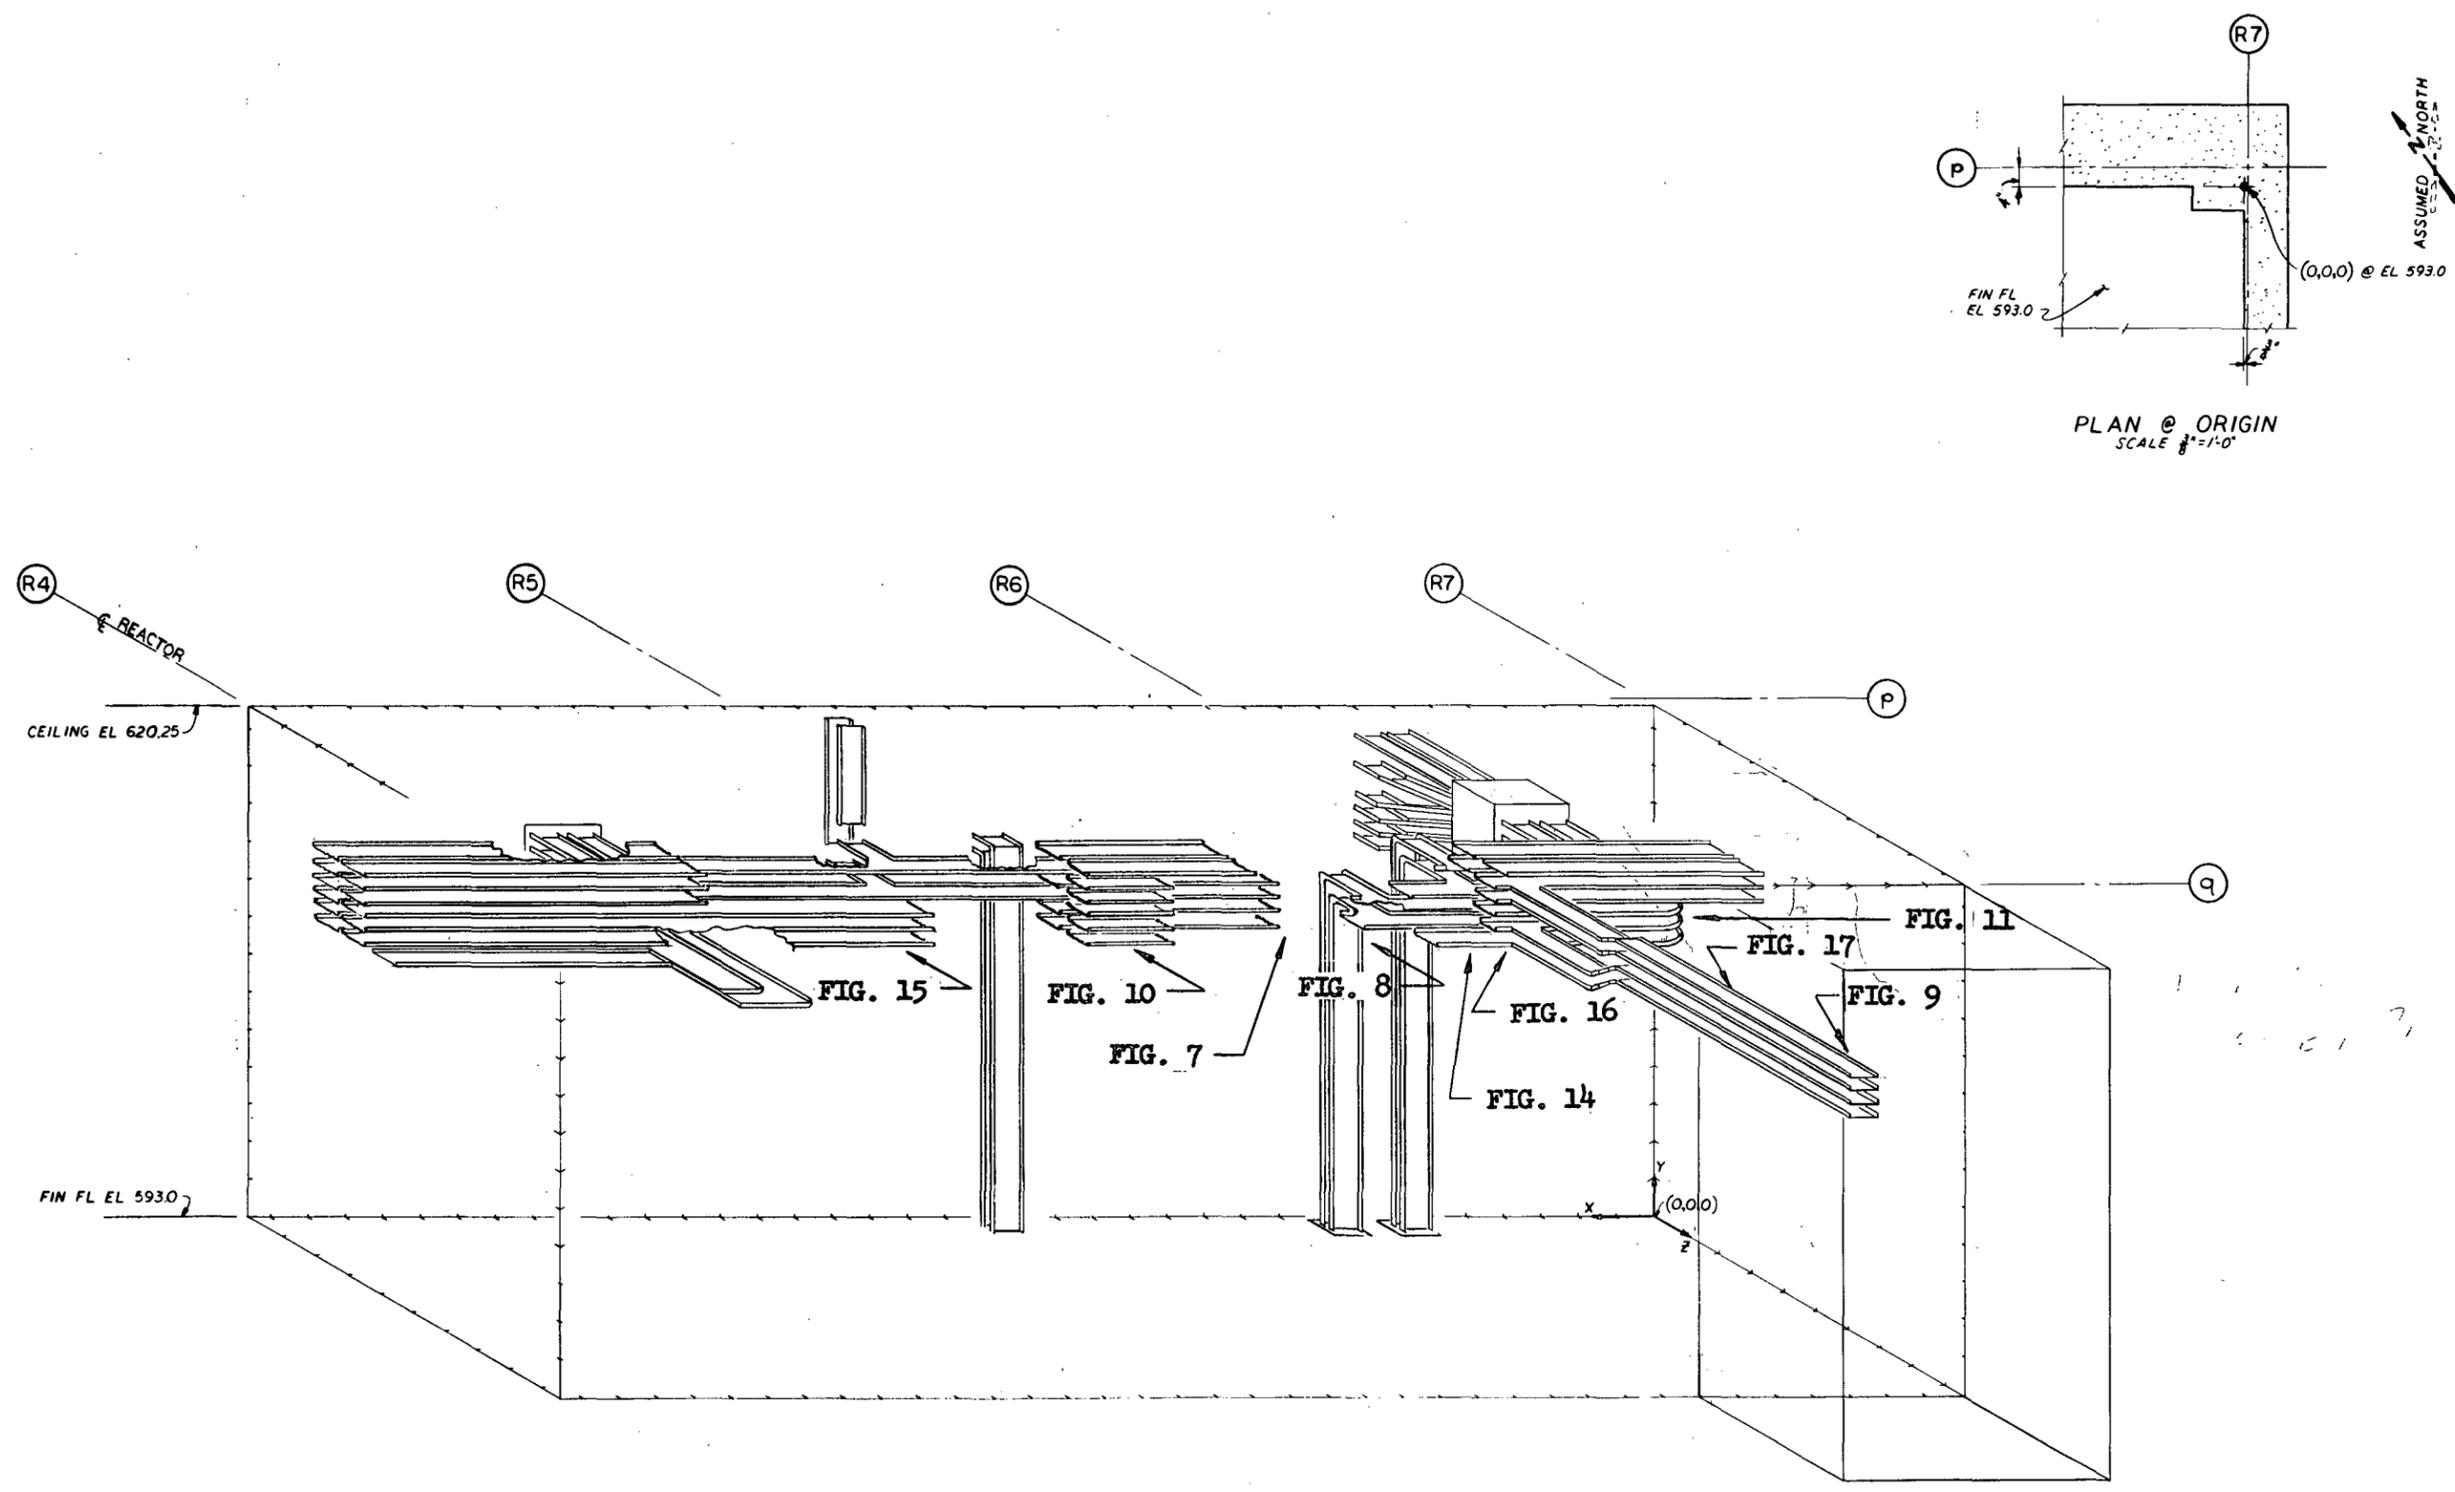
FIGURE 13

Figure 13 is a sketch showing the approximate relationship of the cable trays to the heat affected zone of the unit 1 reactor building and cable spreading room. Figures 14 through 17 are photographs, oriented to figure 13, which show some of the effects of the temperature in the vicinity of the cable trays.
