BROWNS FERRY NUCLEAR PLANT FIRE

HEARINGS

JOINT COMMITTEE ON ATOMIC ENERGY

SEPTEMBER 16, 1975

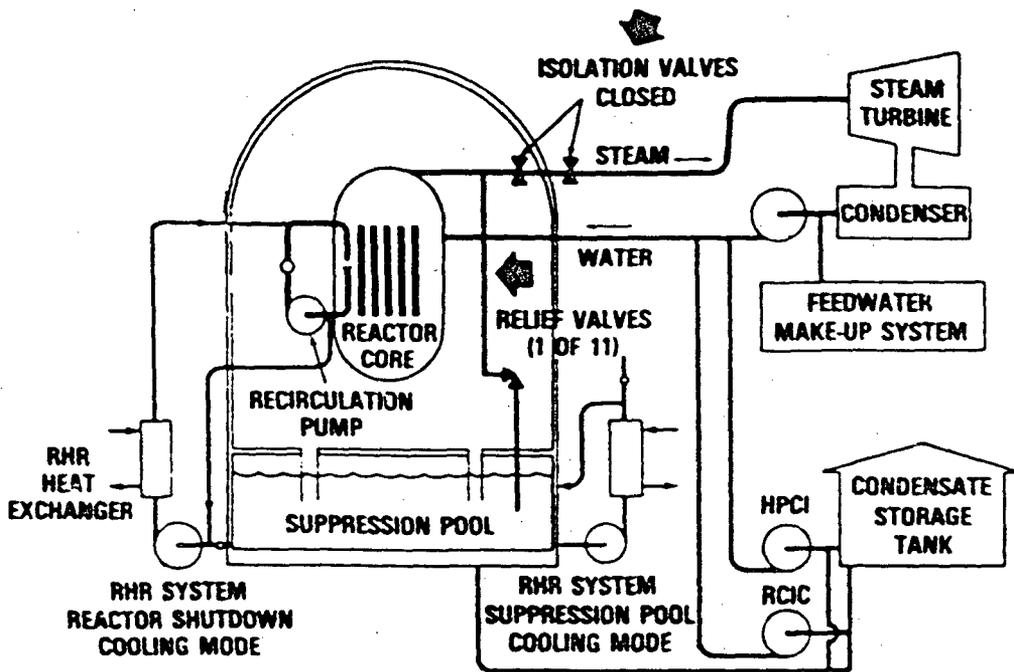
FIGURE 2.—Steam path to suppression pool via relief valves.

Following their selected course, the operators depressurized the reactor by discharging steam from the reactor to the suppression pool through the four relief valves that could be operated from the control room (Figure 2). This discharge heated up the water in the suppression pool as intended. Because of the large volume of water in the pool, about 12 hours of such discharge could be accommodated before the pool water would boil, even though the cooling system for the suppression pool was not available at the time. Even if the pool water had boiled, the resultant steam could have been vented to the atmosphere. Once the reactor pressure was reduced, a low pressure condensate pump was used in conjunction with a condensate booster pump to provide an adequate source of water for cooling the fuel. A total of three of these condensate booster pumps and three condensate pumps were available to the operator at this time. Any of the condensate pumps would have been capable of supplying more than enough water to keep the core covered (Figure 3). Also, the Unit 1 control rod drive pump supplied some water to the reactor throughout reactor cooldown.

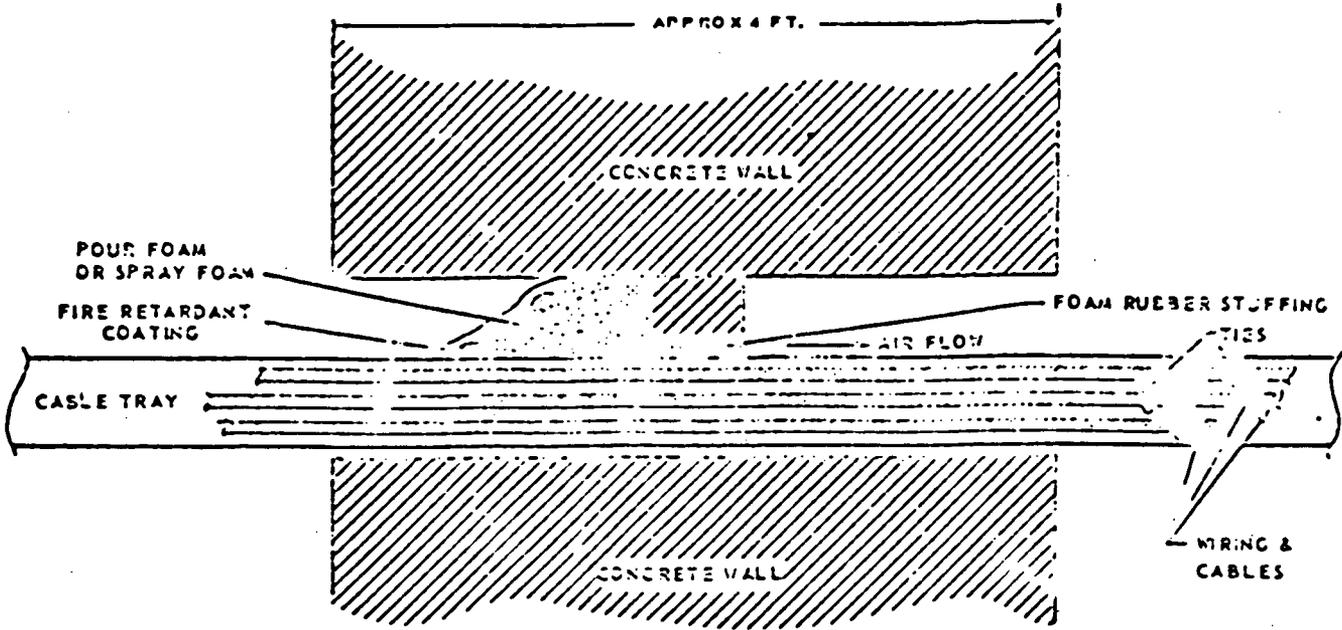
FIGURE 1
CABLE TRAY MATERIALS & USAGES
(OVERALL SIMPLIFIED DEPICTION - NOT TO SCALE)

Inspection of the closest similar cable tray penetration through the wall which was not involved in the fire disclosed use of cotton rags as stuffing material, rather than foam rubber, and only sparse coverage of the foam with the fire retardant coating. Other miscellaneous materials of interest include the nylon cable ties, silicone caulking compounds, and a firewall board material.

In another location, the cavity was completely filled with foam, shaved off and then capped with the firewall board, and sealed at cable interfaces with flame retardant coating.

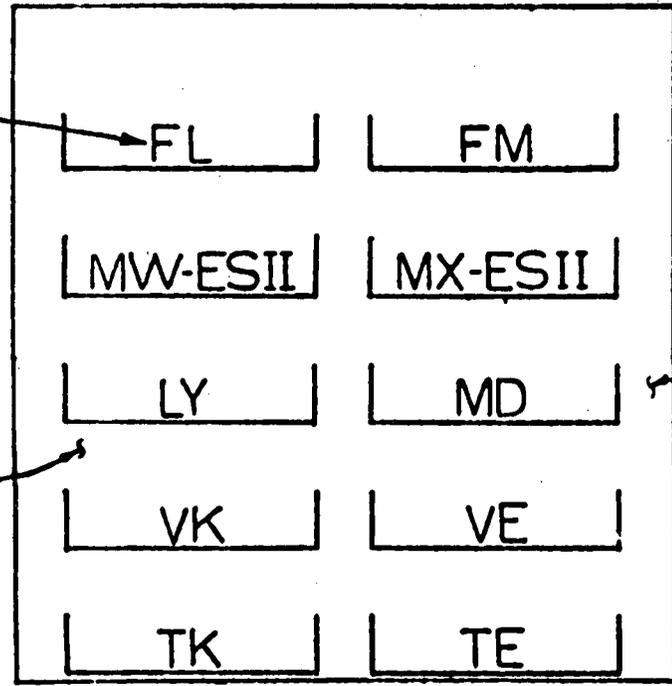
FIRE STARTED IN WEST STACK OF TRAYS

SEE FIGURES 2 and 3 FOR TYPICAL PENETRATION THROUGH WALL
