BROWNS FERRY NUCLEAR PLANT FIRE

HEARINGS

JOINT COMMITTEE ON ATOMIC ENERGY

SEPTEMBER 16, 1975

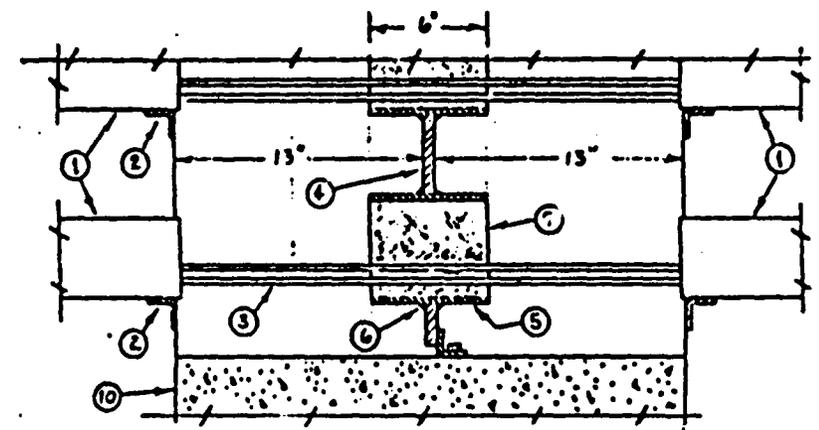
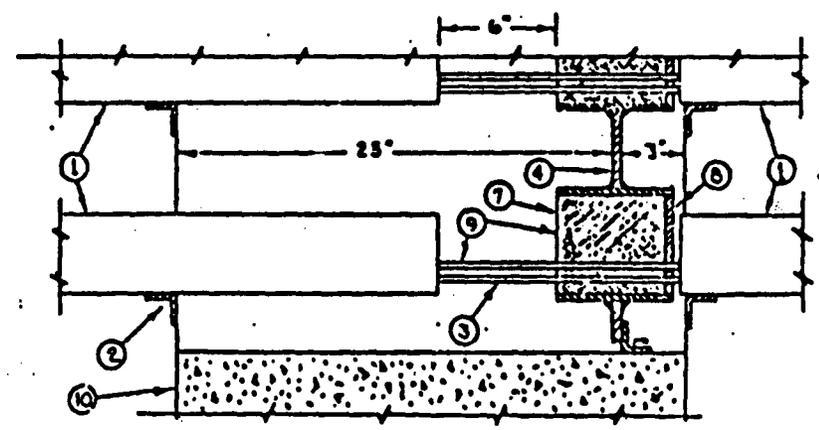
TYPICAL CABLE PENETRATION

AS DESIGNED

AS CONSTRUCTED

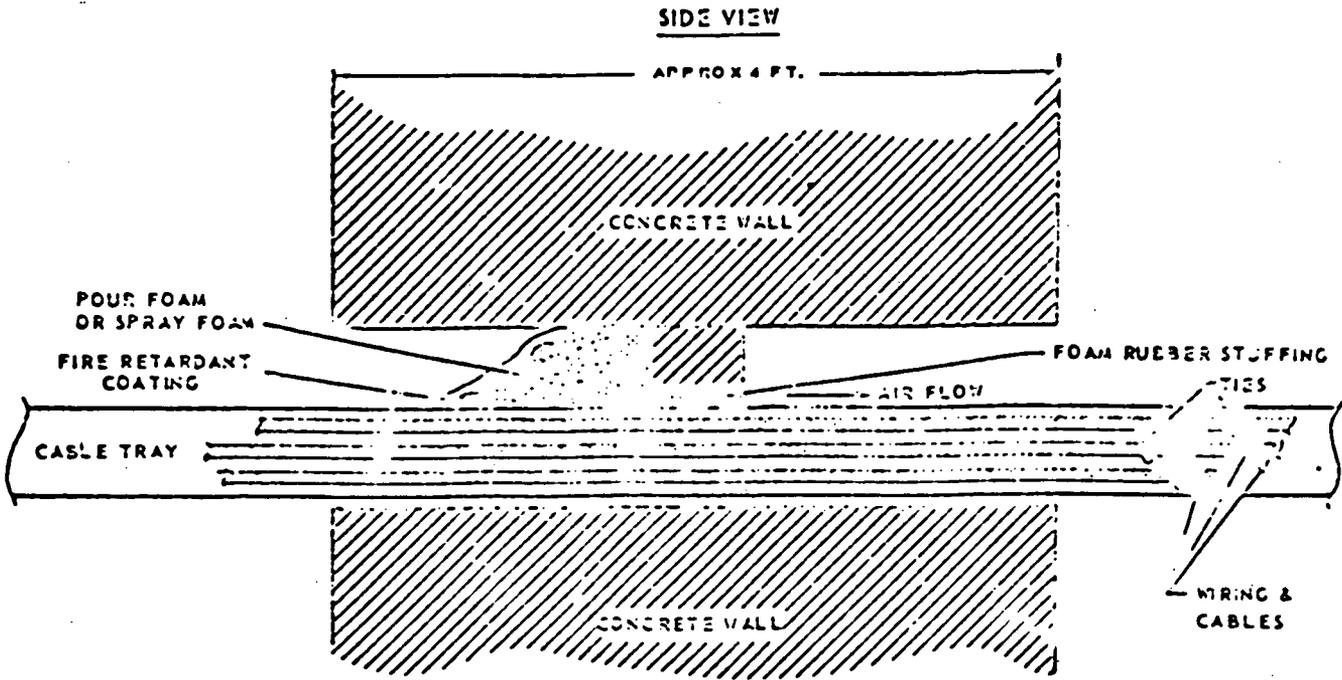
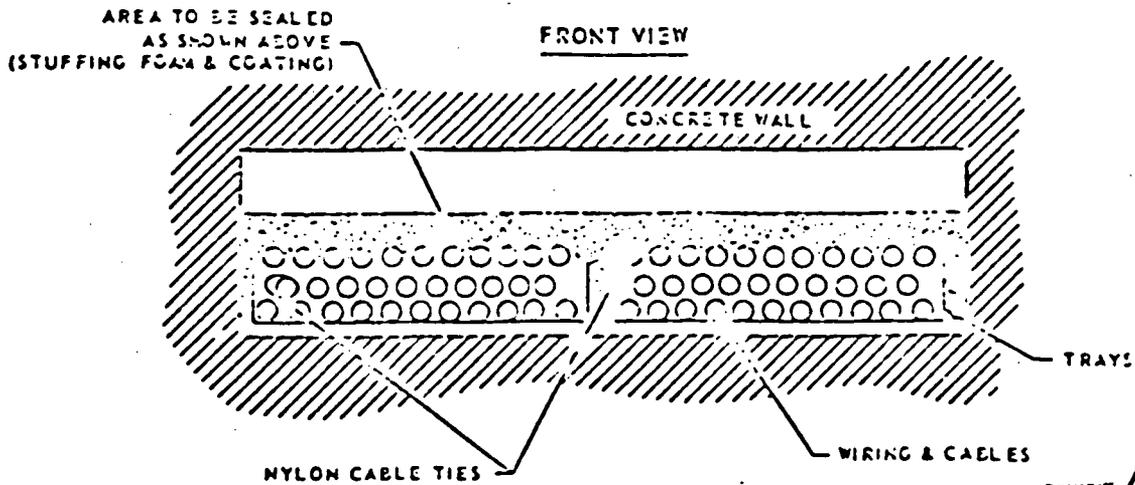
FIGURE 1
CABLE TRAY MATERIALS & USAGES
(OVERALL SIMPLIFIED DEPICTION - NOT TO SCALE)

During this leak checking, the candle ignited the stuffing material (a foam rubber) which initiated the ensuing conflagration.

Inspection of the closest similar cable tray penetration through the wall which was not involved in the fire disclosed use of cotton rags as stuffing material, rather than foam rubber, and only sparse coverage of the foam with the fire retardant coating. Other miscellaneous materials of interest include the nylon cable ties, silicone caulking compounds, and a firewall board material.

In another location, the cavity was completely filled with foam, shaved off and then capped with the firewall board, and sealed at cable interfaces with flame retardant coating.

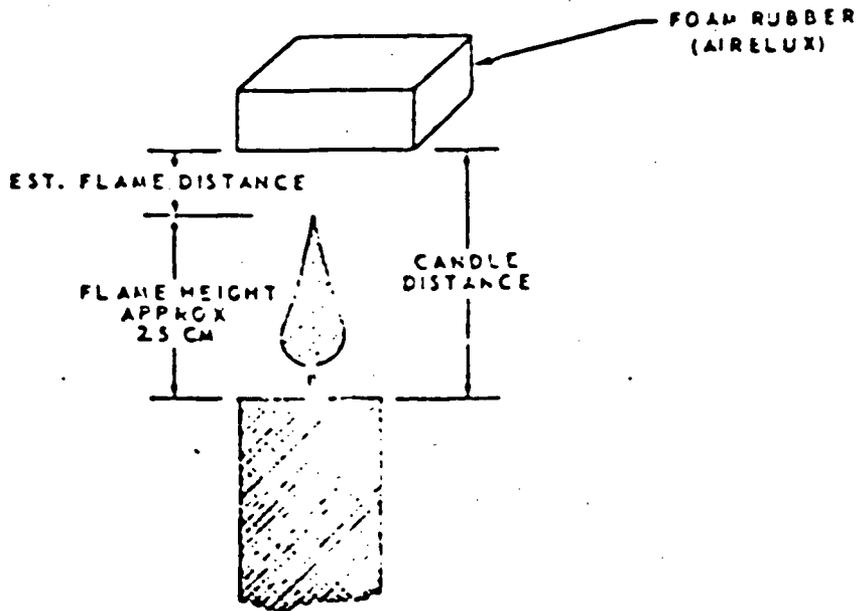
FIGURE 2
CANDLE IGNITION
TEST SETUP

Subsequently, further tests were done to obtain some indication of ease of ignition and proximities required. Figure 2 shows the test set-up. The candle to sample distance was measured. The flame height varied slightly due to natural flicker, but was roughly up to 2.5 cm from the candle to top of the tip.

Table I shows that ignition occurred almost instantaneously 0.5 cm from the flame tip, and in 2-1/2 seconds at 2.5 cm (approximately 1 inch) away. At greater distances the sample did not ignite, but melted through.

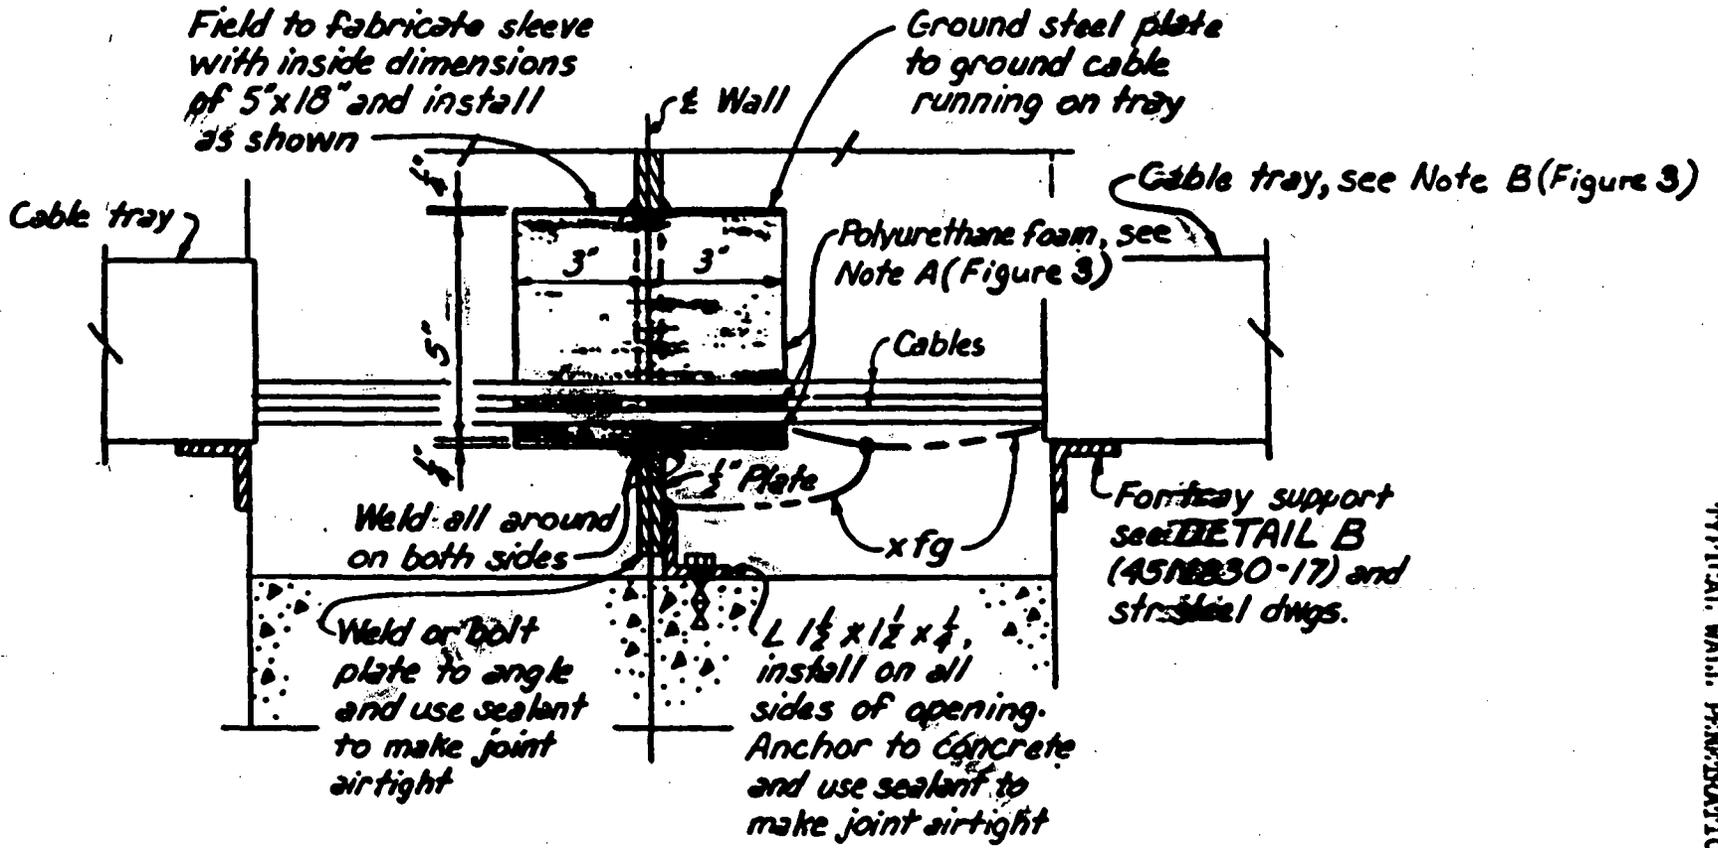
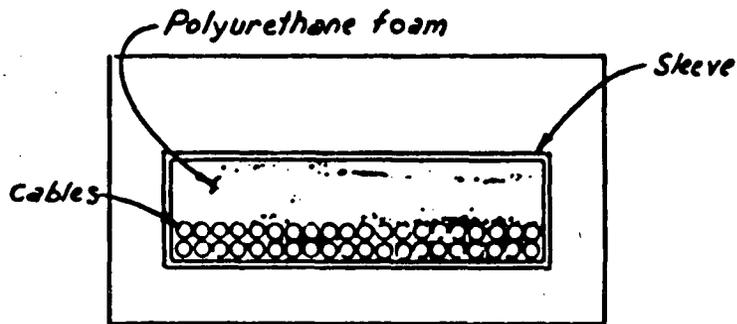
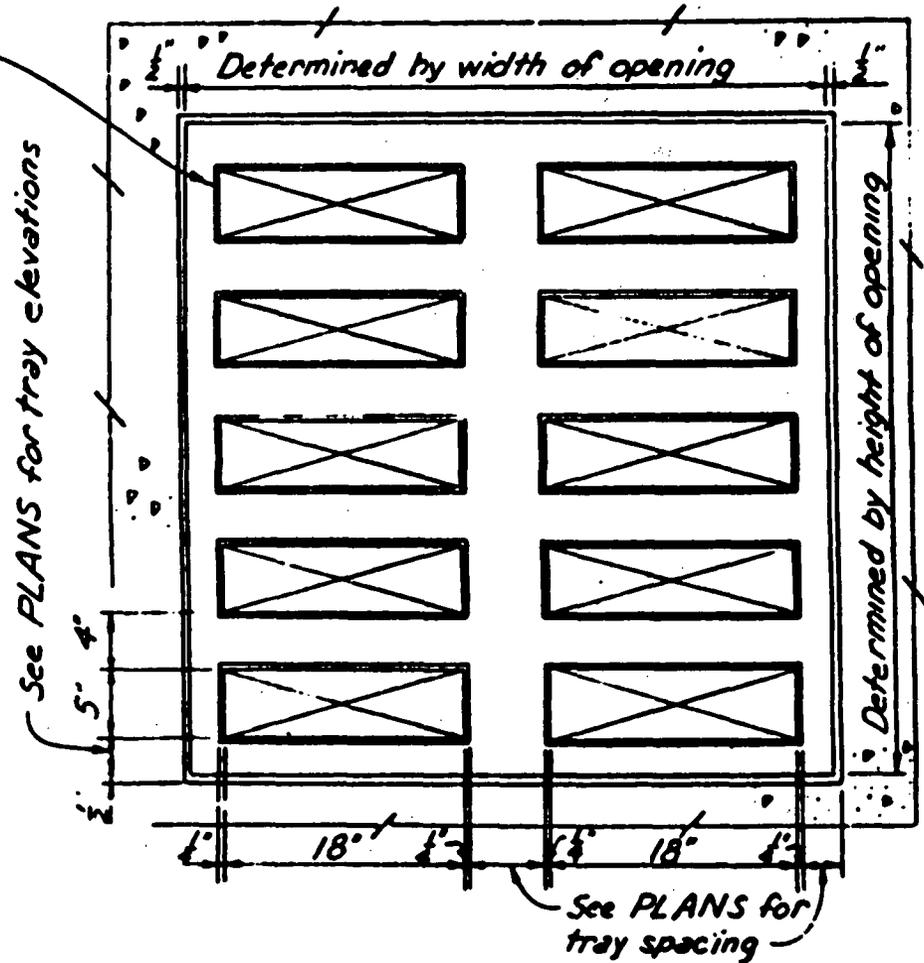
FIGURE 3
TYPICAL WALL PENETRATION

The cable penetration where the fire started is contained in a 48-inch-square opening through the concrete wall separating the units 1 and 2 cable spreading room from the unit 1 reactor building. Division of Engineering Design (DED) drawings require the installation of a 1/2-inch-thick steel plate bulkhead slightly less than 48 inches square in the center of the opening in the concrete wall. Ten openings are cut in the bulkhead plate, and two stacks of five 18-1/2- by 5-1/2-inch steel sleeves are welded into the openings. The steel sleeves are 6 inches long and extend 3 inches on each side of the bulkhead centerline. The vertical clearance between the sleeves is 4 inches, and the horizontal clearance is 5 inches. The steel bulkhead assembly is framed and attached to the wall inside the concrete opening by 1-1/2- by 1-1/2- by 1/4-inch mounting angles. The cable trays abut the wall and are secured to angle iron extending horizontally across the face of the wall. Only the cables extend through the wall penetration. (See figures 2 and 3.)

The design requires that the penetration sleeves, with the cables installed, be filled with polyurethane foam to create an air pressure seal. (See figure 3.) A

Another possible "fuel" was the wall penetration pressure seal materials used between the spreading room and the reactor building. A typical penetration is shown in figures 2 and 3. The sealant material was polyurethane expandable foam, a pressure seal, which is covered with Flamemastic, a flameproofing compound. Another sealant material which is a possible fuel source would be the RTV silicone rubber compound used in sealing conduits through walls and in some cases to seal around new cables added through penetrations.

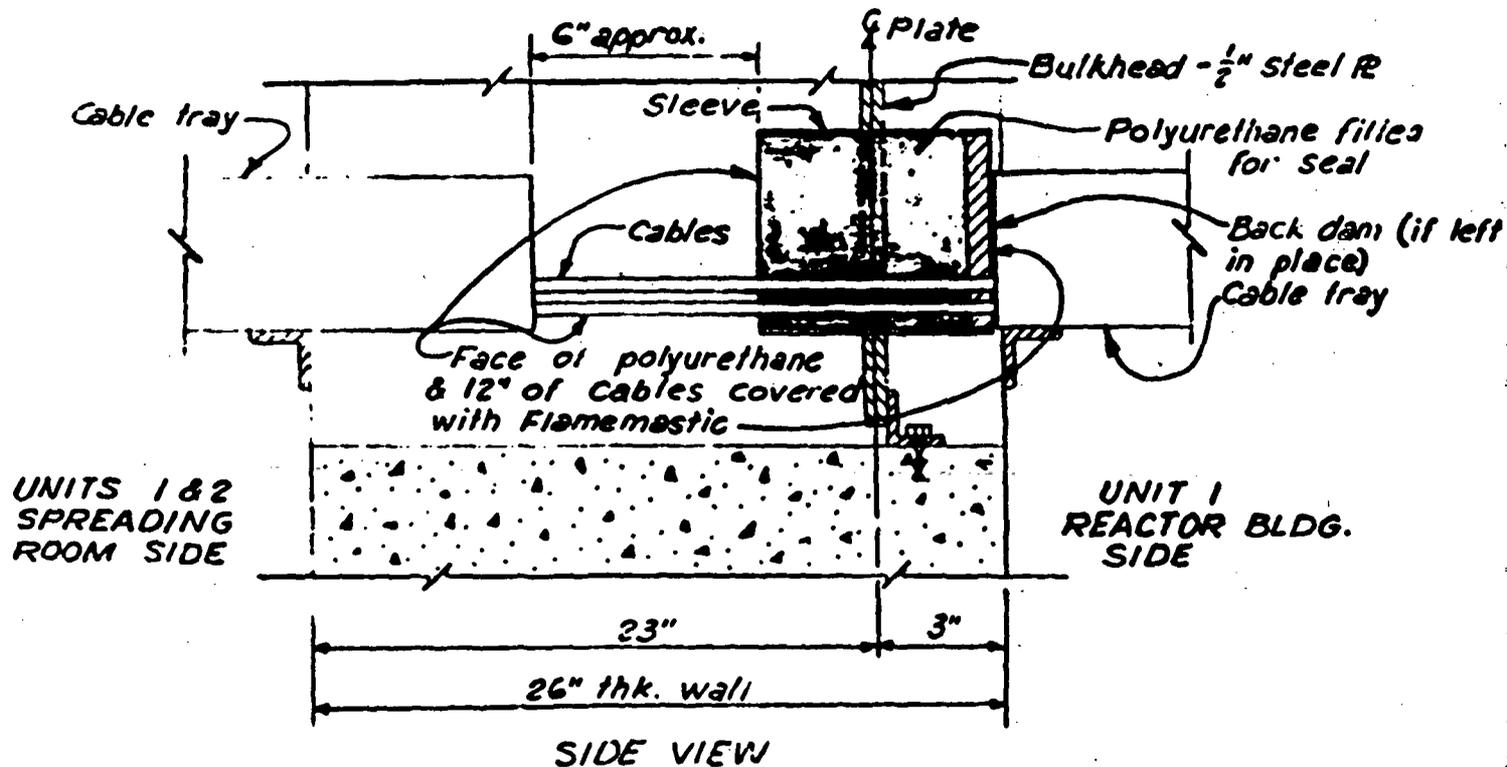
FIGURE 4

NOTE: FIRE STARTED IN SECOND PENETRATION FROM BOTTOM-TRAY VE

PARTIAL CROSS SECTION OF PENETRATIONS (TO SHOW BULKHEAD LOCATION IN WALL AS CONSTRUCTED)

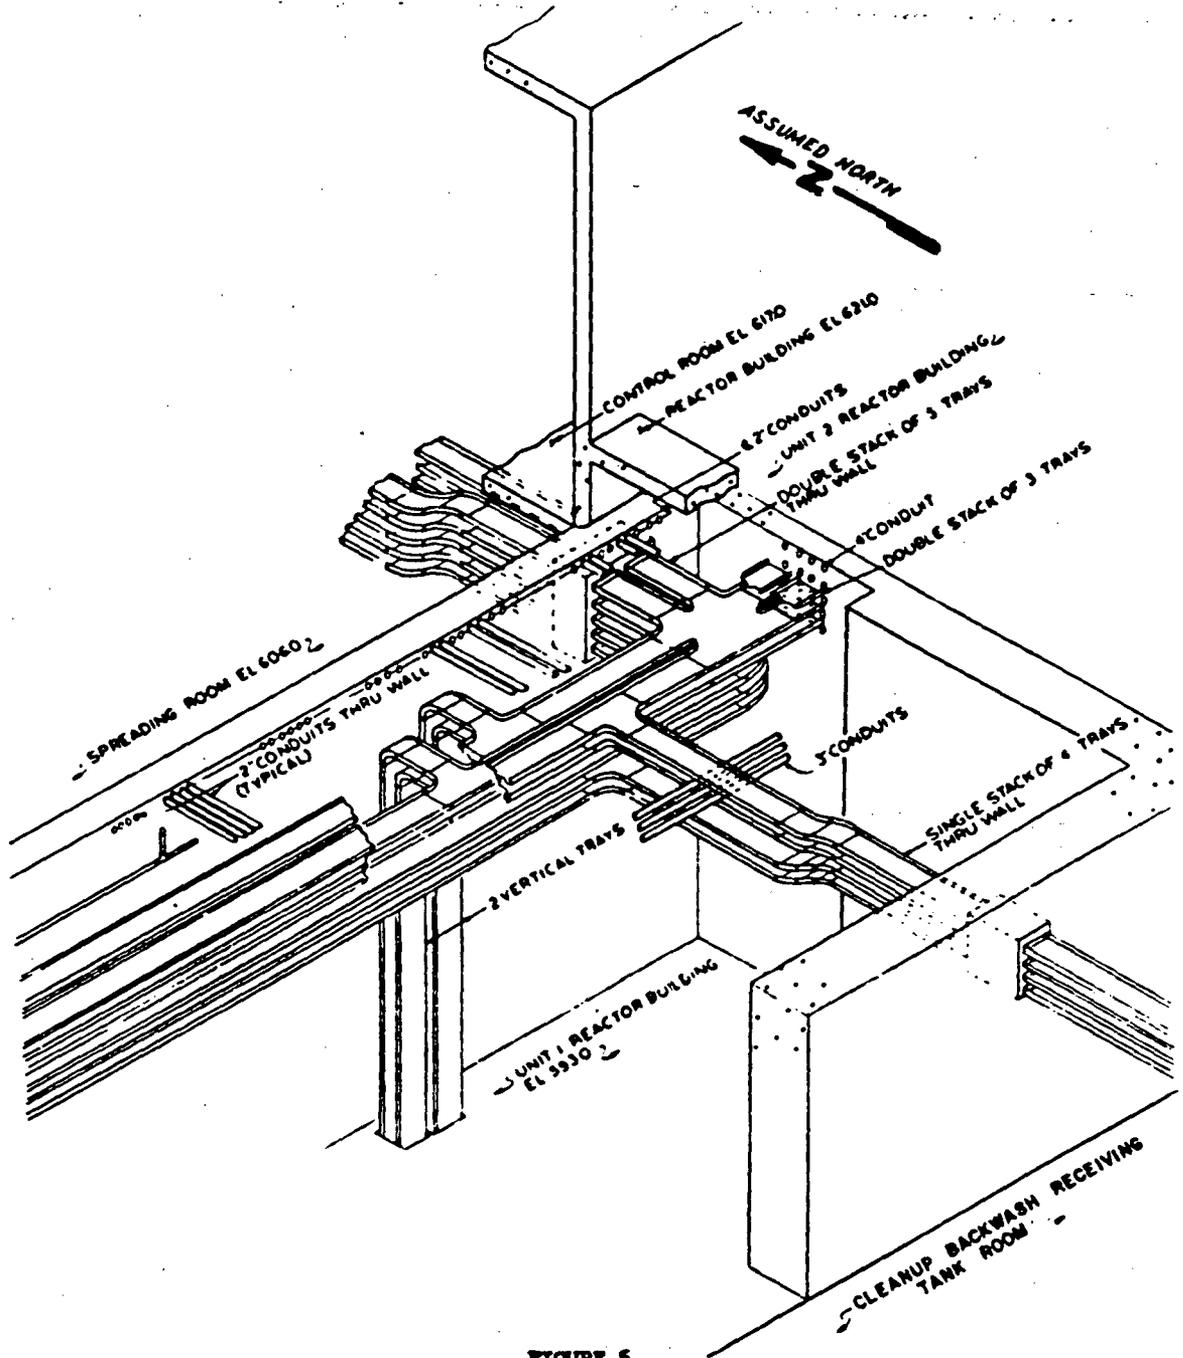
FIGURE 5
AREA OF FIRE

It has been determined that the fire started when an open flame came into contact with material used as the seal around the cables where they penetrate the wall between the units 1 and 2 control bay spreading room and the unit 1 reactor building. Figures 5 and 6 indicate the area being considered in this description. Figure 6 shows the zone of influence of the fire. Figure 7 shows a cross section of trays near the point where the fire started. The cables and raceways in the spreading room were damaged approximately 5 feet north of the wall penetration; and the fire propagated along all trays, as marked on figure 8, in the reactor building on floor elevation 593. Many photographs were taken, and 10 key ones are included in this report as appendix B. Figure 9 shows affected trays and their intersections in single-line representation. Checkpoints used for routing cables on each cable tray are also shown. (See table 2 for loading of cable types onto each tray at each checkpoint.)

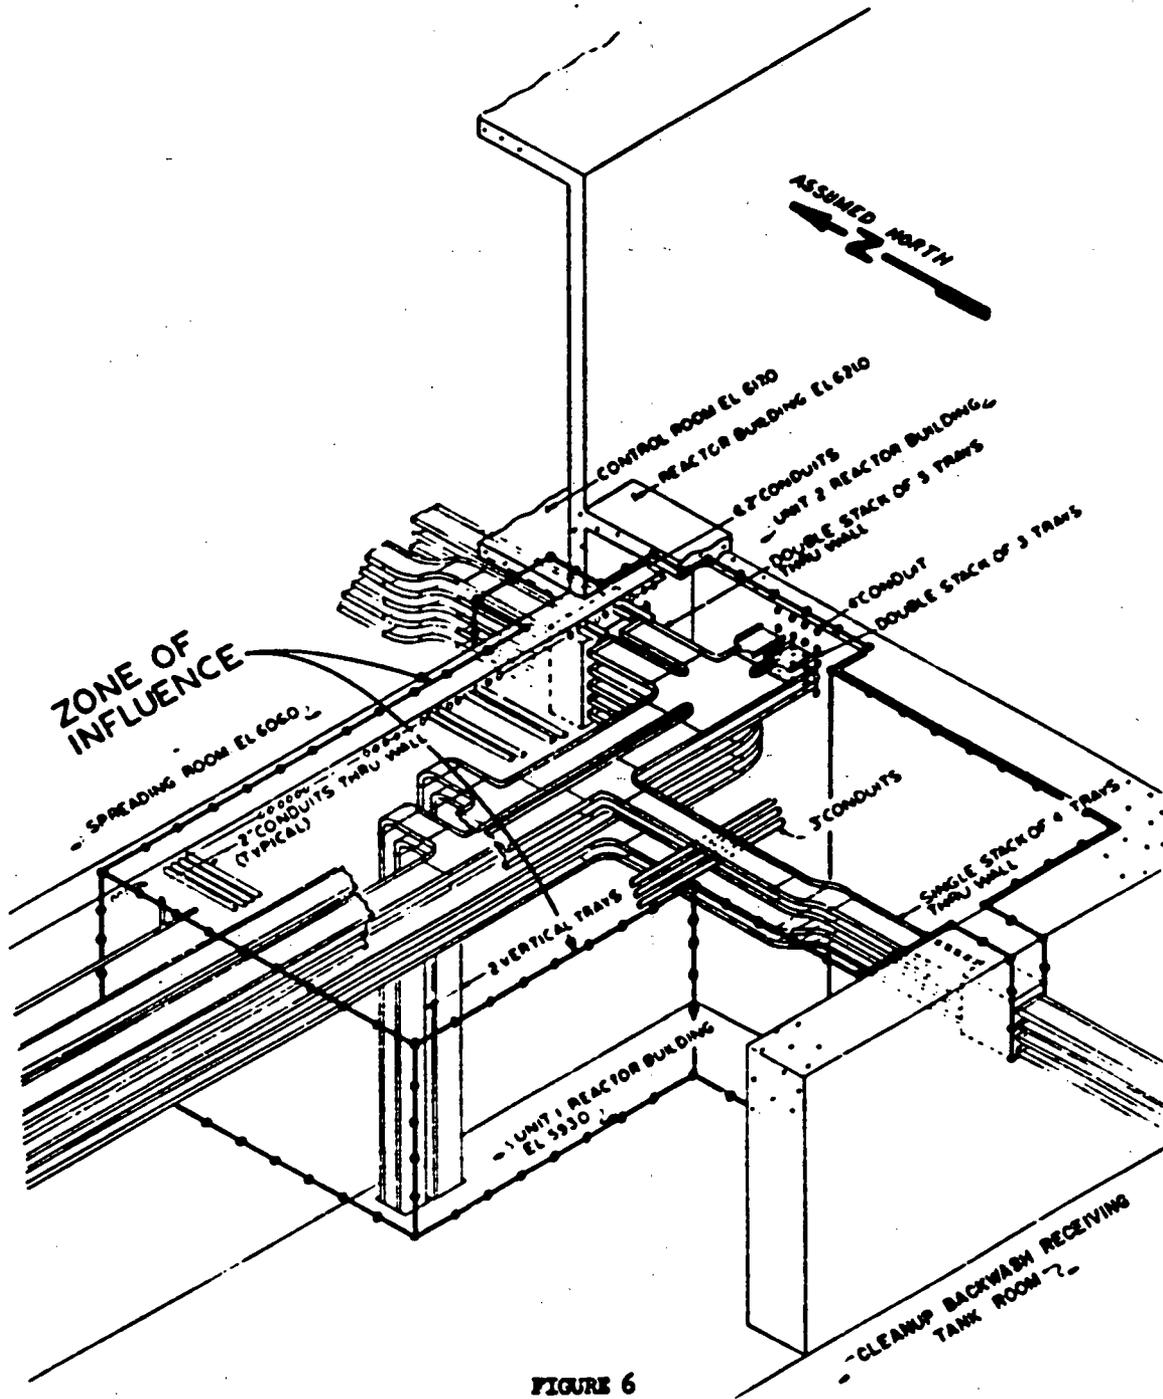
FIGURE 6
AREA OF FIRE

FIRE STARTED IN WEST STACK OF TRAYS

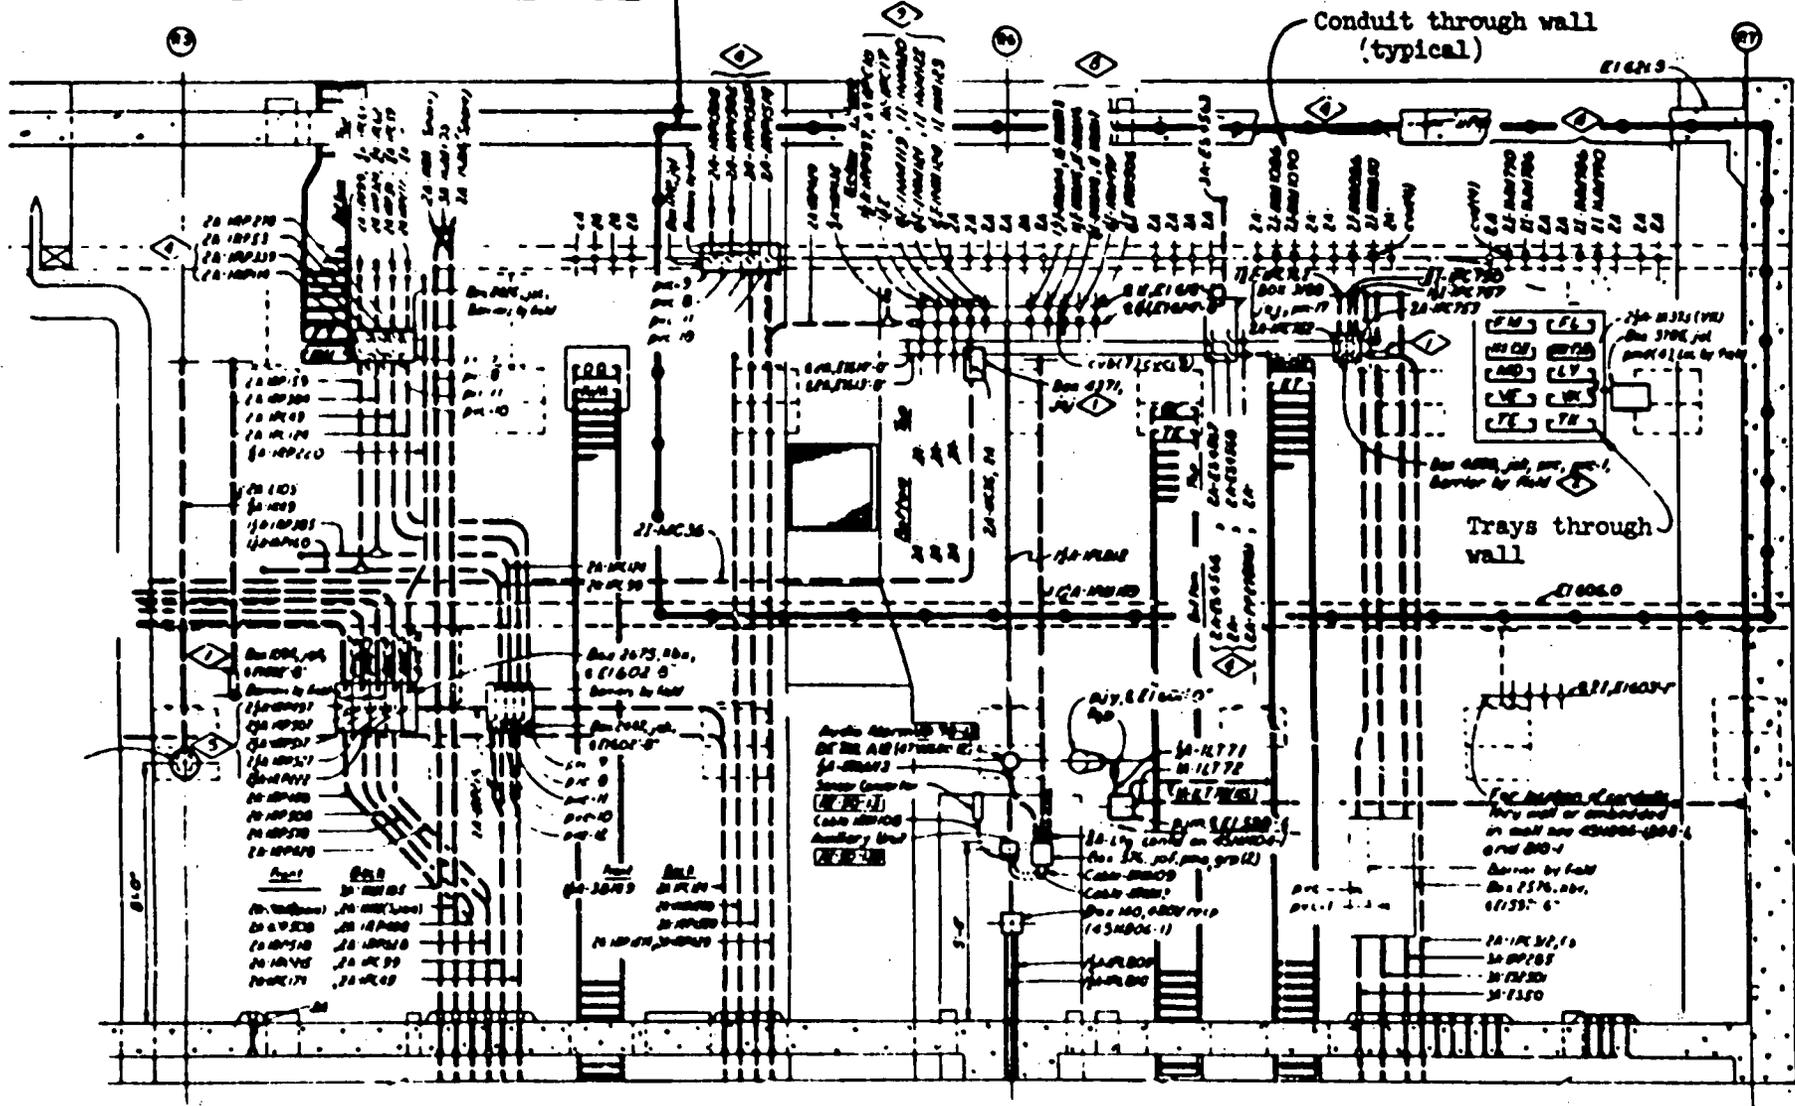
FIGURE 11
ELEVATION VIEW LOOKING NORTH TOWARD CONTROL BAY
FROM REACTOR BUILDING UNIT 1 EI 503 SHOWING CONDUITS
AND TRAYS IN ZONE OF INFLUENCE

ZONE OF INFLUENCE

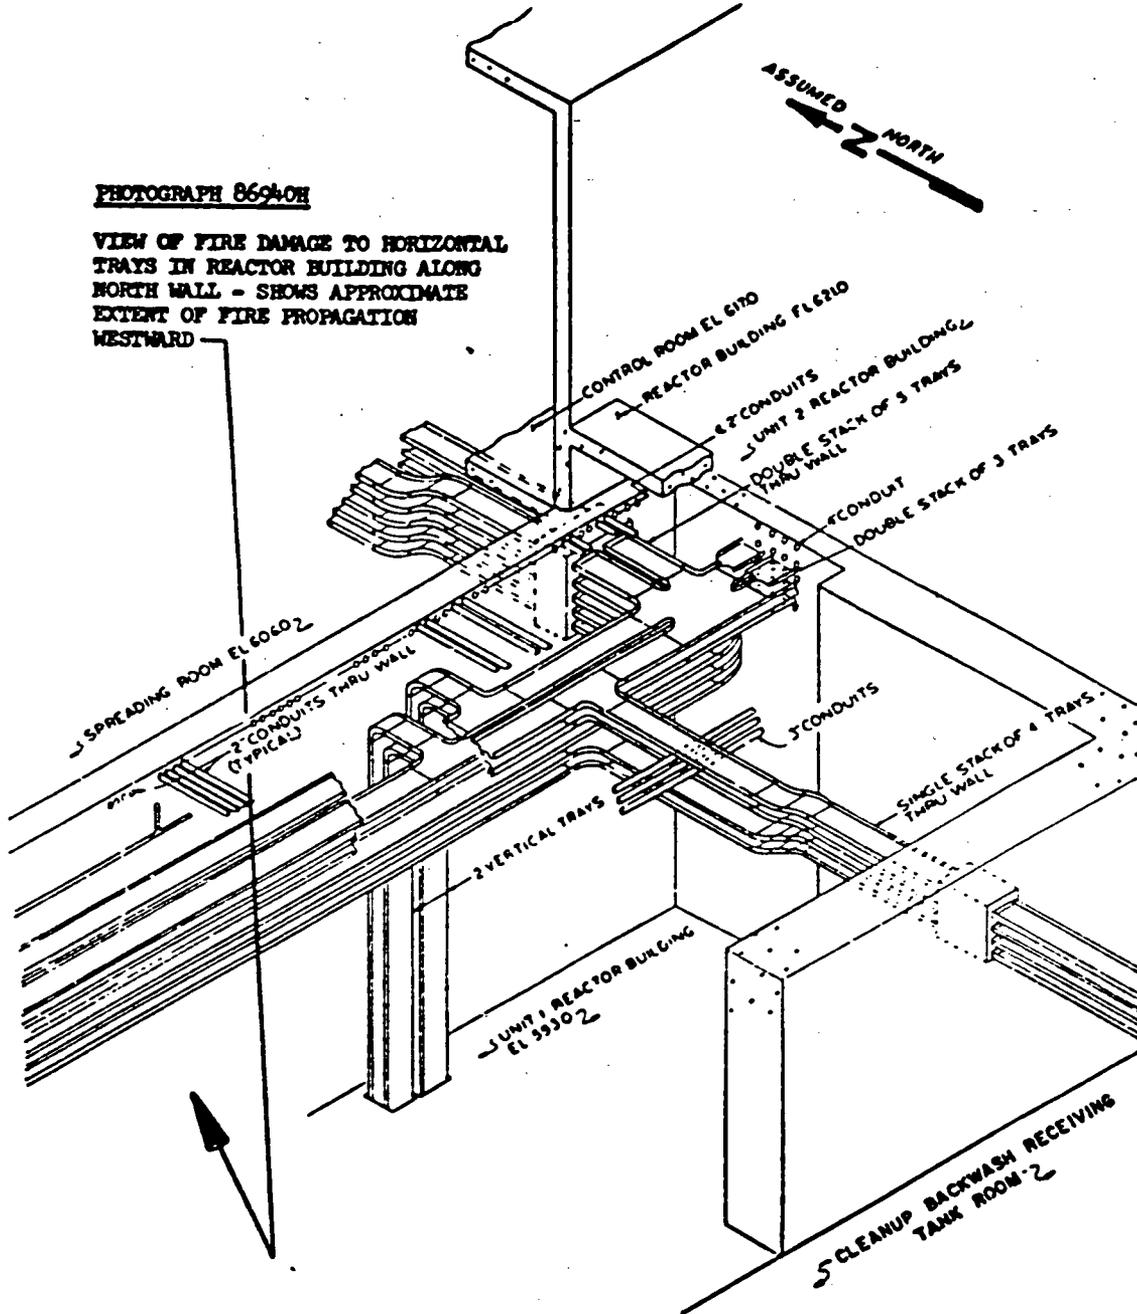
PHOTOGRAPH 86940H

VIEW OF FIRE DAMAGE TO HORIZONTAL TRAYS IN REACTOR BUILDING ALONG NORTH WALL - SHOWS APPROXIMATE EXTENT OF FIRE PROPAGATION WESTWARD

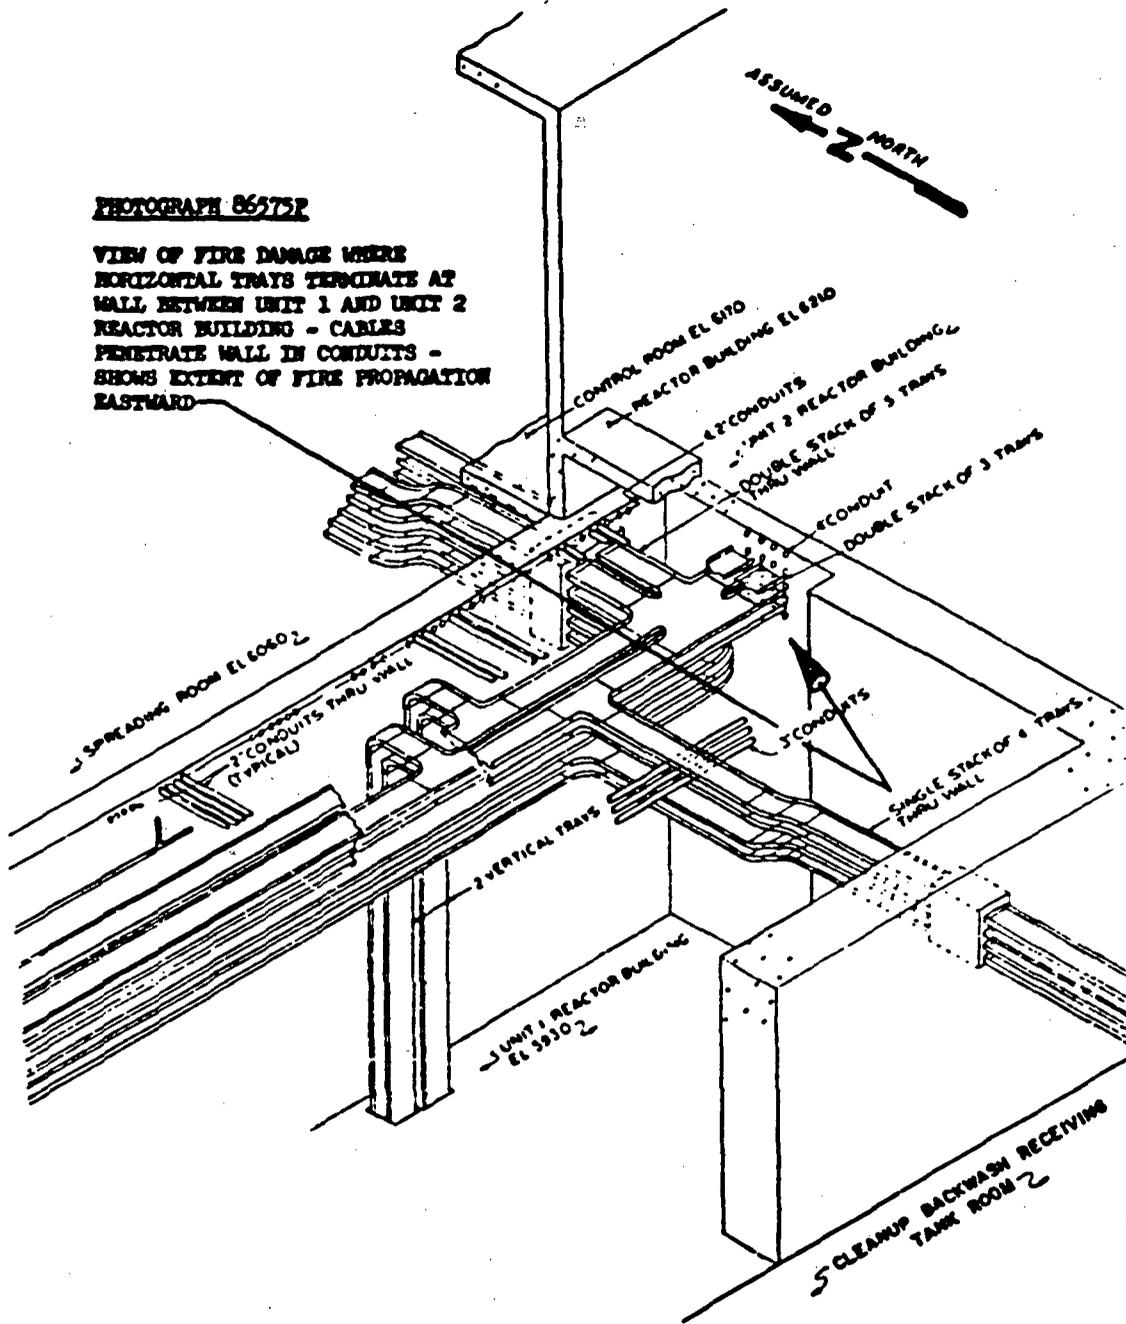
PHOTOGRAPH 86575E

**VIEW OF FIRE DAMAGE WHERE
HORIZONTAL TRAYS TERMINATE AT
WALL BETWEEN UNIT 1 AND UNIT 2
REACTOR BUILDING - CABLES
PENETRATE WALL IN CONDUITS -
SHOWS EXTENT OF FIRE PROPAGATION
EASTWARD**
