Nebraska Public Power District

Subject: Revised Root Cause Investigation – Diesel Generator Amphenol Connector
Cooper Nuclear Station, Docket No. 50-298, DPR-46

Root Cause Investigation (Rev. 1)
Unexpected DG-2 Shutdown
CR-CNS-2008-00304
Dated 7/11/2008

UNEXPECTED DG-2 SHUTDOWN CR-CNS-2008-00304

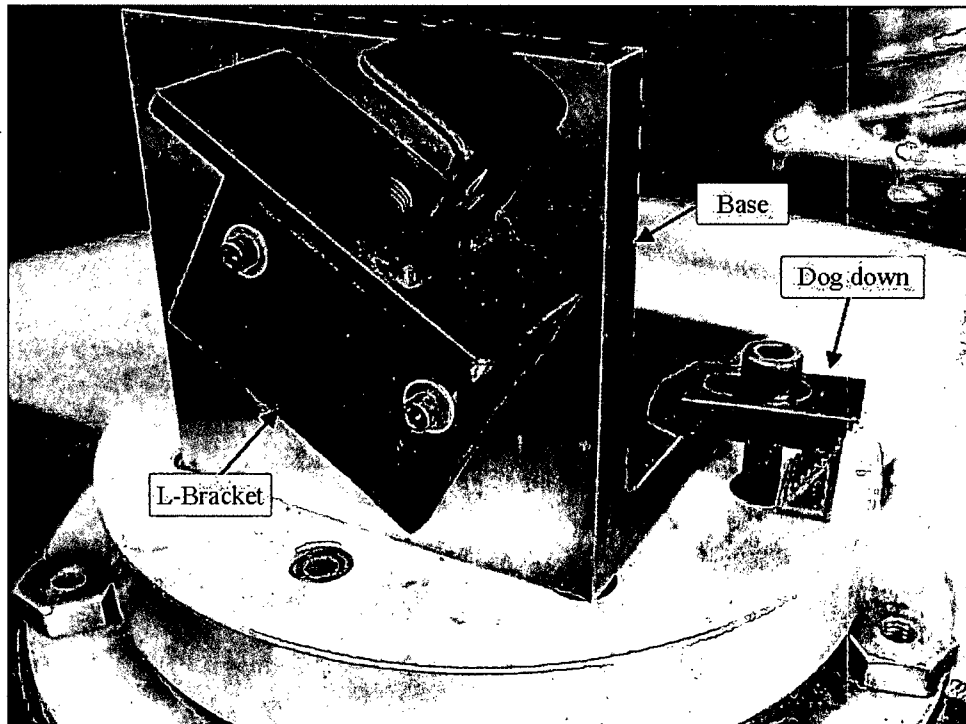
Figure 5. MPU Test Rig for Vibration Testing Set to 30° and Secured to the Shaker Plate

The base of the test rig was constructed from a 0.8 inch thick carbon-steel mounting bracket, 6 inches tall by 6 inches wide. The MPU is held by a smaller L-bracket constructed from ¼ inch steel stock which can be bolted to the larger L-bracket at angles of 0, 30, 60, and 90 degrees. The smaller L-bracket's vertical face is threaded to accommodate the MPU and is locked in position with the MPU's nut. The base is secured to the shaker plate using a "dog down" or setup clamp. Three of these set-up clamps are used to secure the mounting bracket. Figure 5 (below) shows a photograph of the test rig mounted on the shaker plate.

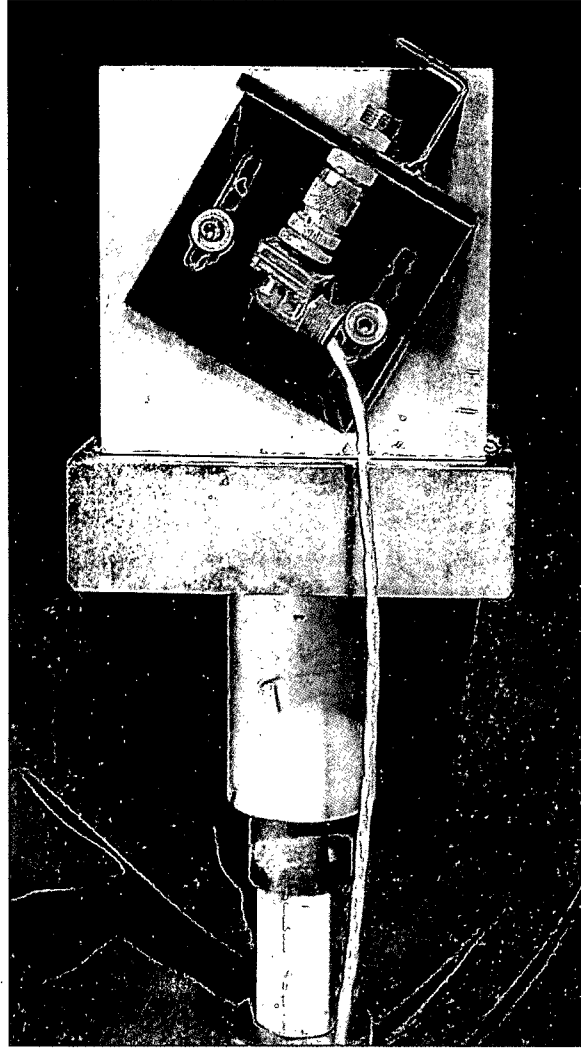
Figure 6. MPU Test Rig in Servo-Hydraulic Frame for Long-Term Vibration

For the long-term testing the test rig was moved from the shaker table to a servo-hydraulic frame. This was done only for the convenience of the test lab and vibration environment is substantially similar to the shaker plate used in the previous (short-term) testing.

The long-term testing was initiated on June 27, 2008 at 3:42:27 PM and continued for a total of 10 days (240 hours). The following conditions were used for this testing:
