FIRE AT BROWNS FERRY NUCLEAR PLANT

TENNESSEE VALLEY AUTHORITY

MARCH 22, 1975

PRELIMINARY INVESTIGATING COMMITTEE

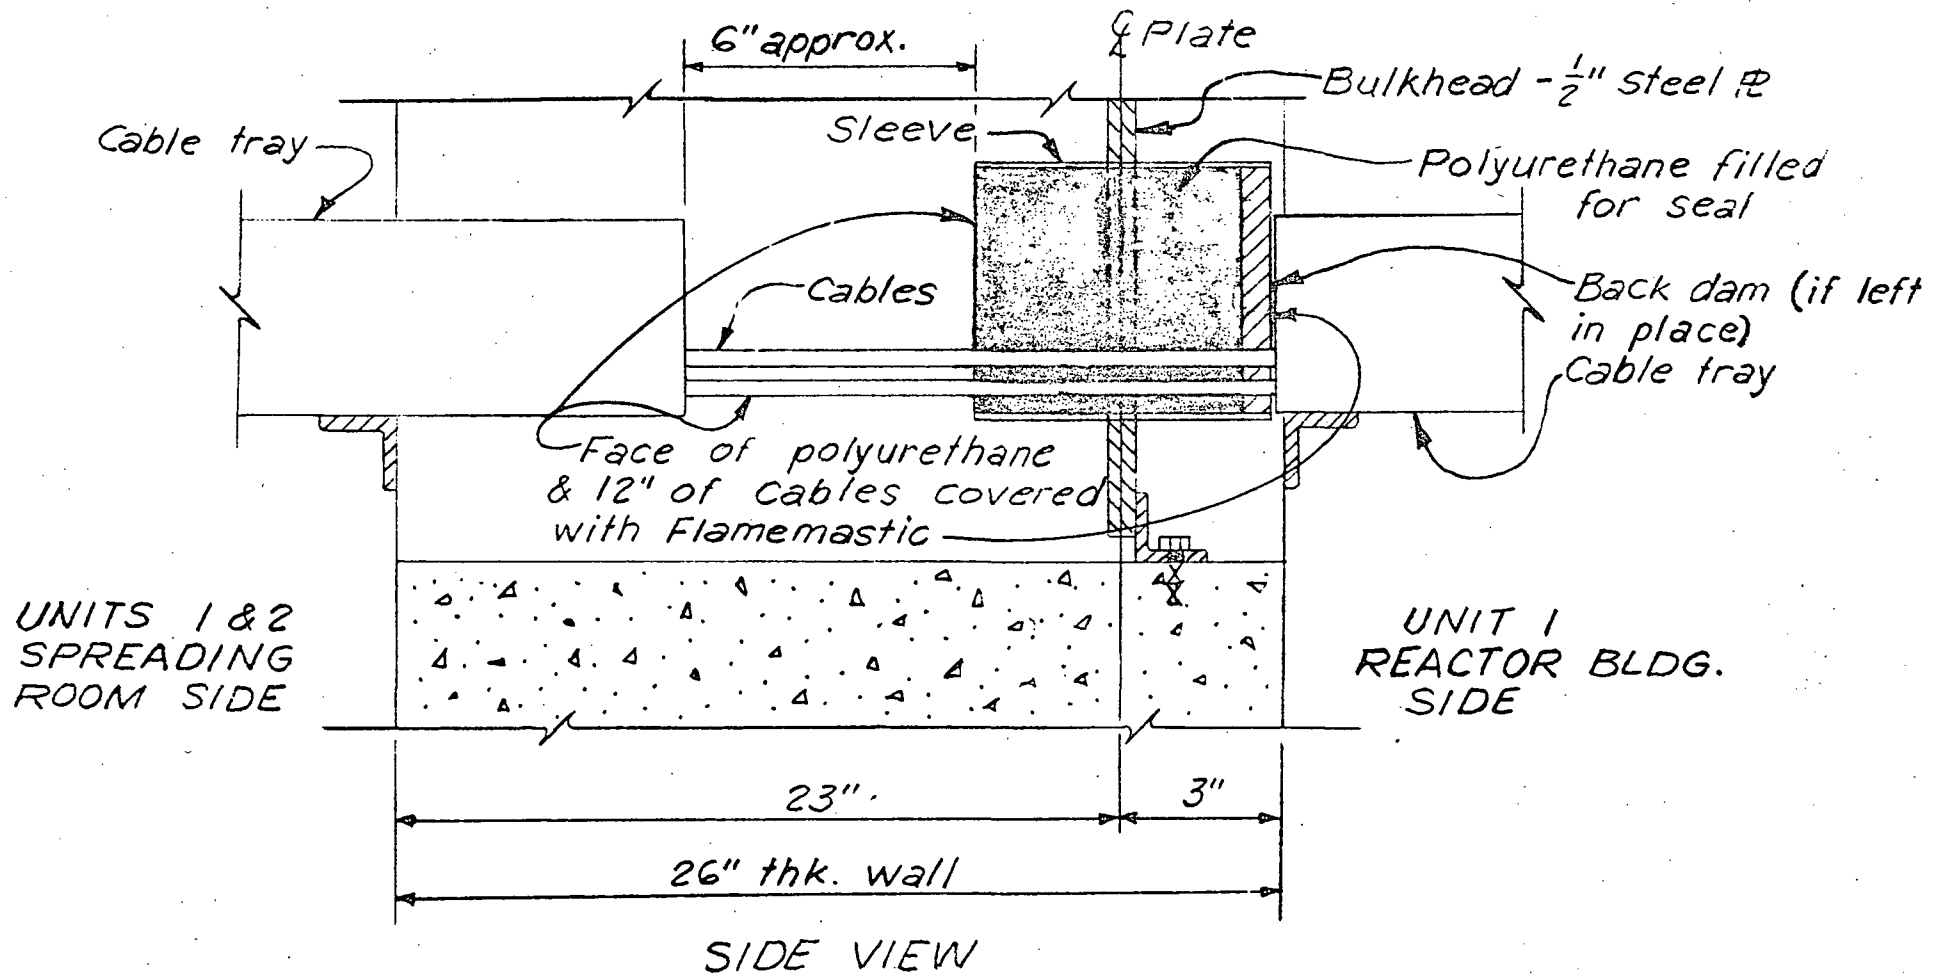
FIGURE 4

inches of cables on both sides of the penetration were then coated with Flamemastic to provide the fire stop. The steel bulkhead as constructed was mounted in the opening with the centerline 3 inches from the surface of the wall on the reactor building side and 23 inches from the surface of the wall on the spreading room side, as indicated by dimensions on figure 4. Materials in addition to polyurethane foam were used to form the pressure seal.

PARTIAL CROSS SECTION OF PENETRATIONS
(TO SHOW BULKHEAD LOCATION IN WALL AS CONSTRUCTED)

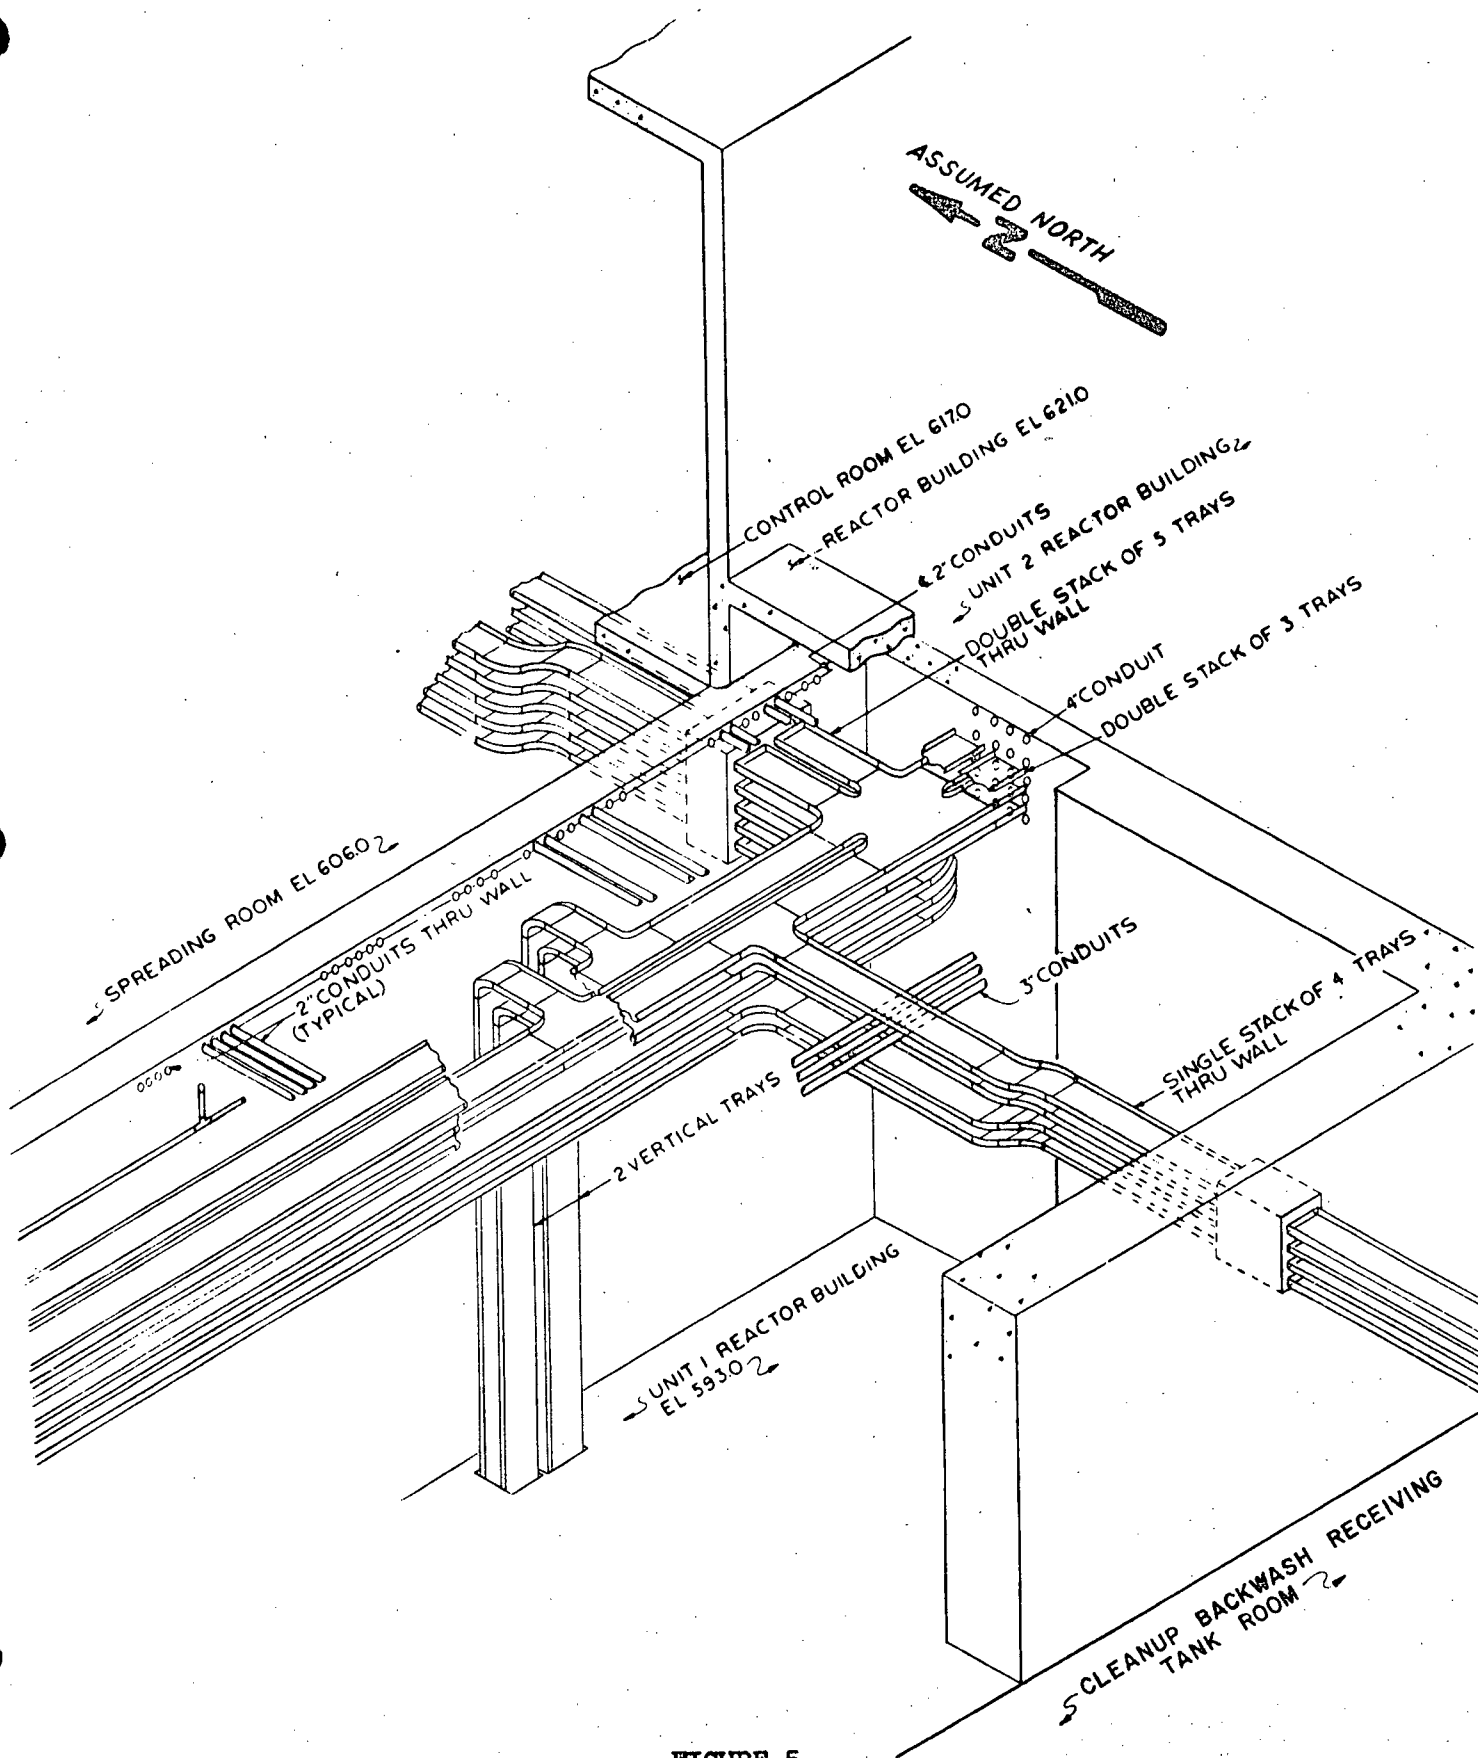
FIGURE 5
 AREA OF FIRE

It has been determined that the fire started when an open flame came into contact with material used as the seal around the cables where they penetrate the wall between the units 1 and 2 control bay spreading room and the unit 1 reactor building. Figures 5 and 6 indicate the area being considered in this description. Figure 6 shows the zone of influence of the fire. Figure 7 shows a cross section of trays near the point where the fire started. The cables and raceways in the spreading room were damaged approximately 5 feet north of the wall penetration; and the fire propagated along all trays, as marked on figure 8, in the reactor building on floor elevation 593. Many photographs were taken, and 10 key ones are included in this report as appendix B. Figure 9 shows affected trays and their intersections in single-line representation. Checkpoints used for routing cables on each cable tray are also shown. (See table 2 for loading of cable types onto each tray at each checkpoint.)

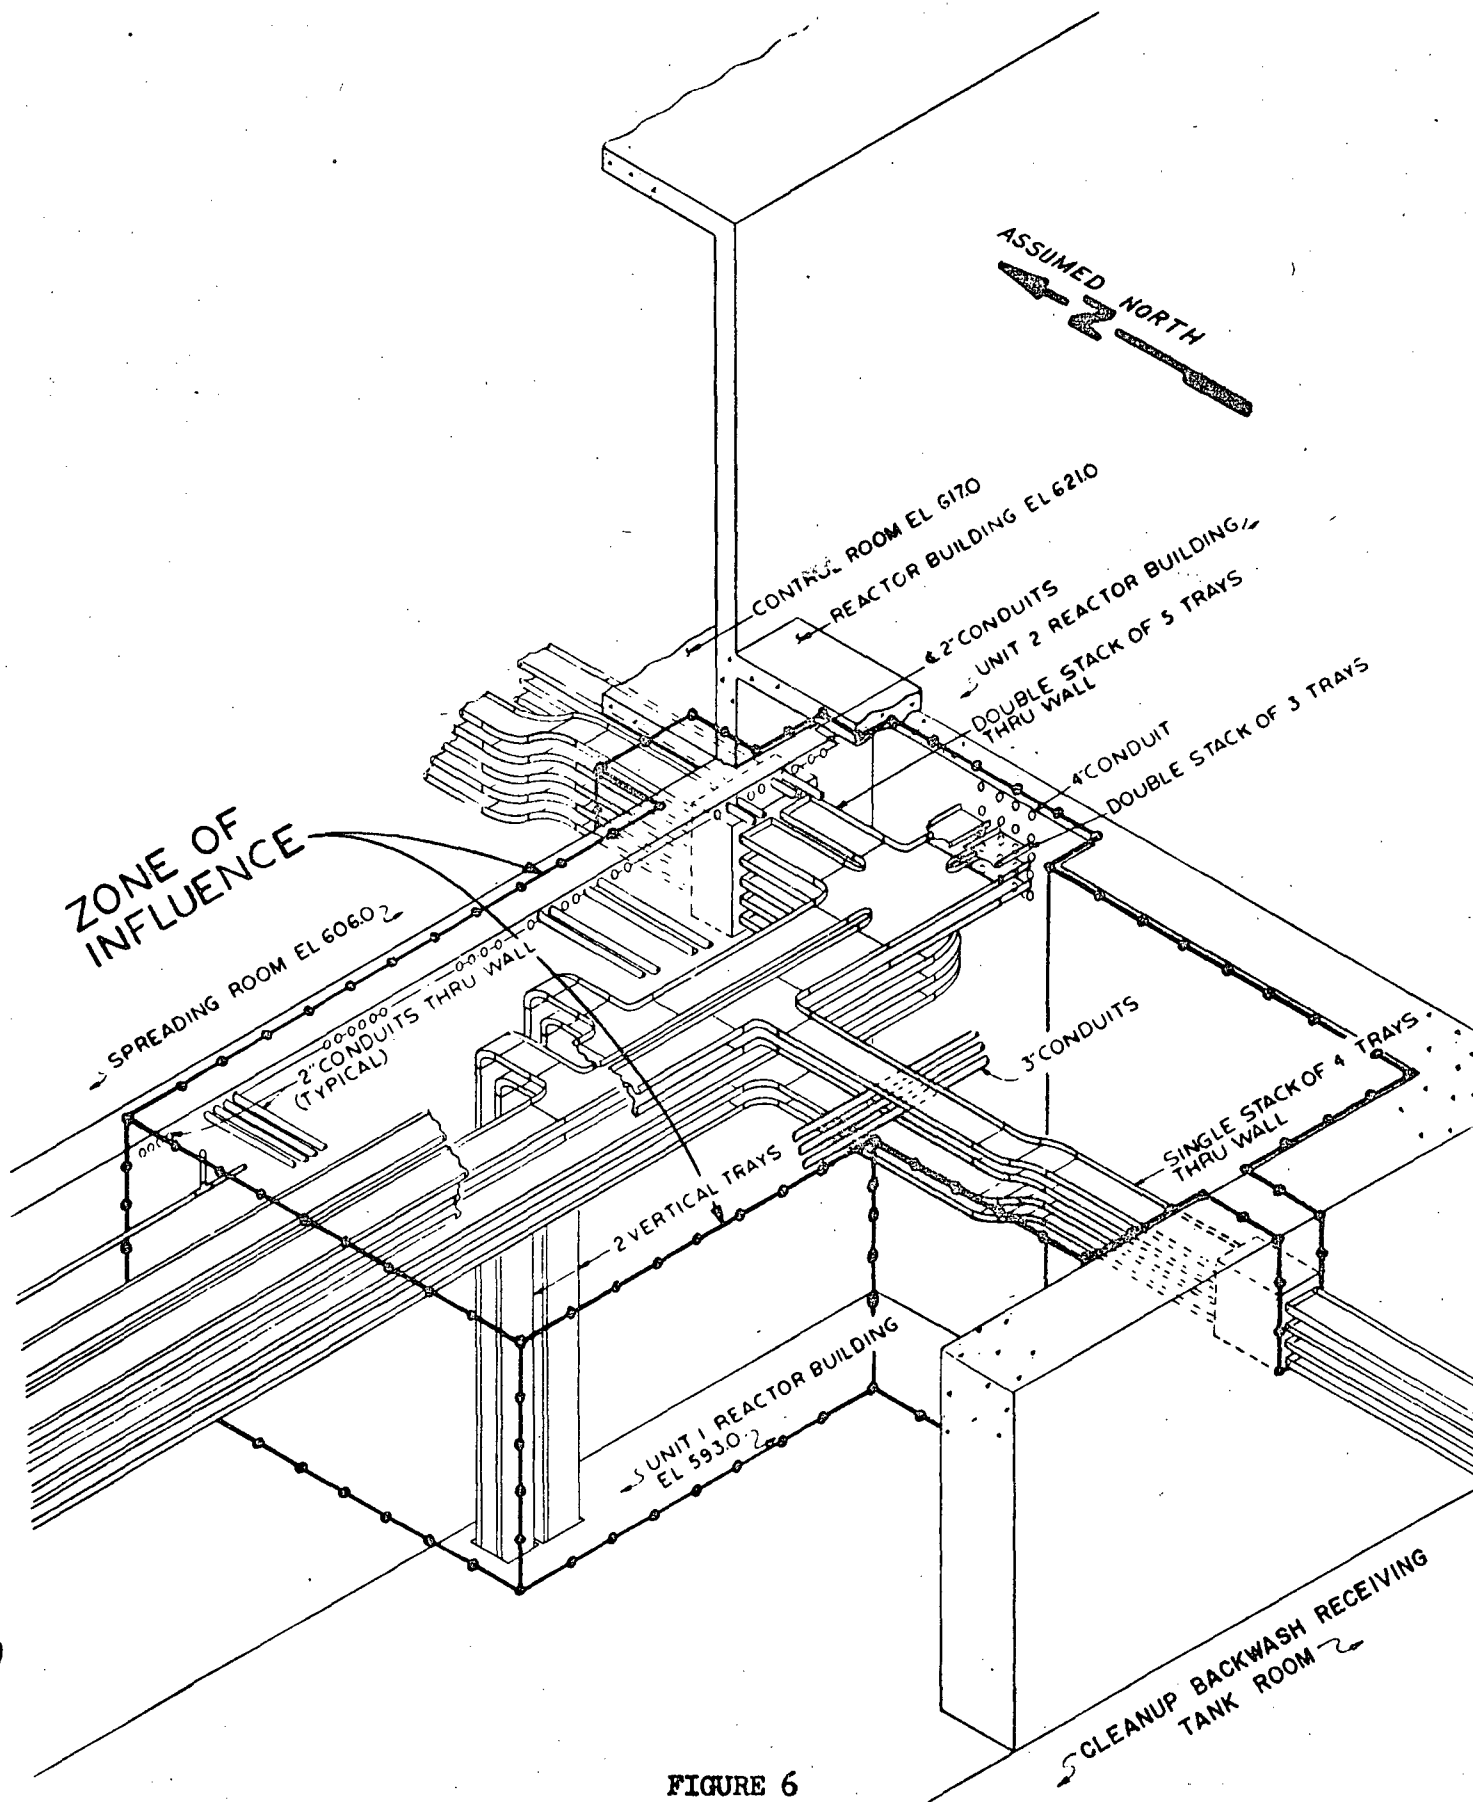
FIGURE 6

FIRE STARTED IN
WEST STACK OF
TRAYS

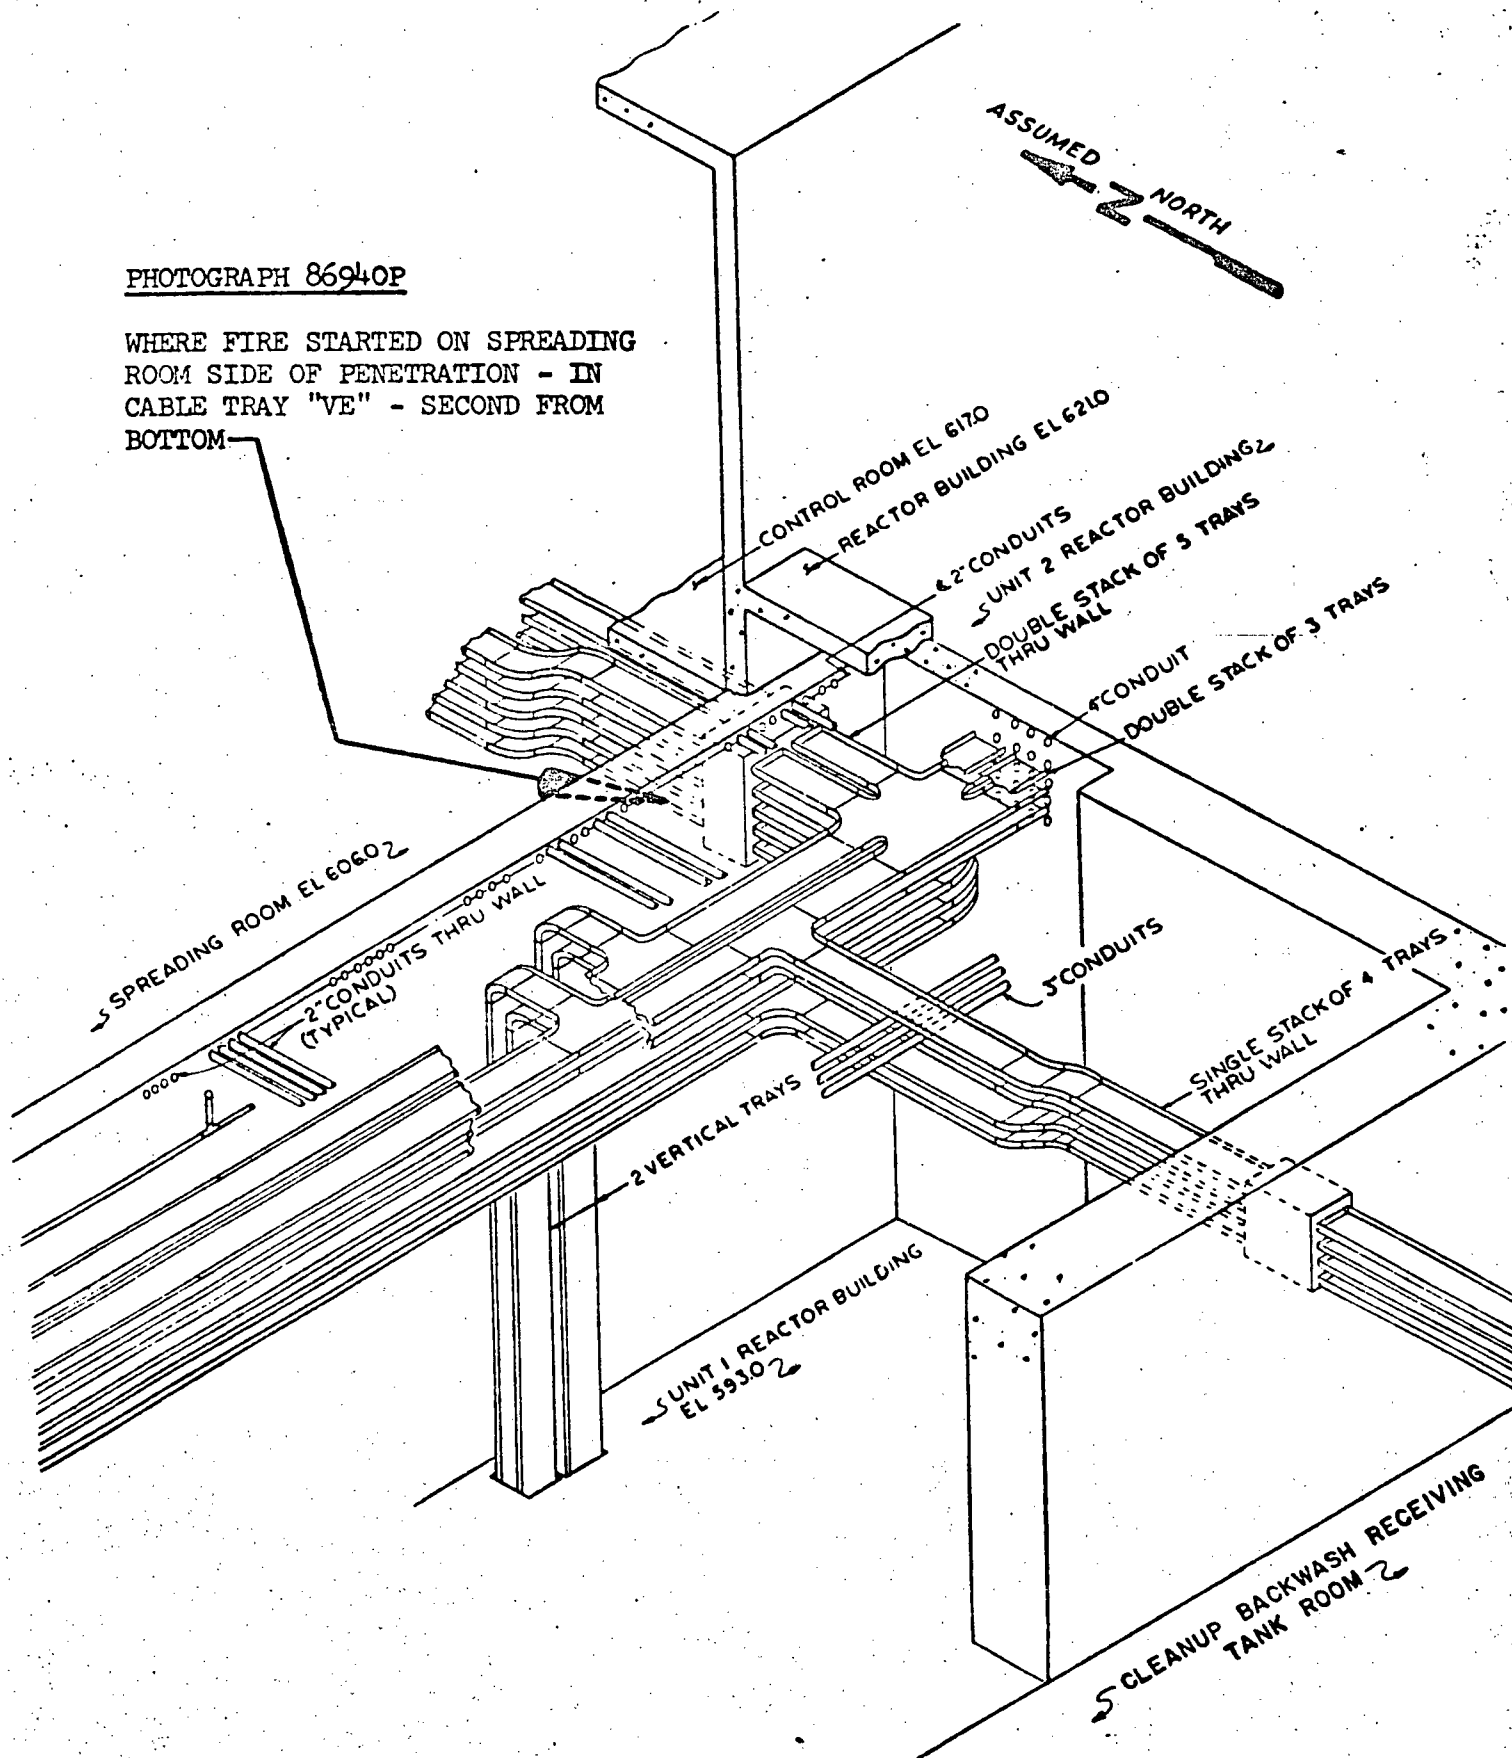
PHOTOGRAPH 86940P

WHERE FIRE STARTED ON SPREADING
ROOM SIDE OF PENETRATION - IN
CABLE TRAY "VE" - SECOND FROM
BOTTOM

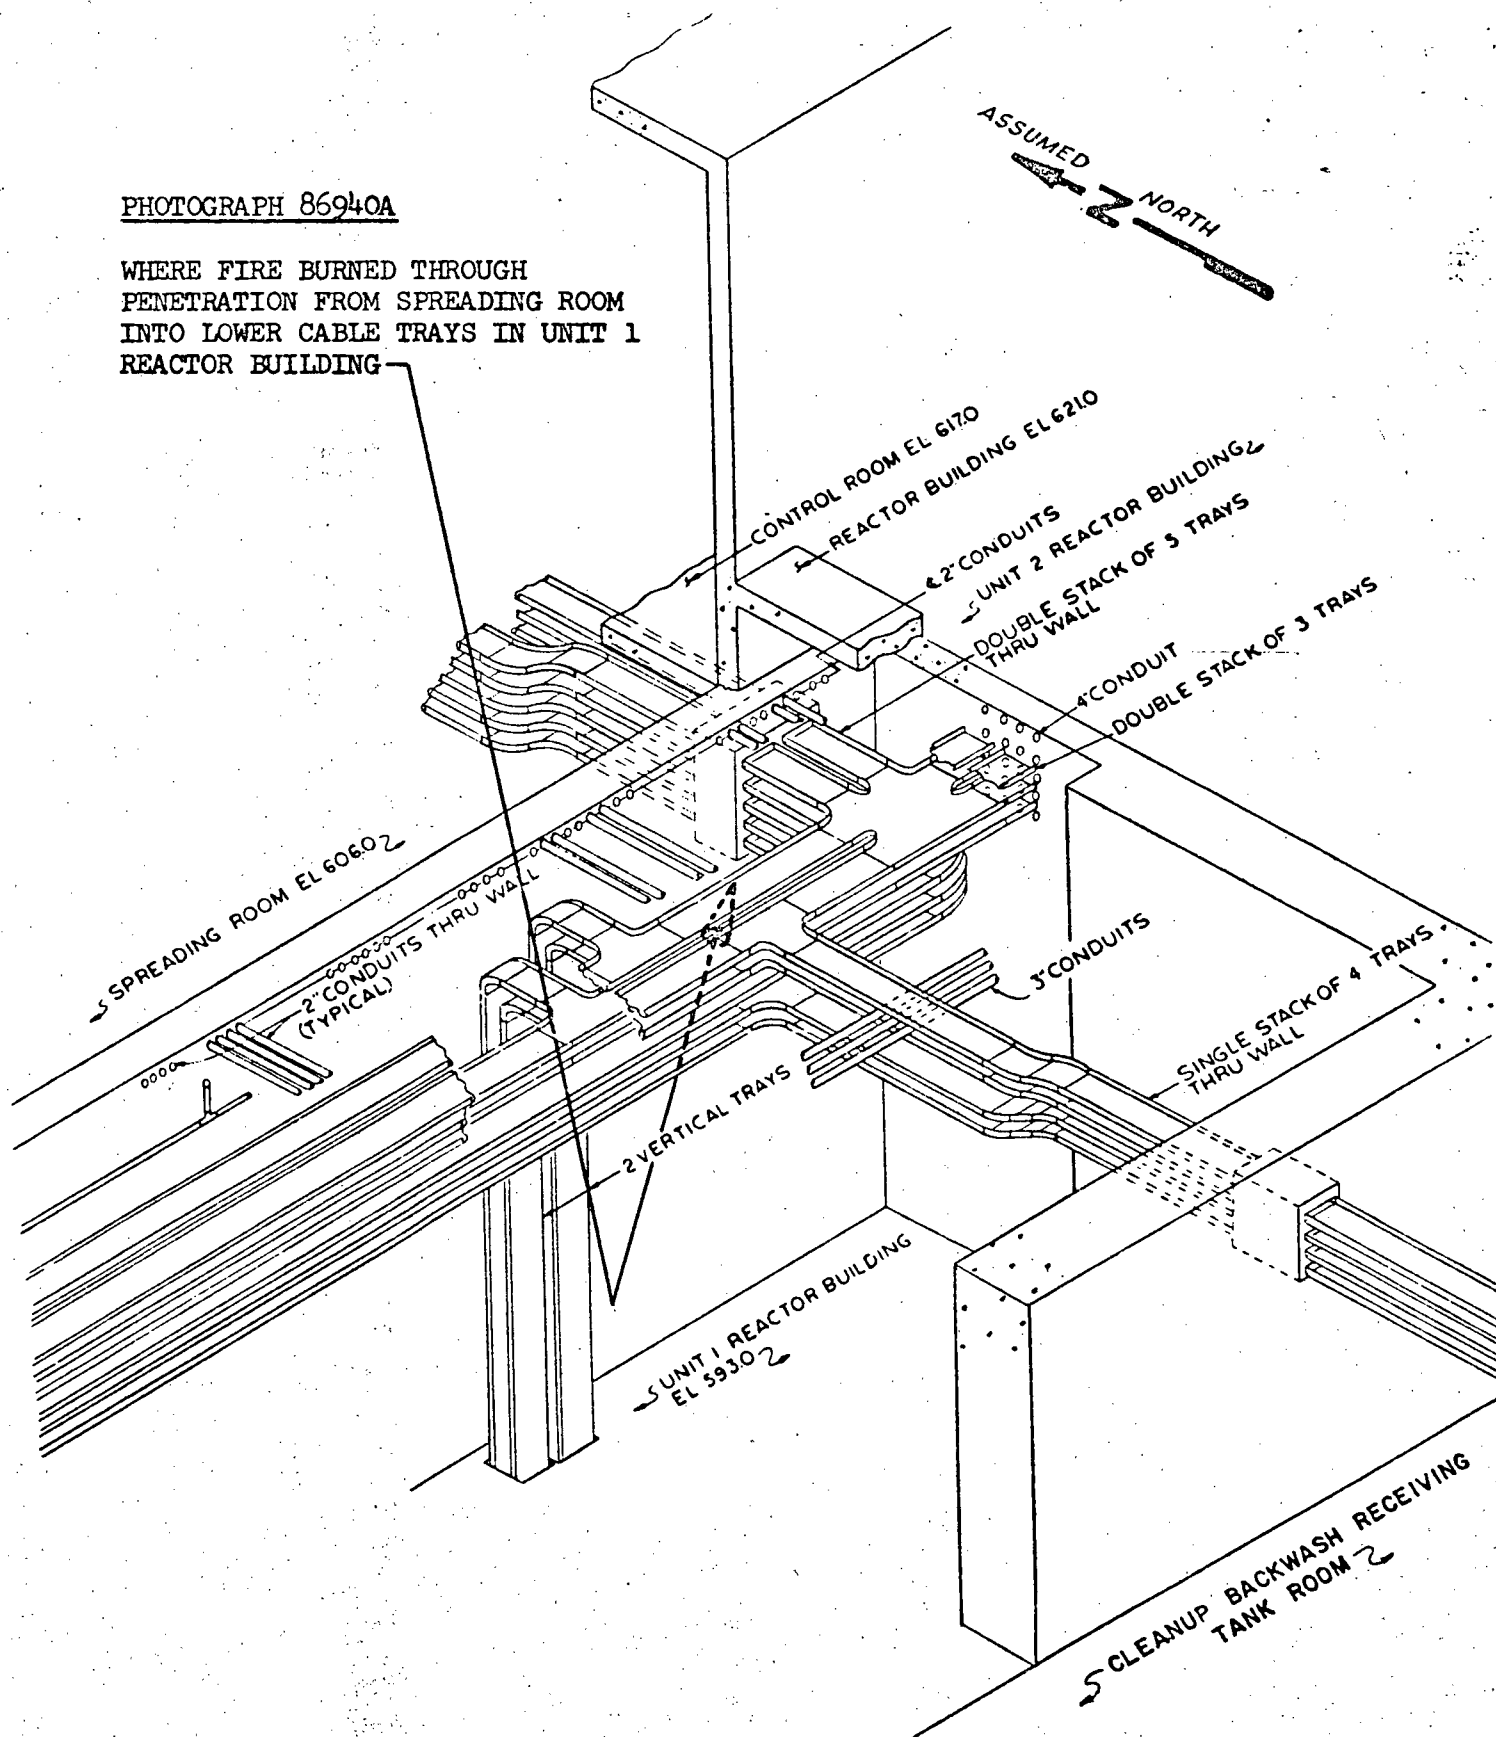
PHOTOGRAPH 86940A

WHERE FIRE BURNED THROUGH
PENETRATION FROM SPREADING ROOM
INTO LOWER CABLE TRAYS IN UNIT 1
REACTOR BUILDING

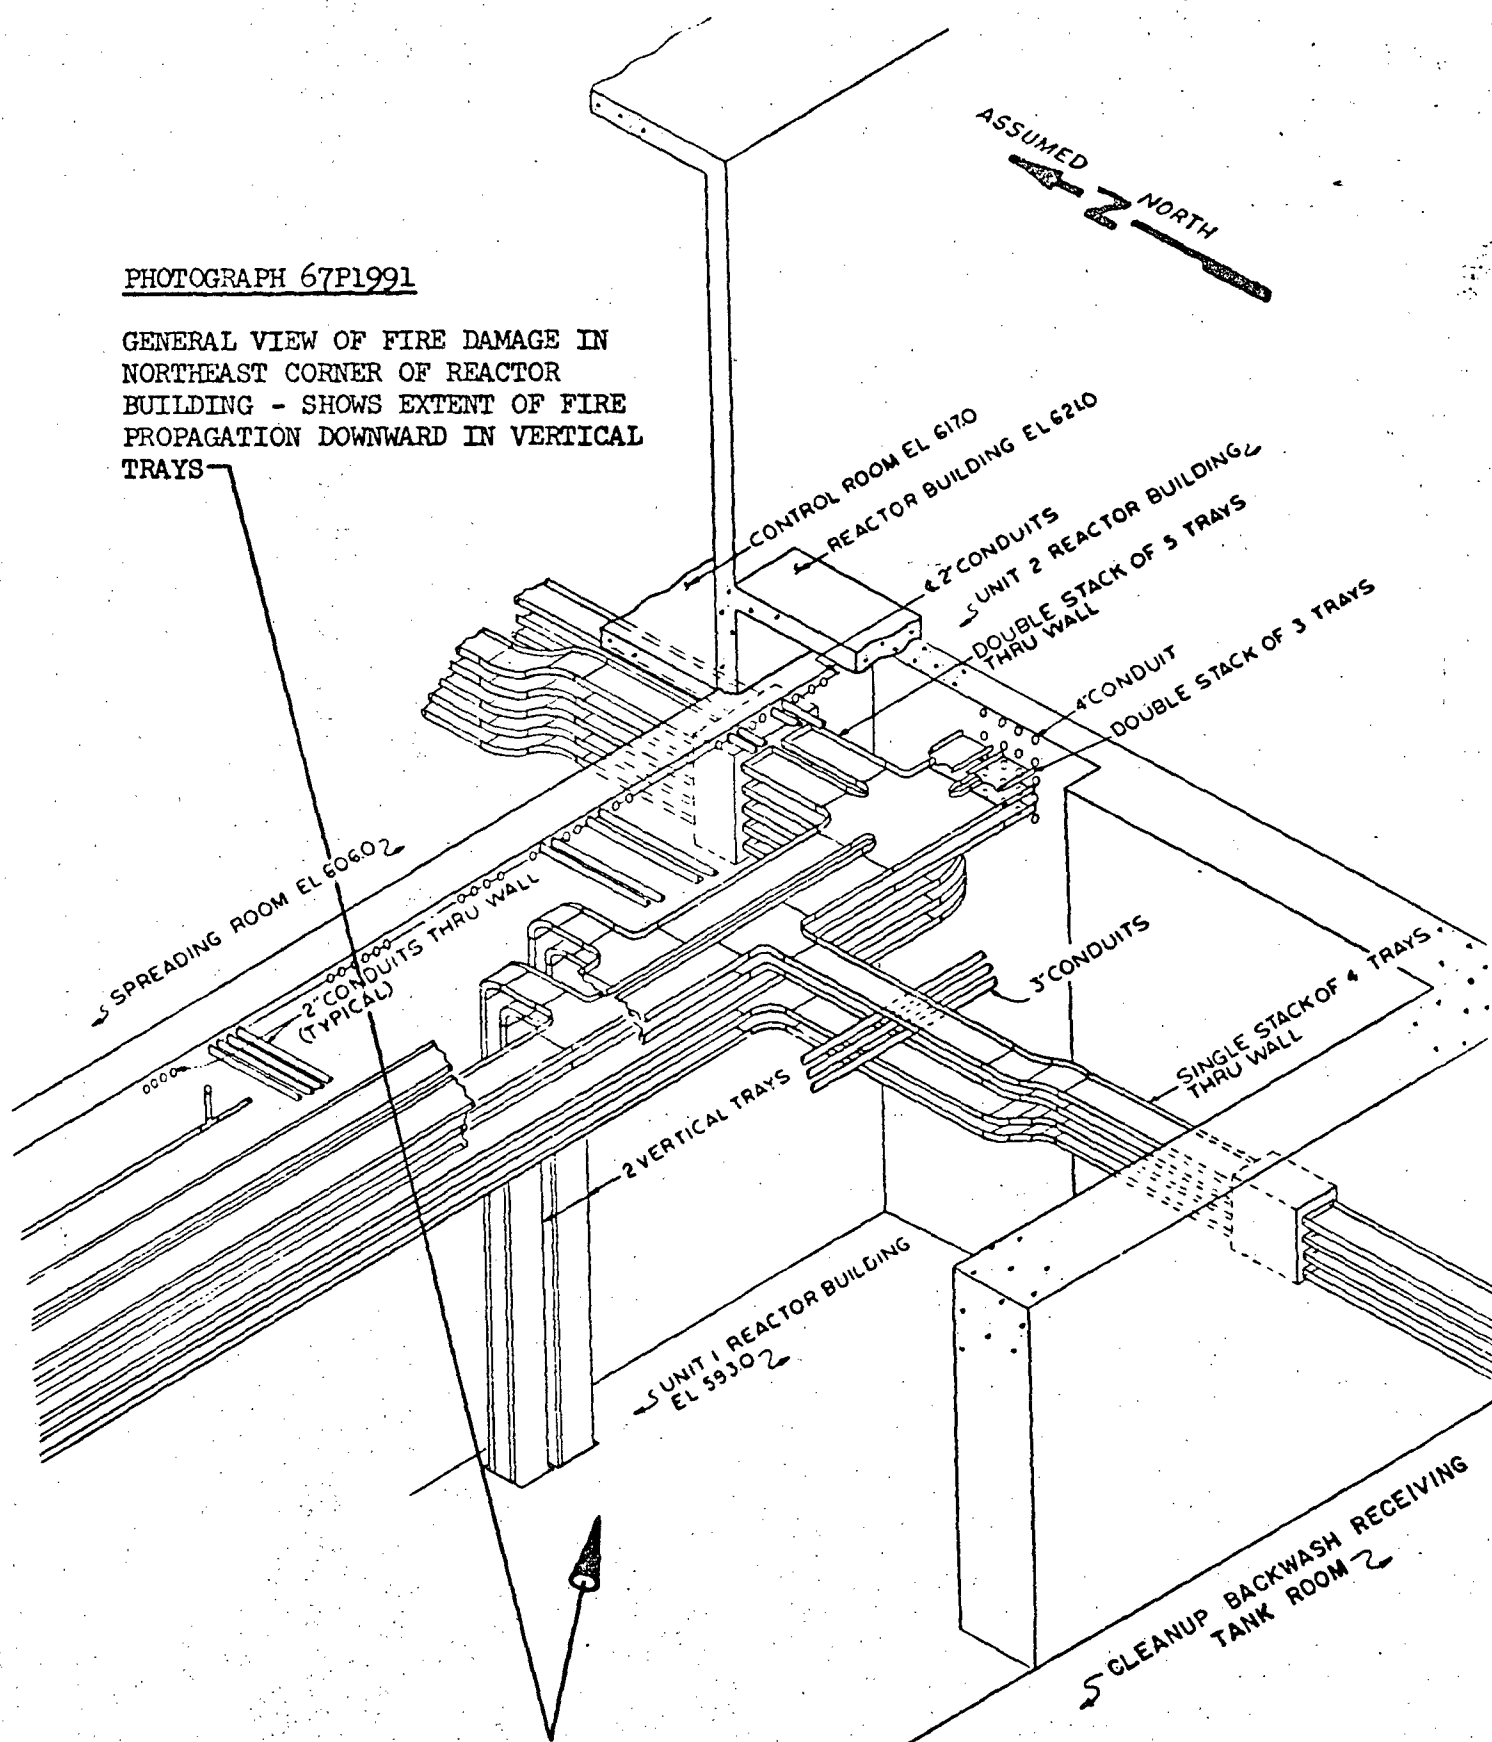
PHOTOGRAPH 67P1991

GENERAL VIEW OF FIRE DAMAGE IN
NORTHEAST CORNER OF REACTOR
BUILDING - SHOWS EXTENT OF FIRE
PROPAGATION DOWNWARD IN VERTICAL
TRAYS

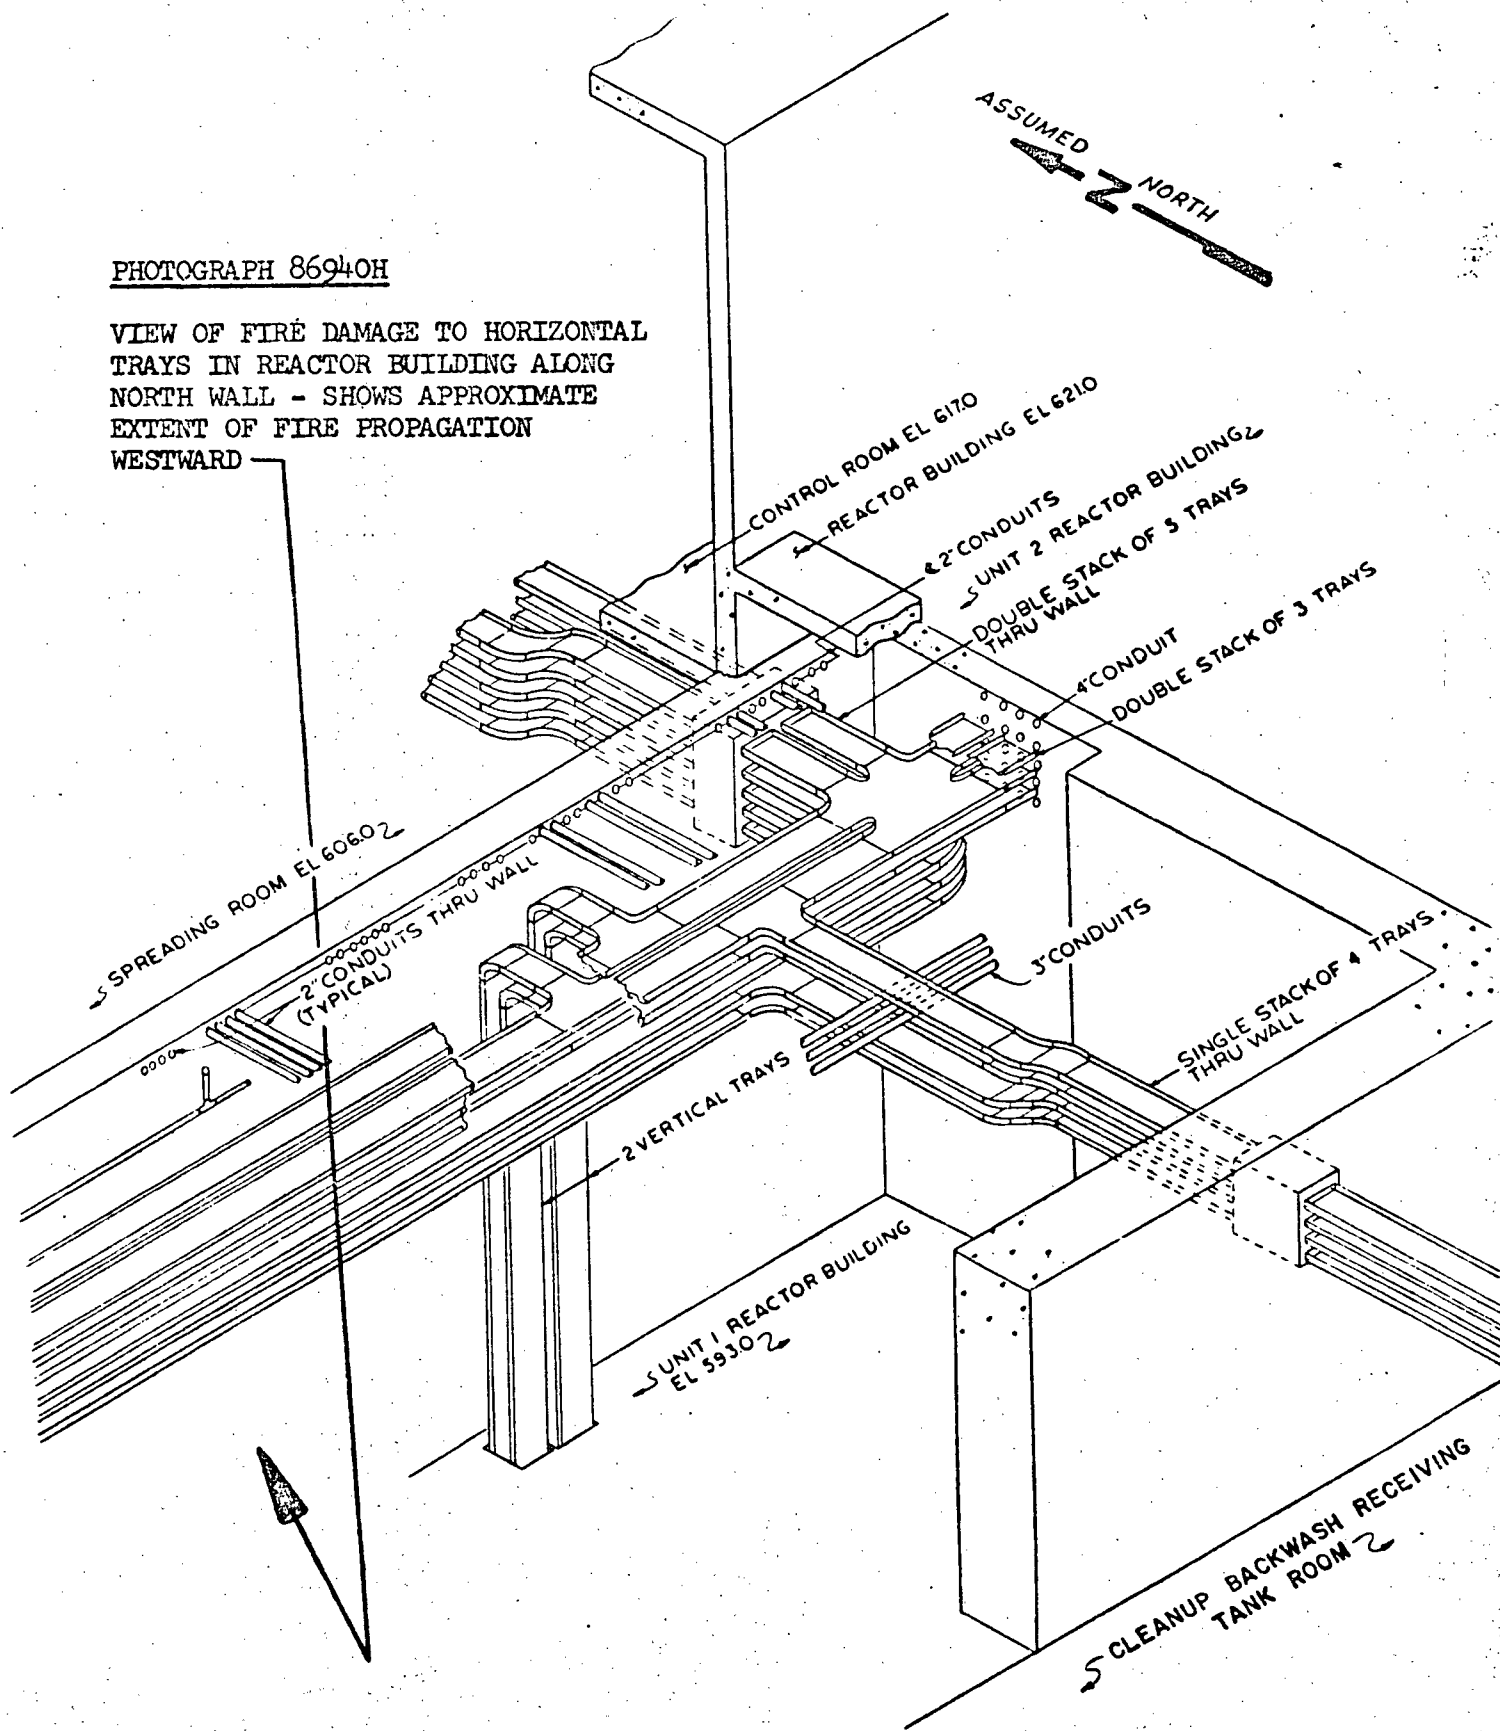
PHOTOGRAPH 86940H

VIEW OF FIRE DAMAGE TO HORIZONTAL
TRAYS IN REACTOR BUILDING ALONG
NORTH WALL - SHOWS APPROXIMATE
EXTENT OF FIRE PROPAGATION
WESTWARD

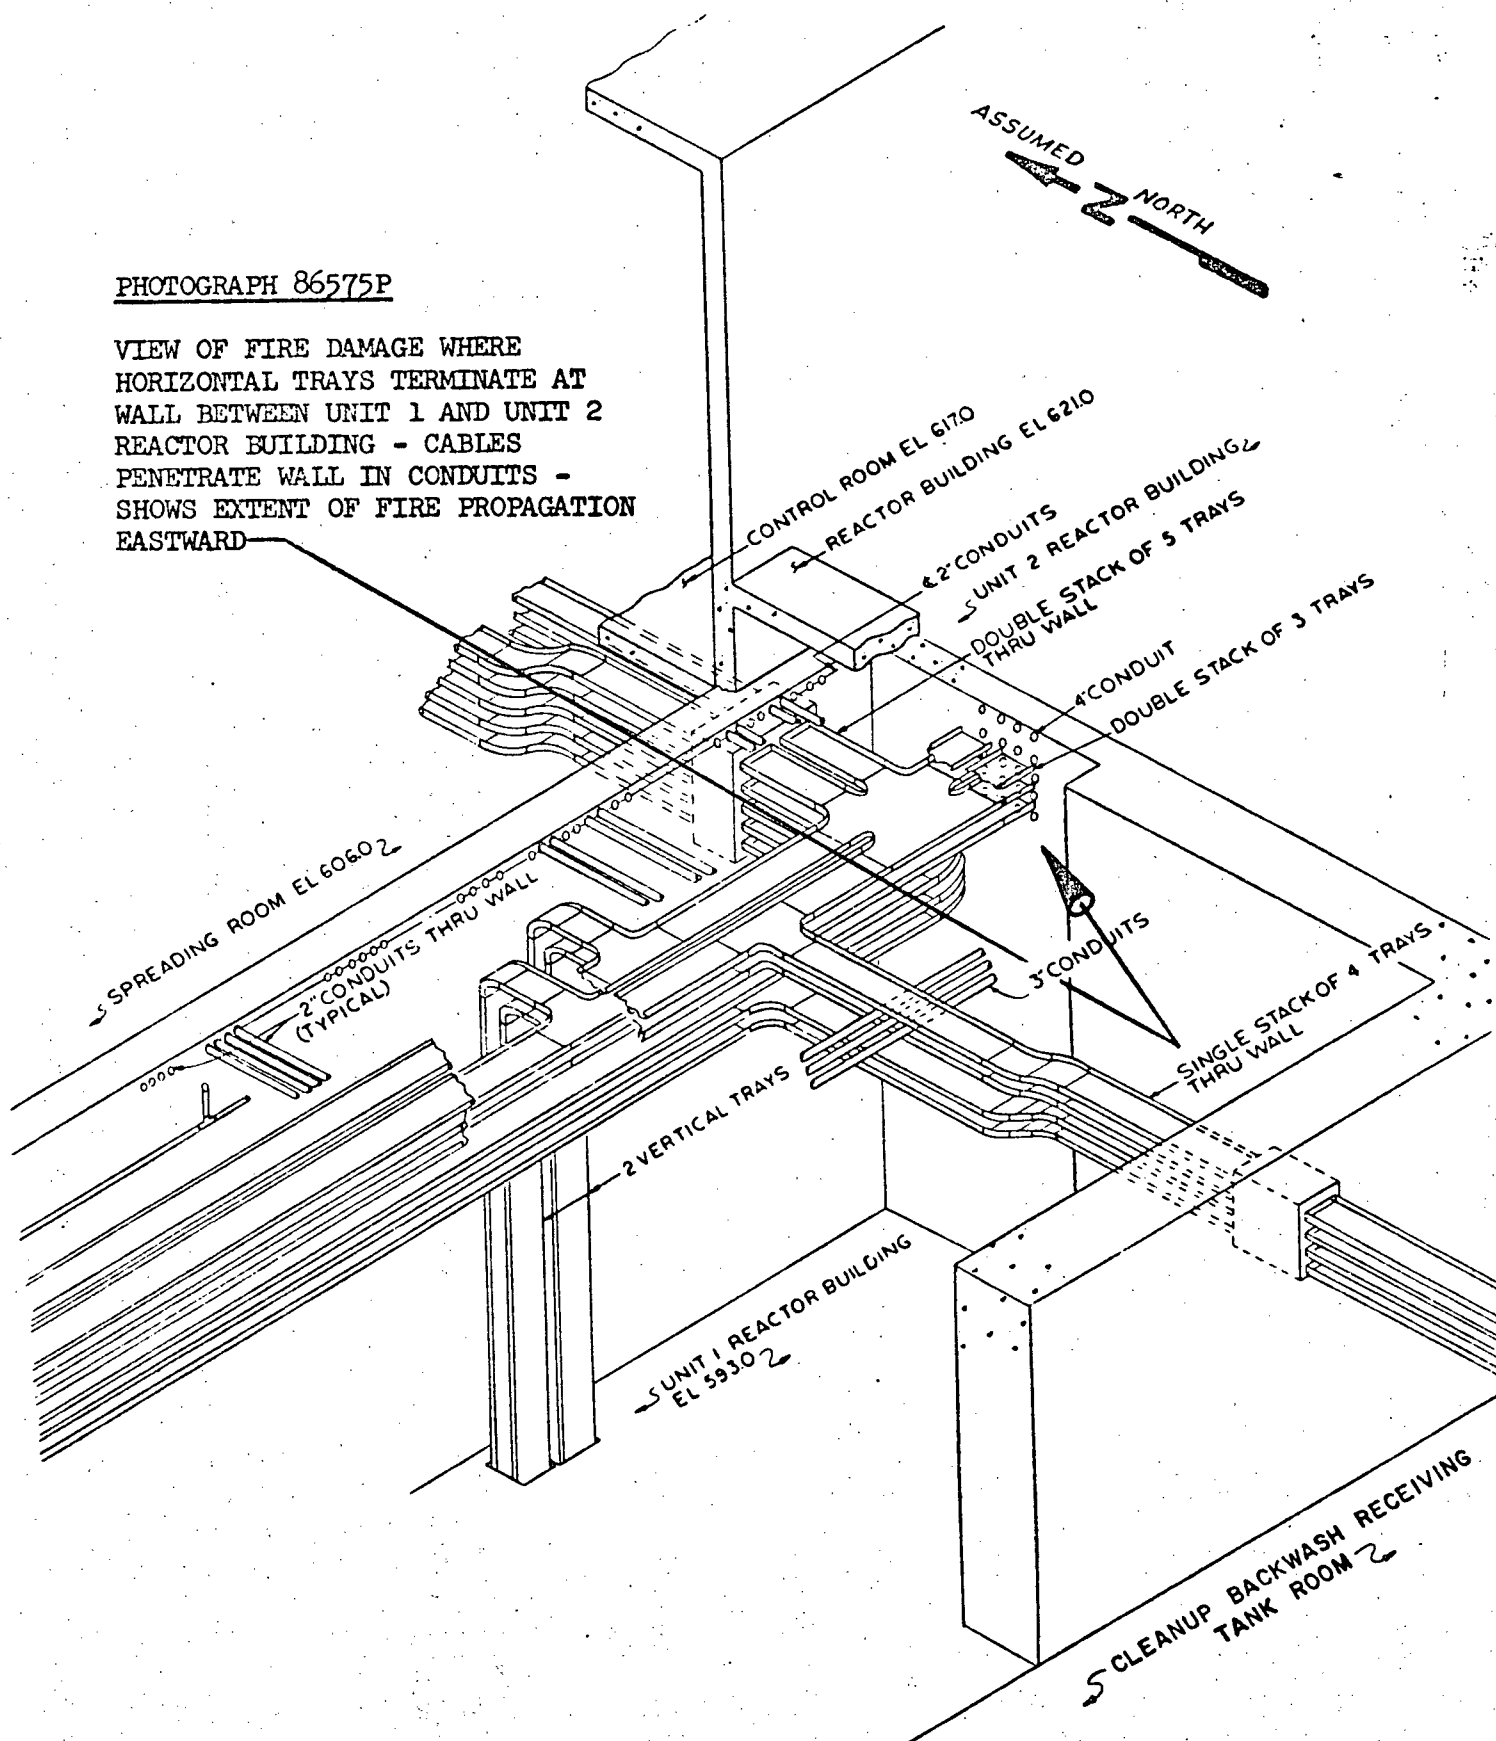
PHOTOGRAPH 86575P

VIEW OF FIRE DAMAGE WHERE
HORIZONTAL TRAYS TERMINATE AT
WALL BETWEEN UNIT 1 AND UNIT 2
REACTOR BUILDING - CABLES
PENETRATE WALL IN CONDUITS -
SHOWS EXTENT OF FIRE PROPAGATION
EASTWARD
