FIRE AT BROWNS FERRY NUCLEAR PLANT

TENNESSEE VALLEY AUTHORITY

MARCH 22, 1975

PRELIMINARY INVESTIGATING COMMITTEE

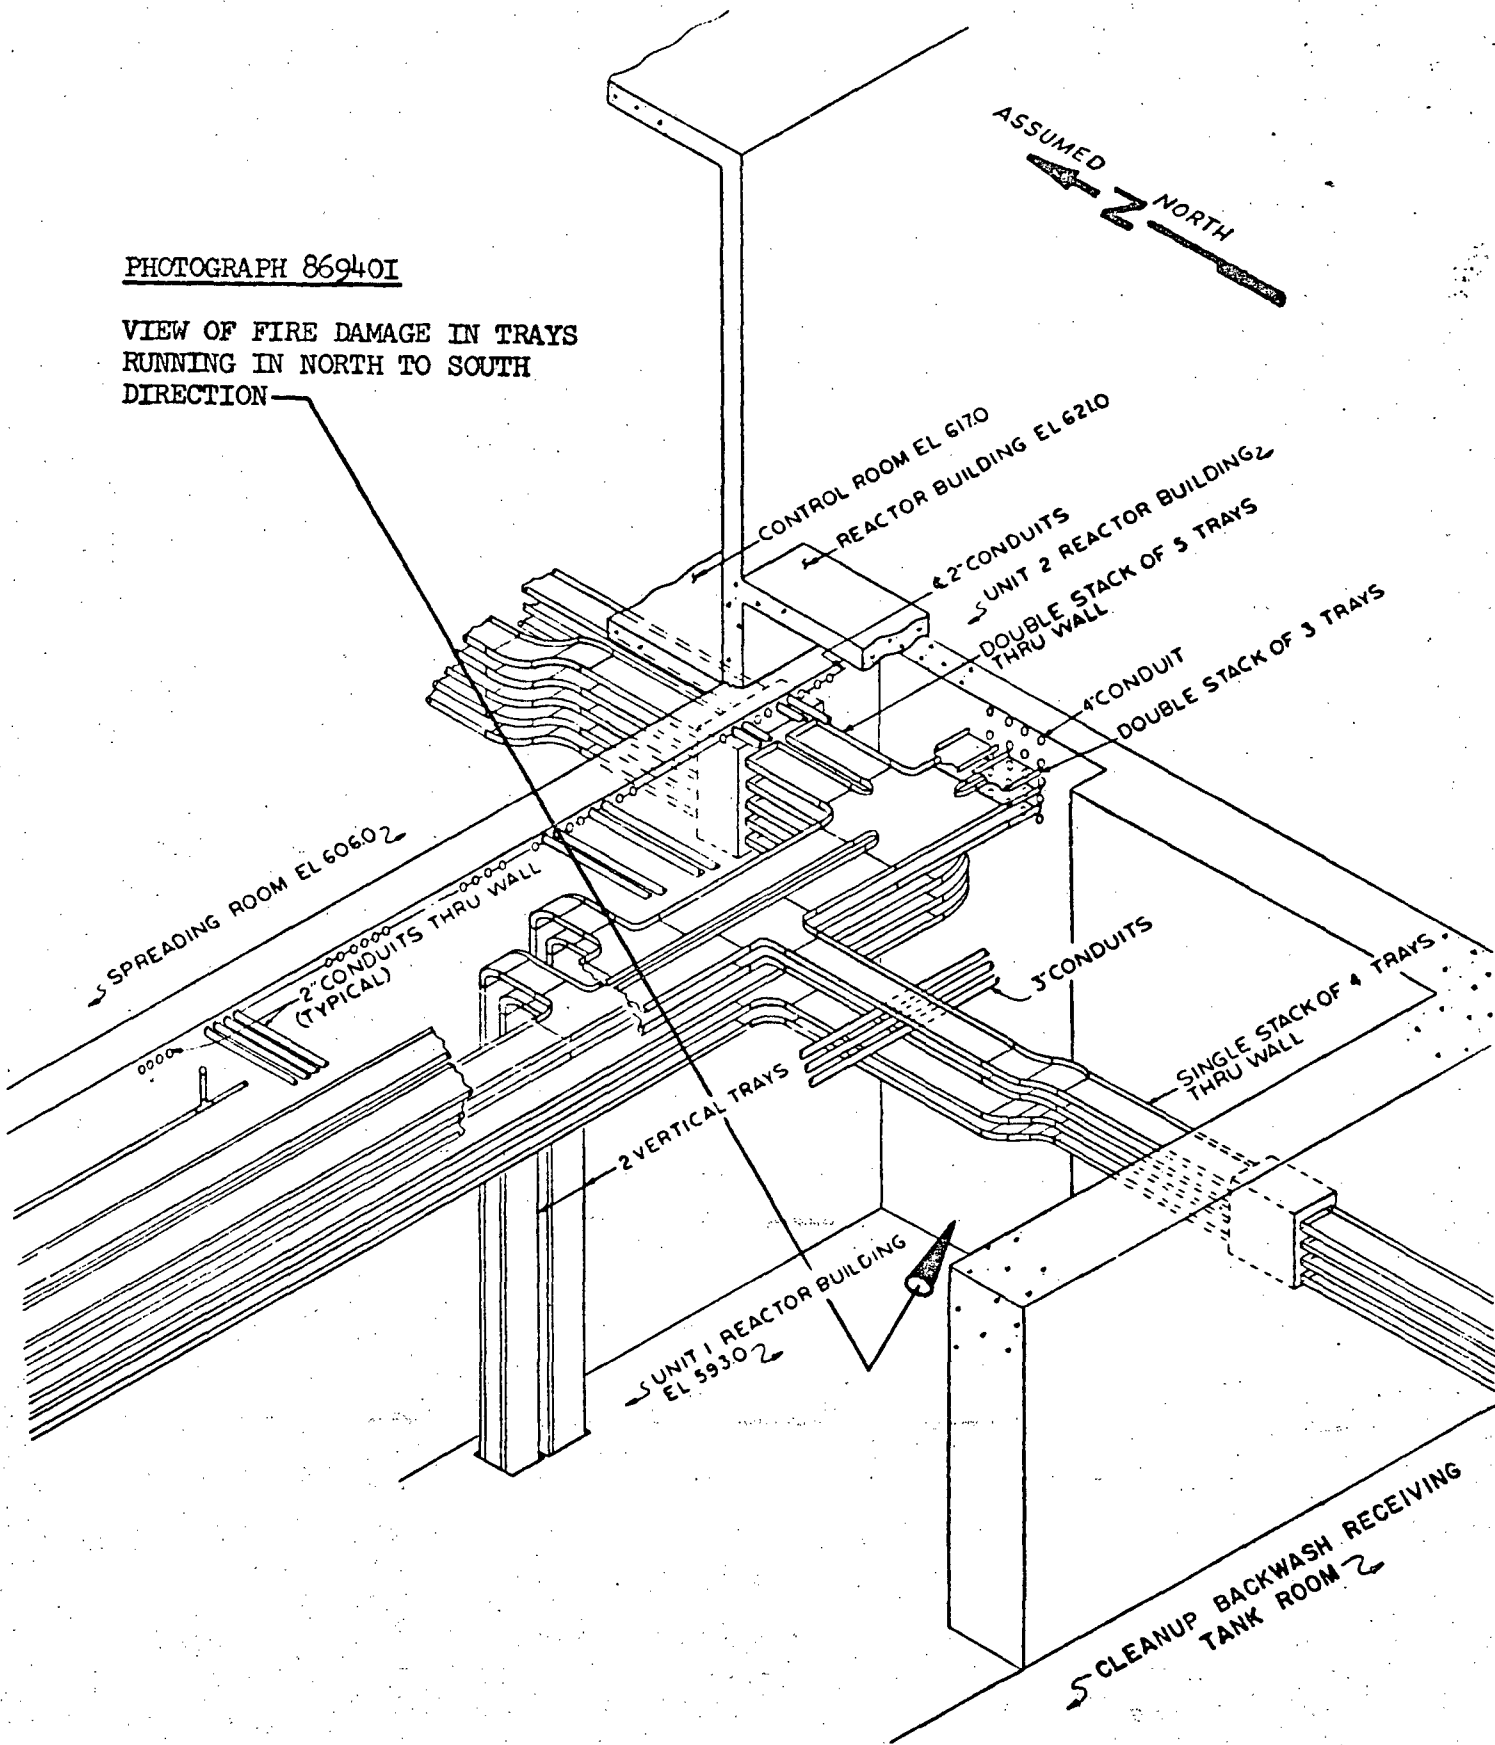
PHOTOGRAPH 869401

VIEW OF FIRE DAMAGE IN TRAYS
RUNNING IN NORTH TO SOUTH
DIRECTION

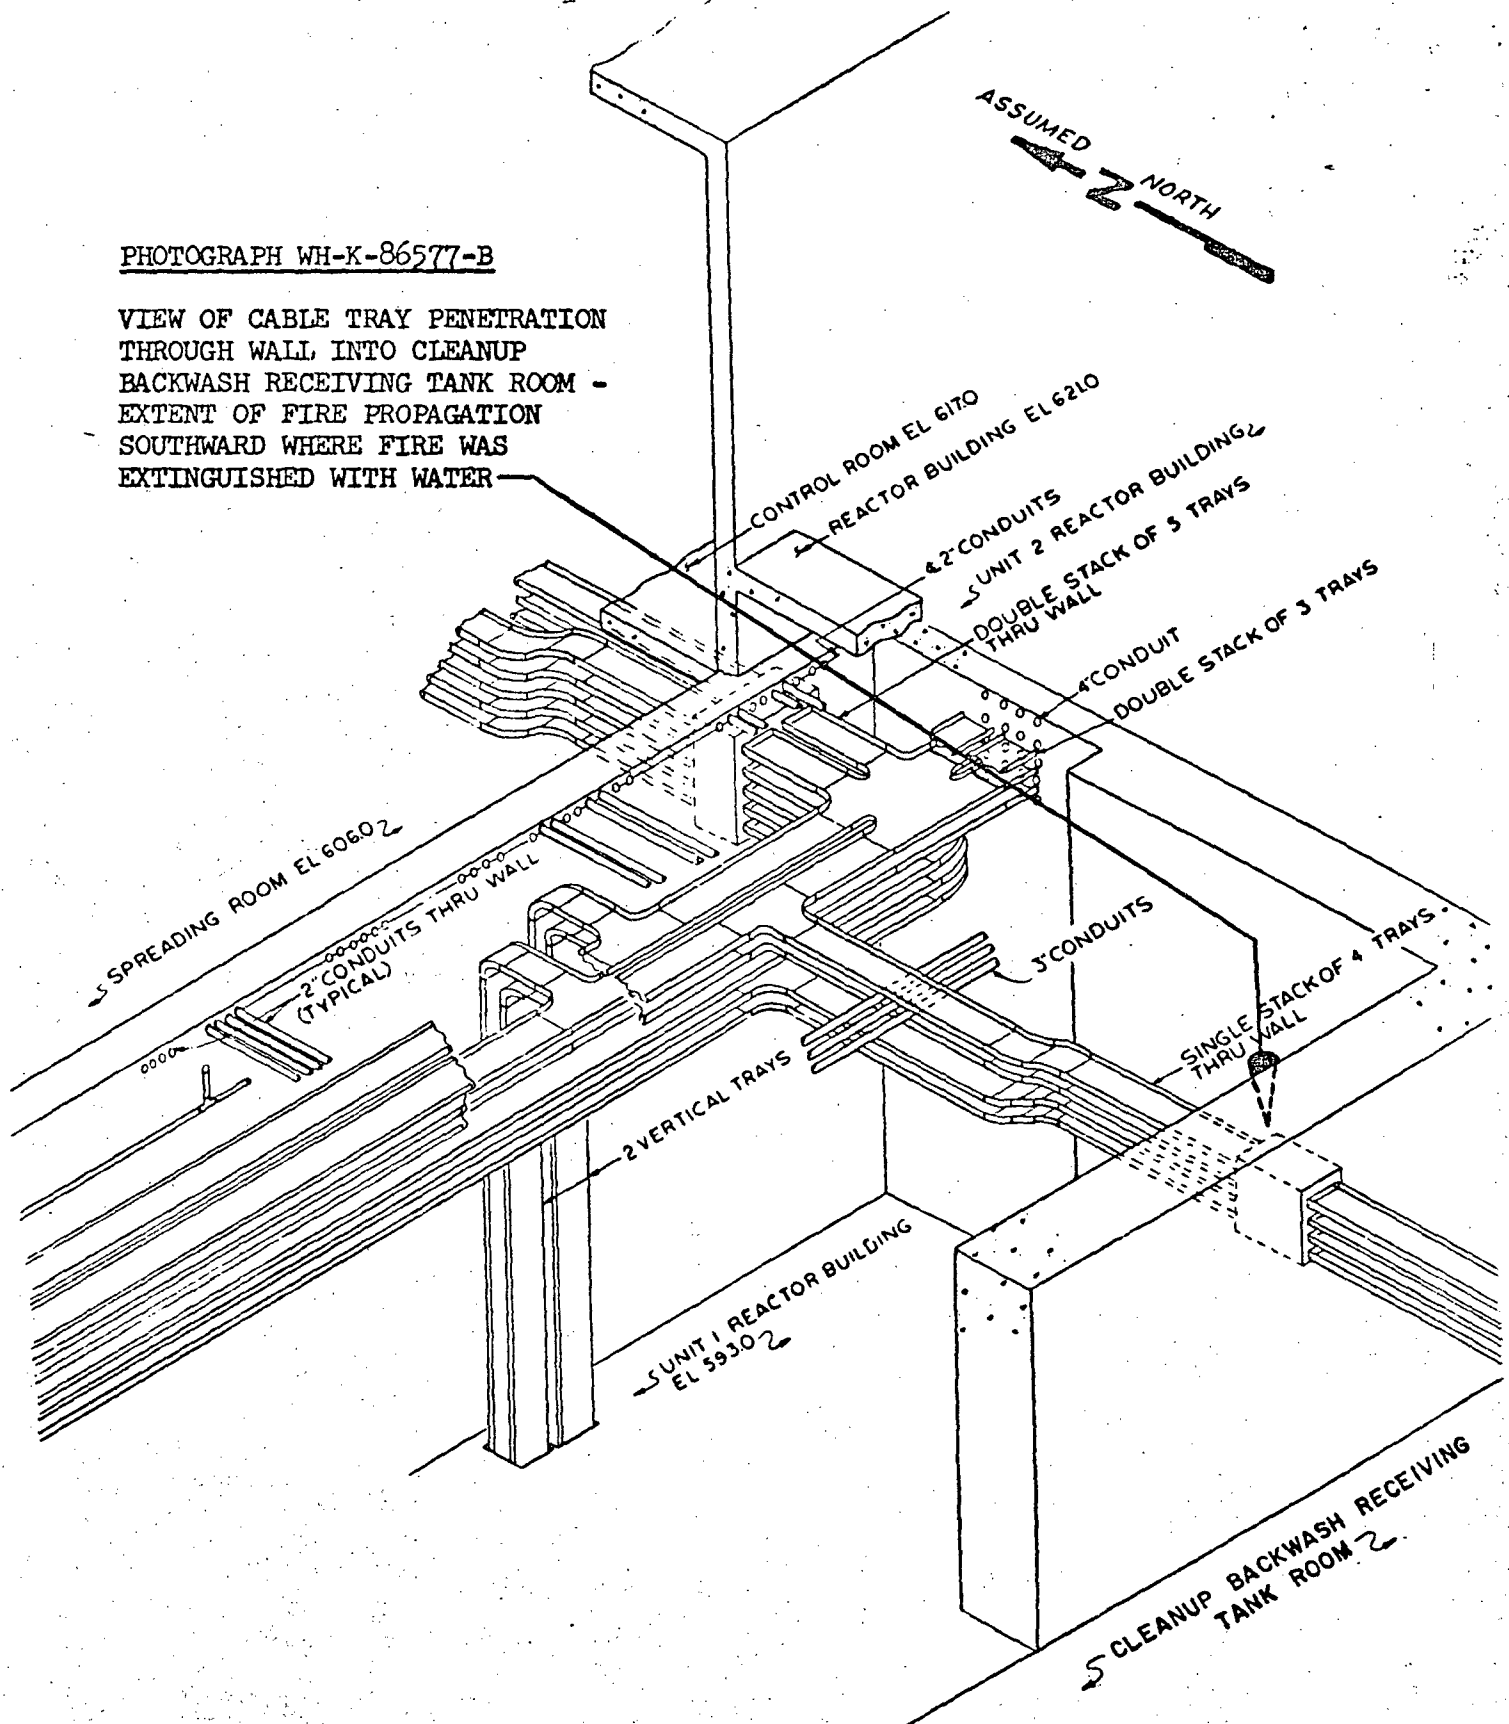
PHOTOGRAPH WH-K-86577-B

VIEW OF CABLE TRAY PENETRATION
THROUGH WALL INTO CLEANUP
BACKWASH RECEIVING TANK ROOM -
EXTENT OF FIRE PROPAGATION
SOUTHWARD WHERE FIRE WAS
EXTINGUISHED WITH WATER

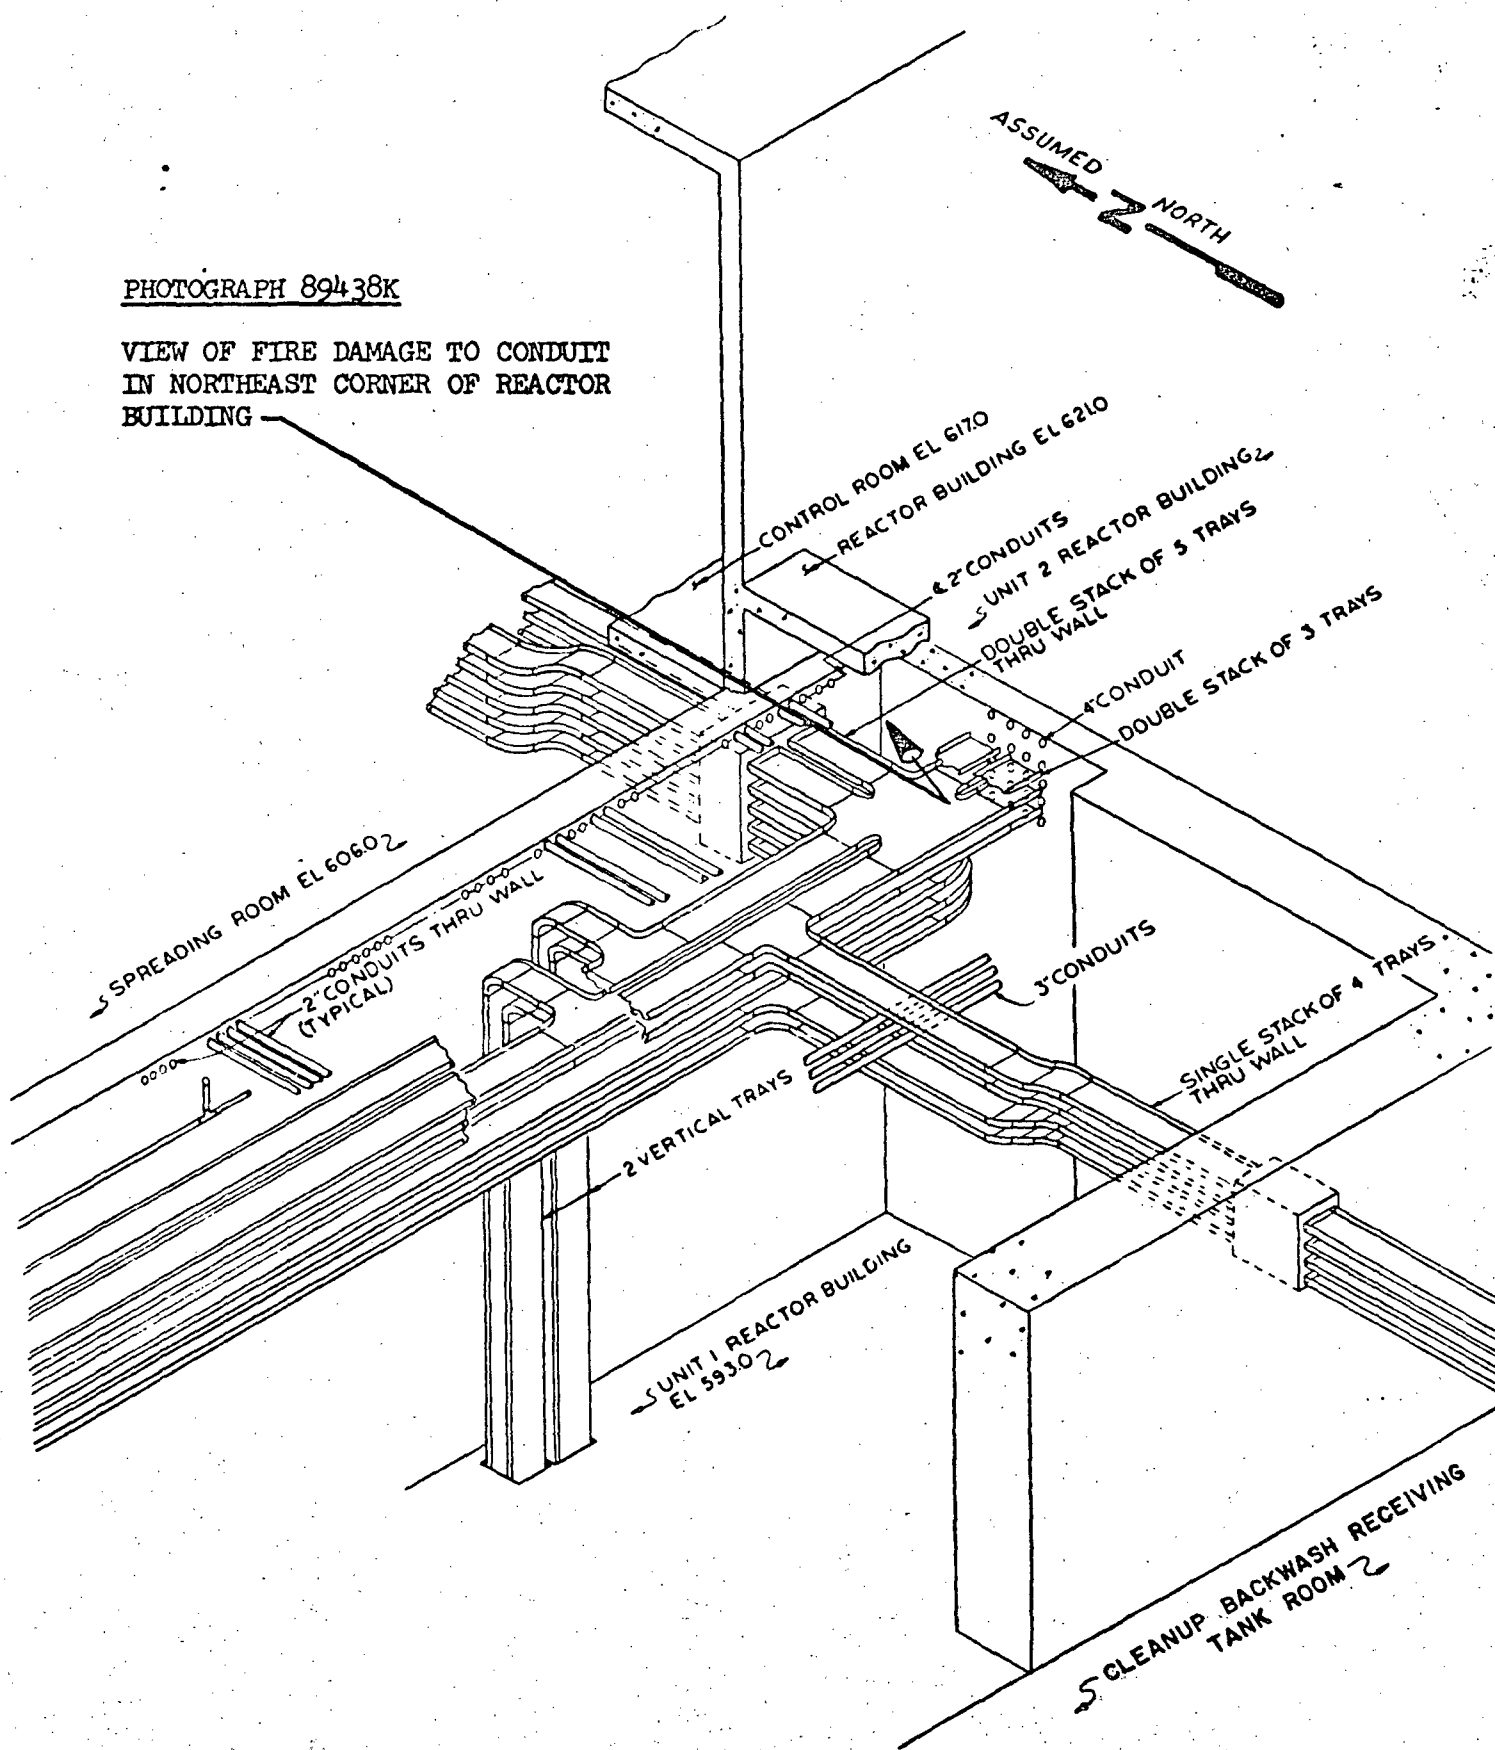
PHOTOGRAPH 89438K

VIEW OF FIRE DAMAGE TO CONDUIT
IN NORTHEAST CORNER OF REACTOR
BUILDING

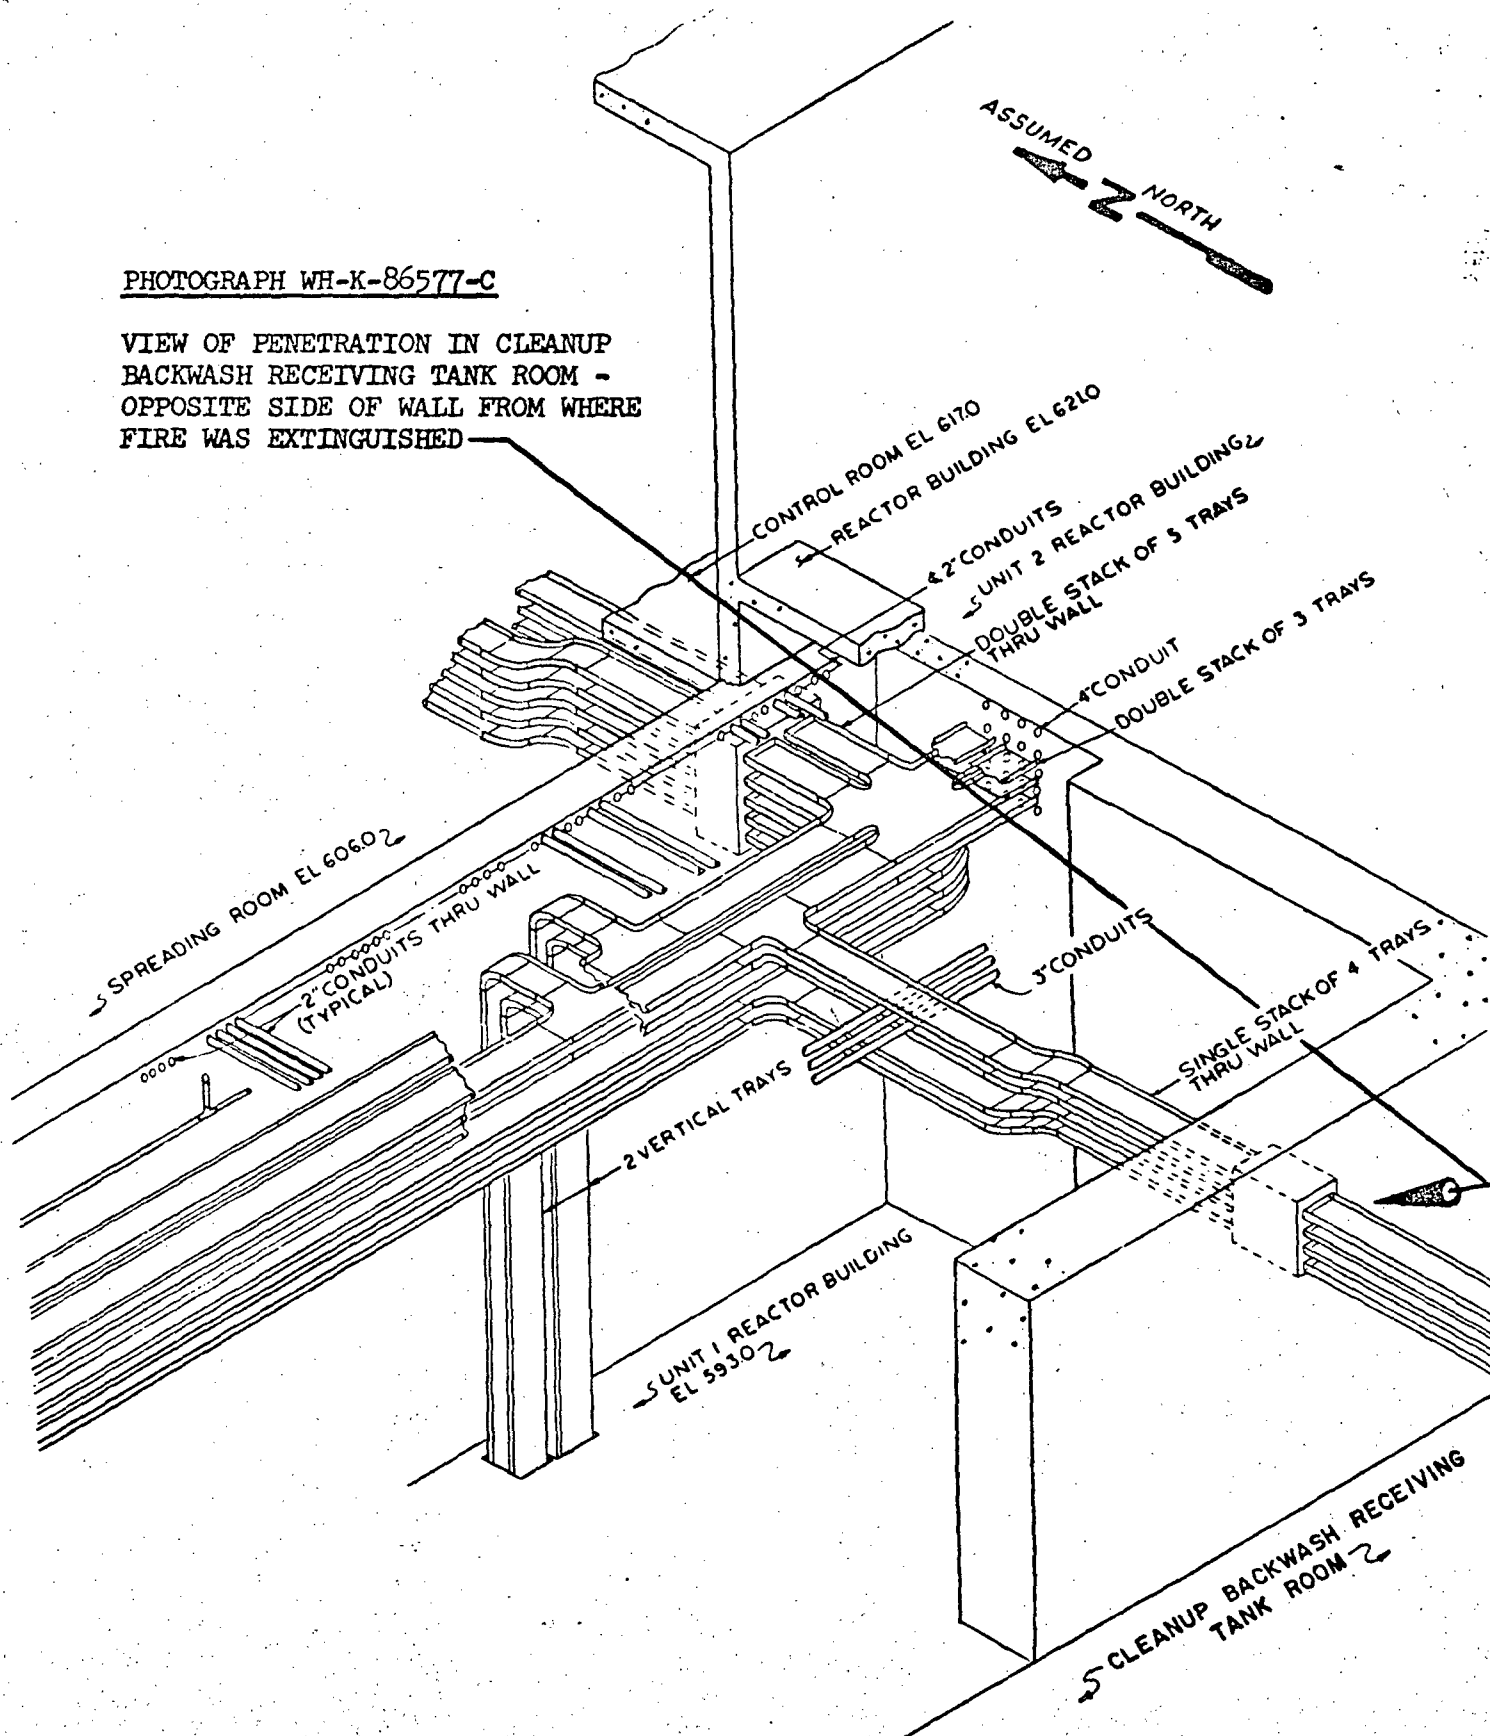
PHOTOGRAPH WH-K-86577-C

VIEW OF PENETRATION IN CLEANUP
BACKWASH RECEIVING TANK ROOM -
OPPOSITE SIDE OF WALL FROM WHERE
FIRE WAS EXTINGUISHED
