Interim Summary on Secondary Piping Rupture  
Accident at Mihama Power Station, Unit 3 of  
the Kansai Electric Power Co., Inc.

September 27, 2004  
The Nuclear and Industrial Safety Agency

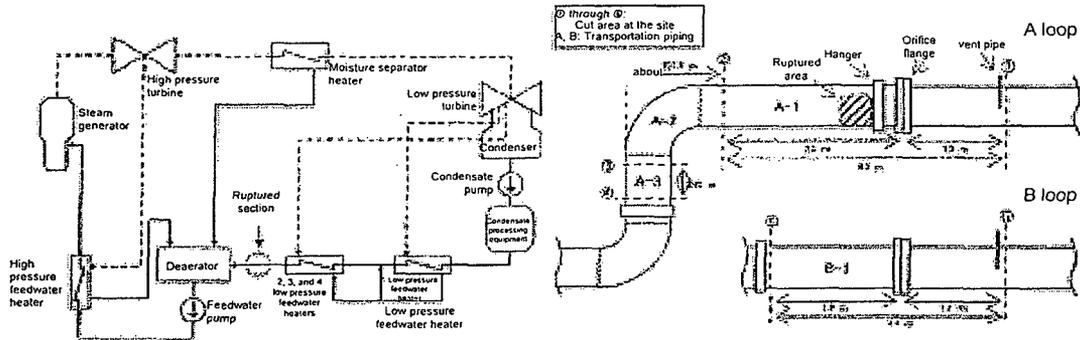
1. Summary of investigation

- (1) Orifice downstream piping, Material: JIS G3103 SB42 Diameter (hereinafter referred to as D): about 560 mm, Thickness: about 10 mm
- (2) Flow condition during operation, Flow rate: about 1,700 t/h, Pressure: about 0.93 MPa (10 kgf/cm<sup>2</sup>), Temperature: 142°C, Flow velocity: about 2.2 m/sec
- (3) Operation time, about 185,700 hours
- (4) Water chemistry: pH: 8.6 to 9.3, dissolved oxygen concentration: less than 5 ppb.

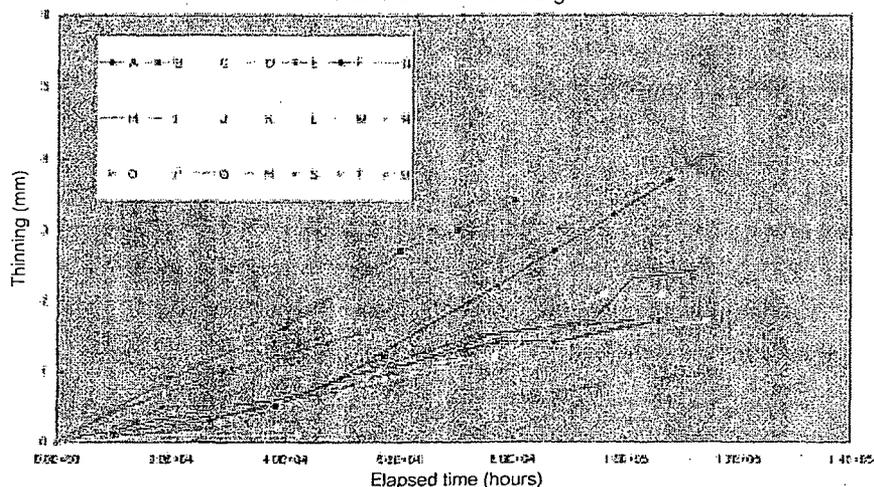
Figure 2 Measurement area and the trend of thinning in PWR piping

Figure 2 shows the trend of thinning measured by every PWR plant and its resultant actual thinning rate. Comparison between the actual thinning rate and the initially set value of thinning rate specified in the PWR Management Guidelines reveals that the actual thinning rate, except for the main feedwater piping in A-loop, is lower than the initially set value of thinning rate.

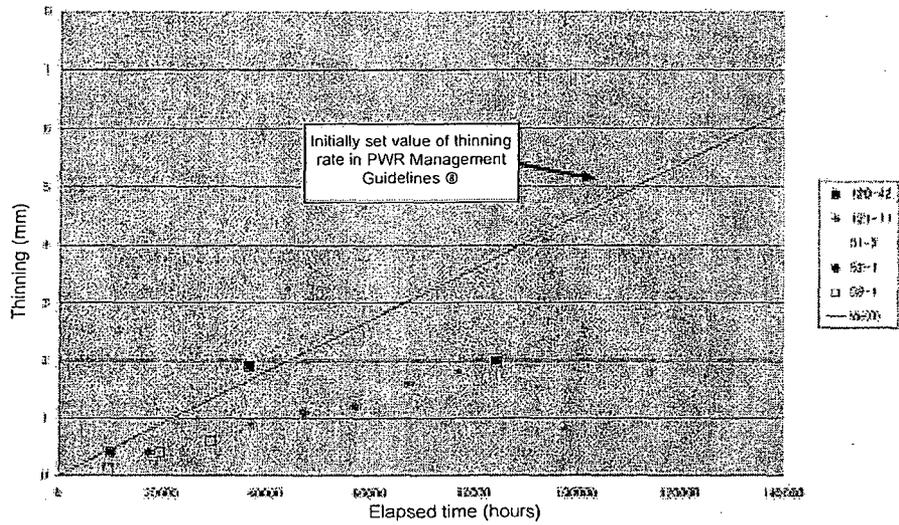
Figure 3 Measurement area and the trend of thinning in Mihama Unit 3 piping

Figure 3 shows the trend of thinning measured at Mihama Unit 3, and comparison with the initially set value of thinning rate shown in the PWR Management Guidelines. According to the figure, the actual trend of thinning is lower than the initially set value of thinning rate except small part of data.

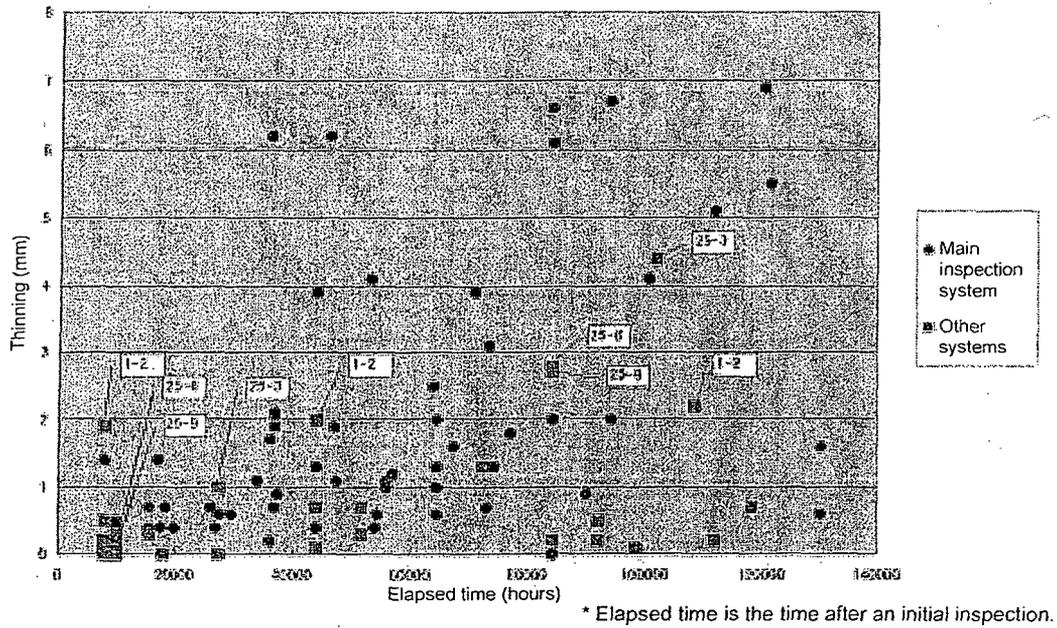
Figure 4 Comparison of main inspection systems and other systems in Mihama Unit 3

Figure 4 shows a comparison of thinning between main inspected systems, all of which are inspected in accordance with the PWR Management Guidelines and other systems inspected on a sampling basis. As a result, the thinning rate of other systems is smaller than that of the main inspected systems as a whole. This suggests that the thinning rate is affected by an environmental difference. Nevertheless some other systems show thinning rates comparable with the main inspected systems.

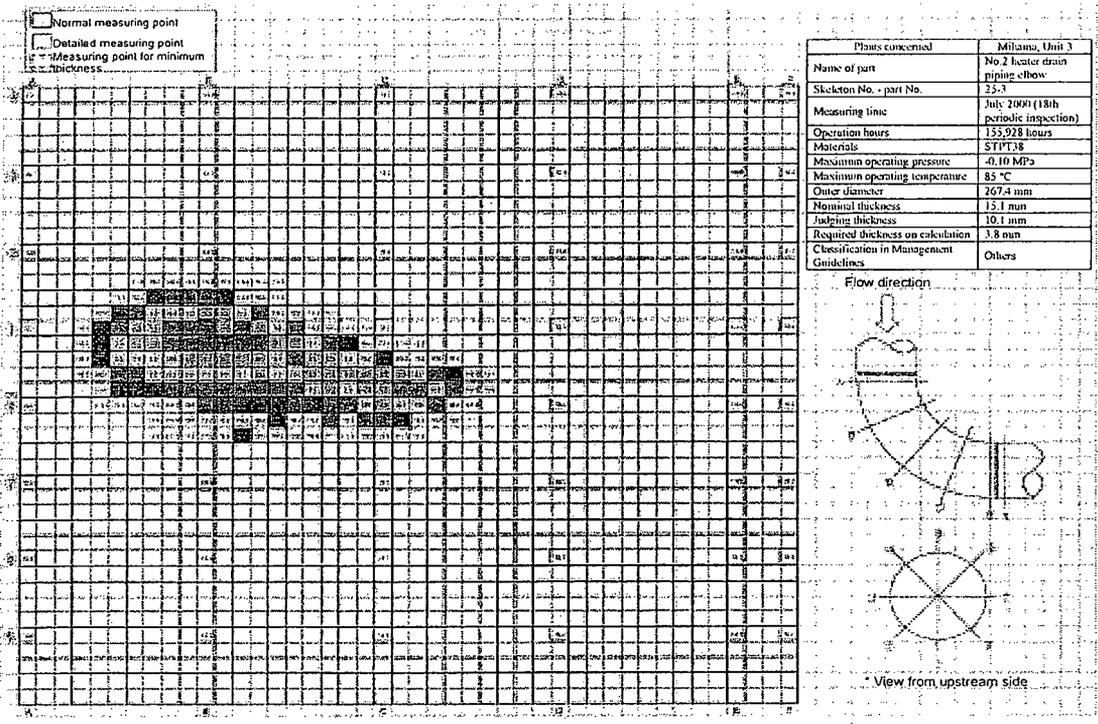
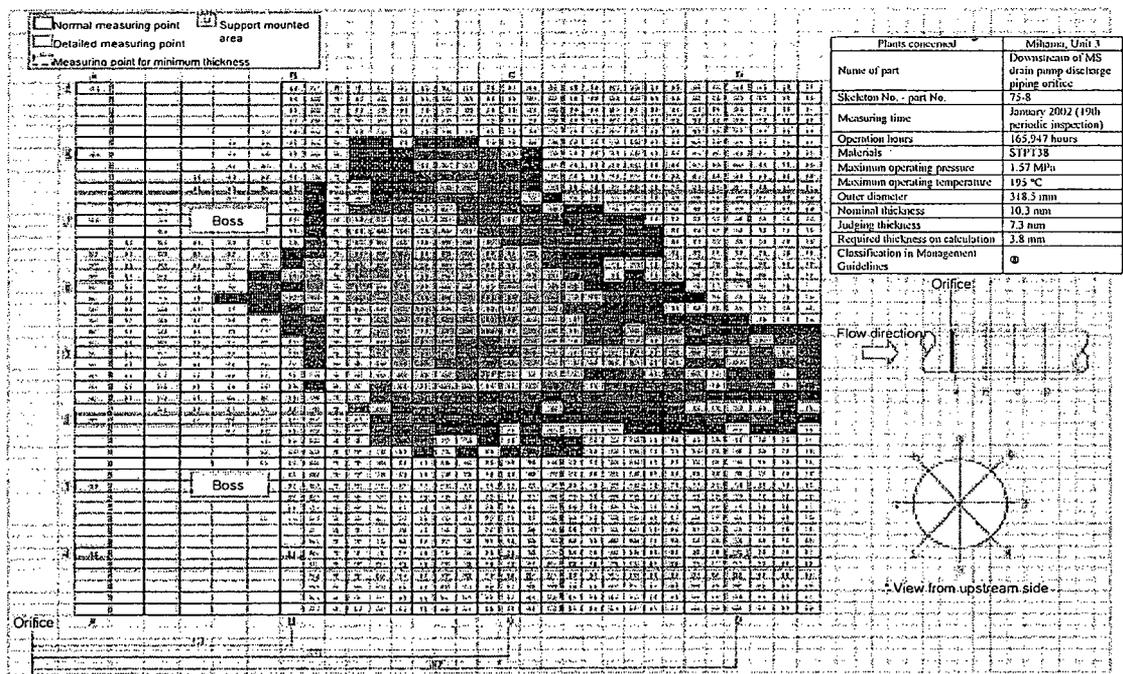
Figure 5 Measured results of Mihama Unit 3 (example)

NISA used detailed measurement results of Mihama Unit 3 obtained from KEPCO through the report collection requirement to analyze the relation between the measuring area and measuring points and occurring situation of thinning. Figure 5 shows distribution of measured results. This reveals that measurement by the typical measuring points and resultant detailed measurements are effective to judge the shape and dimensions of the area concerned.

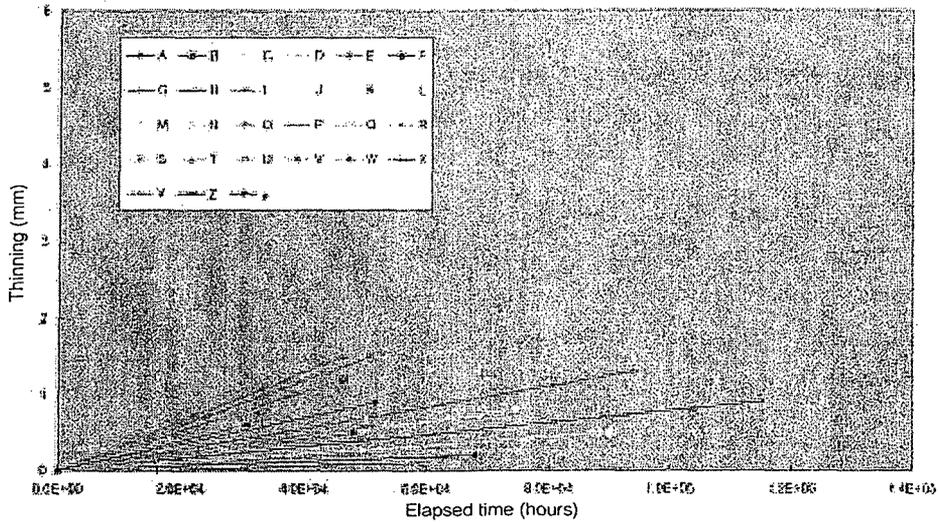
Figure 6 Measured parts of thinning and its trend of BWR piping

Figure 6 shows the trend of thinning measured at BWR plants and its resultant actual thinning rate. Comparison of Figure 2 and 6 reveals that PWR and BWR are different in the trend of thinning and the rate of BWR is lower than that of PWR. This is caused by the difference in water chemistry control between PWR and BWR.
