INGERSOLL-RAND
PUMPS

Subject: 10CFR21 Reportability of a Potential Safety Hazard
From Broken Cast Iron Diffusor Pieces in Auxiliary
Feed Water Pumps

The purpose of this letter is to update the NRC on Ingersoll-Rand's evaluation of damage experienced by several utilities on auxiliary feedwater (AFW) pumps of Ingersoll-Rand manufacture with cast iron internals. These are our model HMTA units.

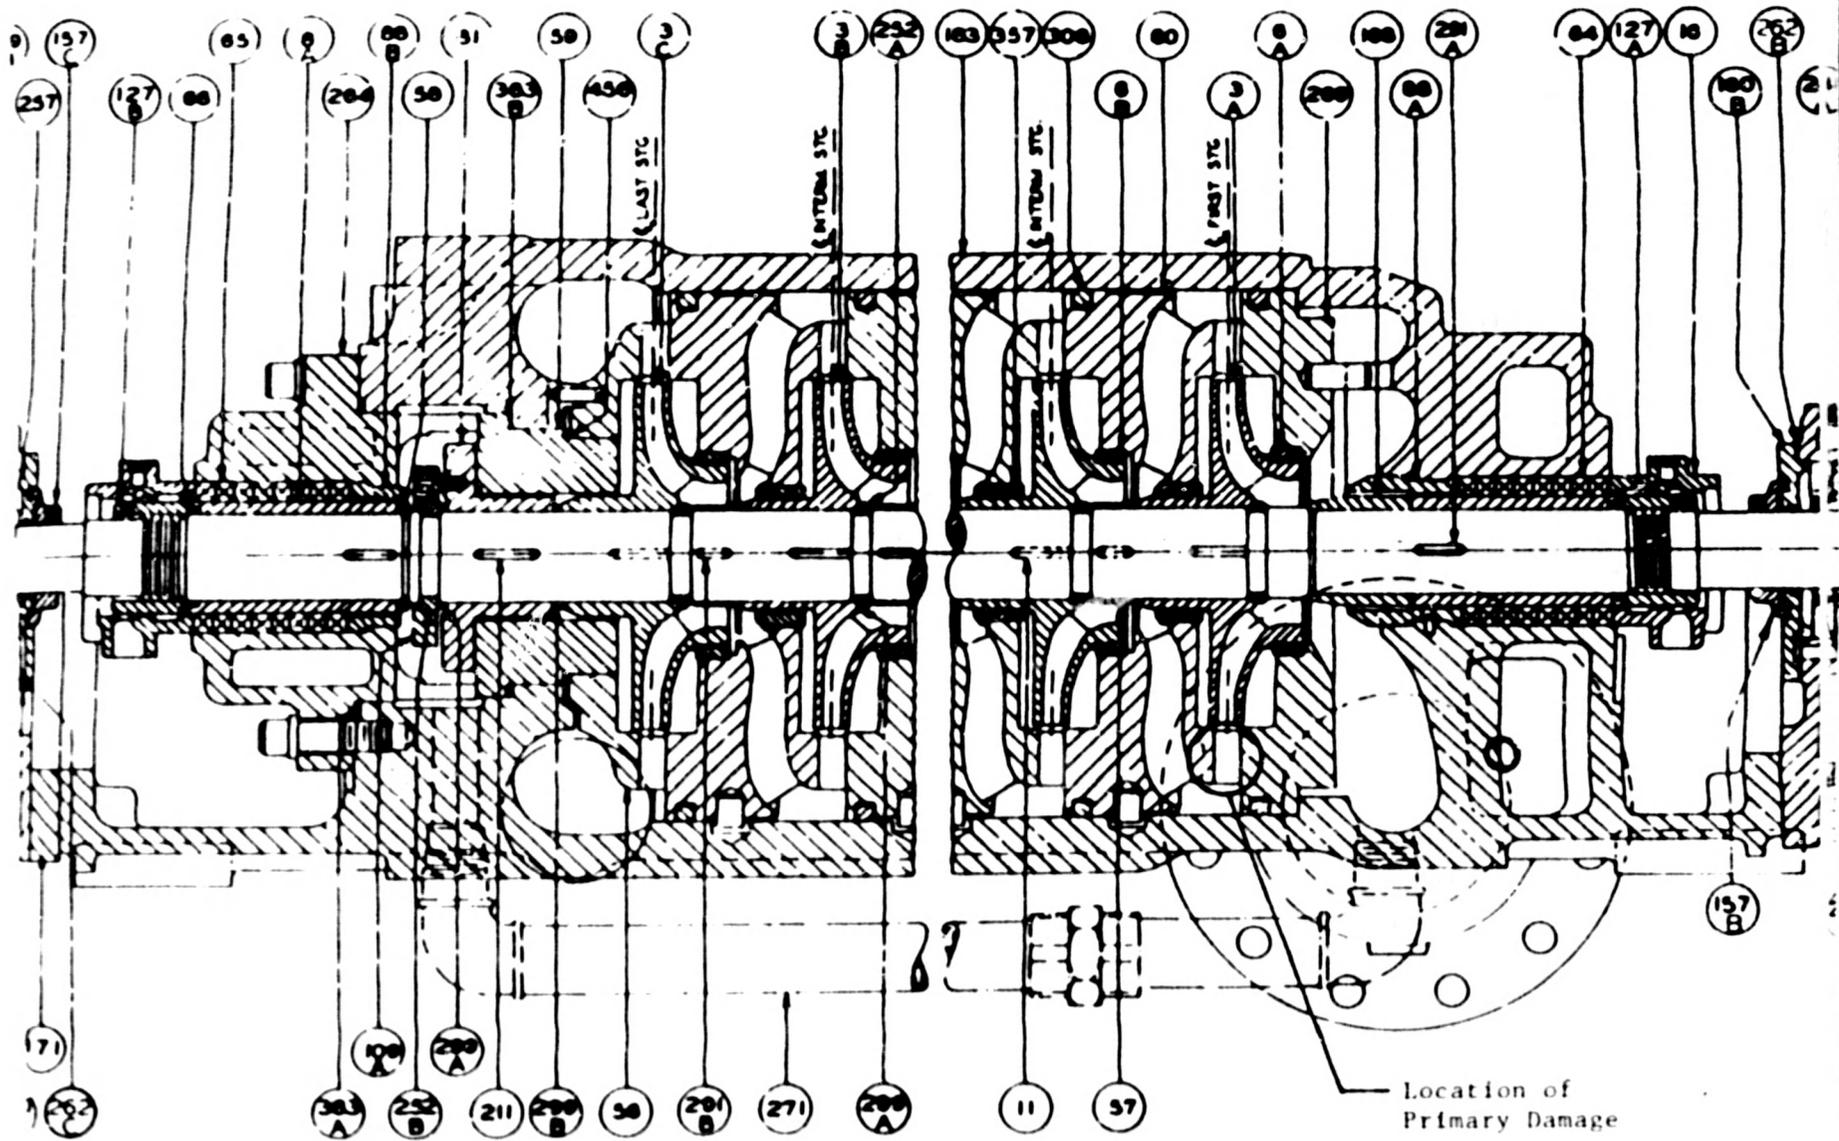
Ingersoll-Rand Model HMTA Pump
 Auxiliary Feedwater Service

The first stage diffuser suffered the greatest cavitation/corrosion/erosion damage, and appeared to be the originating point of the initial vane breakage. Other stages exhibited similar types of damage, though to a lesser degree. The other AFW pumps of the same or like designs servicing the same system at this plant were inspected and found to have similar damage. Photos and figures of typical damage observations are attached.

- 1) Inspect the pumps at reasonable intervals for possible damage to the cast iron diffuser and channel ring parts.
- 2) If part replacement is required, use a martensitic or austenitic steel to replace the damaged components.
- 3) If possible, conduct the required in-service tests at higher flow rates.
