Re: Mine Permit No. 633; Smith Ranch-Highland Uranium Project (SR-HUP):
Release of Solutions Report pursuant to WDEQ-LQD Non-Coal R&Rs, Chapter 11,
§12(a)(ii)(A-D), Mine Unit K Injection Trunk line to Header House K-6, 17 August 2008

Power Resources, Inc Smith Ranch-Highland Uranium Project URANIUM IN SITU FLUID RELEASE REPORT

**MINE UNIT K
 SPILL AND SAMPLE
 LOCATIONS**

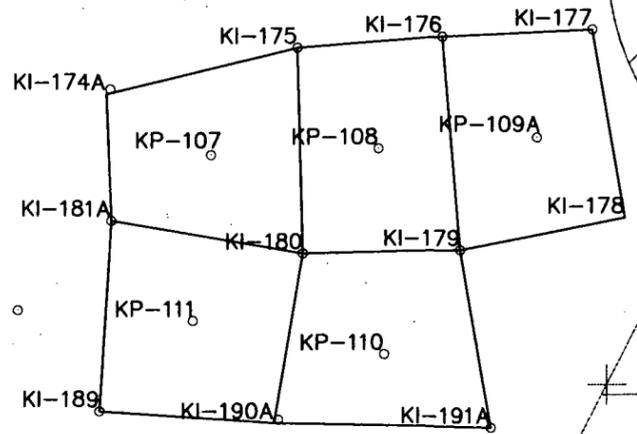
map, which also gives the gamma readings in microrems (μR). Readings from the spill area were 20 μR ; a background reading at K-5 showed 15 μR , a negligible difference. The fluid is not considered hazardous material under RCRA and is not reportable under SARA.

SAMPLE K-4
20µR
≈60ft. FROM K-3
AND ≈60ft. FROM K-2

SAMPLE K-2
20µR
≈60ft. FROM K-4
AND ≈120ft. FROM K-1
