Building Engineering Report

Defense National Stockpile Depot

GS05P90GBD0028RIN91011, Work Order No. 10

Climate Controlled Occupied Buildings

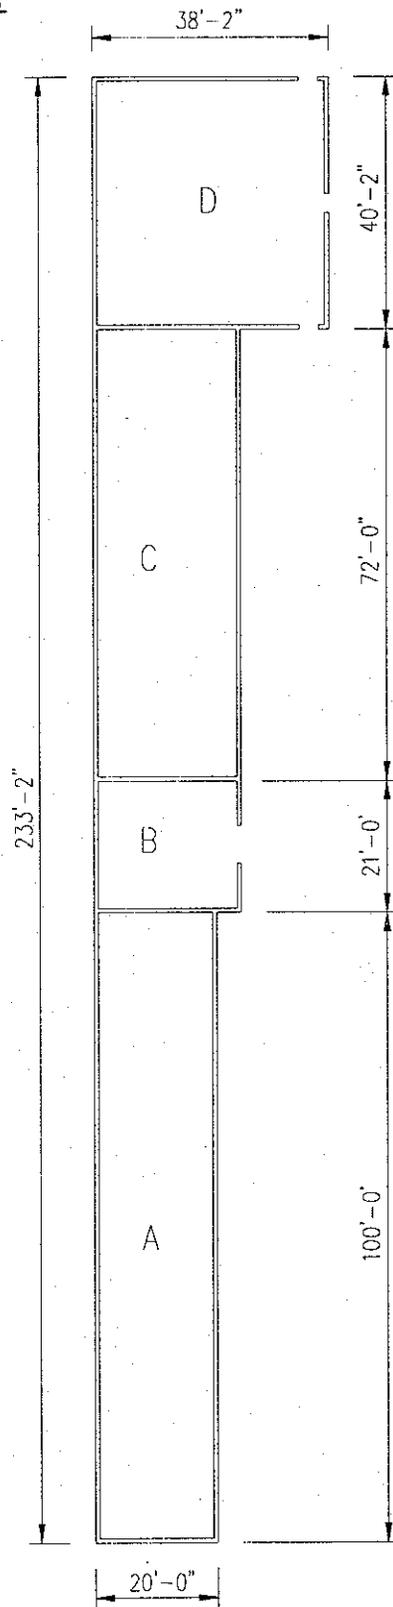
T141 (IN0643NH)

This building has rotted siding and should be scraped, painted and caulked. The roof should be replaced as well as the gutters and downspouts. Splashblocks should be added to divert the water away from the building. In the second and third sections of the building there is evidence of water entering the building. This damage should be repaired and replaced. The exposed rafters in the section are also water-marked. The floor is concrete and has a major crack running down the center of the building in an east to west direction. This crack should be repaired.

This is a wood framed building with a wood structural system and rolled roofing. There are some siding that has rotted as well as the window sills and the doors. The doors and windows should be replaced. The entire building should be scraped, painted and caulked. The roof needs to be replaced as well as the downspouts and gutters. Splashblocks should be added to divert the water away from the building.

This portion of the building is used for equipment storage by on-site maintenance staff. The outside of the building is in bad need of paint and should also be caulked. The roof should be replaced. The sliding doors and jambs have rotted areas. Part of the siding and sill at the south elevation also is rotted. Gutters and downspouts should be replaced and splashblocks added to divert the water away from the building. The interior slab is badly cracked and settled. It should be replaced. There is as much as 3" of differential settlement and some of these cracks are 1 1/2" - 2" wide. There is a heating pipe that is insulated and wrapped running the length of the building. The insulation and pipe wrap should be checked for asbestos. Towards the west end of the building there are some water damage and rotted roof joists that should be replaced. Also, there is split corner bracing and diagonal column braces that should be replaced.

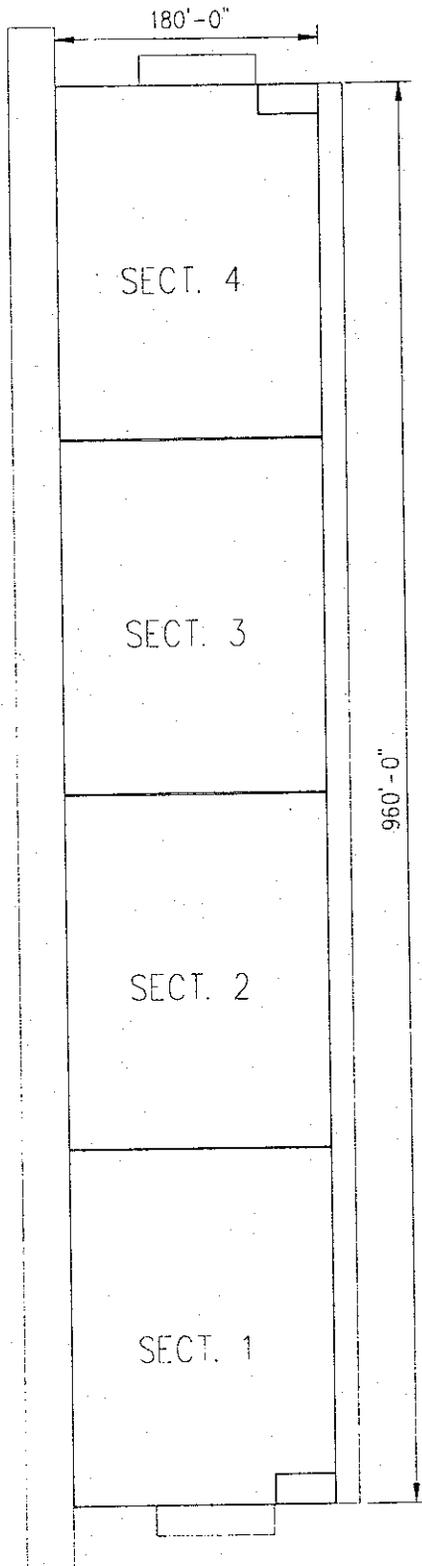
T210 (IN0612NH)

This warehouse building is 960' long by 180' wide. It is a wood construction, wood structural system, wood deck and a modified bitumen roof. The docks at either end of the building as well as the ramps are concrete and filled with asphalt. The wood bumpers for the dock should be replaced. The concrete steps at either end of the building are spalling and should be replaced. The wood rail is rotted and deteriorated. It also should be replaced. The platform at the south elevation of the building has several areas where the asphalt has been patched. These are at the downspout leaders. The patching was done incorrectly and has heaved. This should be corrected. The wood windows and wood personnel doors are deteriorated and should be replaced. The entire building is in bad need of paint and should be scraped and caulked also. Any trim that has deteriorated as well as siding should be repaired and replaced. The building has a relatively new modified bitumen roof, however, the gutters and downspouts were not replaced at that time. These need to be replaced. The building is divided into four sections by brick fire walls. The ends of the firewalls should be sealed at the exterior walls. Above the roof the parging on the firewalls is pulling the brickface off. This should be corrected. There are interior offices and restrooms located at the west end of the building as well as the east. Some of the drywall for these offices and restrooms should be replaced because they are water damaged. All areas if used should be repainted. A small basement exists at the southwest corner of the building. At one time it housed the boiler and coal bins. It extends under the south dock. There is a small amount of water standing on the floor. The reinforcing in the ceiling is exposed. The side walls are leaking. The basement is not used at this time and the boiler does not exist. The sprinkler system also should be upgraded to function properly.

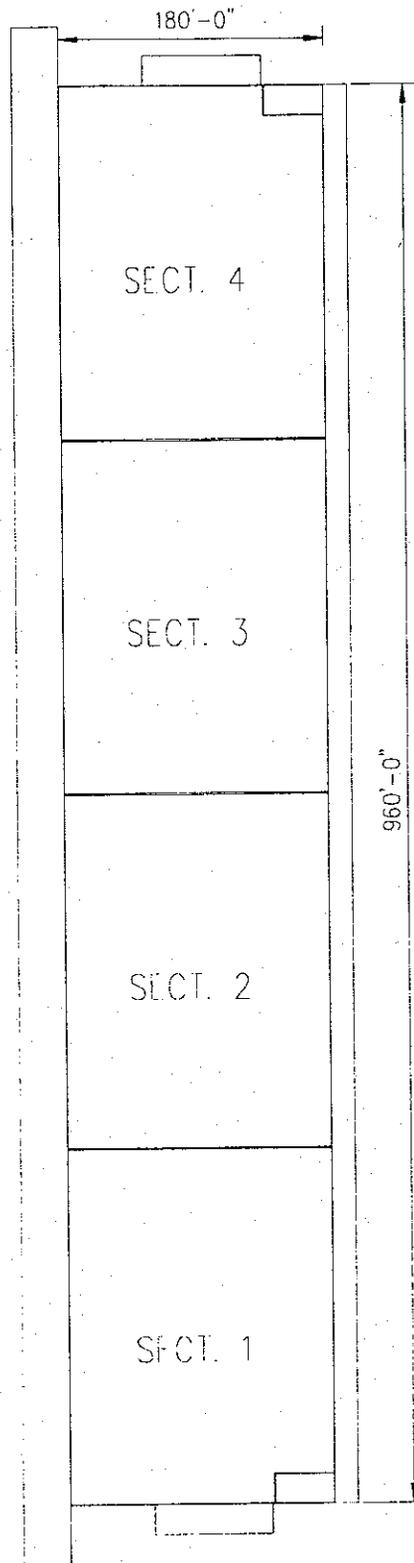
T211 (IN0613NH)

This is a 960' by 180' warehouse building with a slab-on grade, wood exterior walls with a wood structural frame system, wood roof deck and a modified bitumen roof. The east and west docks are concrete with asphalt fill. The wood dock bumpers are rotted and deteriorated and should be replaced. The concrete steps are spalling and should be replaced. The wood rails are deteriorated and should be replaced. There are scattered areas of spald concrete at the edges that should be repaired. The north and the south retaining walls are out of plumb. The gutters and downspouts drain under the platforms and empty onto the railroad tracks on both the north and the south elevation. There is no swale evident to carry the water away. The roof has been replaced recently, however, the gutters and downspouts were not and should be replaced. Also, the cast iron leaders should be checked for blockage. There are indications that they may be stopped up. The windows and personnel doors in the entire building should be replaced. The entire building should be scraped, caulked and painted. All of the trim work should be repaired or replaced as needed. The wood louvers on the exterior walls are in very bad repair and should be replaced. In general, the concrete floor is cracked, however, at the northwest ramp door and around the overhead doors they are especially bad. This building also has a partial basement at the northwest corner. It is standing in one inch of water. The offices and restrooms at the east and west end are of wood partition with drywall construction and show some signs of water stain and damage. It was suggested that these rooms be demolished and the space used for additional storage. The floors at the fire doors as reported on the previous report have not been corrected. The corrections per the fire sprinkler survey have not been made.

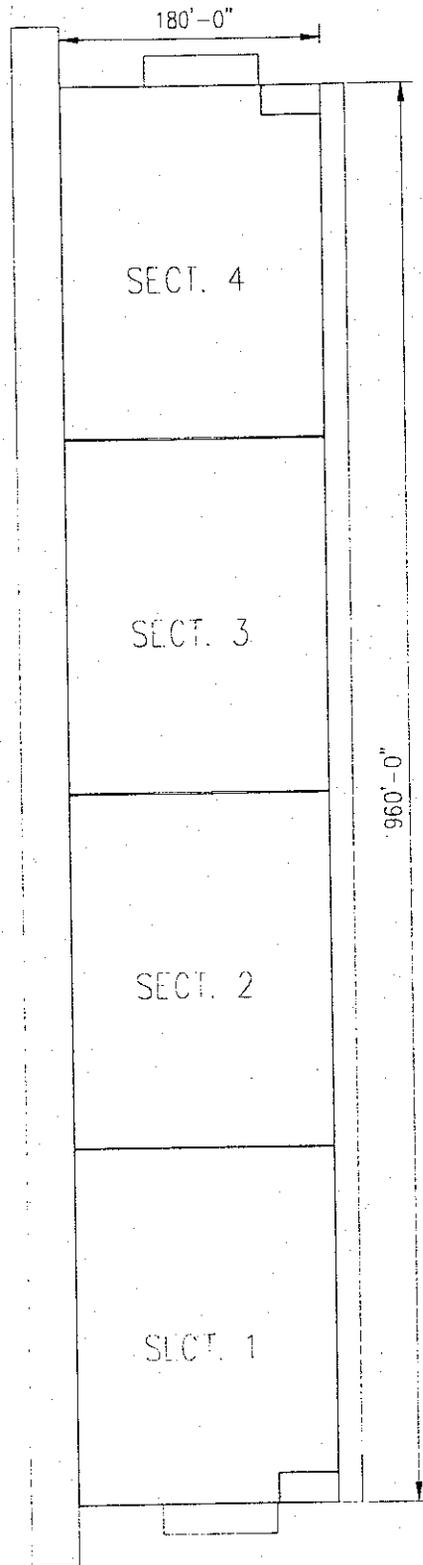
T212 (IN0614NH)

This building is used as a warehouse. It is elevated approximately 3 1/2' and has a dock on all four sides. At the east and west end the docks have concrete ramps for access to the platforms. There are concrete steps in the truck dock area. The concrete for the most part is spald. The asphalt on the east and the west end is breaking up and is cracked. The handrails for the steps are of wood and are rotted. At the north elevation the concrete retaining wall for the elevated dock is out of plumb. The building is of wood frame construction and has wood siding. The roof is a rolled roof and is in bad condition. The entire exterior paint is cracked, chipped and peeled. All of the siding and trim should be replaced as necessary. The entire exterior should be scraped, primed and painted after it has been caulked. Nine person doors at the exterior are in poor condition and are coming apart. The doors, frames and hardware should be replaced. Where the elevated dock joins the building there is a crack. This crack should be filled with sealant. At the outer end where the asphalt meets the concrete retaining wall there also is a joint that is allowing water to penetrate behind the concrete. This joint should be filled with sealant. The gutters and downspouts for this building are corroded. The joints are open and the brackets and nails are loose. All gutters and downspouts should be replaced. The building is divided into four areas by brick firewalls. Above the roof on these firewalls the flashings have failed and should be replaced. In general the floor slab is cracked, especially bad are bays 51, 52, 55 and 56. The slabs at most overhead doors are cracked and fall away towards the doors. At each end of the building there are offices and restrooms that are no longer used. If it is determined that these need to be brought back into operable condition, extensive repairs will be necessary. At the southwest corner of the warehouse a partial basement exists that once housed a boiler. The sidewalls, floors, and ceiling are in need of repair. Water is standing on the floor. In some cases the reinforcing is exposed at the ceiling, however the boiler has been removed. Inspection of the electrical system reveals that the light levels from the incandescent lights is at a very low level. The roof leaks are damaging the electrical system to the point of being very dangerous. This situation should be corrected at once. There are some siding panels at the exterior of the building that appear to be transite. Those panels should be tested for asbestos. The sprinkler risers were renovated approximately three years ago and appear to be in good condition. However, the sprinkler mains and branch lines may not be in such good shape.

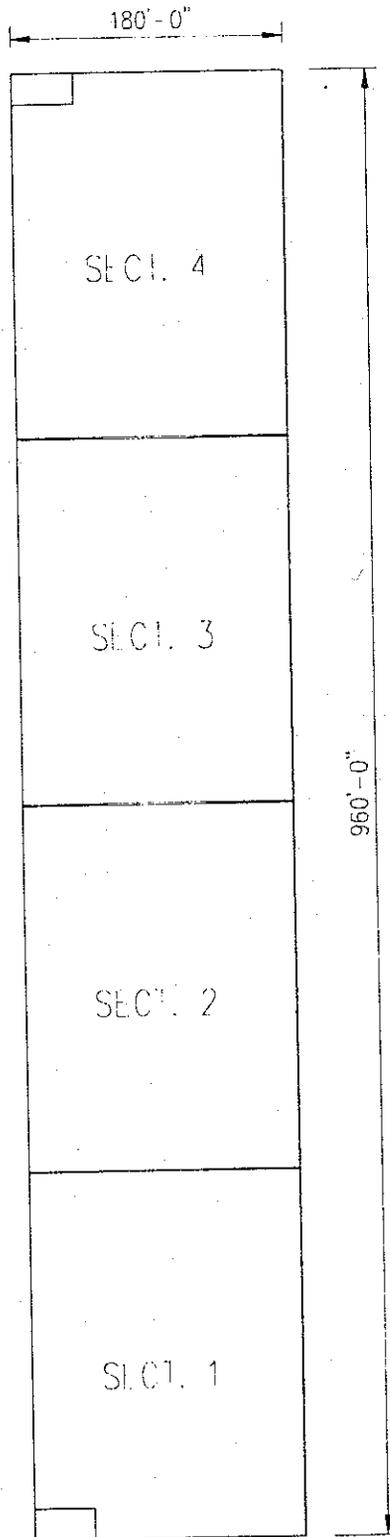
T213 (IN0615NH)

This building is used as a warehouse and has poured concrete exterior walls, has a wood frame, wood roof deck and rolled roofing. There are asphalt drives at the east and west end and concrete walks on three sides of the building with a railroad track on the fourth side. All overhead doors are new steel insulated sectional overhead doors. The person doors are for the most part in bad shape and disrepair, as are the windows. The building is divided into four sections separated by brick firewalls. The floors are concrete. The walks along the south elevation are in bad repair and should be patched and/or replaced. At several locations around the building there are cracks in the concrete wall that should be repaired. The building is painted, however, the paint is cracked, chipped and peeled. All exterior surfaces should be caulked scraped, primed and painted. The joint between the sidewalk and the building should be filled with sealant. The lawn at the west end of the building during periods of rain stands in water as does the drive at the east end of the building. The roofing is old and deteriorated and should be replaced. At the time the roof is replaced the roof deck should be inspected and rotted decking replaced. The gutters and downspouts for this building are in bad repair and should be replaced. The flashing on the firewalls above the roof have pulled loose and are in bad repair. These flashings should be replaced. There are offices and restrooms located at the west and the east end of the building that are no longer used. It was suggested that these offices and restrooms be removed to allow additional storage space. The sprinkler risers were updated approximately three years ago and are in good condition. The sprinkler system, mains and branch lines may be in need of repair.

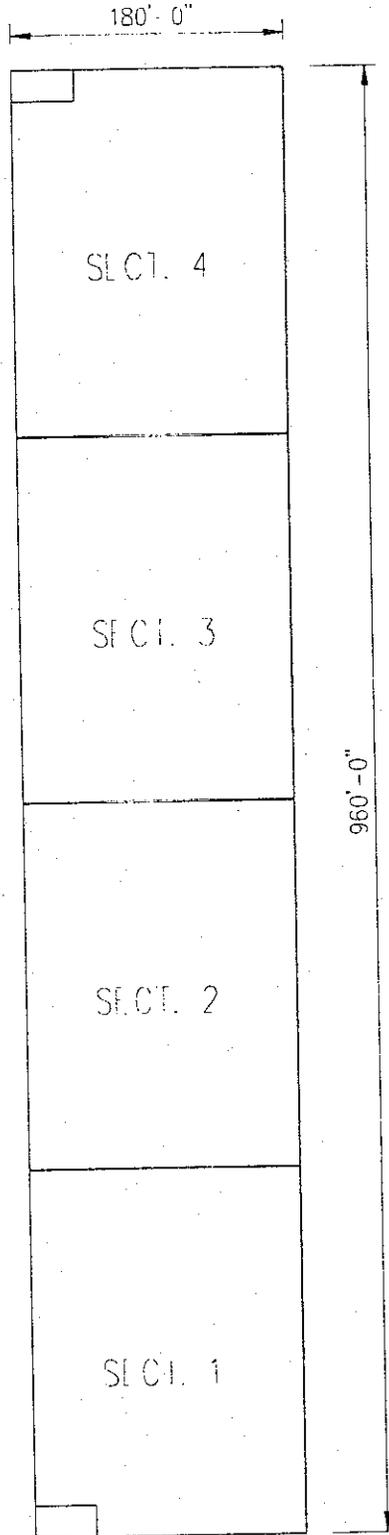
T214 (IN0616NH)

This warehouse is 960' long by 180' wide, has poured concrete perimeter walls, a wood frame structural system, a wood roof deck, and a new modified bitumen roof. All of the flashings, gutters and downspouts have been replaced recently. There is a concrete walk on three sides of the building that is in bad repair. Inside of the building at the northwest corner is a de-contamination room for the employees. At the opposite end of the building there are offices and restrooms that are no longer in use. The partition walls are wood and drywall. The asbestos panels at the east and west ends of the building have been removed and a new metal panel has been installed around the perimeter at the roof. The entire building should be scraped, caulked and painted. All of the control and expansion joints should be filled and caulked. The overhead doors have been recently replaced. The drives at either end of the building should be seal-coated. The personnel doors and the windows in the office areas should be replaced. This building is sprinklered and the sprinkler riser housings appear to be in good shape. Modifications to the floor slab at the fire doors have not been made.

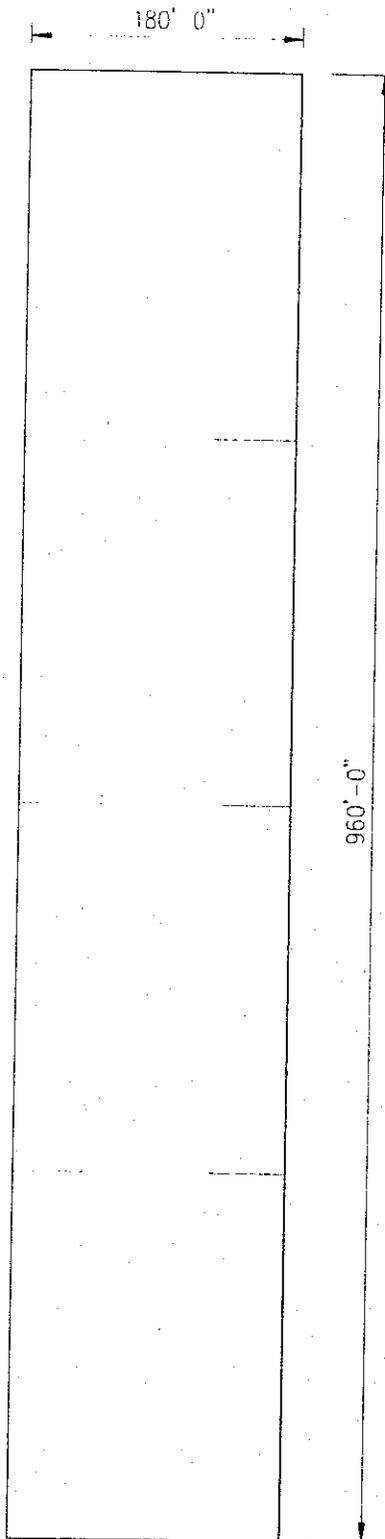
T215 (IN0617NH)

This building is a 960' by 180' warehouse having concrete block exterior walls with a wood frame structure, a wood roof deck and rolled roofing. The concrete block throughout this building is very badly cracked and deteriorated. Also, the paint is chipped and flaking throughout the building. Part of the reason for this is that water is cascading down the building from the roof due to the poor condition of the gutters and downspouts. It is causing water to enter the building. Adding to the problem is the very poor condition of the roof itself. It is very badly blistered, even in cold weather, and shows evidence of the decking being rotted below. Around the perimeter of the building at the top there are panels which appear to be transite. These panels should be tested for asbestos content. The interior of this building is one big room and does not have the firewalls the other buildings have. At the east elevation of this building the block has two expansion joints. However, the building is making its own expansion joints between the existing joints. The concrete foundation extends approximately 16 inches above grade. At the east elevation the top of the concrete foundation is spalling almost the entire length. The interior slabs are broken and heaved in several areas. In general, the areas around the overhead doors are broken and sloped towards the doors. Along the north and south exterior walls there is evidence that the roof is leaking and that water is entering the building. Midway of the south wall, a pilaster has been damaged and the rebar is exposed. There is no sprinkler system in the building, however, there are pull stations located around the building on the exterior. There are offices and restrooms located on either end of the building. These offices and restrooms have wood partition walls with drywall. Neither are in use. To bring this building to a reasonable condition we would suggest that the roof be removed, the decking that has deteriorated be replaced and a new roof applied over. All of the flashings, gutters, and downspouts should be replaced. The asbestos or transite siding should be removed and replaced with a metal panel similar to what was done on building 214. The entire building should be tuckpointed and caulked and then painted. Although the sidewalks on this building are not nearly as bad as other buildings, we would suggest that the joint between the concrete sidewalk and the building be filled and sealed. The personnel doors and windows should be replaced at this time also. It was suggested that the offices and restrooms at either end of the building be demolished since they are no longer used and the space be used for additional storage. Since this building is being used as high pile storage we would suggest that the floor slabs be repaired

and in some cases replaced to facilitate the high pile storage.
