Davis-Besse Reactor Pressure Vessel Head Degradation

Overview, Lessons Learned, and
NRC Actions Based on Lessons
Learned

NUREG/BR-0353, Rev. 1
August 2008

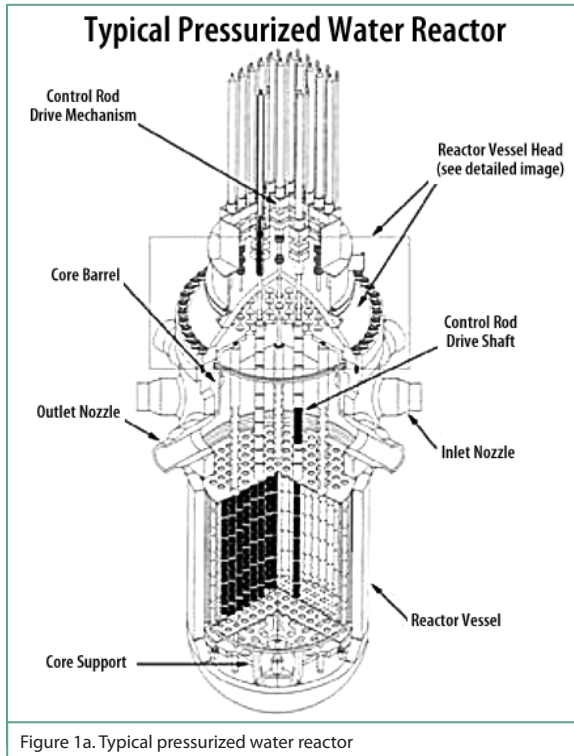
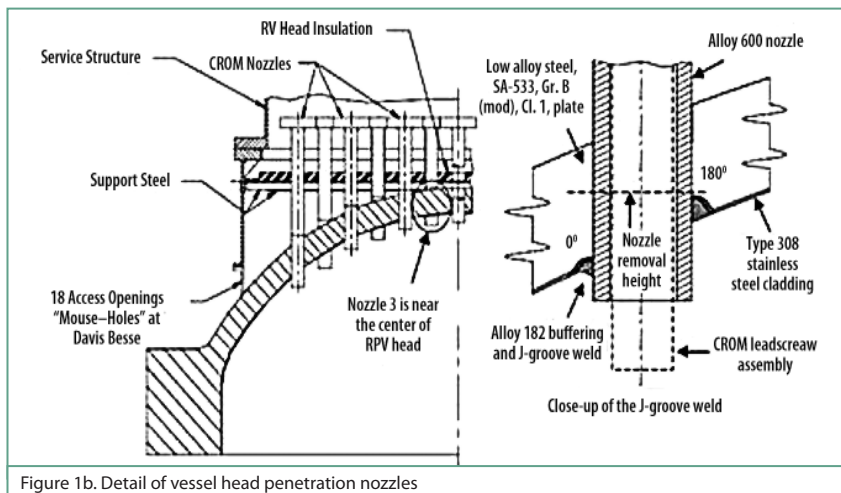
The licensee investigated the condition of the RPV head surrounding CRDM nozzle 3. The investigation included removing the CRDM nozzle and removing boric acid deposits from the top of the RPV head. Upon completing the boric acid removal on March 7, 2002, the licensee conducted a visual examination of the area and identified a large cavity in the RPV head on the downhill side of CRDM nozzle 3 (**Figure 2**). The corrosion was caused by borated water that leaked from the reactor coolant system onto the vessel head (**Figures 3 and 4**) through cracks in the nozzle and the weld that attached nozzle 3 to the RPV head (**Figures 5 and 6**). The remaining thickness of the RPV head in the wastage area was found to be approximately 3/8 inch. This thickness consisted of the thickness of the stainless steel cladding on the inside surface of the RPV head, which is nominally 3/8 inch thick. The stainless steel cladding is resistant to corrosion by boric acid, but it is not intended to provide structural integrity to the vessel. Failure of the stainless steel cladding would have resulted in a loss-of-coolant accident (LOCA). The LOCA would have resulted in actuation of the plant's emergency systems.

Figure 2. Region of the vessel head depicted by the model and photo of the cavity after it was removed from the vessel head
