## BWR steam dryer integrity

### SIL No. 644 Revision 2

August 30, 2006

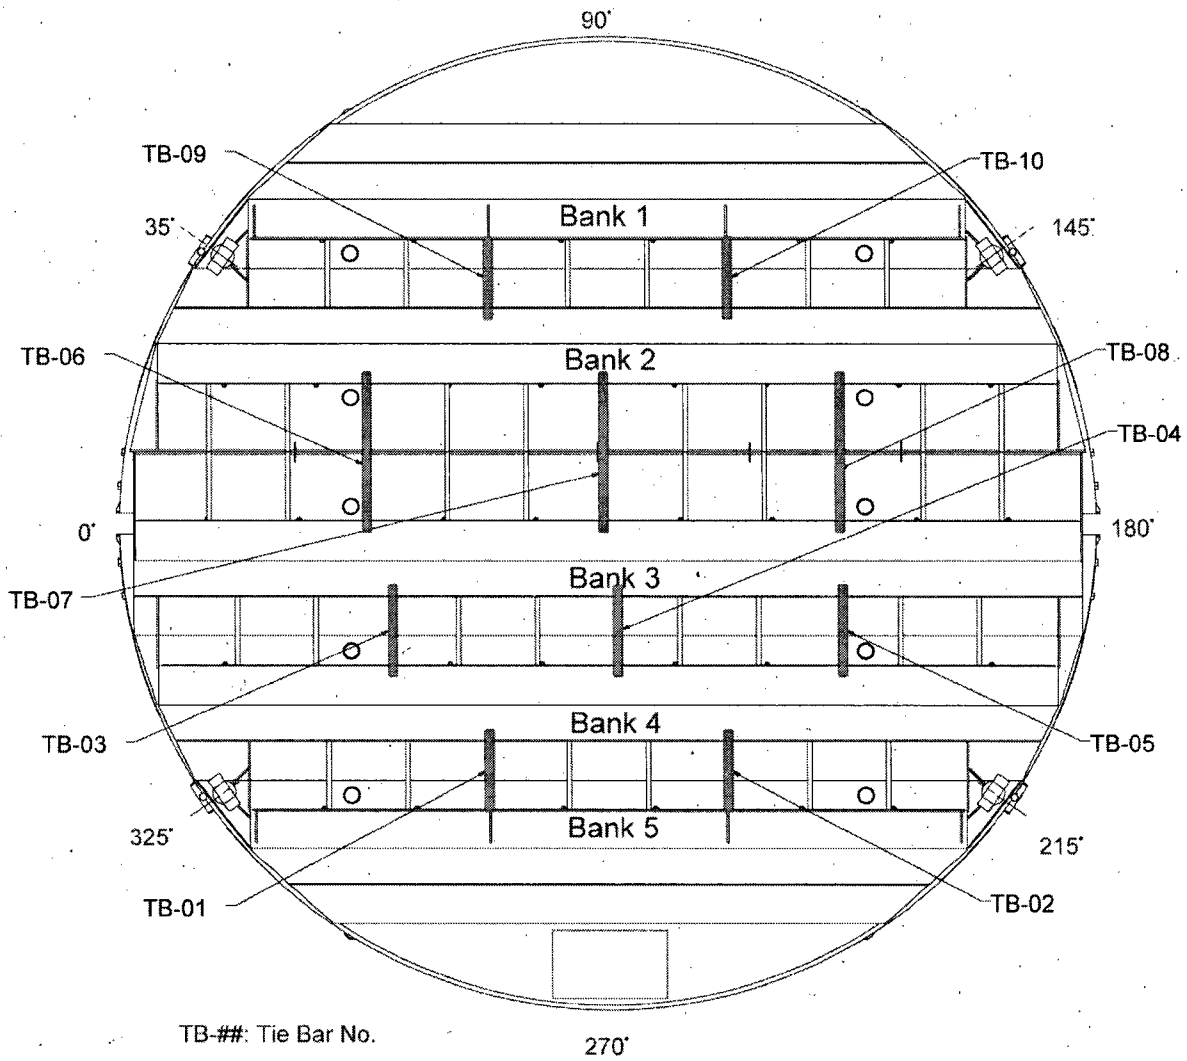
Figure C-10: Tie Bar Locations (Slanted Hood Dryers)

In addition to the outer bank and interior bracket locations, tie bars also require inspection. Figure C-10 provides a schematic of the tie bar locations joining the tops of each set of banks. The primary concern is the presence of fatigue cracking through the bar base material cross-section at axial location where the tie bar is attached to the bank.

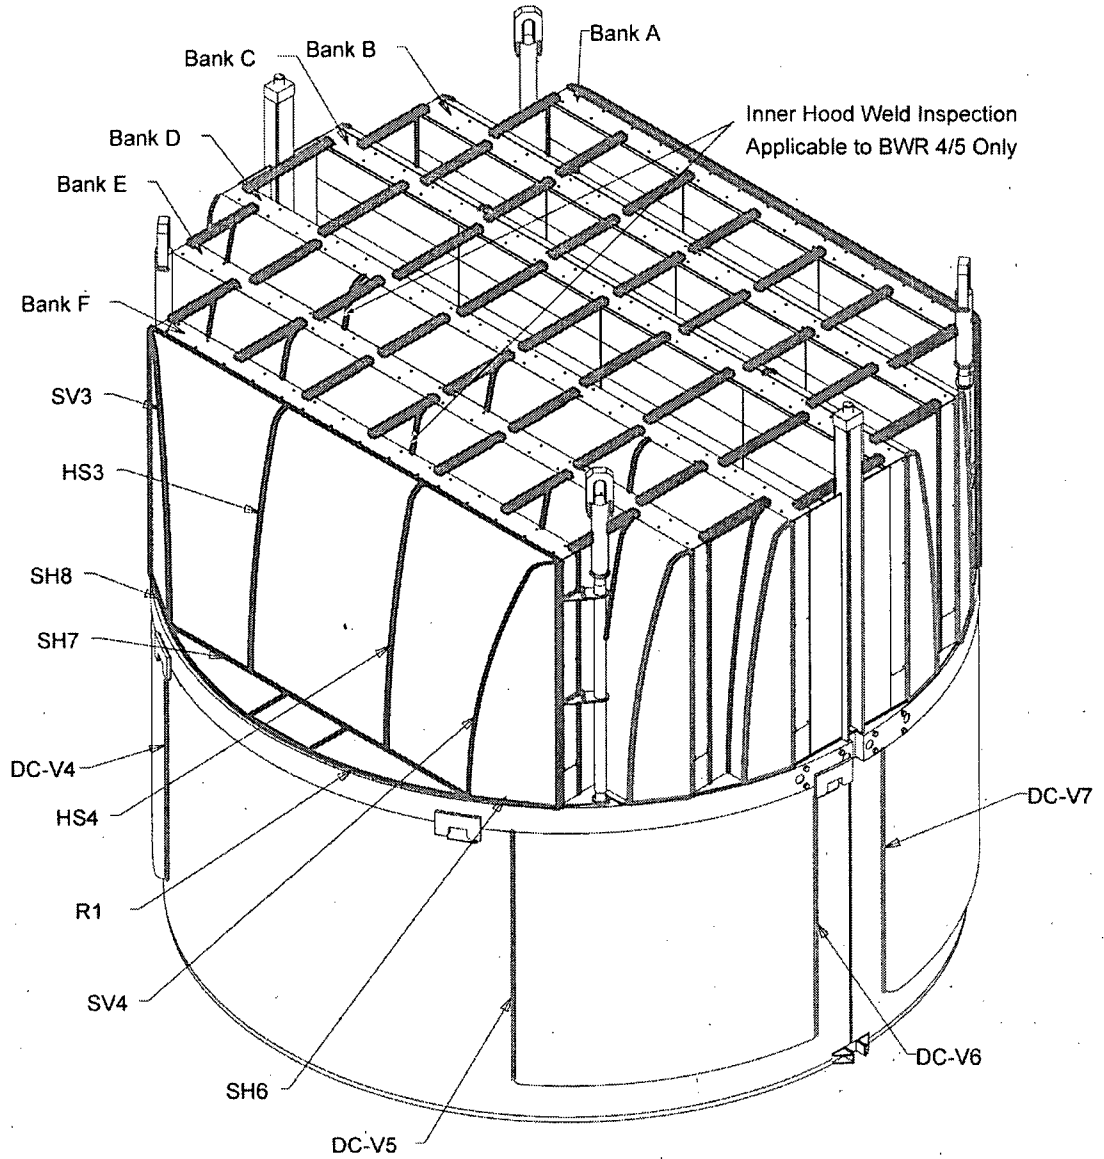
Figure C-11: Inspection Locations (Curved Hood Dryer)

Cracking has been detected in the end panels in later design dryers. Therefore, these additional weld seams associated with the outer side of the inner banks should also be inspected in that this represents a steam path through the dryer. These areas are shown in green in Figure C-11. Cracking has been observed in these locations in dryers of this design. The other locations of interest are primarily associated with IGSCC in drain channels (refer to SIL No. 474 "Steam Dryer Drain Channel Cracking" issued October 26, 1988) and lifting rod attachments:
