Secondary Piping Rupture Accident at Mihama Power Station, Unit 3, of the Kansai Electric Power Co., Inc. (Final Report)

March 30, 2005
The Nuclear and Industrial Safety Agency

(Translated by JNES, Rev 1 as of May 14, 2005)

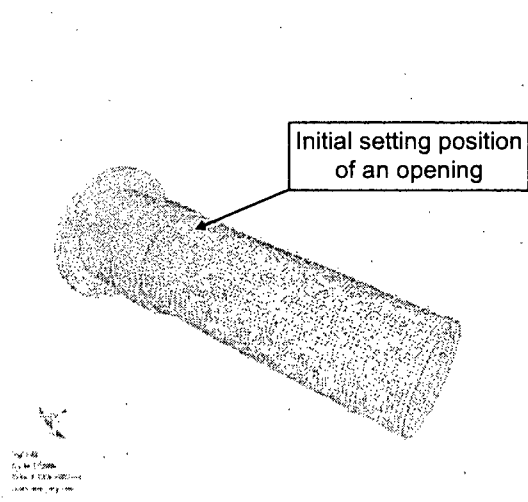
Figure 1 Analytical model of an opening progress

In order to investigate the fracture mechanism of the pipe ruptured opening, the opening progress is analyzed by using the nonlinear dynamic analysis code AUTODYN-3D. As a result, it is estimated that the crack progressed and became the final form in one hundredth of a second after the occurrence.

Blue dots: Fracture positions read from the ruptured opening sketch

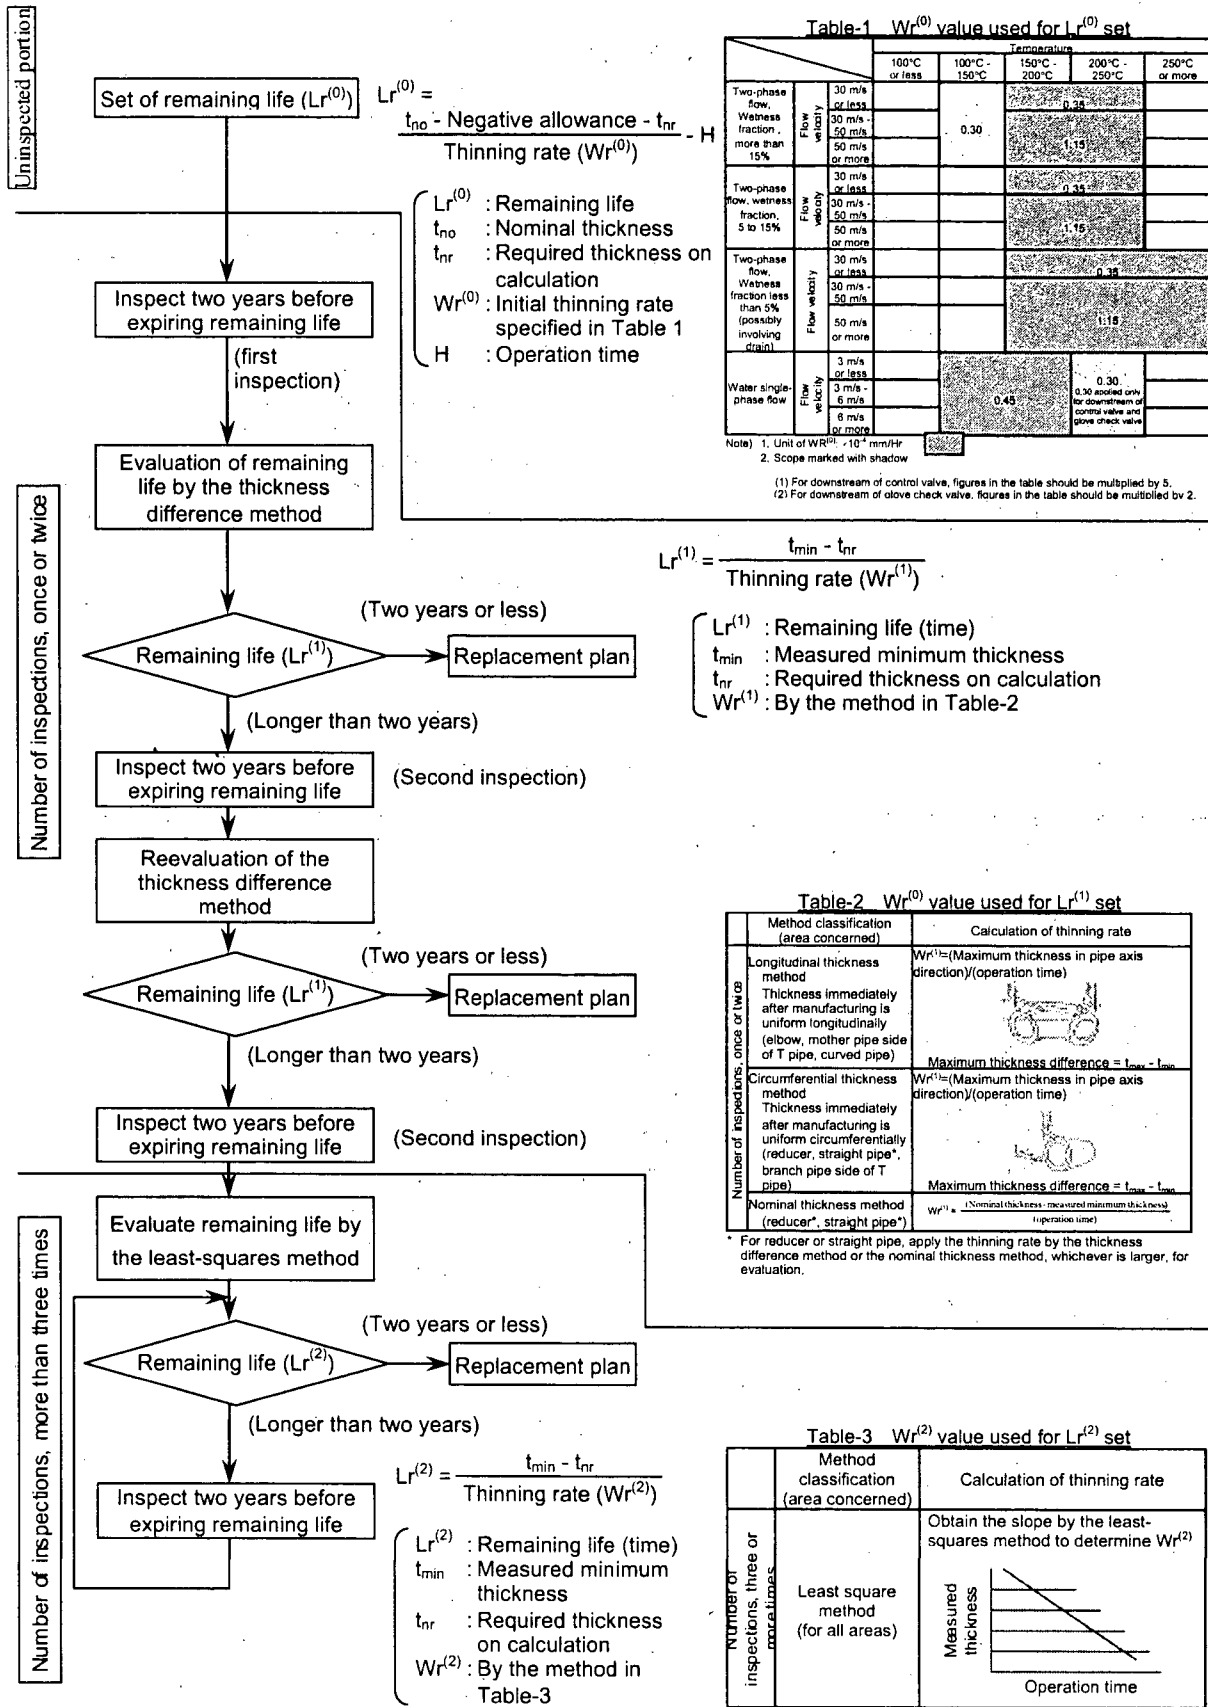
Figure 1 Remaining life determination method

Remaining life to the necessary minimum thickness on calculation should be determined at each location, and the area concerned should be inspected before the remaining life is less than two years. It is also stipulated that the inspection should be repeated using evaluation of inspection results until the remaining life reaches to less than two years (Figure 1).

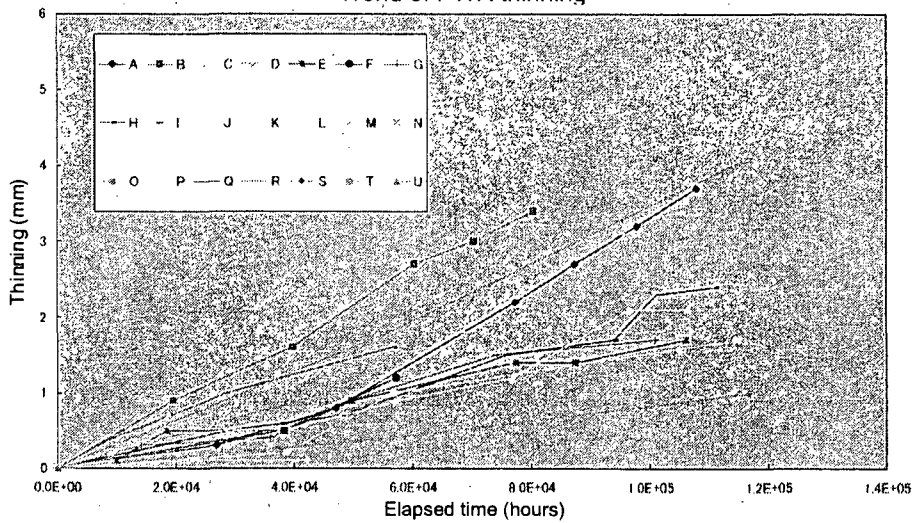
Figure 2 Measurement area and the trend of thinning in PWR piping

Figure 2 shows the trend of thinning measured by every PWR plant and its resultant actual thinning rate. Comparison between the actual thinning rate and the initially set value of thinning rate specified in the PWR Management Guidelines reveals that the actual thinning rate, except for the main feedwater piping in A-loop, is lower than the initially set value of thinning rate.

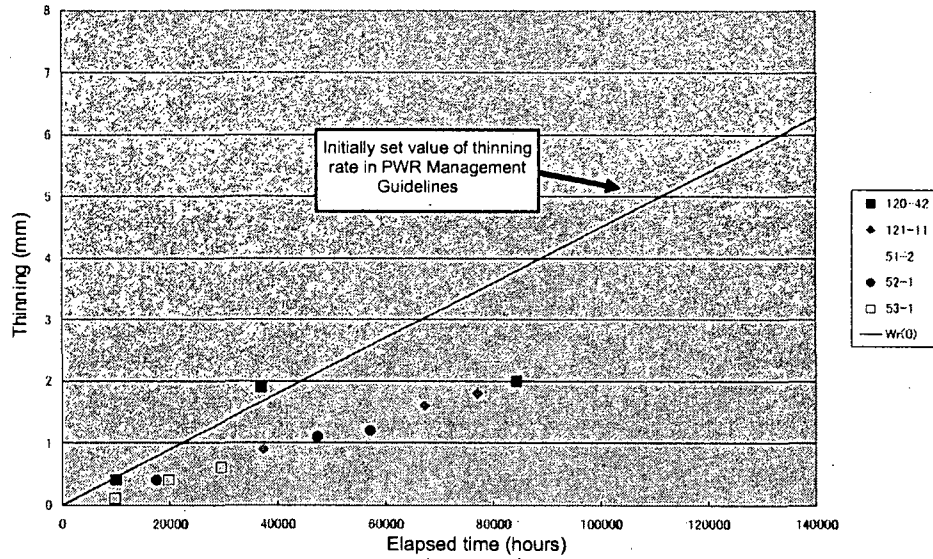
Figure 3 Measurement area and the trend of thinning in Mihama Unit 3 piping

Figure 3 shows the trend of thinning measured at Mihama Unit 3, and comparison with the initially set value of thinning rate shown in the PWR Management Guidelines. According to the figure, the actual trend of thinning is lower than the initially set value of thinning rate except small part of data.

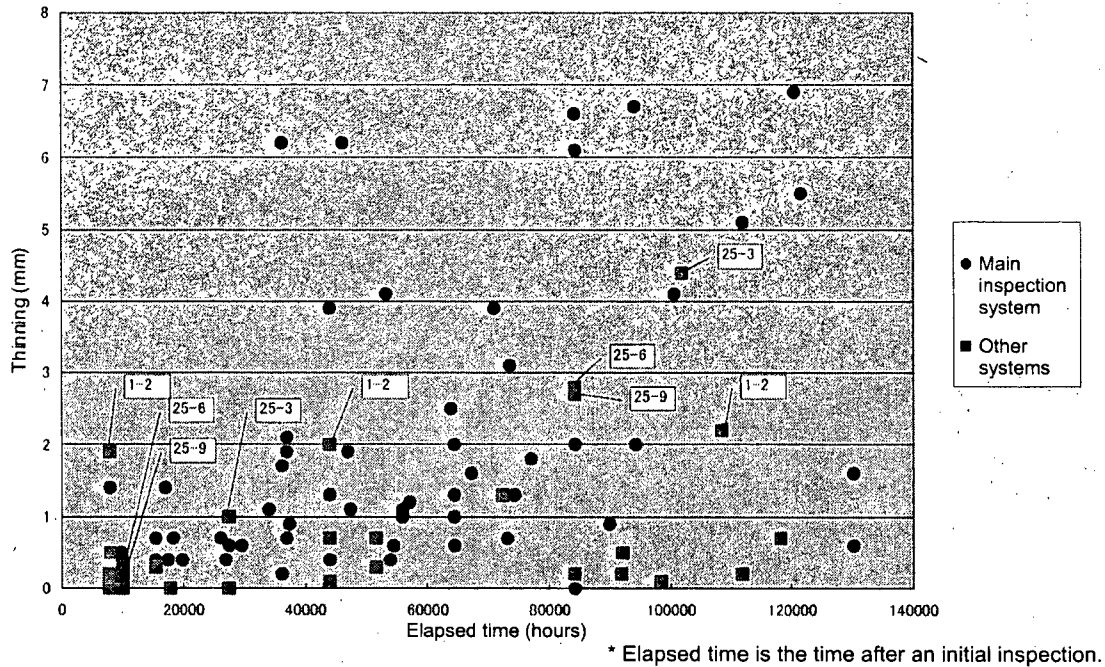
Figure 4 Comparison of main inspection systems and other systems in Mihama Unit 3

Figure 4 shows a comparison of thinning between main inspected systems, all of which are inspected in accordance with the PWR Management Guidelines and other systems inspected on a sampling basis. As a result, the thinning rate of other systems is smaller than that of the main inspected systems as a whole. This suggests that the thinning rate is affected by an environmental difference. Nevertheless some other systems show thinning rates comparable with the main inspected systems.

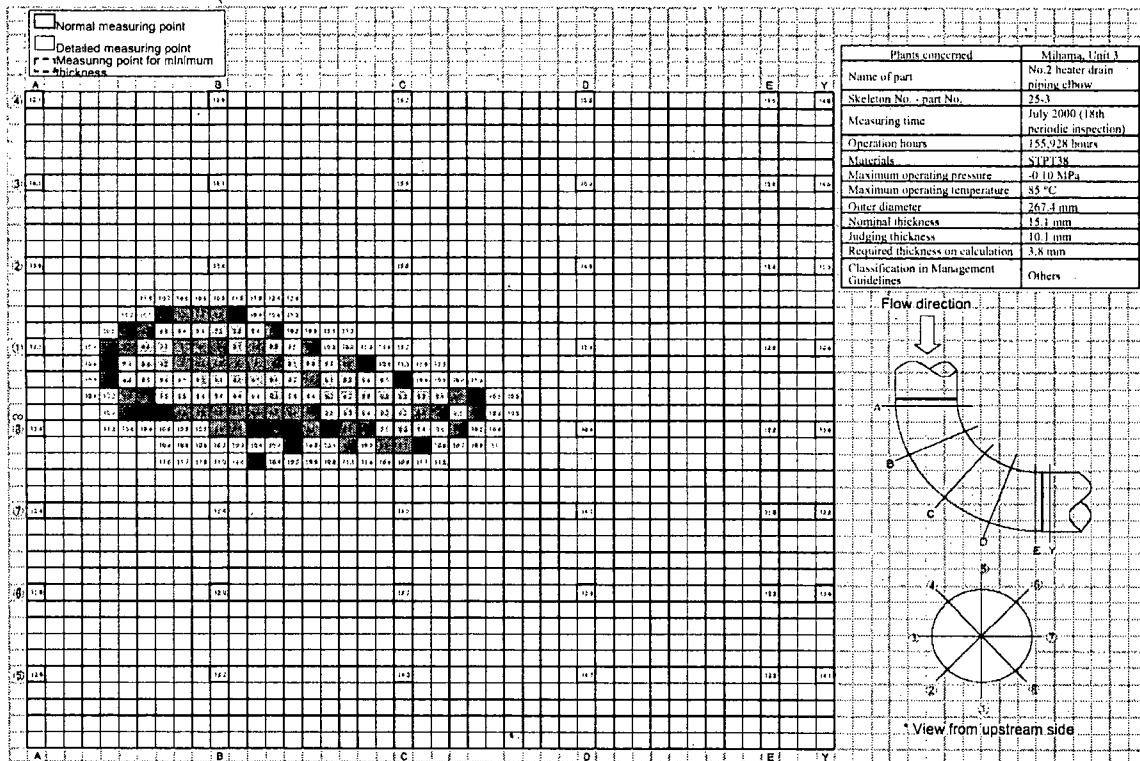
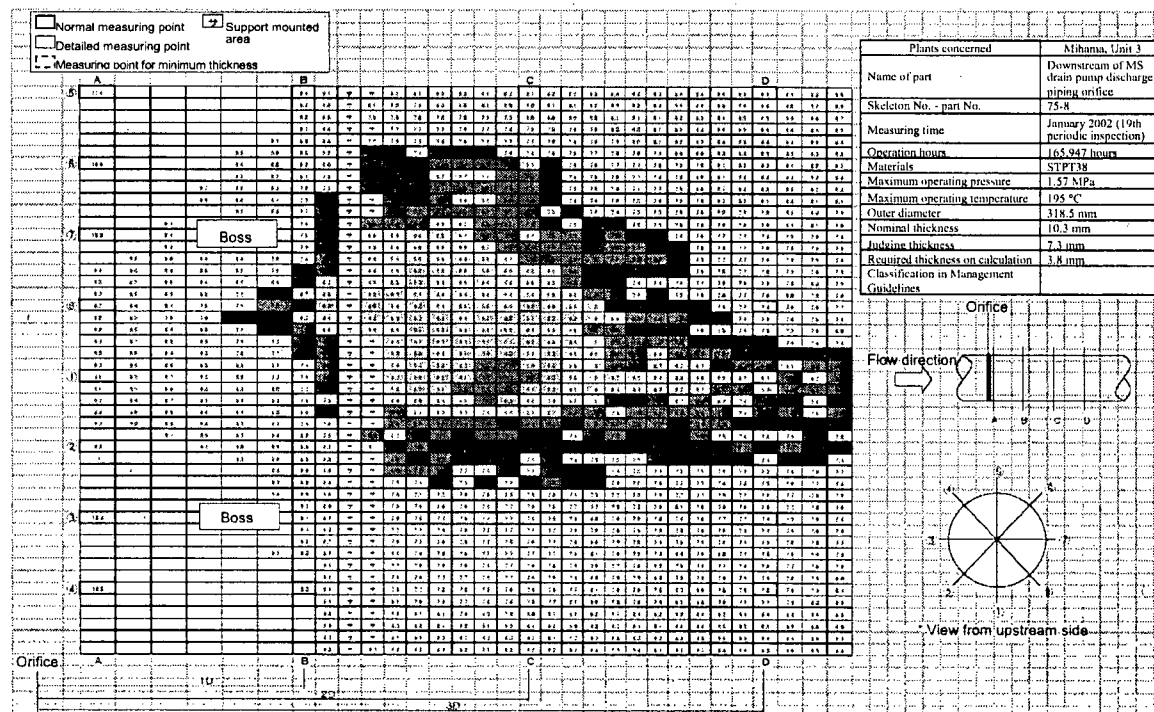
Figure 5 Measured results of Mihama Unit 3 (example)

NISA used detailed measurement results of Mihama Unit 3 obtained from KEPCO through the report collection requirement to analyze the relation between the measuring area and measuring points and occurring situation of thinning. Figure 5 shows distribution of measured results. This reveals that measurement by the typical measuring points and resultant detailed measurements are effective to judge the shape and dimensions of the area concerned.

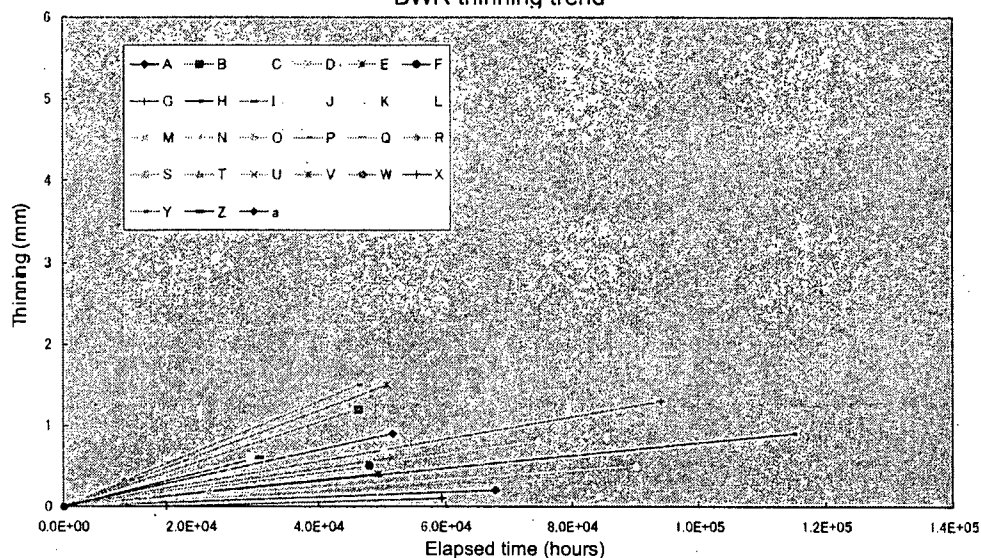
Figure 6 Measured parts of thinning and its trend of BWR piping

Figure 6 shows the trend of thinning measured at BWR plants and its resultant actual thinning rate. Comparison of Figure 2 and 6 reveals that PWR and BWR are different in the trend of thinning and the rate of BWR is lower than that of PWR. This is caused by the difference in water chemistry control between PWR and BWR.
