D. Work Activities Related to the Thimble Tube Cleaning Prior to the Accident

1. Work Activities During the Evening of April 18 to Approximately 0830 on April 19

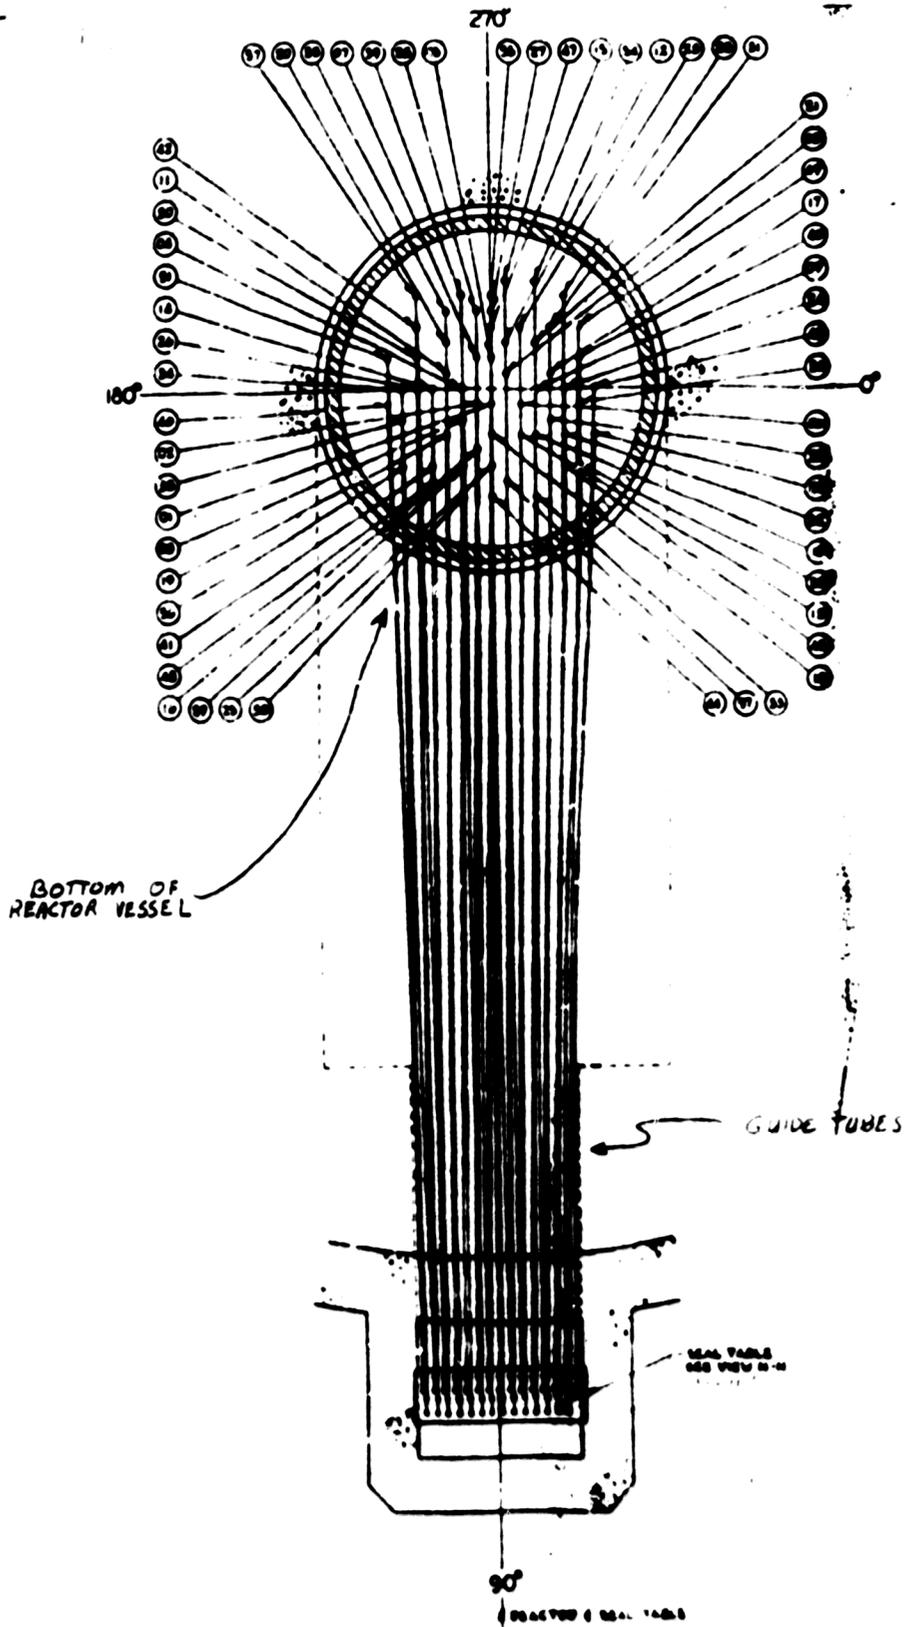
FIGURE 3

THIMBLE TUBE (SHOWING DESIGN AND EXPANSION FOR MECHANICAL SEALS AT THE SEAL TABLE)

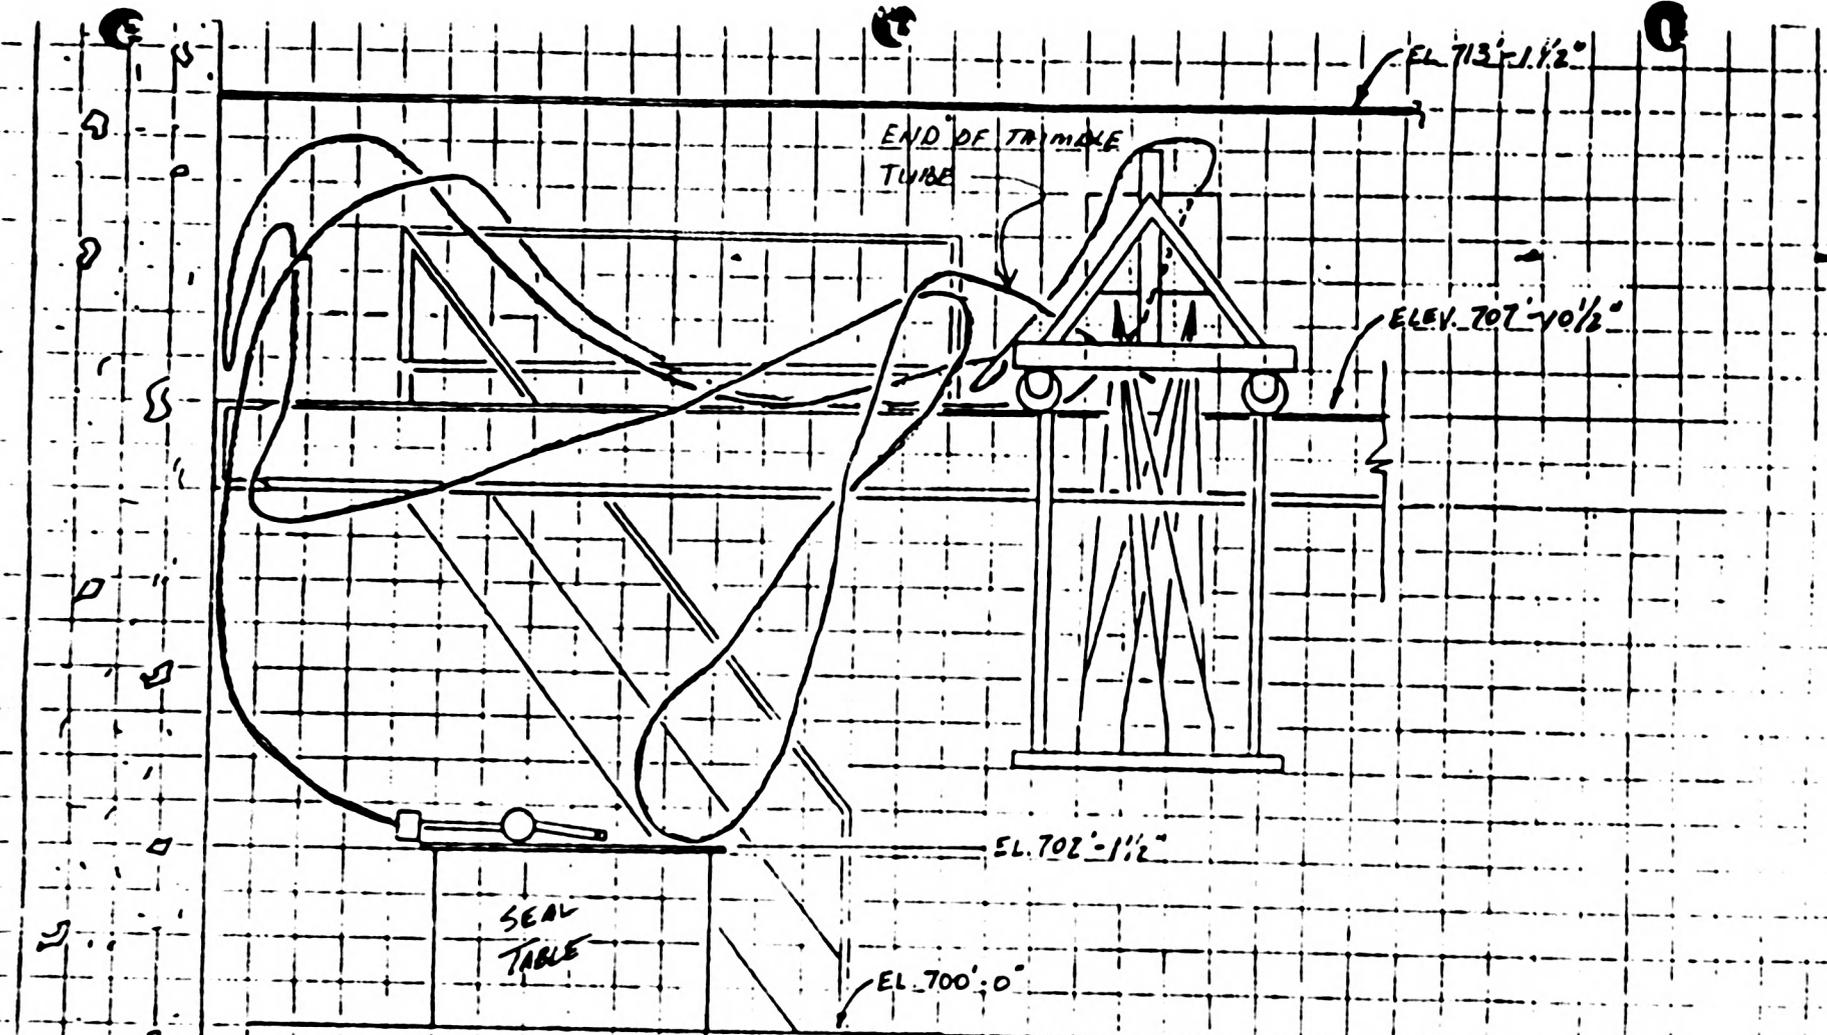
REPRODUCED DRAWING OF ELEVATION CHIMNEY TUBE
FIGURE 15

The film was developed and the photographs returned to the plant. From the photographs the plant staff composed a drawing of the thimble tube configuration (see figure 15). An entry into the instrument room was made on April 23 at 1300 by the plant HP section supervisor, an HP shift supervisor, and an HP technician to confirm that the actual configuration was as depicted in the drawing. In addition, contact dose rates were taken at various locations on the ejected thimble tube with a radiation measuring instrument with an extendable radiation detector (see figure 16 for contact dose rates.) They determined that the actual configuration of the thimble tube was in agreement with that depicted in the drawing. The highest radiation dose received (based on high-range dosimeters) during the entry was 0.4 rem.
