D. Work Activities Related to the Thimble Tube Cleaning Prior to the Accident

E. The Accident

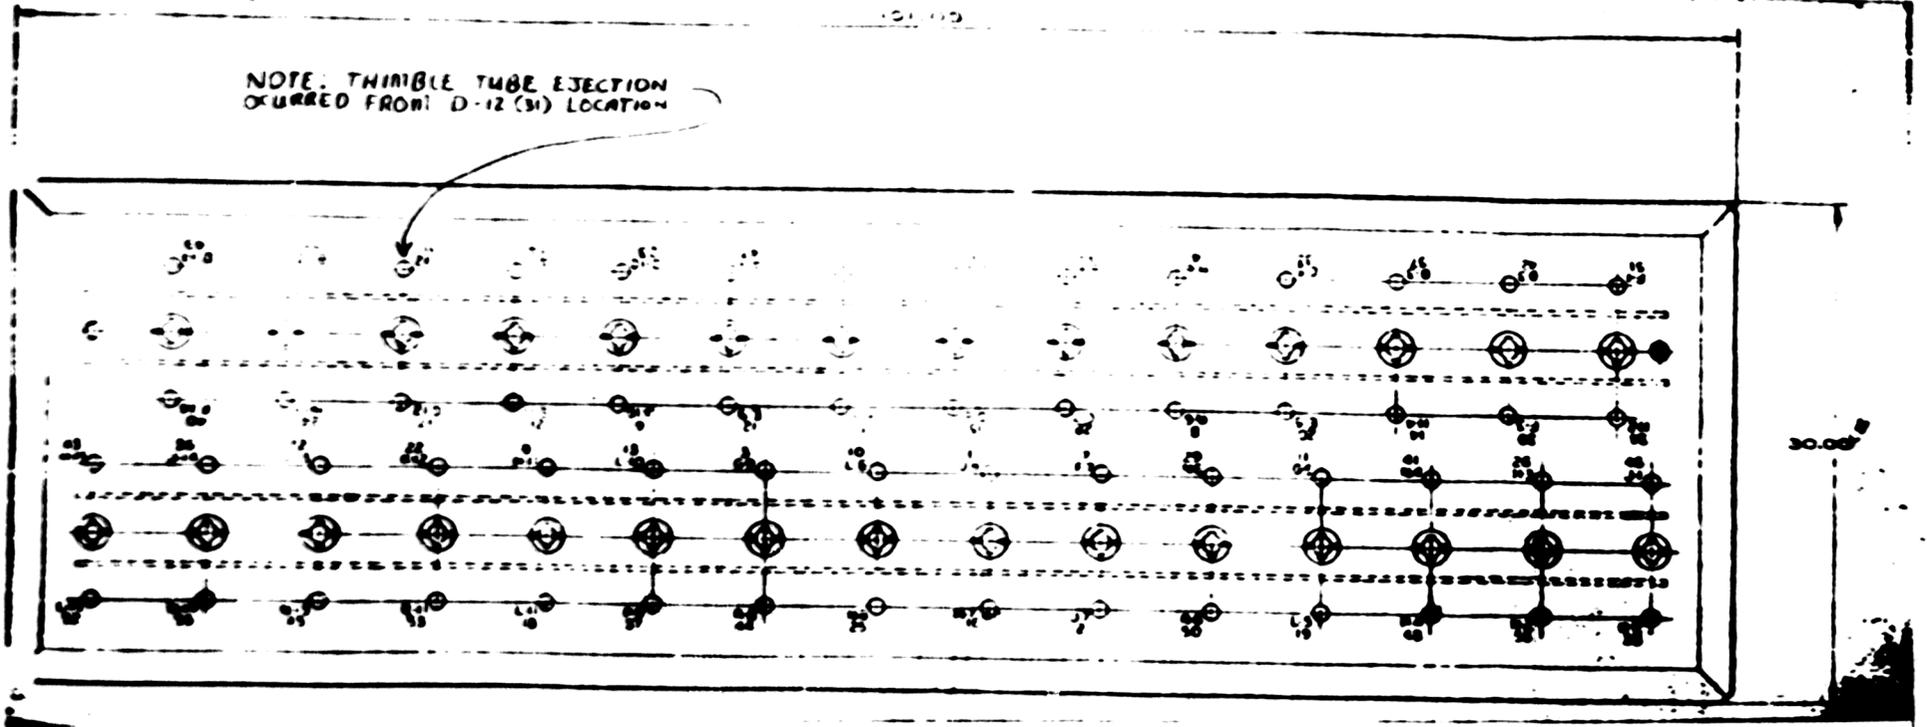
FIGURE 1 INCORE DETECTOR SYSTEM

NOTE: THIRIBLE TUBE EJECTION
OCCURRED FROM D-12 (31) LOCATION

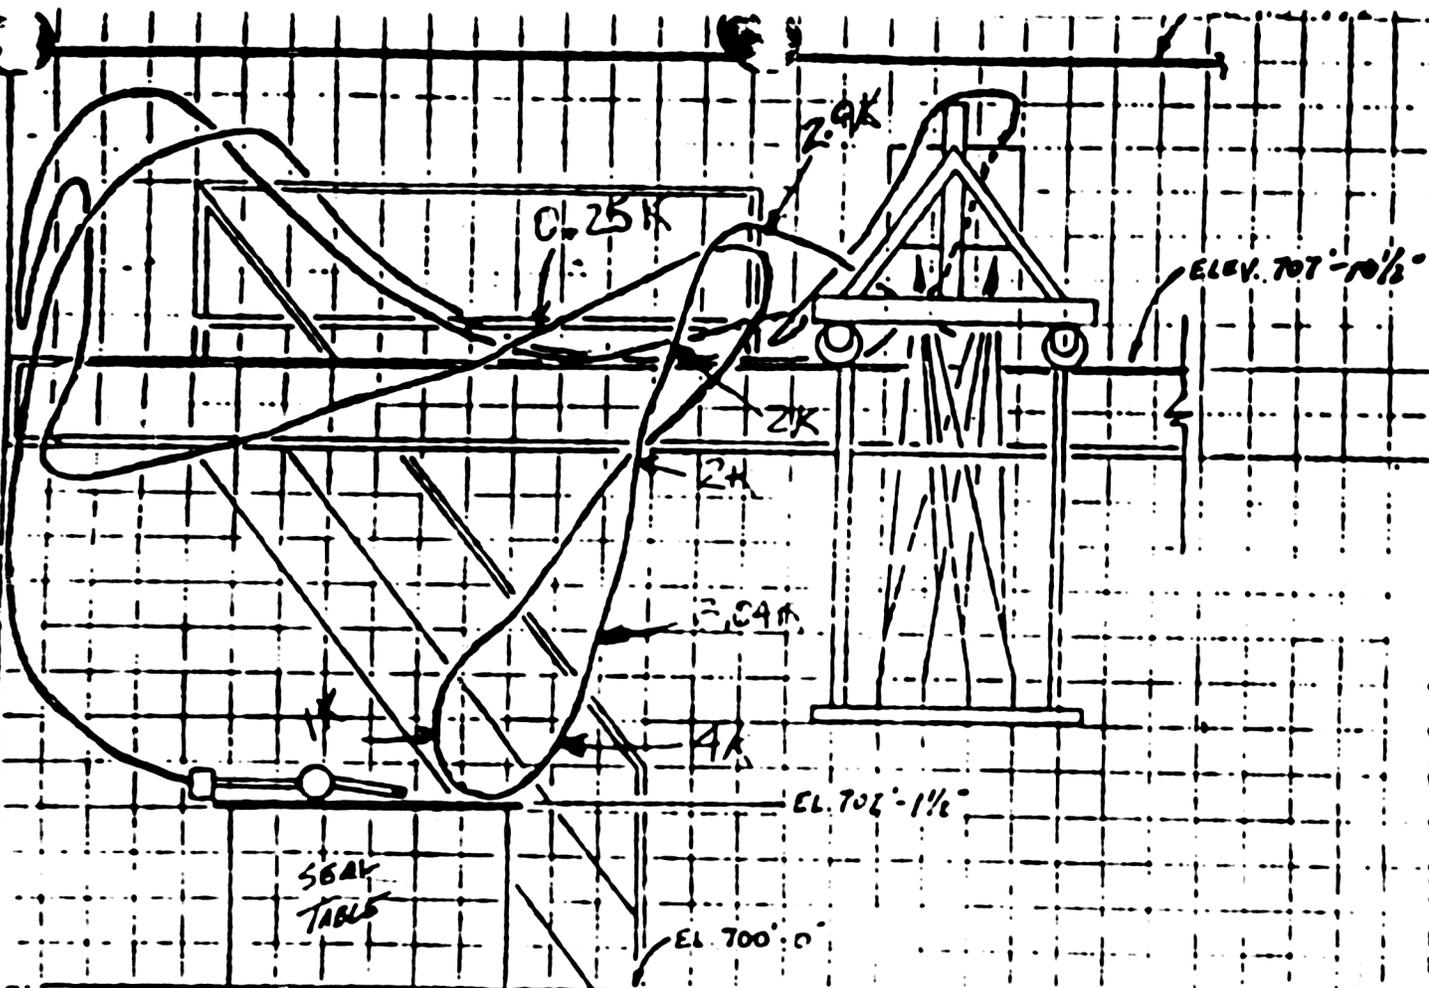
REPRODUCED DRAWING OF EDELCO CHIMNEY TUBE
FIGURE 15

The film was developed and the photographs returned to the plant. From the photographs the plant staff composed a drawing of the thimble tube configuration (see figure 15). An entry into the instrument room was made on April 23 at 1300 by the plant HP section supervisor, an HP shift supervisor, and an HP technician to confirm that the actual configuration was as depicted in the drawing. In addition, contact dose rates were taken at various locations on the ejected thimble tube with a radiation measuring instrument with an extendable radiation detector (see figure 16 for contact dose rates.) They determined that the actual configuration of the thimble tube was in agreement with that depicted in the drawing. The highest radiation dose received (based on high-range dosimeters) during the entry was 0.4 rem.
