SUBJECT: SPECIAL REVIEW OF NCR WBNSWP8303 RELATED TO MISSING PIPE SUPPORT CALCULATIONS - WATTS BAR NUCLEAR PLANT - UNITS 1 AND 2 - NUCLEAR SAFETY REVIEW STAFF REPORT NO. R-84-07-WBN

SUBJECT: WATTS BAR NUCLEAR PLANT - UNITS 1 AND 2 - SPECIAL
REVIEW OF NCR WBNSWP8303 RELATED TO MISSING PIPE
SUPPORT CALCULATIONS

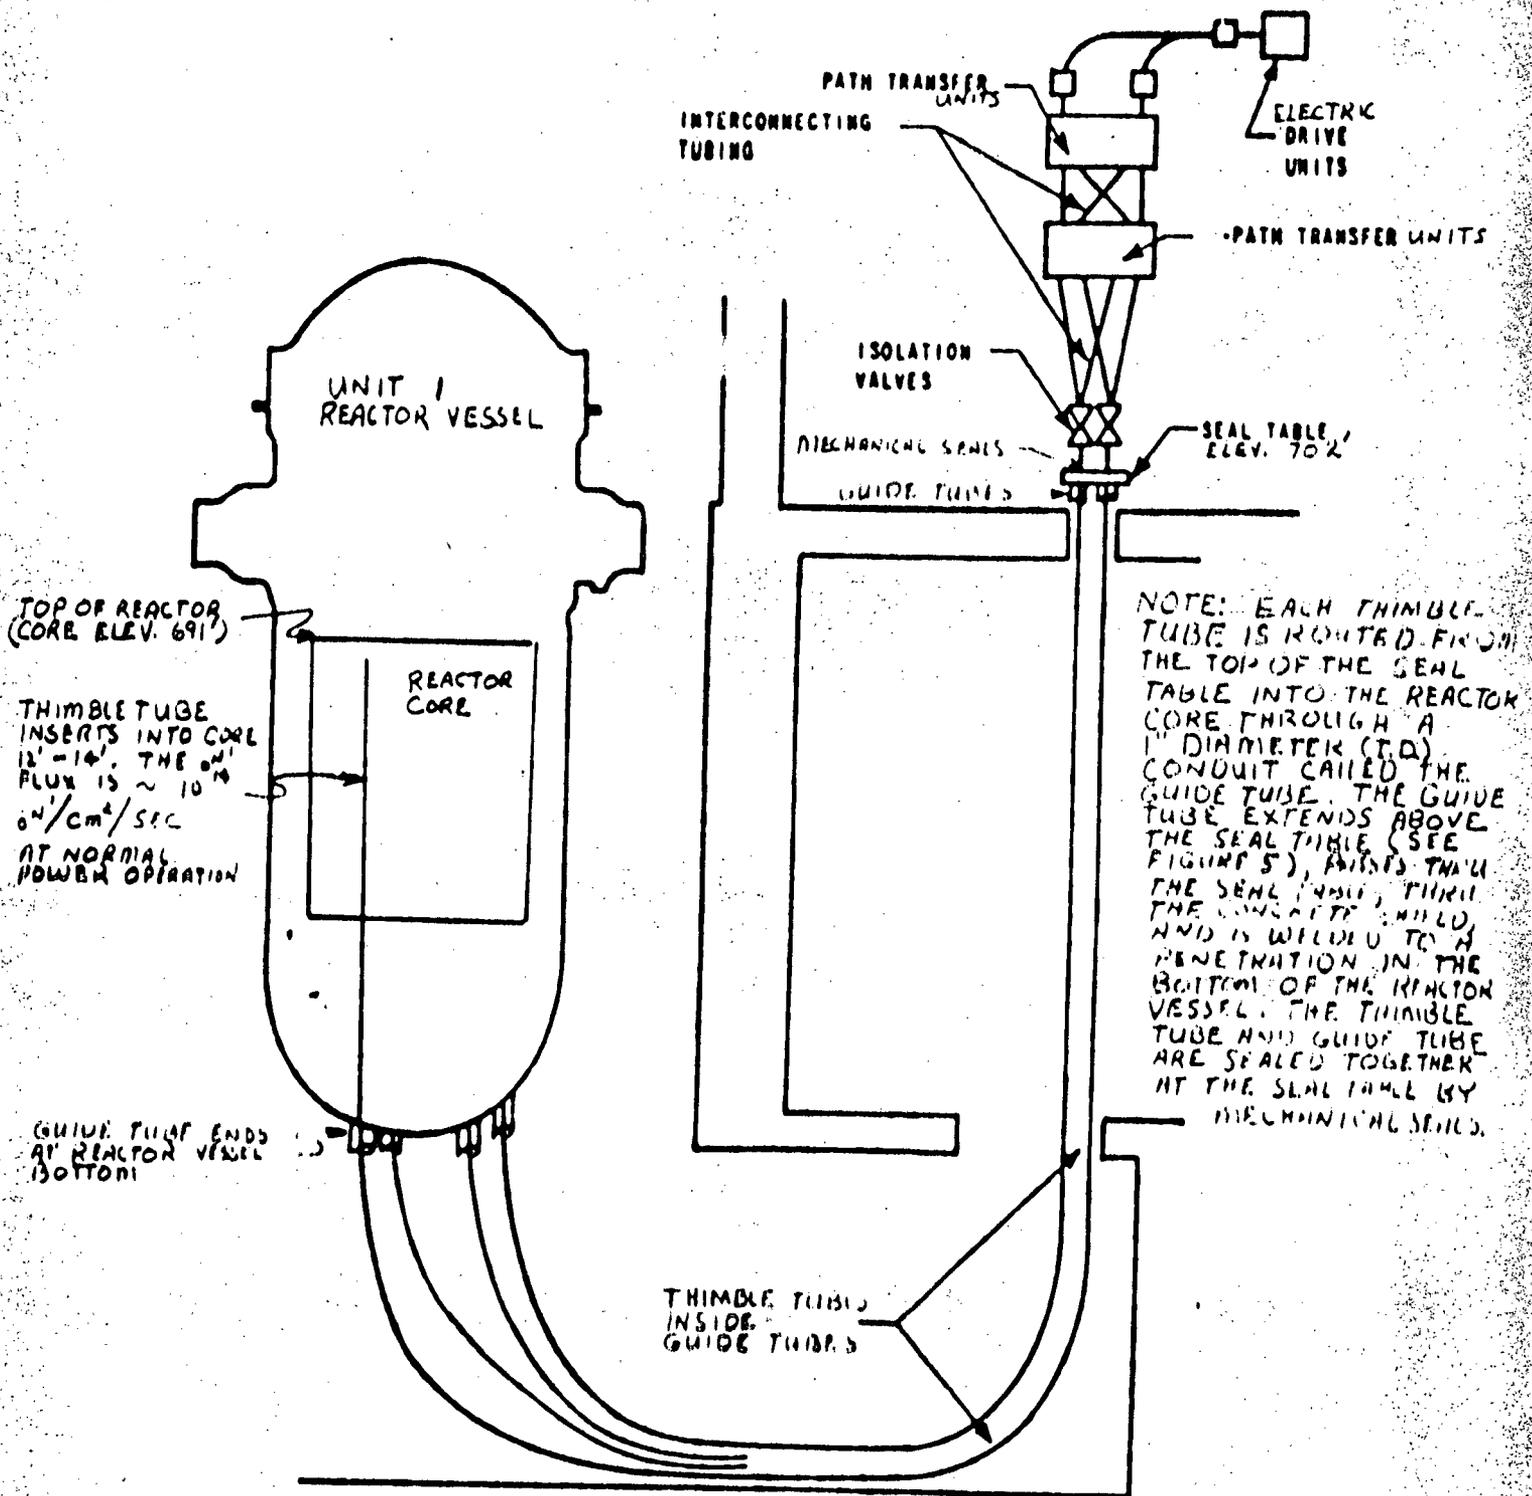
FIGURE 1 INCORE DETECTOR SYSTEM

NOTE: THIS BLE TUBE EJECTION
ORDERED FROM D-12 (3) LOCATION

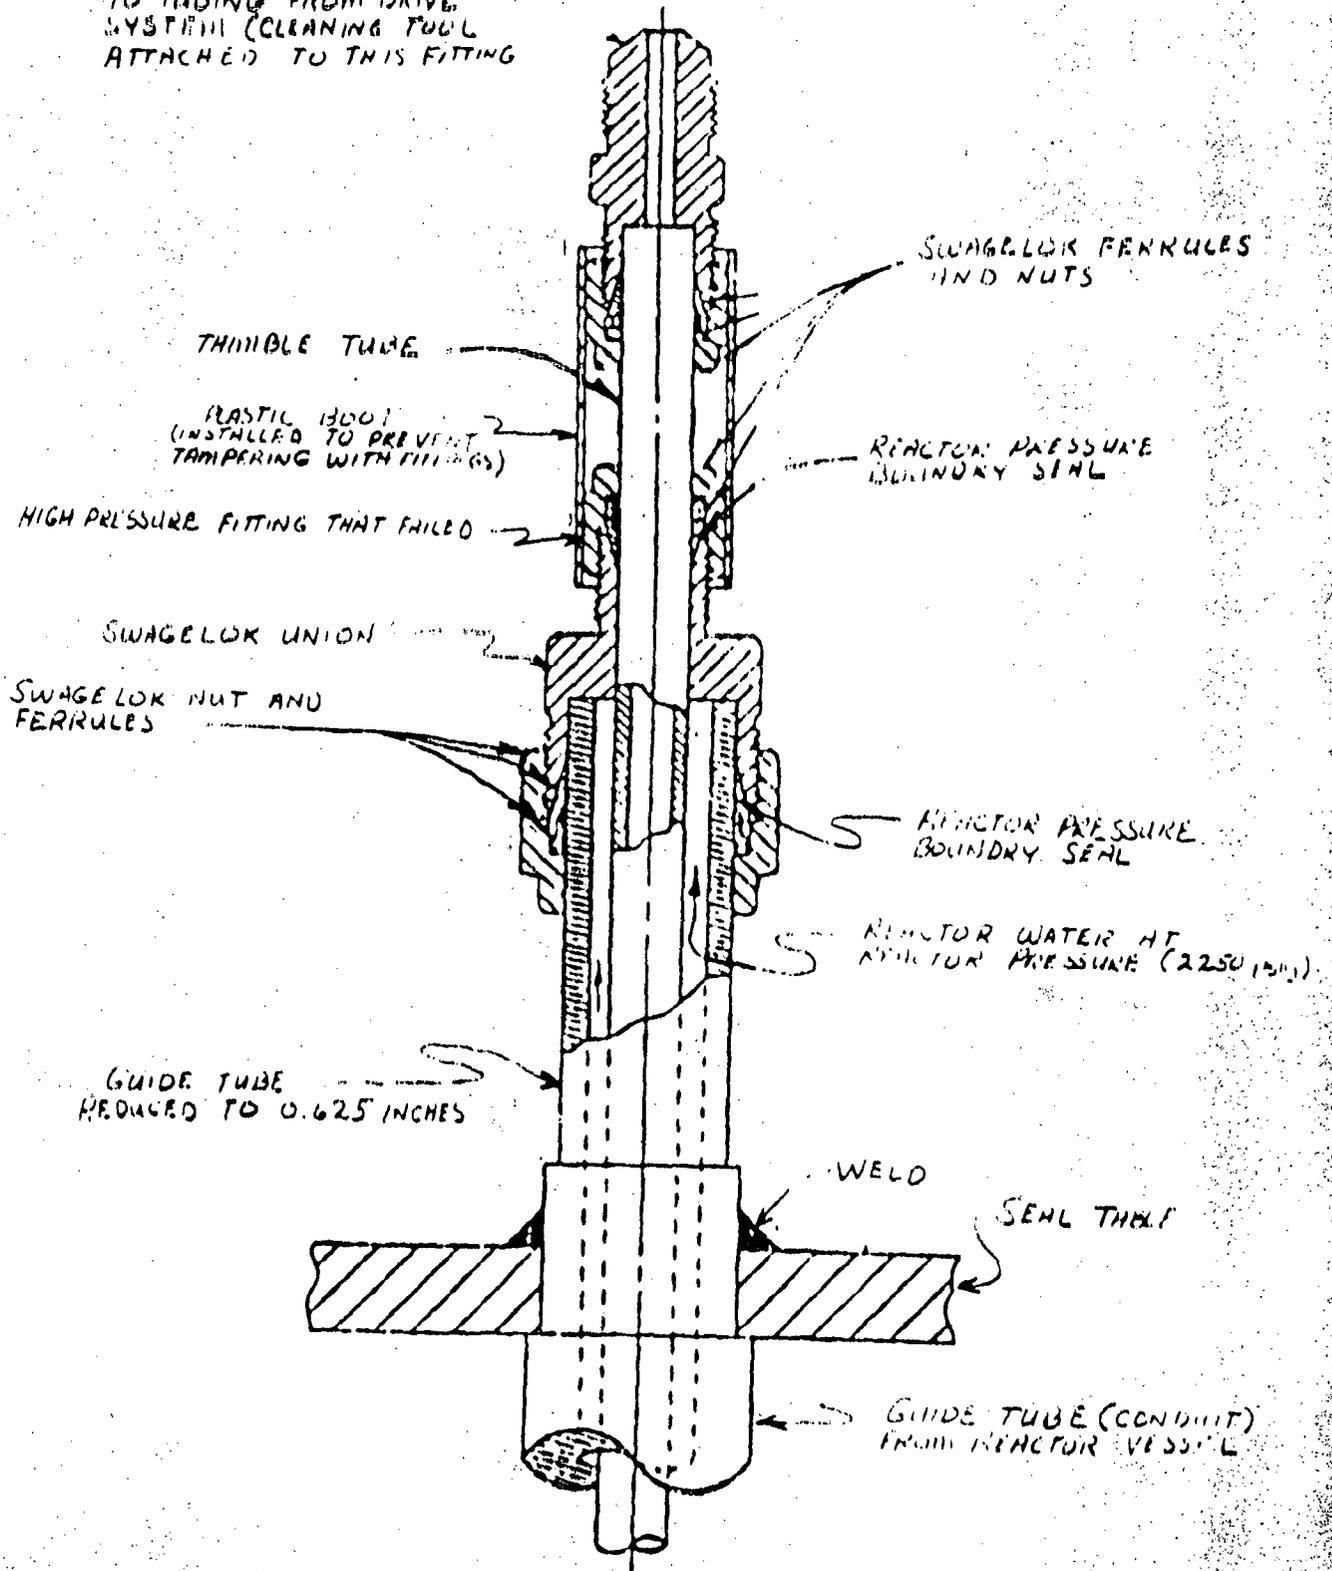
FIGURE 5

THIN WALLE TUBE MECHANICAL SEAL

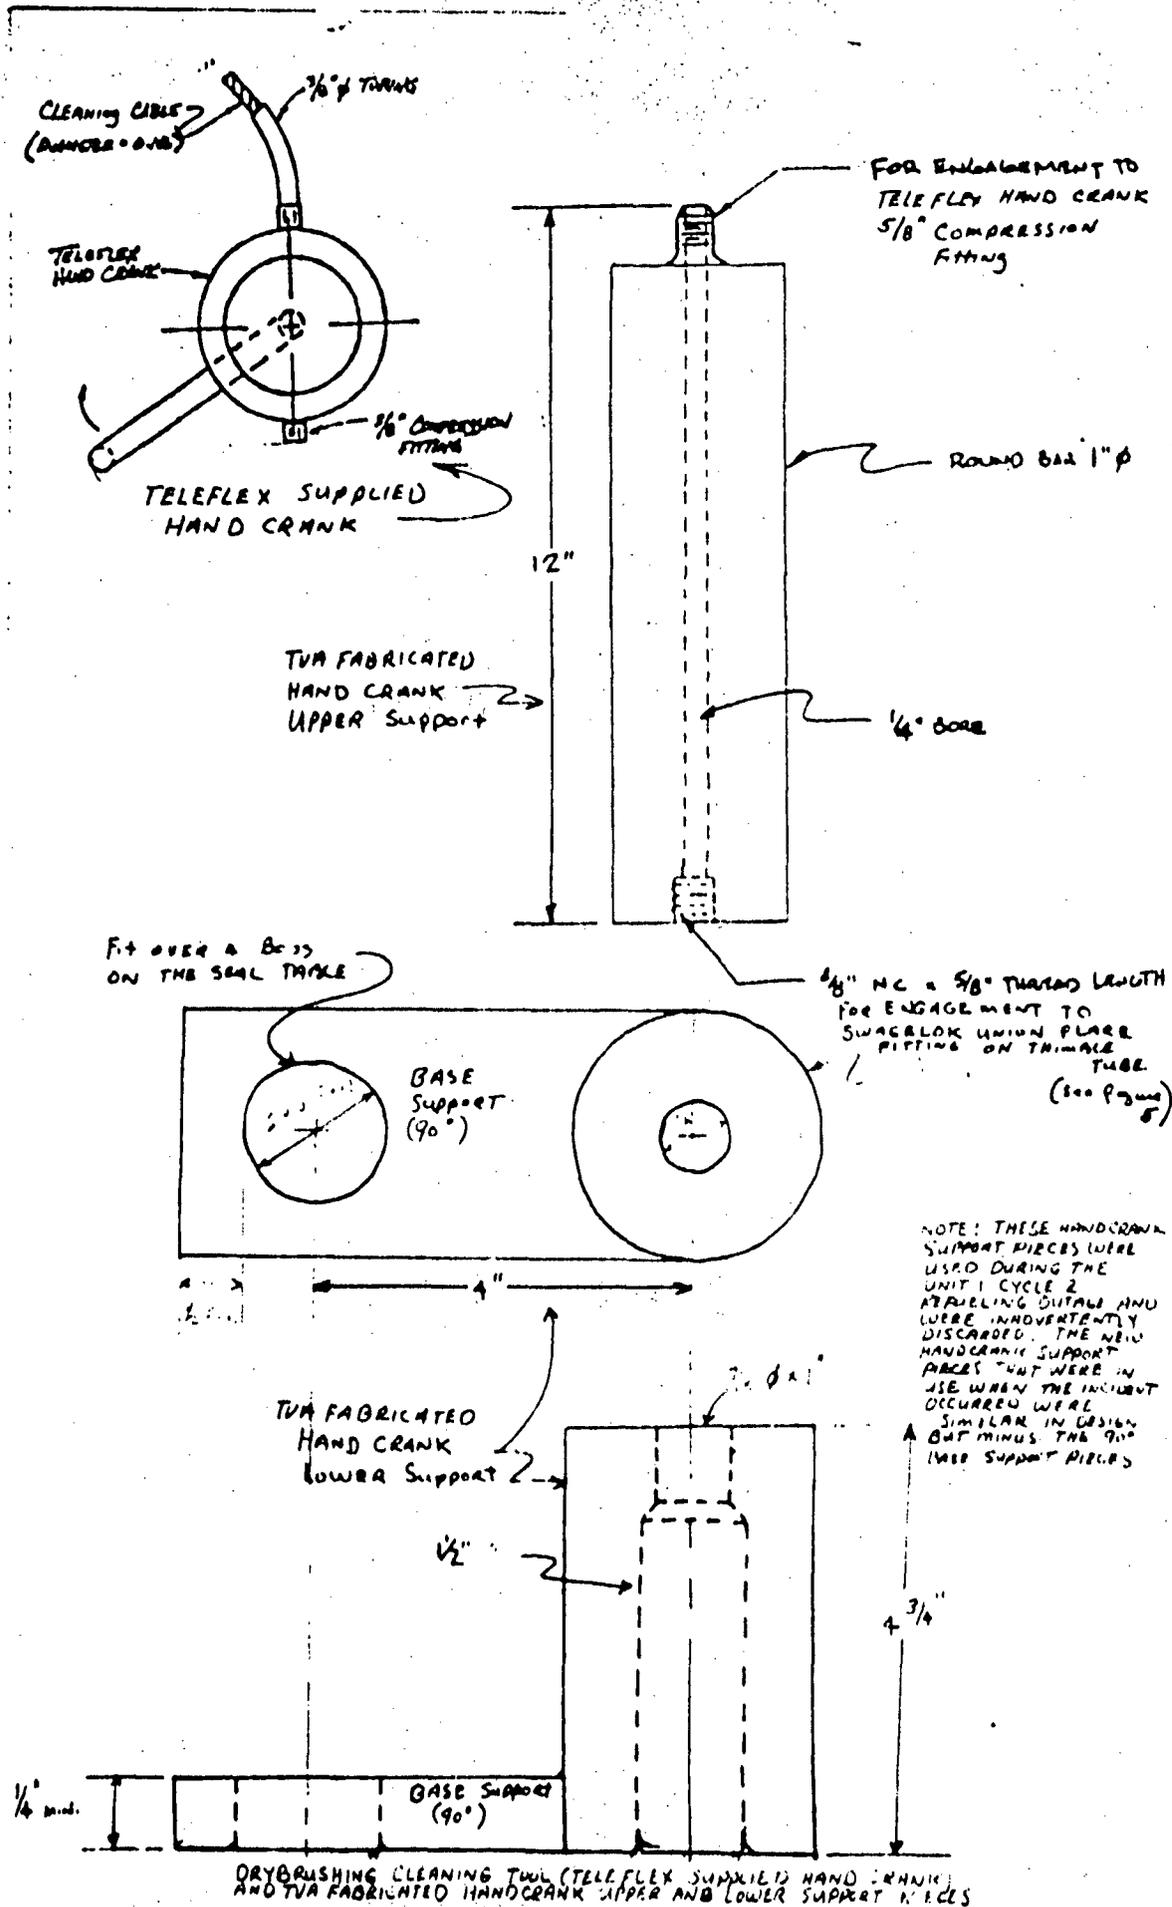
FIGURE 11A

- (2) Dry Brushing (Refer to figures 11A, 11B, 12A, and 12B). The dry brushing step involved the use of a brush assembly which consisted of a 0.200 inch od brass wire brush welded to a 0.187 inch od carbon steel helical (spiral wound) cable driven by a handcranked drivebox. The brush assembly was provided by the same vendor (Teleflex) that provided the detector drive system. The upper and lower supports for the handcrank device were fabricated by TVA. The lower support was equipped with a 90° base support that fit over a boss on a seal table providing additional stability to the support assembly as the handcrank was turned. The fit of the base support over the bosses for all the thimble tubes was not always secure. The brush assembly was used to "dry" brush each of the thimble tubes to dislodge particles and dried lubricant attached to the thimble tube wall by the scrubbing action of the brush. The brush was driven into the thimble 10 inches for each revolution of the handcrank. The brushing motion was strictly linear without any rotation of the brush.

HANDCRANK

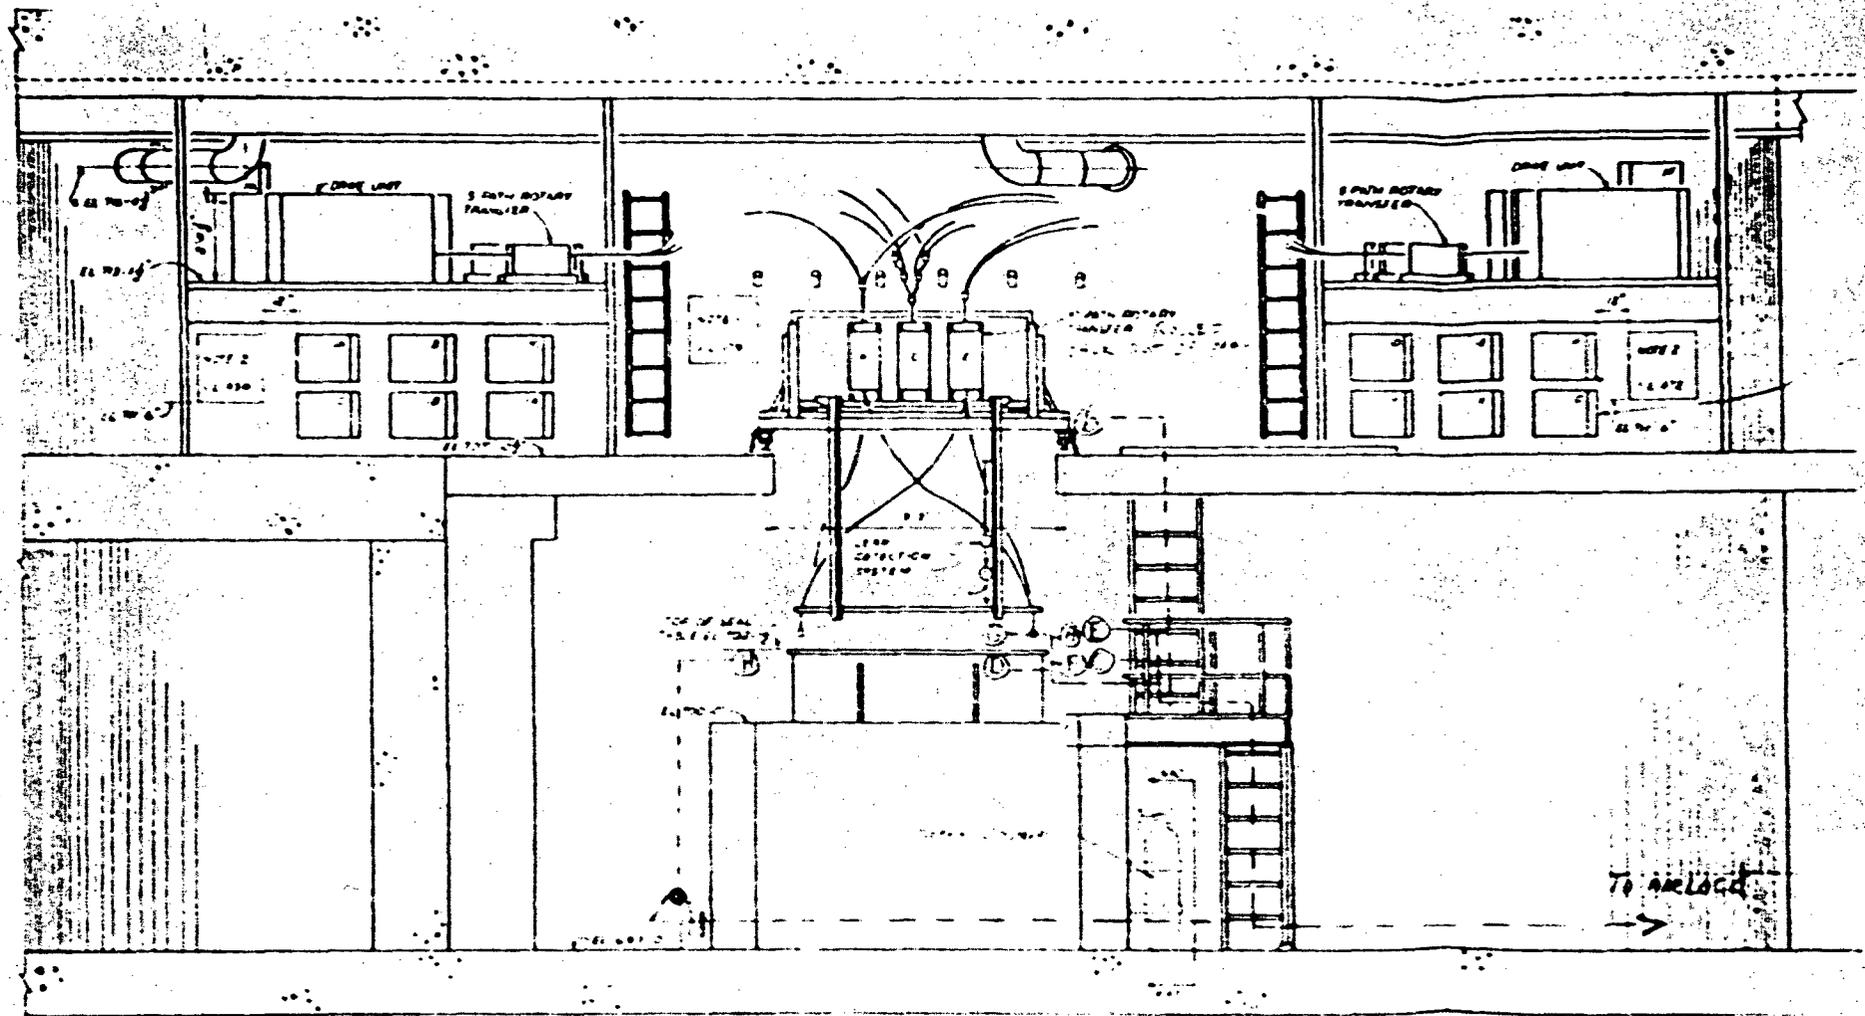
NOTES (1) FLIGHT TO BE OVER
 -CHECK - HIT TOOLBOX AND EAT
 TO THE AIRLOCK

LOCATION OF WORKER AND POSITION
 DURING FLIGHT
