Combined License Application

Part 11G: Site Area Paleoliquefaction And Surface Faulting Investigation Program

Revision 0
November 2008

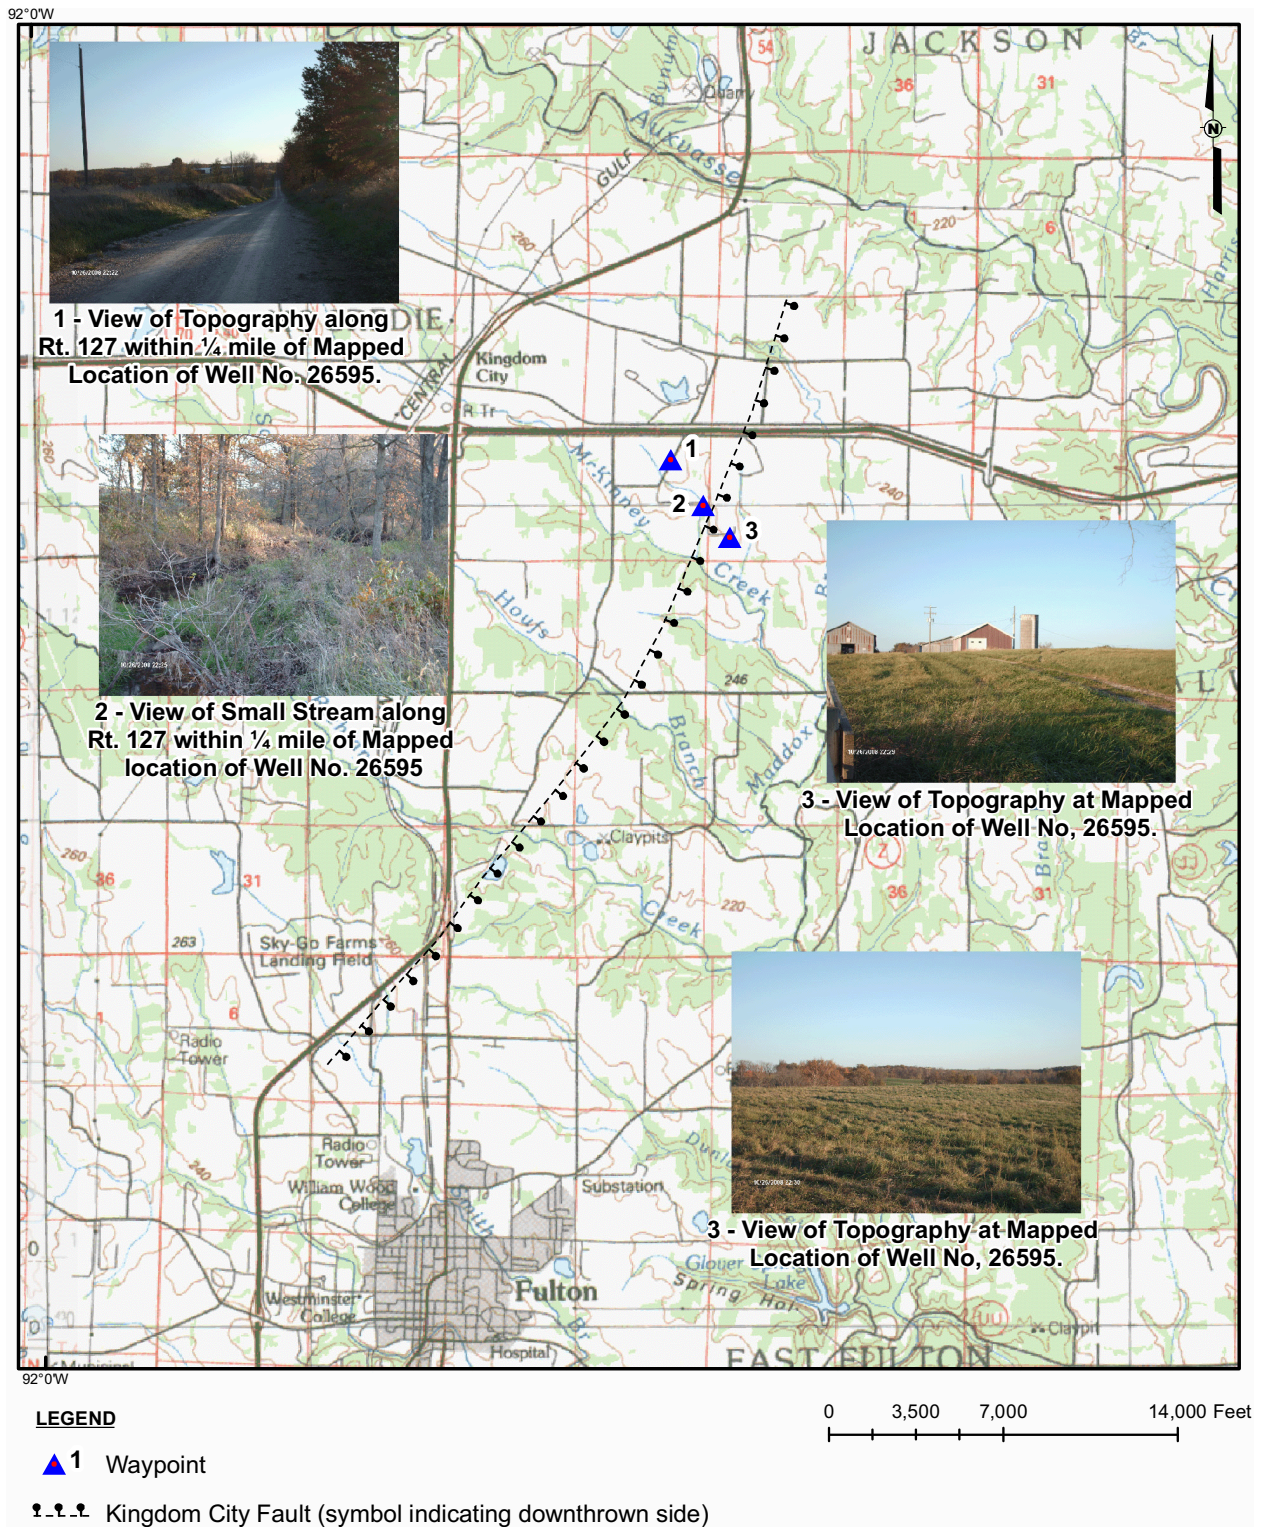
Figure No. 15—Waypoints Along the Kingdom City Fault

Kingdom City Fault, as reported in section 2.5.1.1.4.2.2, trends east-northeast in Callaway County, Missouri on the Kingdom City Quadrangle Map, 14 miles (23 km) to the northwest of the Site ([Table No. 5](#) and [Figure No. 15](#)). The evidence for this fault is on well log 26595 at the Missouri Geological Survey and Water Resources. It is interpreted to be a reverse fault that cuts the St. Peter Formation twice, displacing the formation 200 to 300 ft (61 to 91 m) with the downthrown side being to the southeast. A reproduced version of well log 26595 is provided in [Table No. 6](#) showing the interpretation that indicates an offset.

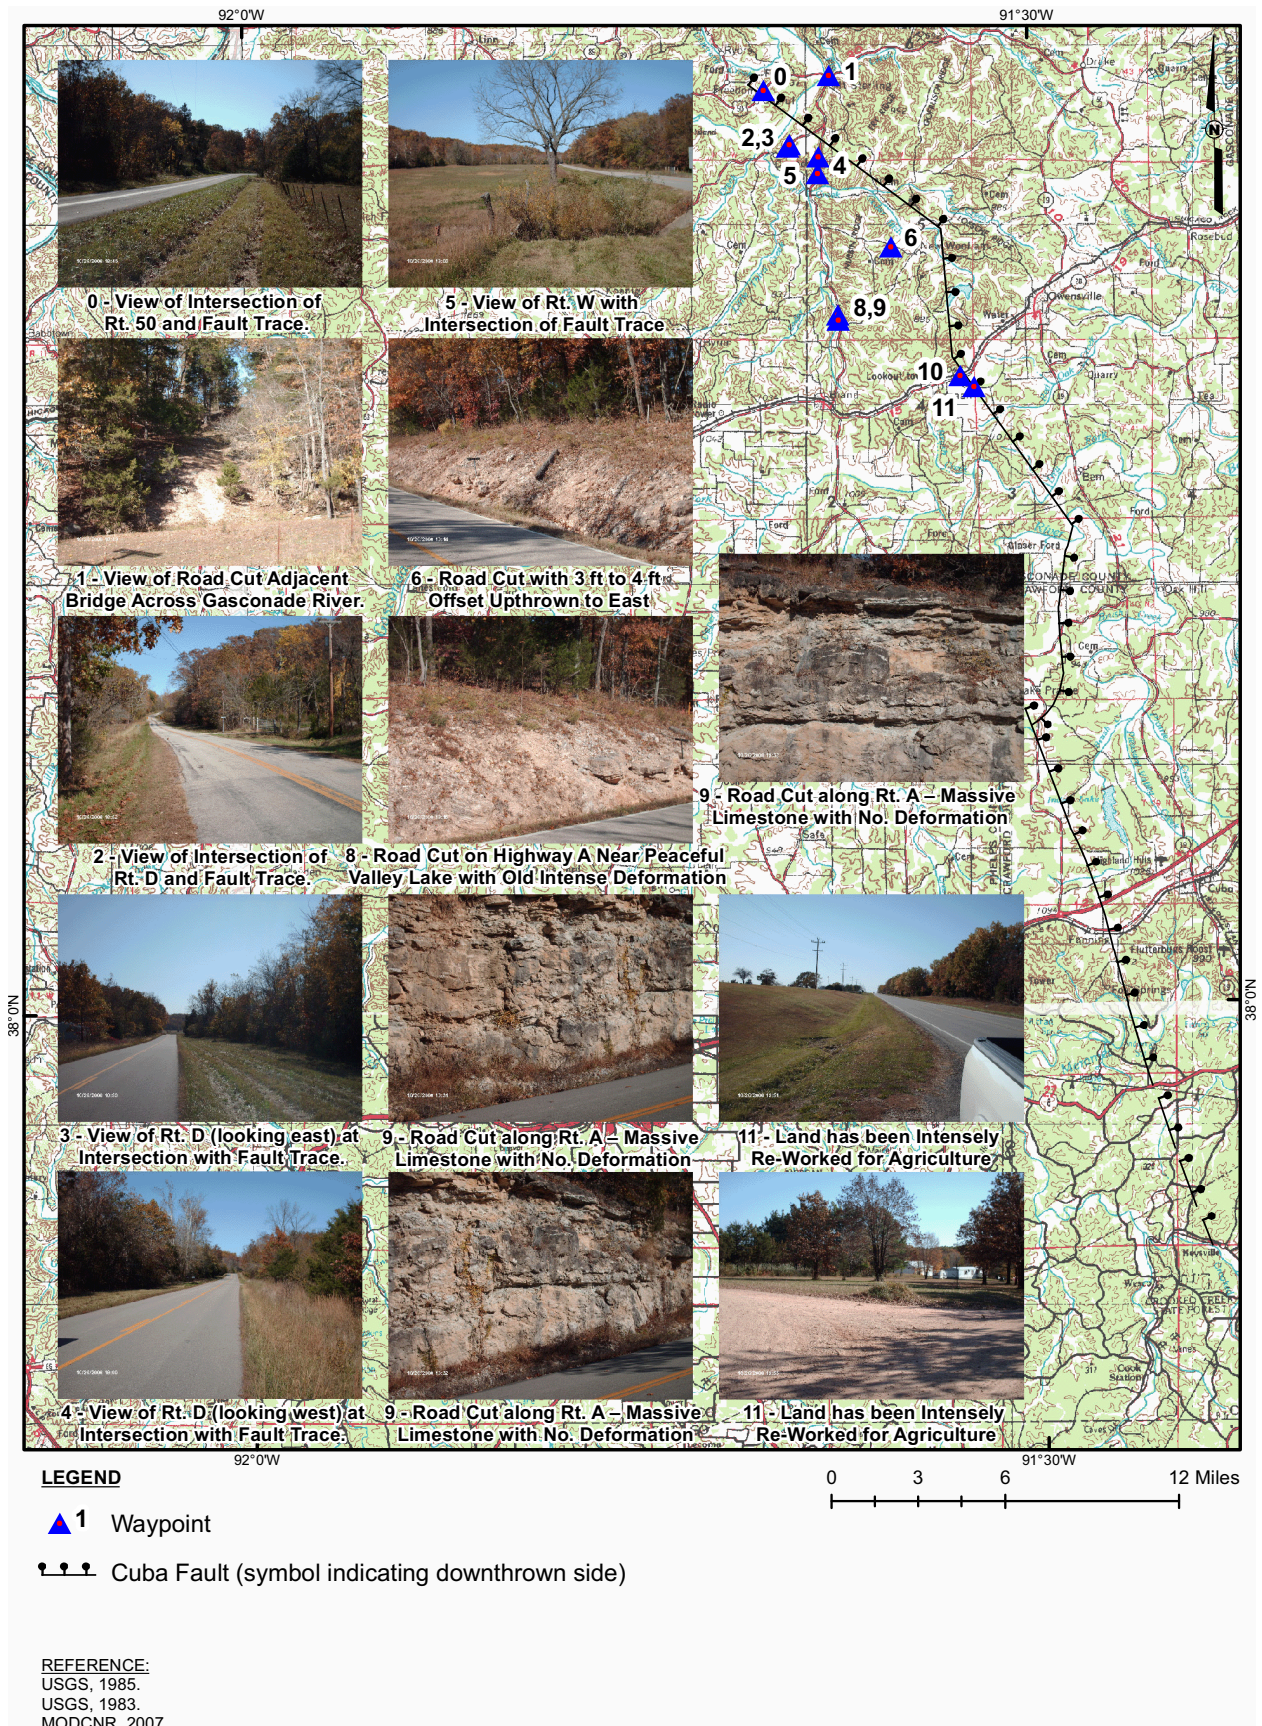
Figure No. 18—Waypoints Along the Cuba Fault

The alignment of the feature is basically north-south, and road cuts on east-west roads in Osage and Gasconade Counties were the focus of the effort (Figure No. 18 and Table No. 7). The published alignment was traversed at twelve waypoints where visual observations were made. These, plus other road cuts in the local area, were investigated for evidence of offsets and shears. No new roads have been cut and no significant new development has occurred in recent years.

The results of the new investigation indicate that in many instances the area of the alignment is heavily vegetated, or reworked for agricultural purposes. At most road cuts across the alignment, such as at Waypoint 1 (Figure No. 18), no deformation is apparent. In contrast, the road cut at Waypoint 6 (Figure No. 19) showed small offsets but the upthrown side is to the east, which is contrary to the overall throw reported for the Fault in the literature.

At Waypoint 8 (Figure No. 20), a road cut along Highway A near Peaceful Valley Lake, the deformation on the north side of the road cut is intense, but very old. At another road cut on Highway A, Waypoint 9 (Figure No. 18), the road cut indicates massive, undisturbed limestone with no evidence of deformation. No deformation was observed in road cuts at Waypoints 10 and 11, both of which intersect the reported fault trace (Figure No. 18).

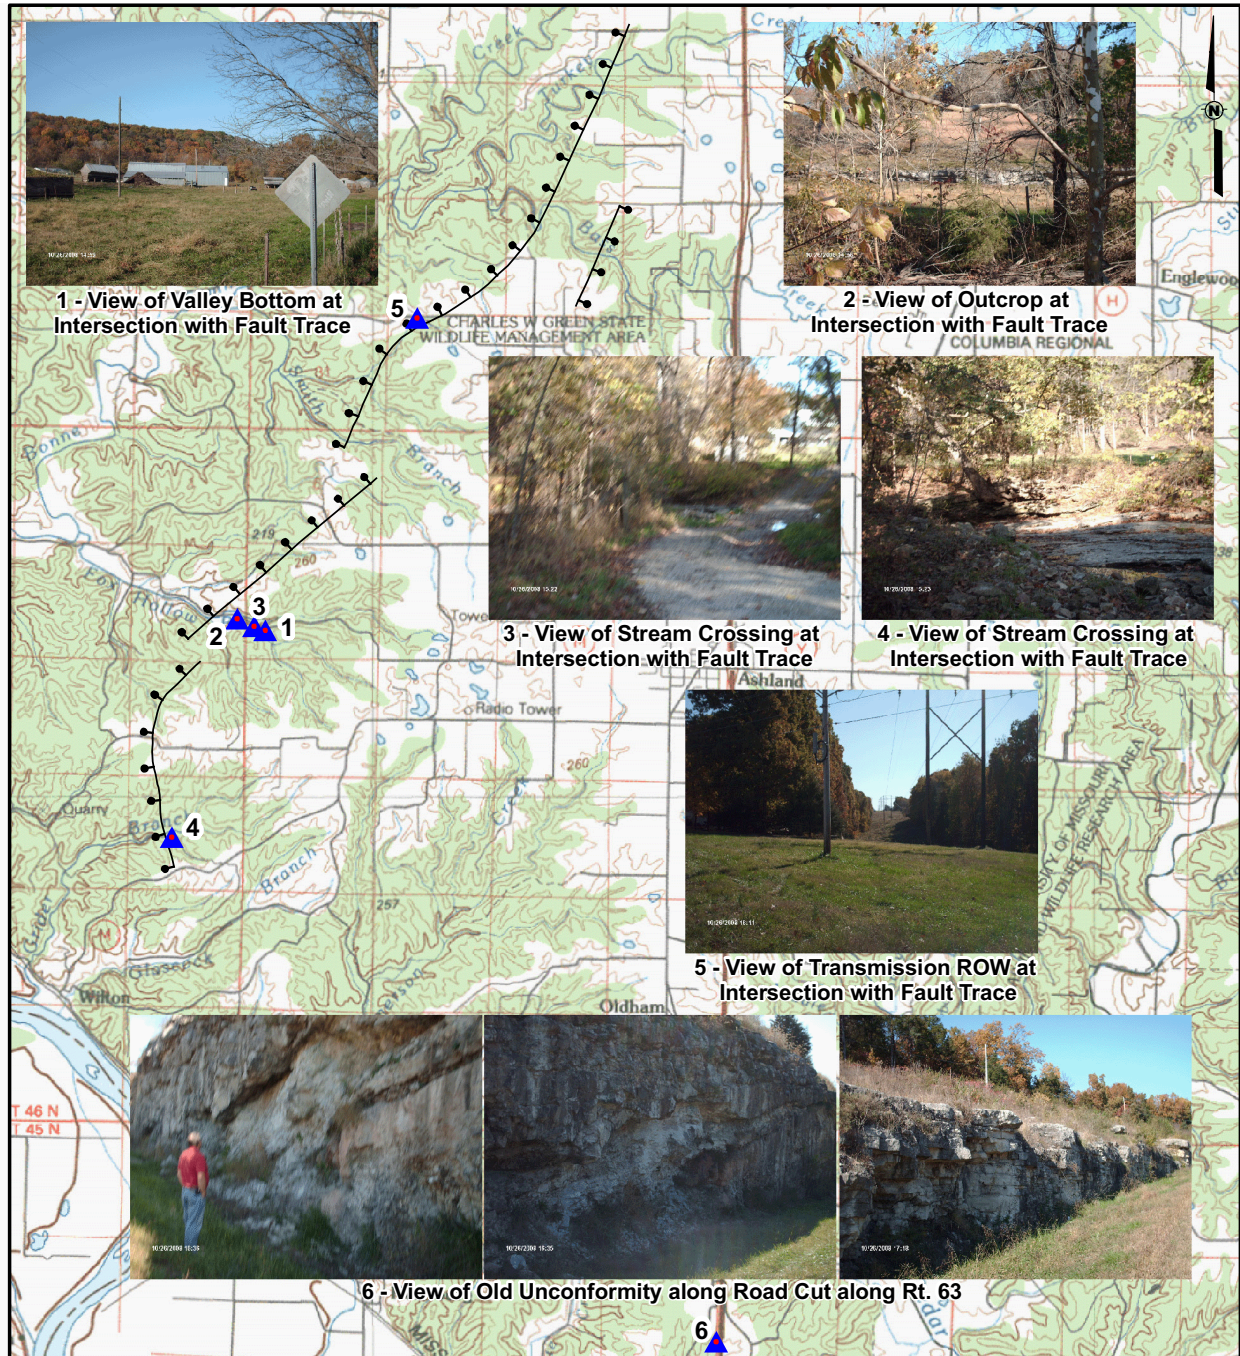
Figure No. 21—Waypoints along the Fox Hollow Fault

The Fox Hollow Fault was revisited during this investigation to determine if any new evidence has evolved since the feature was reported in the Callaway Plant Unit 1 FSAR (Figure No. 21 and Table No. 8). For example, the investigation was directed at new road cuts and new facilities, if any, in the area of the Fault that would provide more knowledge of the feature.

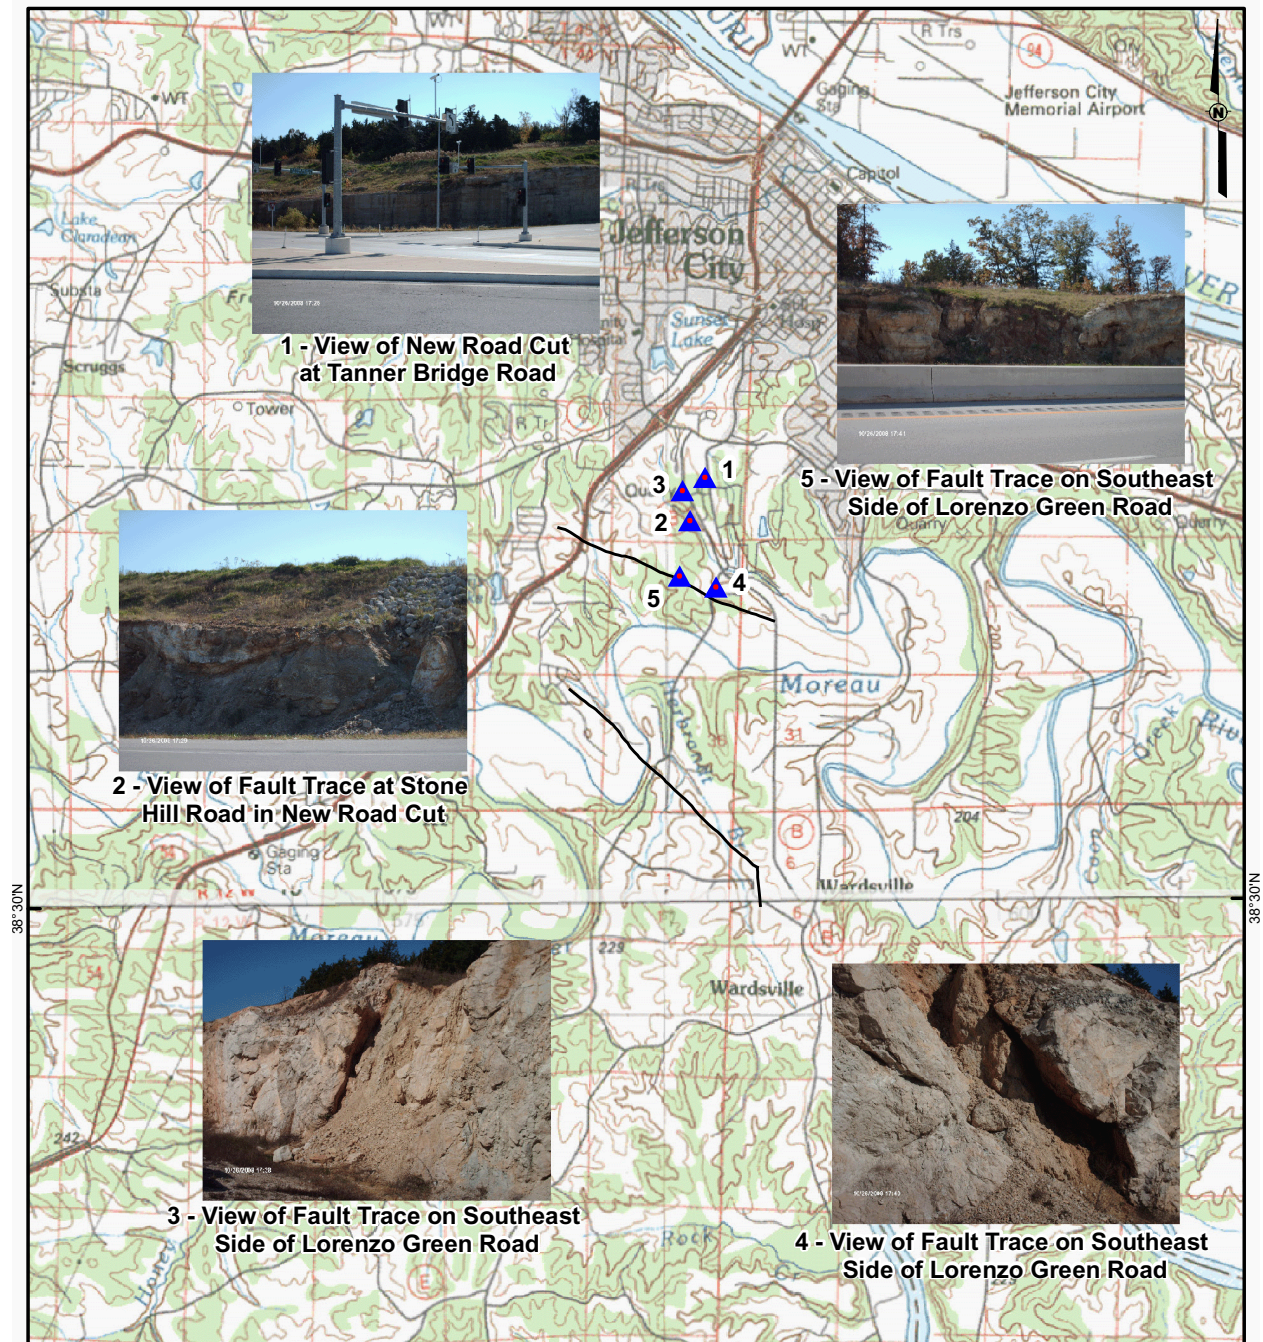
Figure No. 24—Waypoints along the Wardsville Fault

The area of the feature was re-visited and studied at several waypoints where visual observations were made (Figure No. 24 and Table No. 9). Several new road cuts are now available for inspection. These road cuts as shown on photos in Figure No. 25 and Figure No. 26 show clear offsets that indicate an alignment and suggest a total offset in the range of 100 feet (30 m), as reported in the Callaway Plant Unit 1 FSAR. At Waypoint 3 along the west side of Lorenzo Green Road (Figure No. 25) and east of Tanner Bridge Road, approximately 100 ft (30 m) offset could be accounted over several steps associated with the road cut and adjacent residential development. New road cuts on Route B near the intersection with Christy Drive (Figure No. 26) allow for verification of the strike in this area (generally to the east). At a waypoint at the intersection of Route B and Tanner Bridge Road, the down thrown blocks were observed on both sides of the Route B, allowing for a determination of strike-generally northeast in this area.
