Vermont Yankee
Cooling Tower
Update

October 14, 2008

- **August 2007: Cell 2-4 Failure**
- **July 2008: Support Saddle Failures**
- **September 2008: Distribution Header Leak**

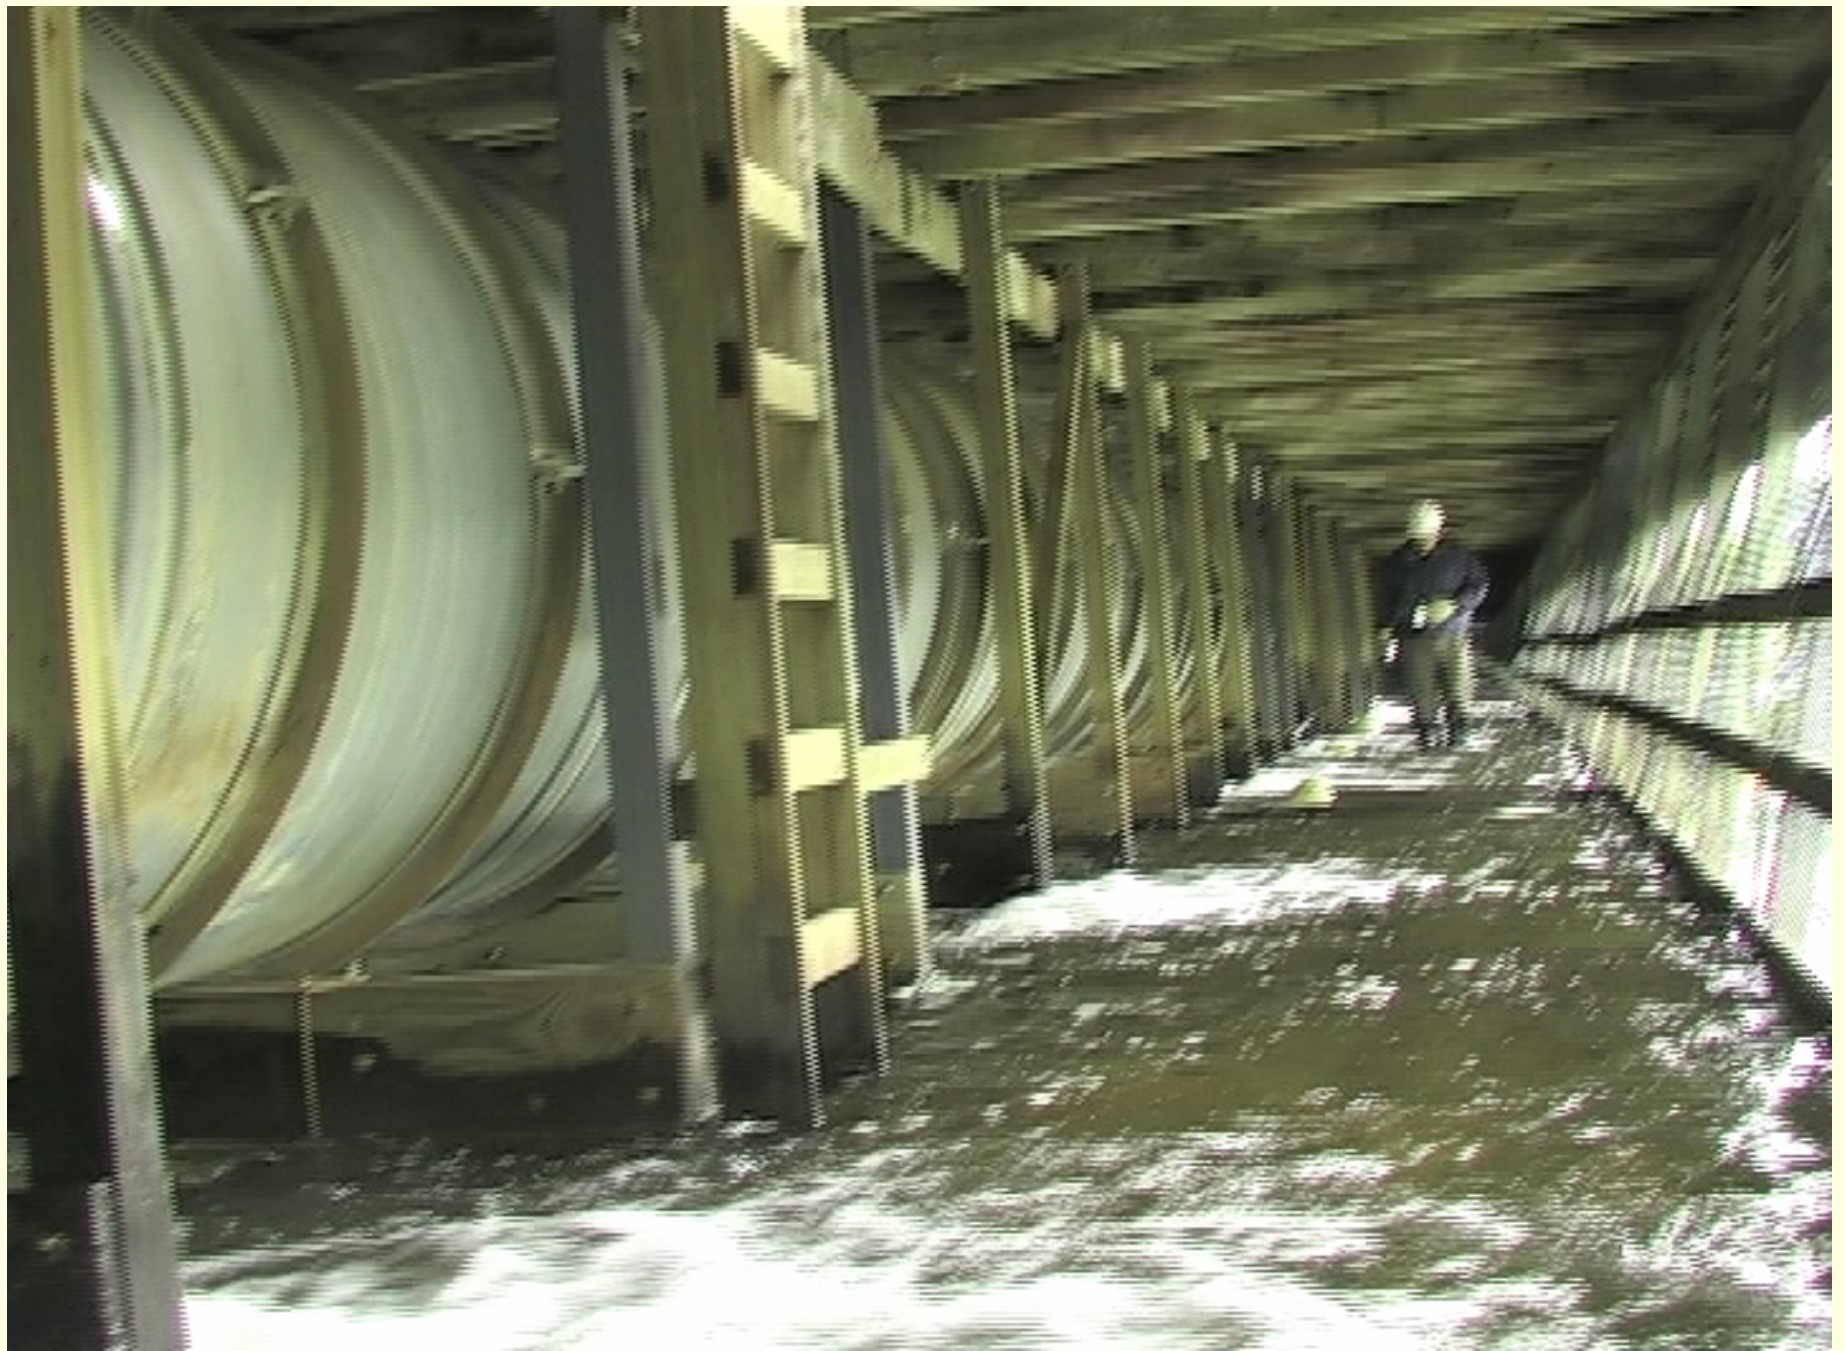
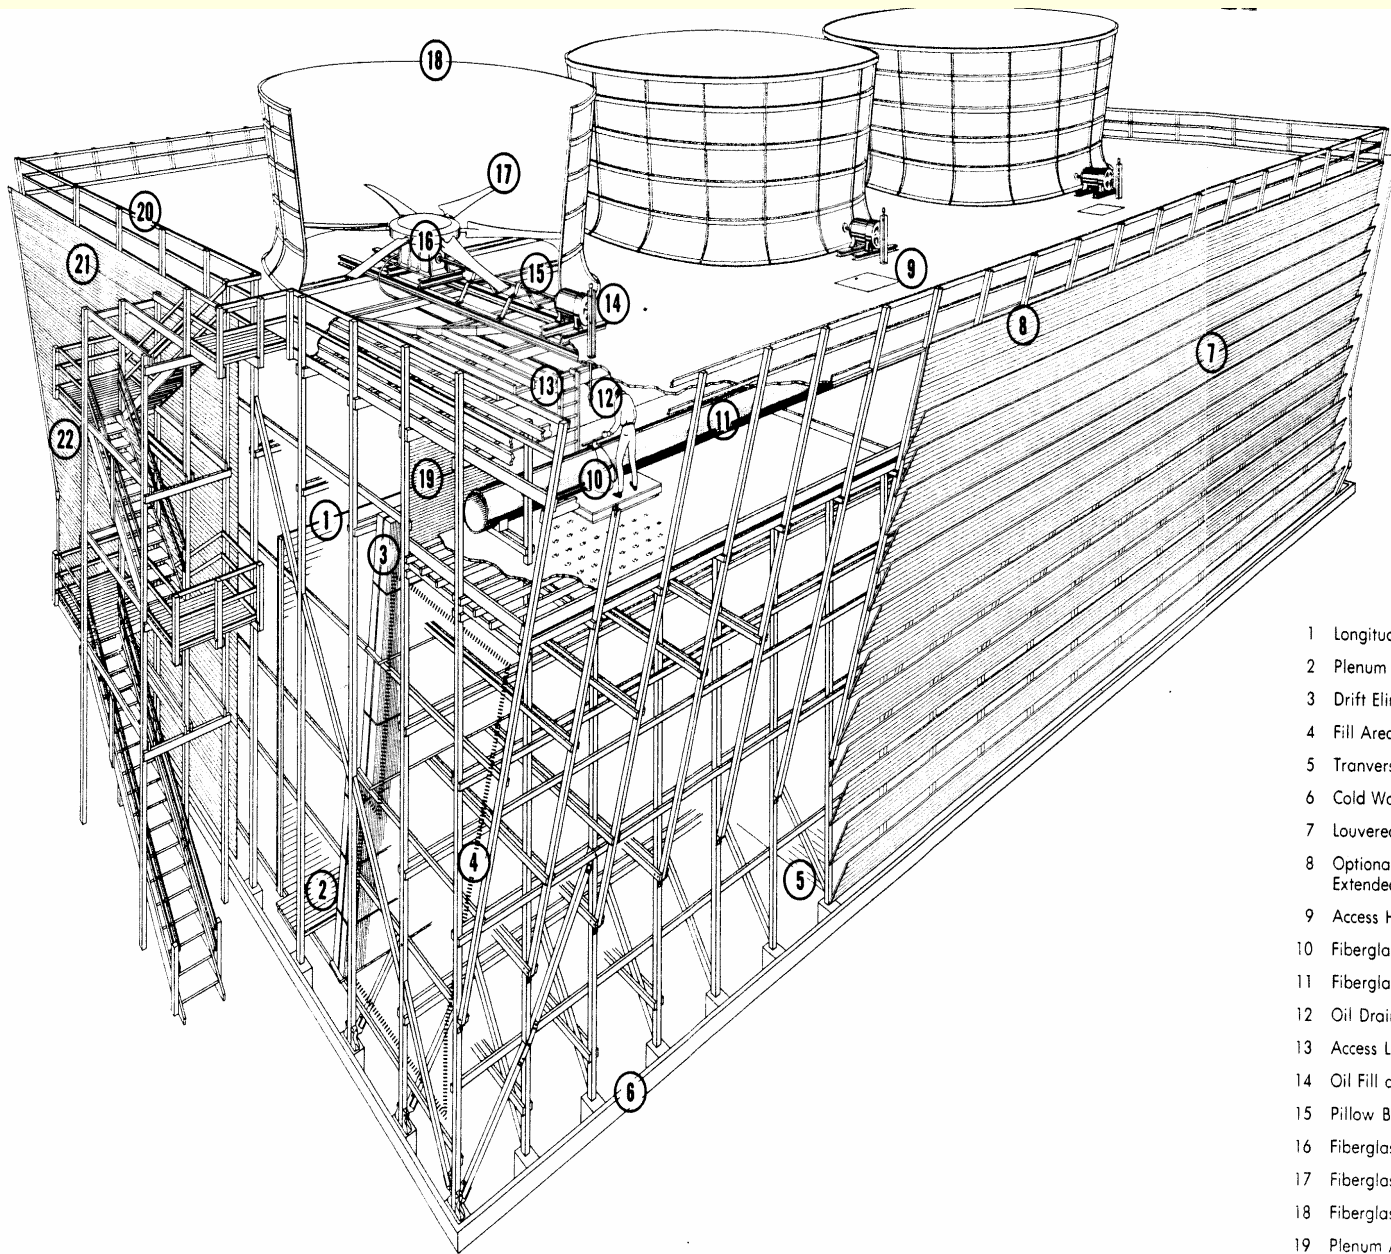
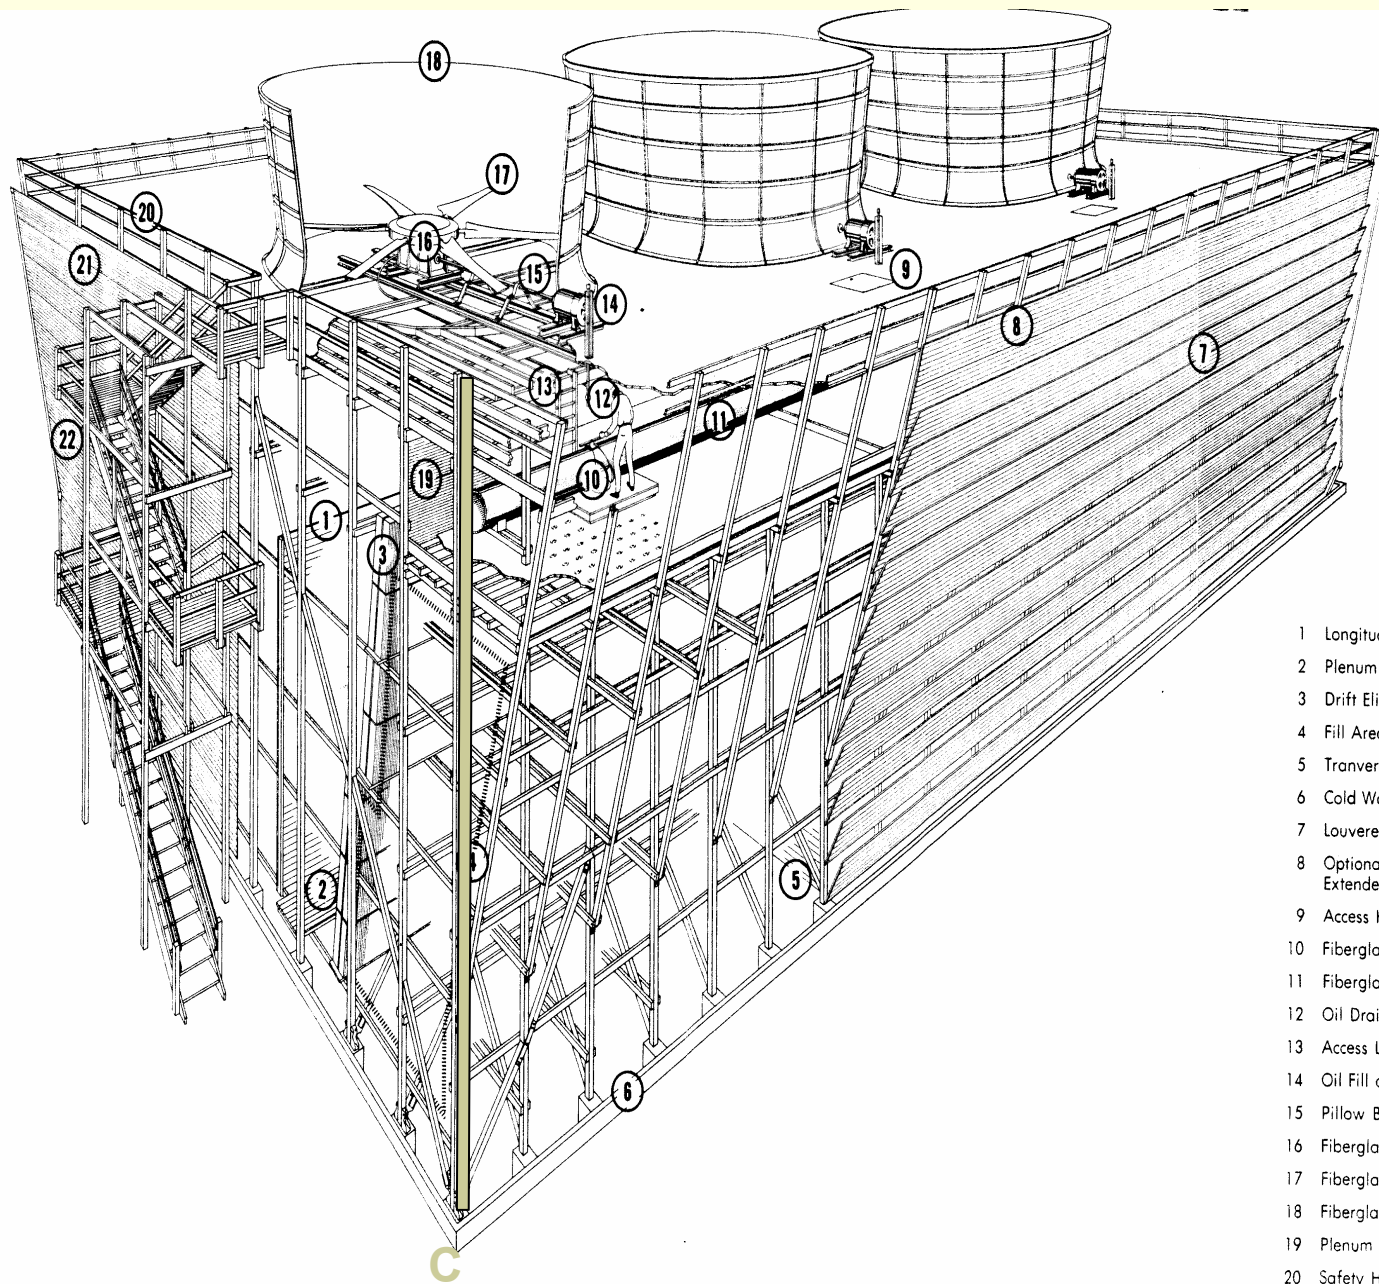
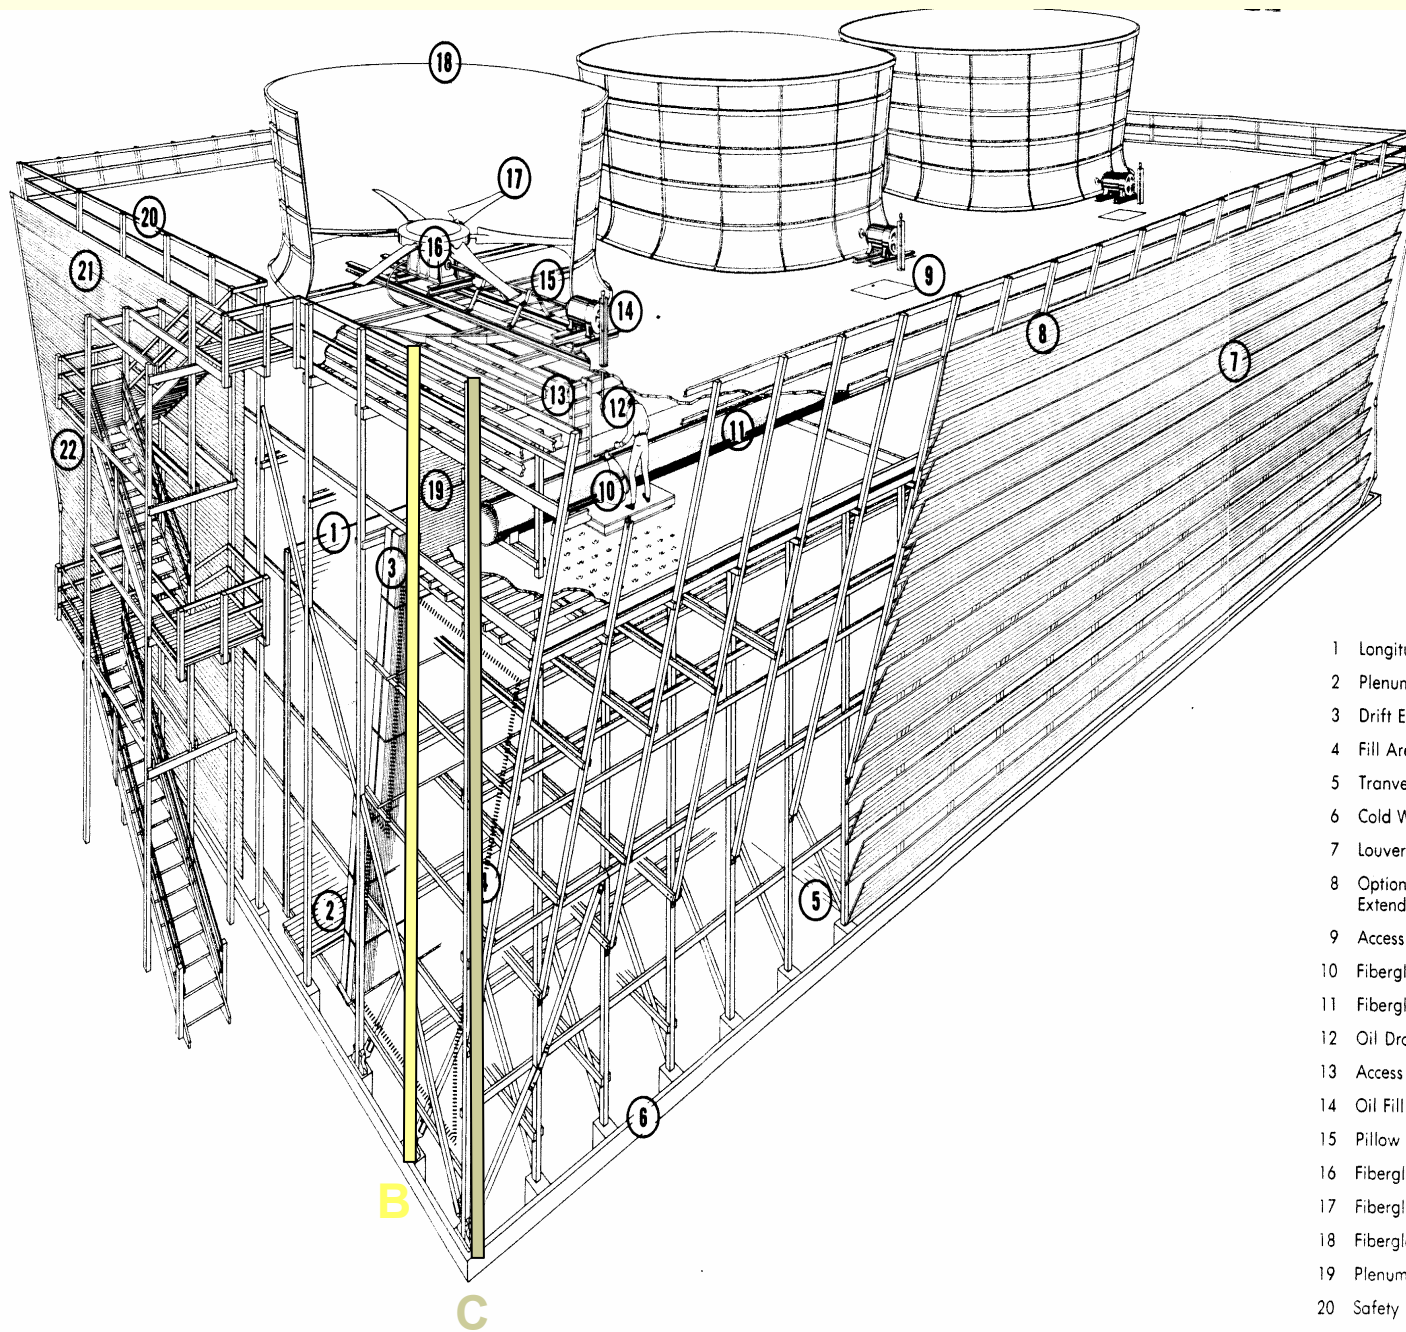
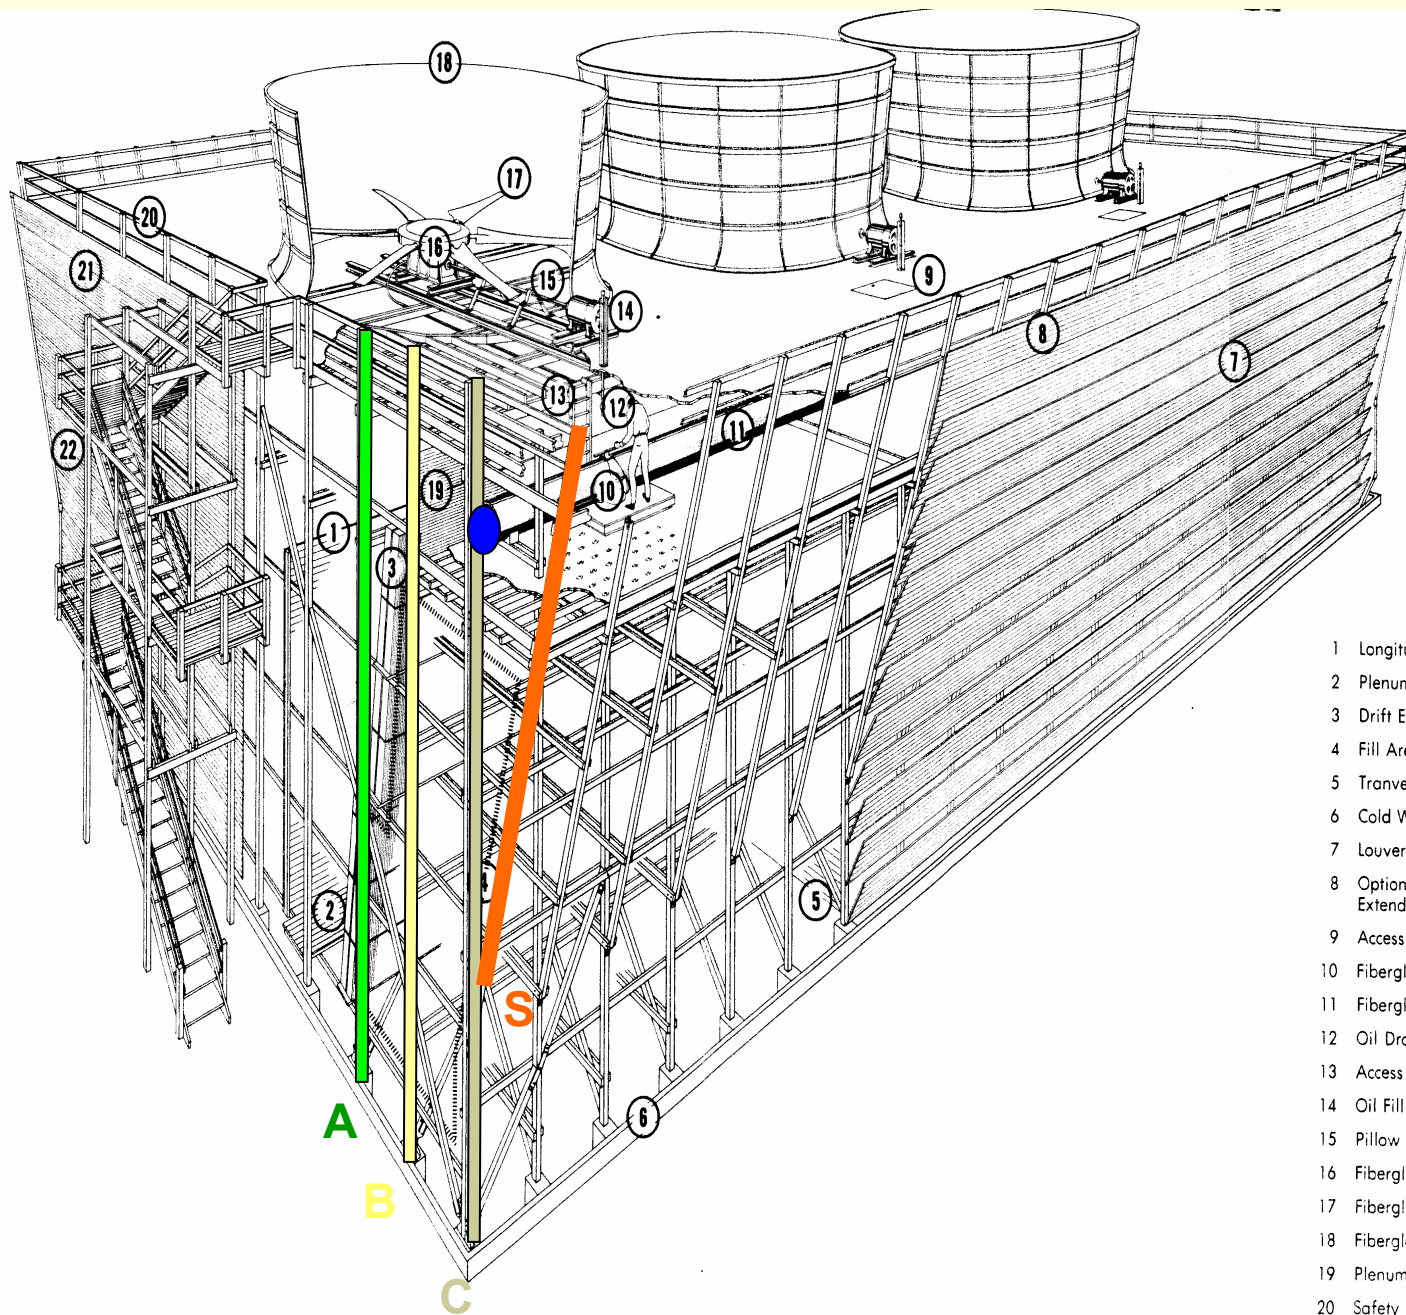
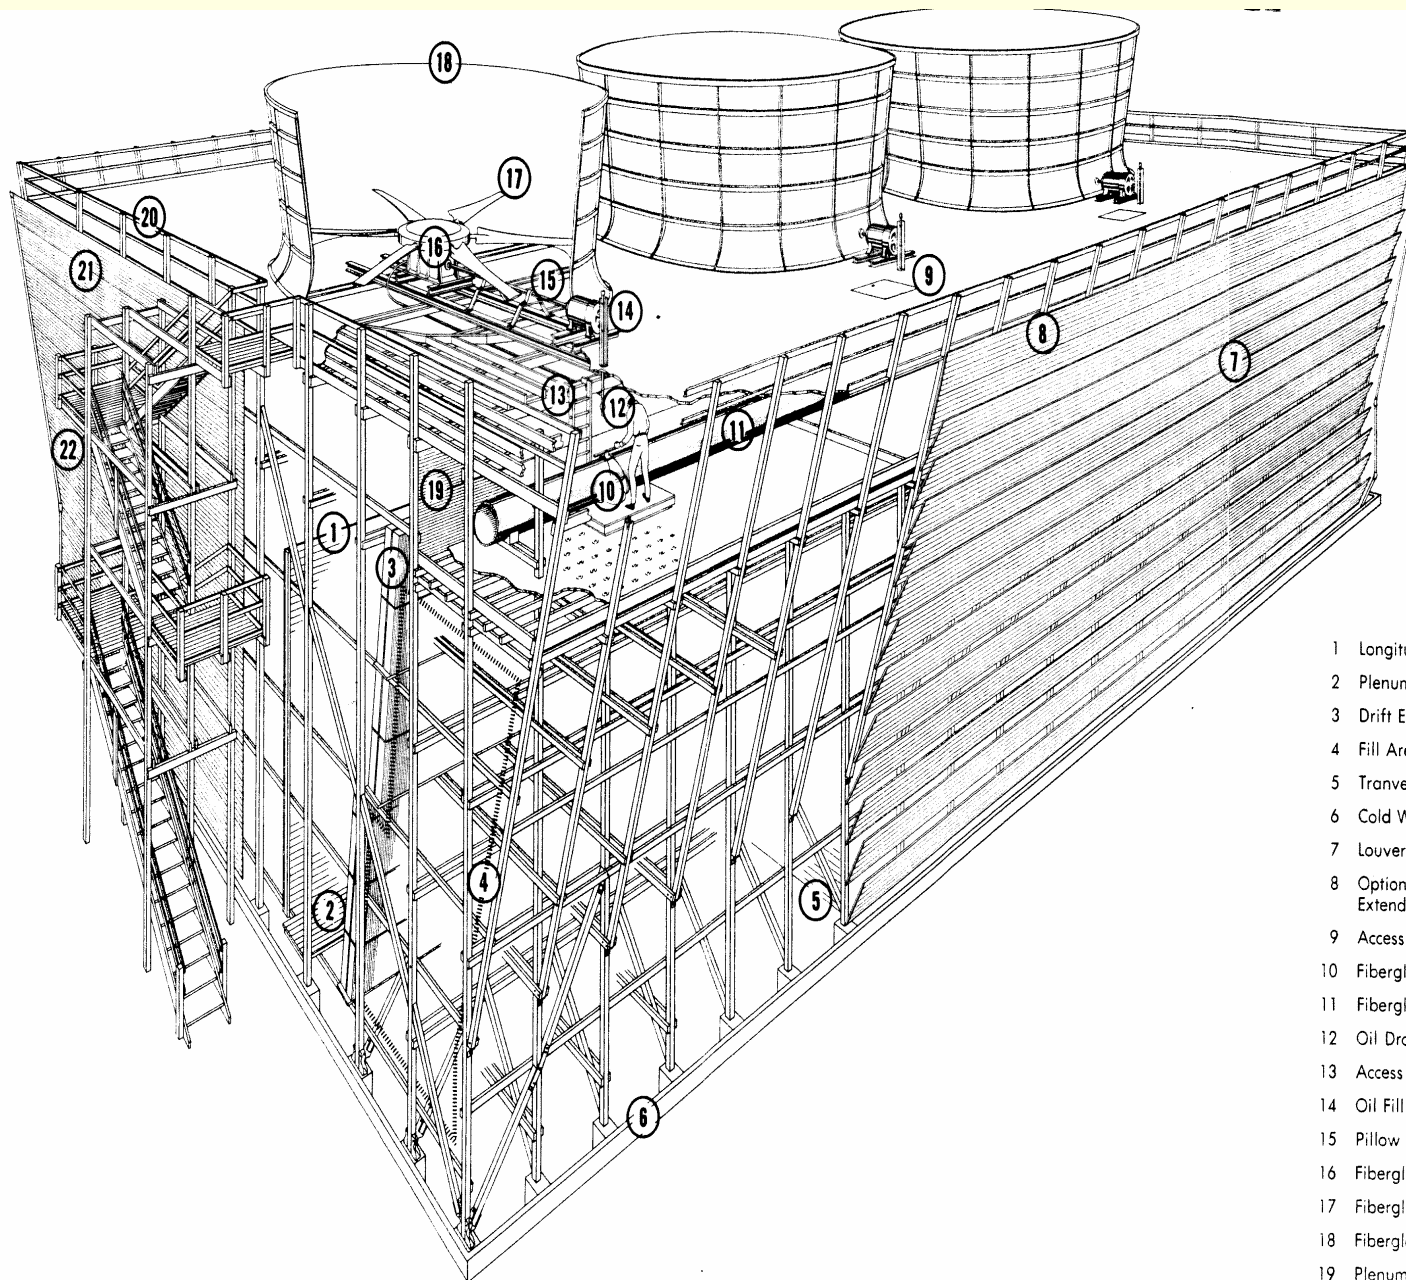
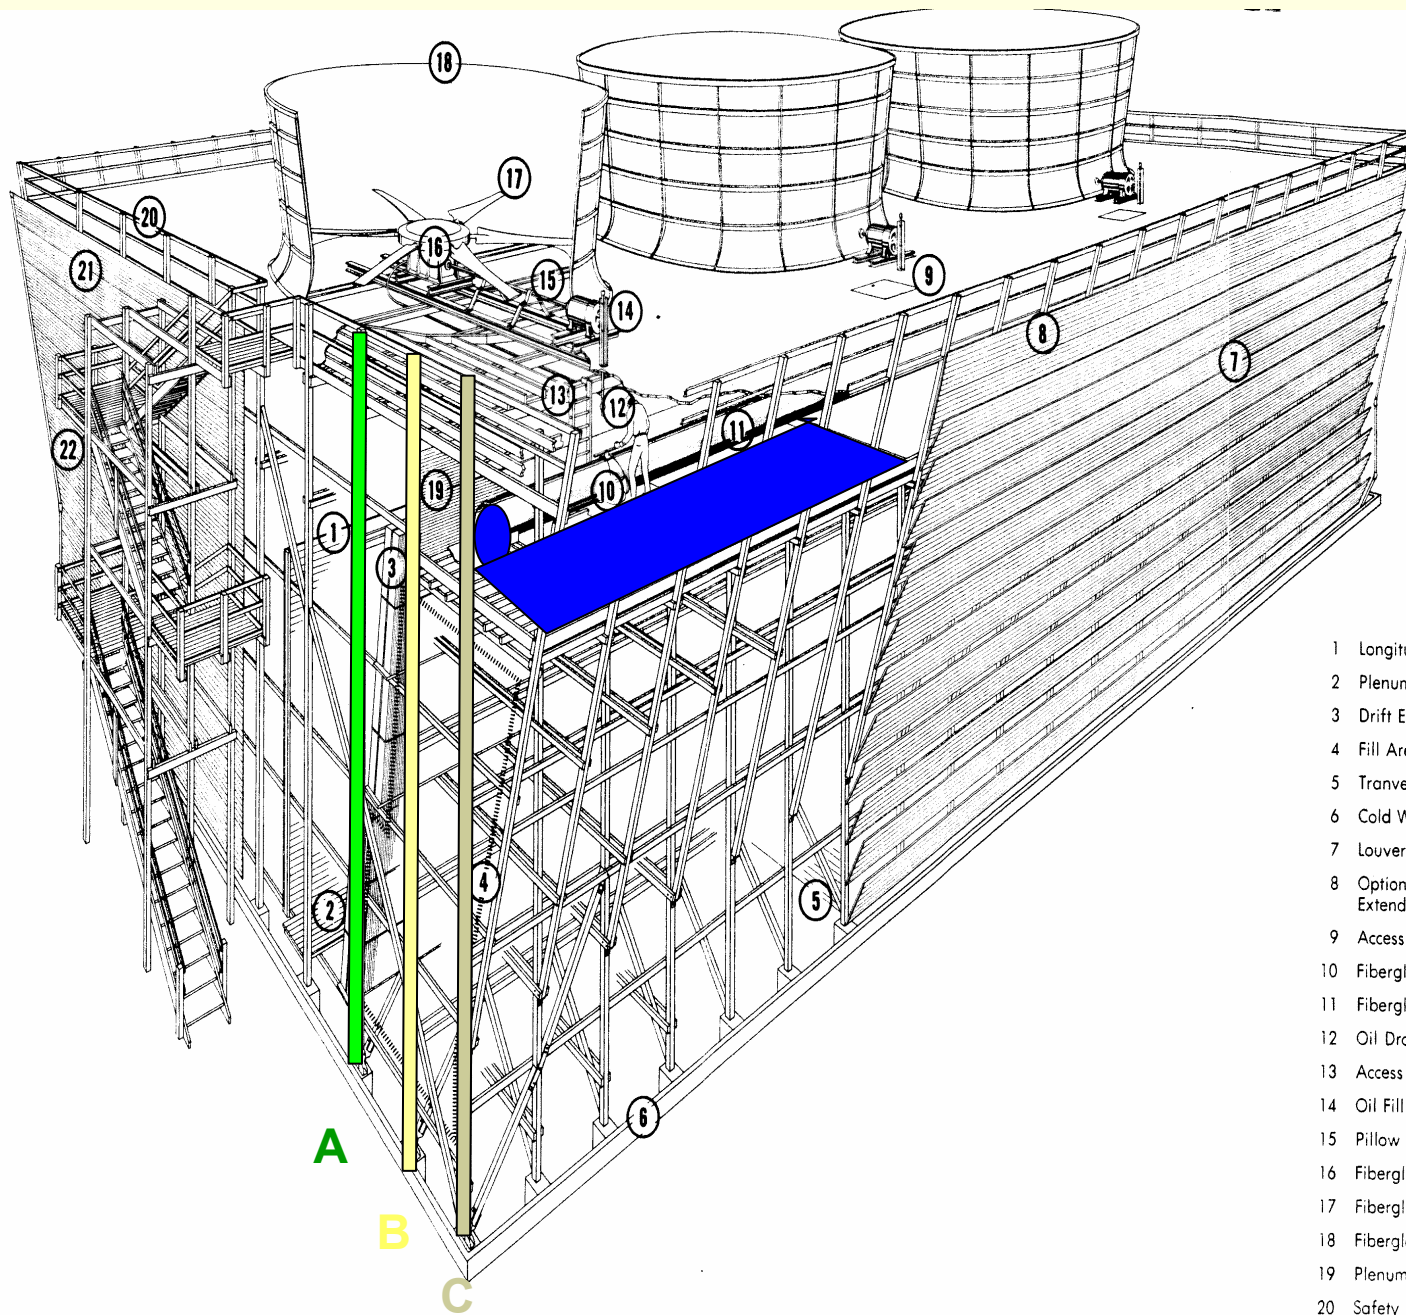
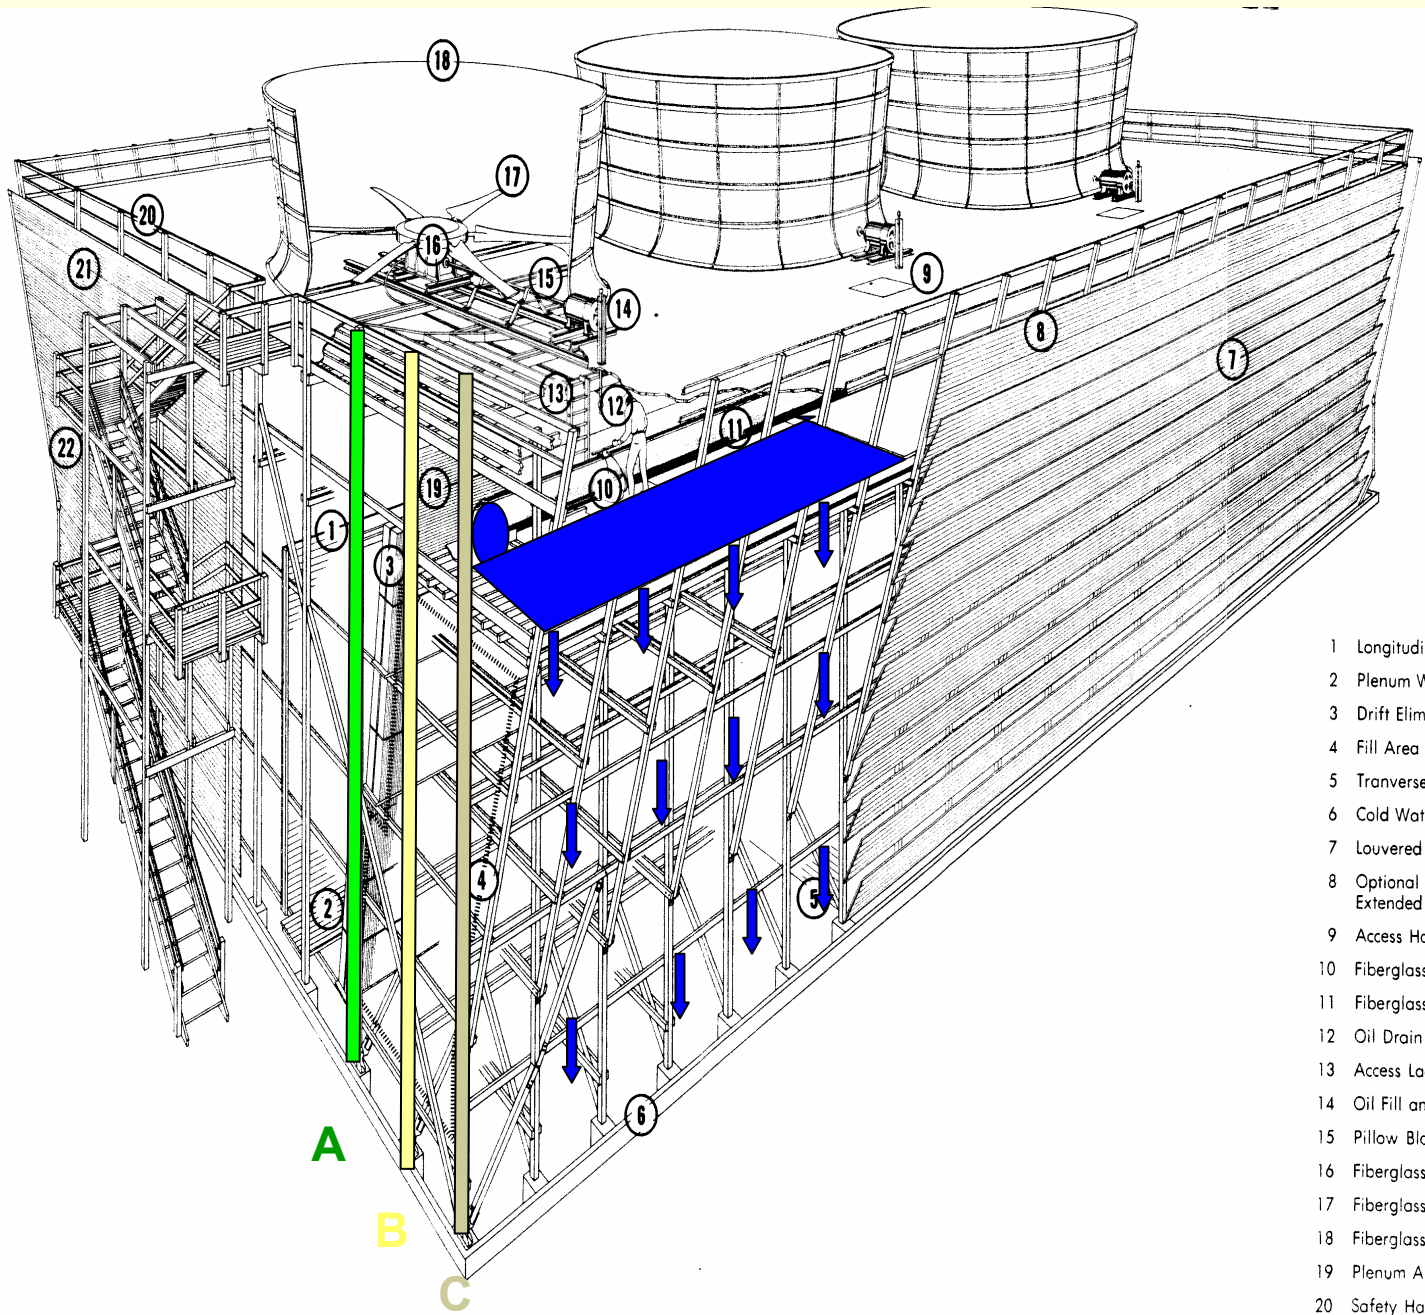
- Two support columns failed
- Failure of B Columns caused Distribution Header to sag
 - Loosened slip joints and caused large leaks
- Additional water increased weight on remaining support columns
- Other Support columns overloaded and failed
- Resulted in a partial collapse

Cell 2-4 Failure – Causal Investigation

- **Root Cause:**

- Support columns failed due to overload condition**

- **Other Causes:**

- **Inadequate Inspection Methods of Wood Structure**
 - **Inadequate Preventative Maintenance**

- **Contributing Cause: Design of Fill Material**

Cell 2-4 Failure – Corrective Actions

- **Rebuilt Cell 2-4**
- **Completed Extent of Condition Inspections and Repairs**
- **Fully Revised Inspection Procedures and Acceptance Criteria**
- **Established 2008 Cooling Tower Project Plan**

- **Phase 1 of Long Range Plan – Completed May 2008**
 - **1/3 Replacement – (Bay 4)**
 - **New Structural Member Material: Fiberglass Reinforced Plastic (FRP)**
 - **New Fill Material**
 - **Extent of Condition Repairs**
- **Used External/Fleet Technical Expertise**
- **Long Range Plan**
